**Archaeological
Building Survey:**

Woods Mill, The
Narrow Spinning
Mill, Glossop

Report No:
2015/25

Document Type: Archaeological Building Survey

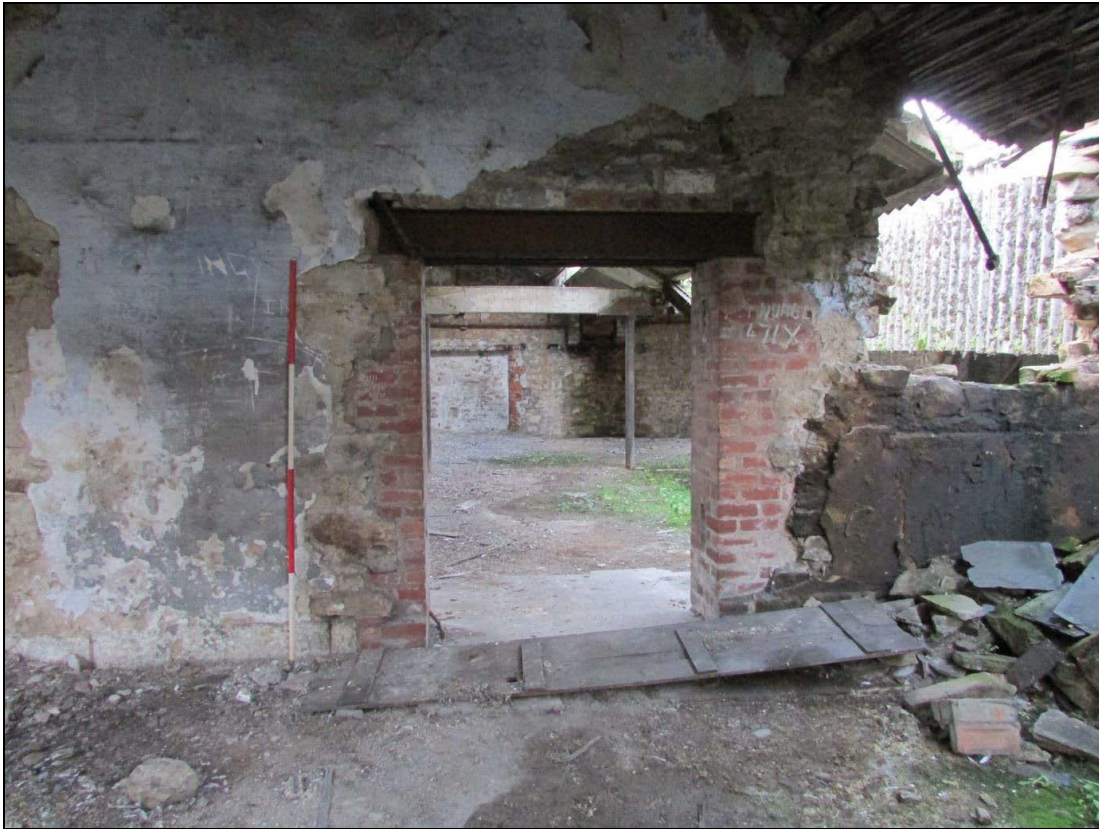
Within the western elevation, there was an entrance blocked by the lift shaft at the southern extreme. There was a central entrance into the engine house which had been inserted into the random rubble coursed wall. It had a metal lintel and the entrance was squared off by constructing machine-made brick around the stone wall. A large aperture in the wall immediately north of the entrance appears to be where the top steady bracket for the upright shaft was located (Plate 30). This was photographed *in situ* during the 2007 Buildings Assessment, however had since been removed.

Plate 30 An inserted entrance into the engine house and position of robbed out top steady bracket (to the right)

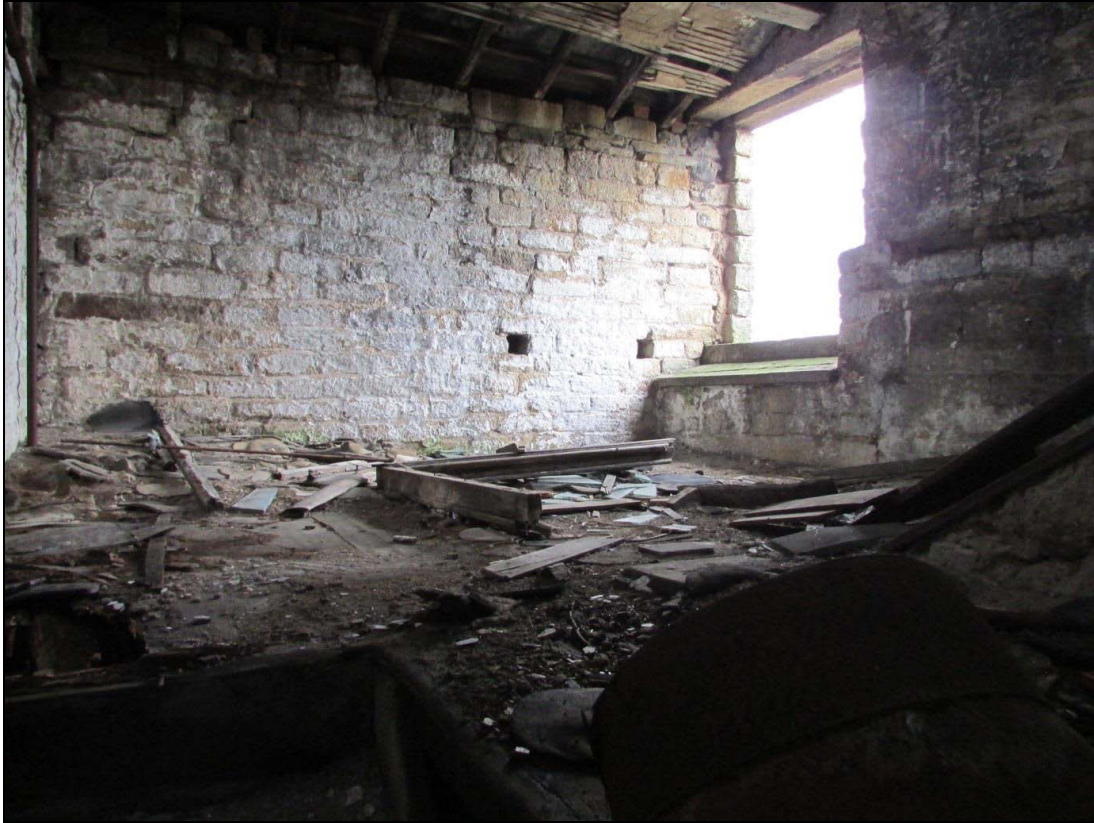
Located within the stair tower was an 'attic' space which was accessed via four timber steps (Plate 31). The timber was rotted in places therefore it could not be accessed however two apertures within the northern wall appeared to have formed timber supports. The coursed undressed stone wall forming the division was partly built around the window.

Plate 31 A small attic space located in the stair tower and accessed from the fourth-floor

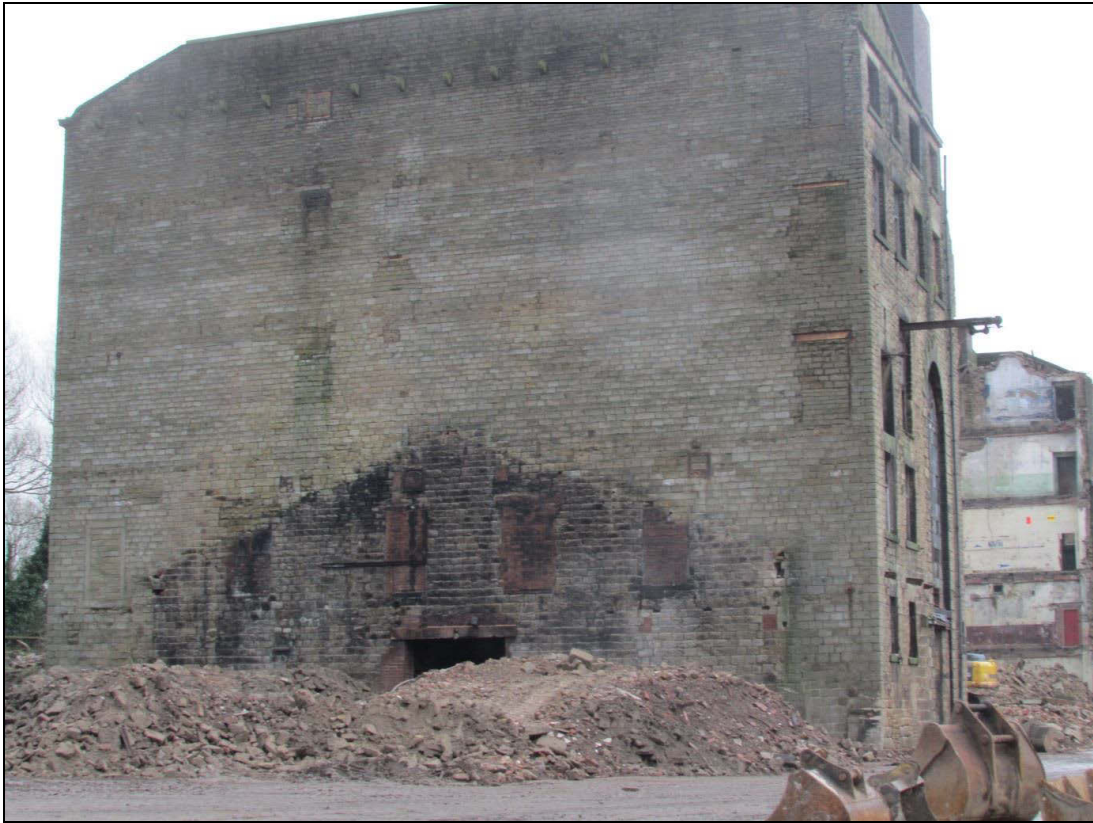
This elevation consists of six bays and contains regularly coursed roughly dressed small yellow sandstone blocks. At ground-floor level, there is a central entrance which appears to be a later insertion and partly built from machine-made brick. The metal lintel is obscured by a metal frame which appears to have been for a sliding door. On the southern side, there is a blocked doorway with one of the tie rod plates immediately south of it. On the first-floor, there are a total of five blockings with the northern one blocked with stone and two others blocked with machine-made brick. Two others are blocked with stone and brick, the brick blocking coinciding with the position of the former warehouse.

Plate 32 General view of the Engine House western elevation, after removal of the 20th century warehouse (its former position still visible)

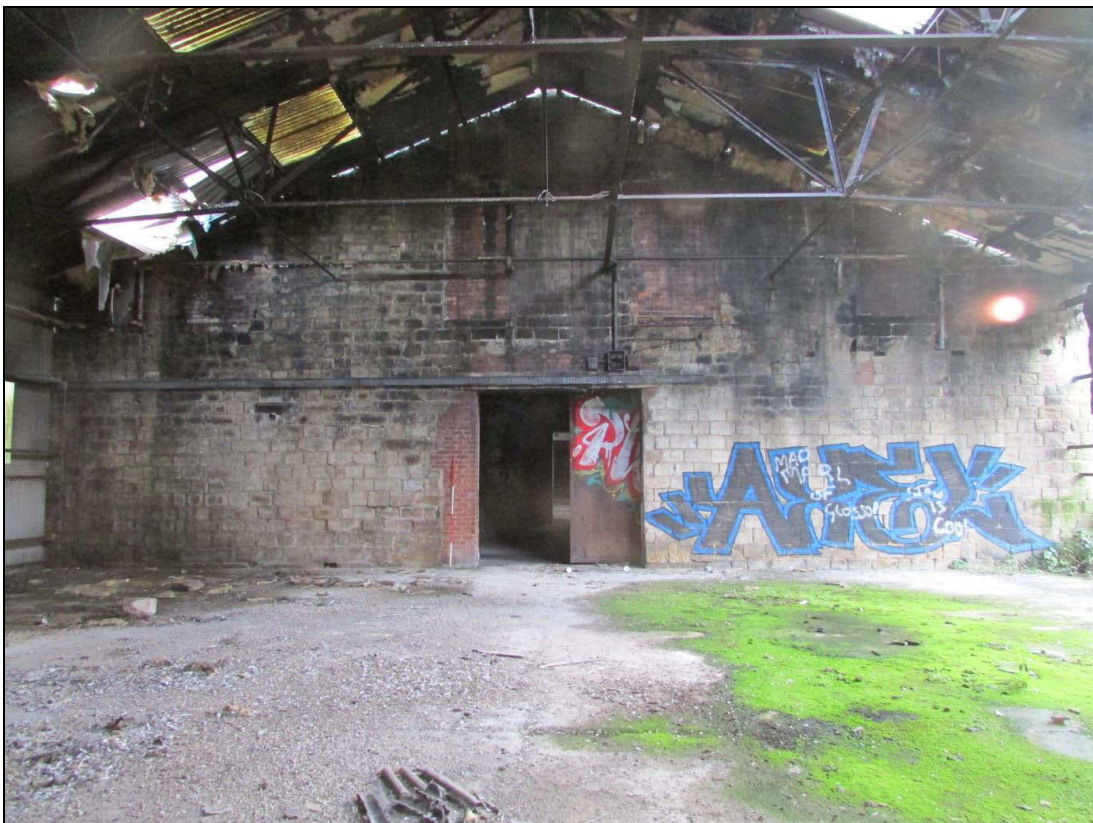
Plate 33 Close up of inserted ground floor entrance and blocked entrances on the first-floor

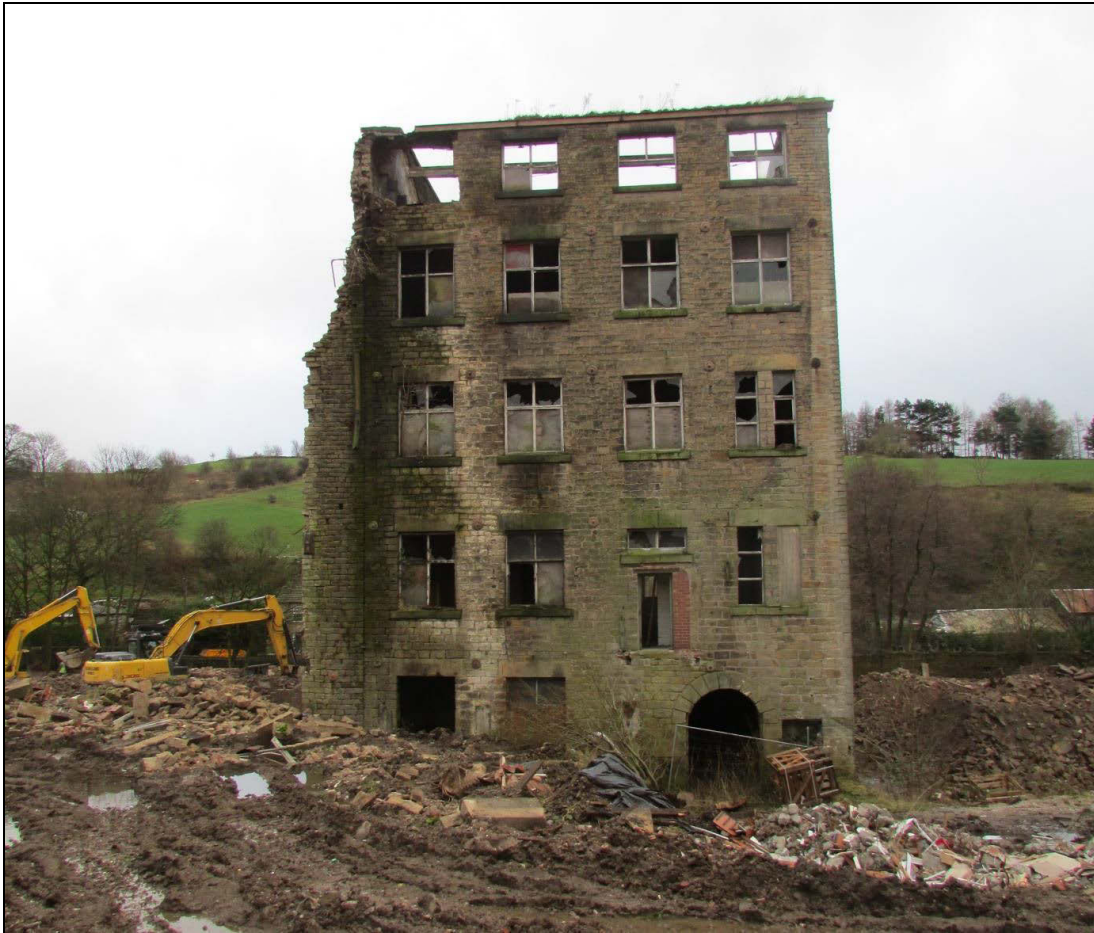
The first-floor contains three windows, measuring 1.80 x 1.40m with sills and lintels measuring the same as observed on the mill's northern elevation. The window at the western end had a stone pillar in the middle of the window with a slightly different window frame design. The window to the east of this one was modified and an entrance inserted with a metal lintel and machine-made brick to square it off. This appears to have been for a gangway which ran into a building which once stood to the north. The third and fourth-floor have four windows each, as described for the northern elevation of the mill. The exception is the western window which also has a stone pillar in the centre, as the floor below. The fourth-floor windows are smaller, four light windows and are as described for the northern elevation for the mill.

Plate 34 Northern elevation of the engine house

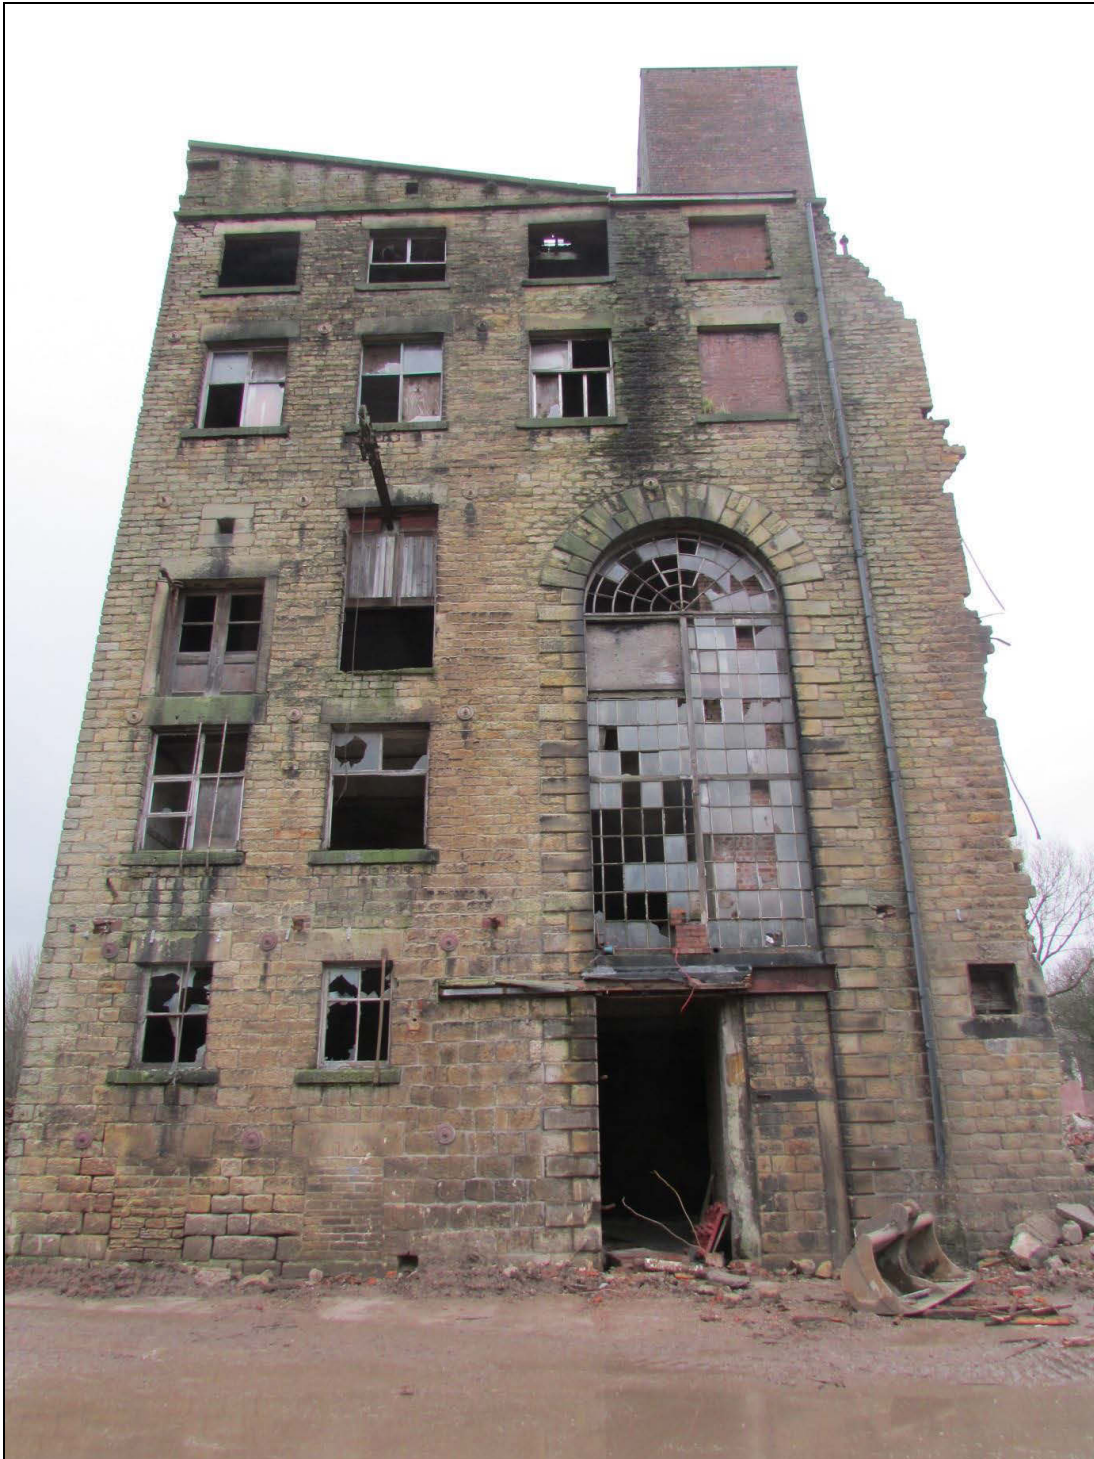
The southern elevation consists of four bays with regularly coursed, roughly dressed small yellow sandstone blocks. The window arrangement differs from the rest of the mill, with the eastern two bays dominated by a large round headed window, with fanlight and dressed rusticated quoins. This window covers the first and second-floor level although the dressed stones continue down to ground level where it defines coursed stonework on the east side and an entrance on the west side. The entrance appears to be a later modification, with a metal RSJ inserted for the lintel and fittings for a sliding door.

Plate 35 Southern elevation of the engine house

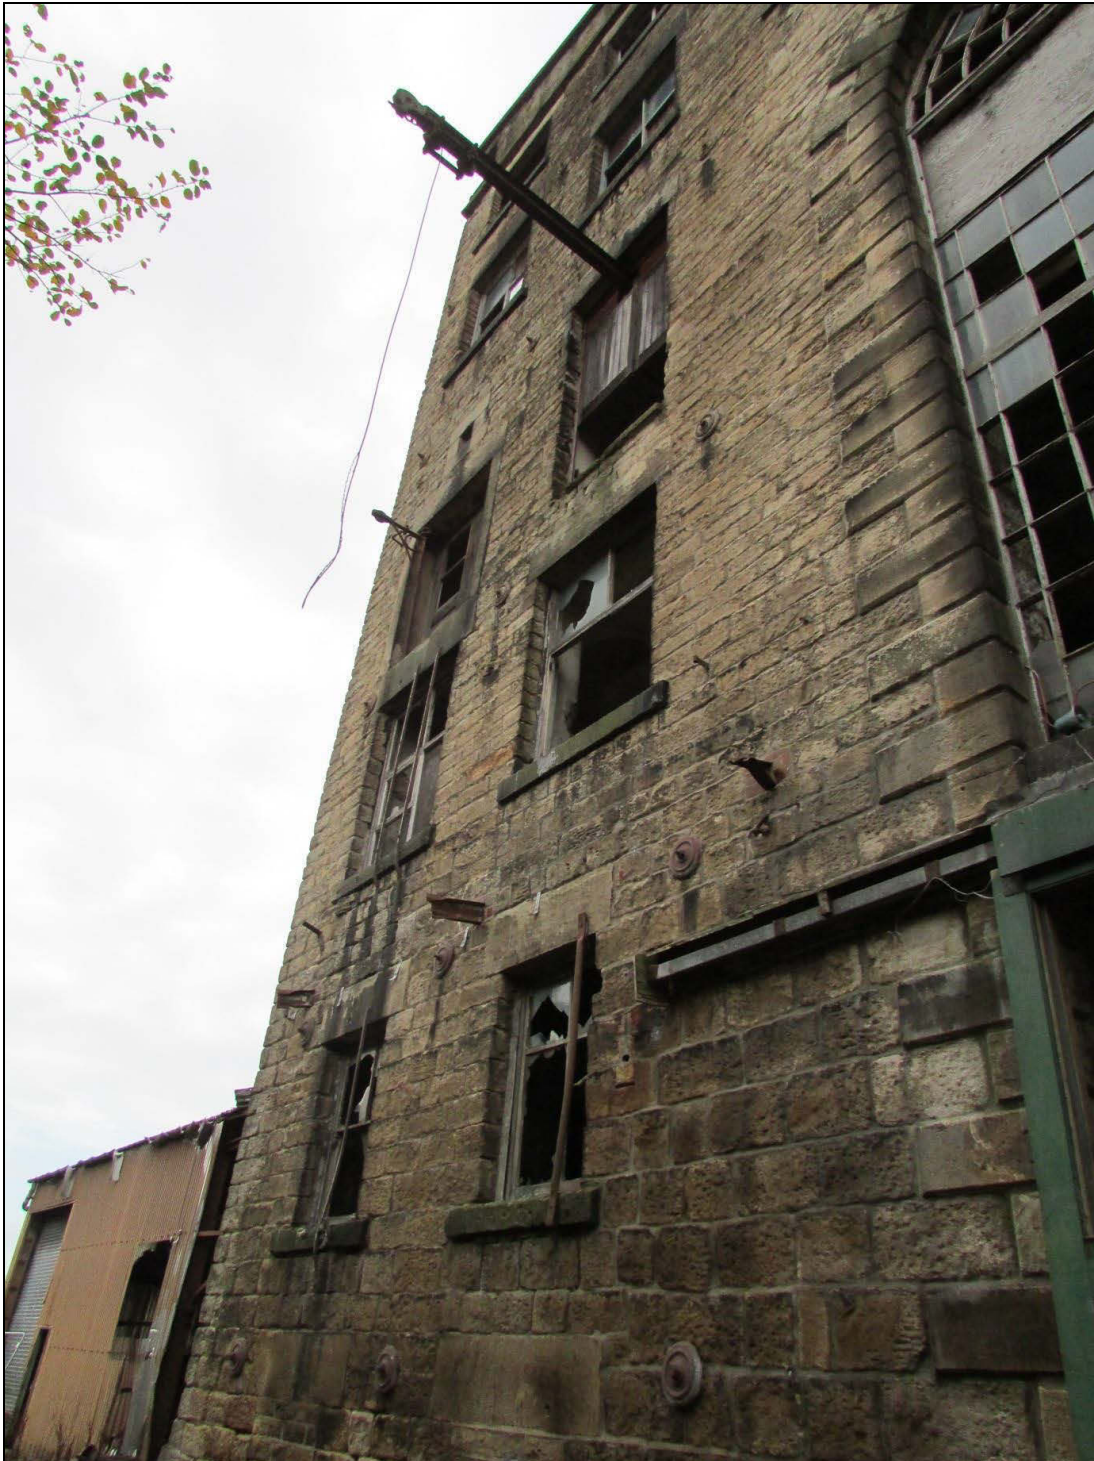
Plate 37 The western part of the engine house has taking- indoors on the third-floor including in situ cat head and swivelling crane jib

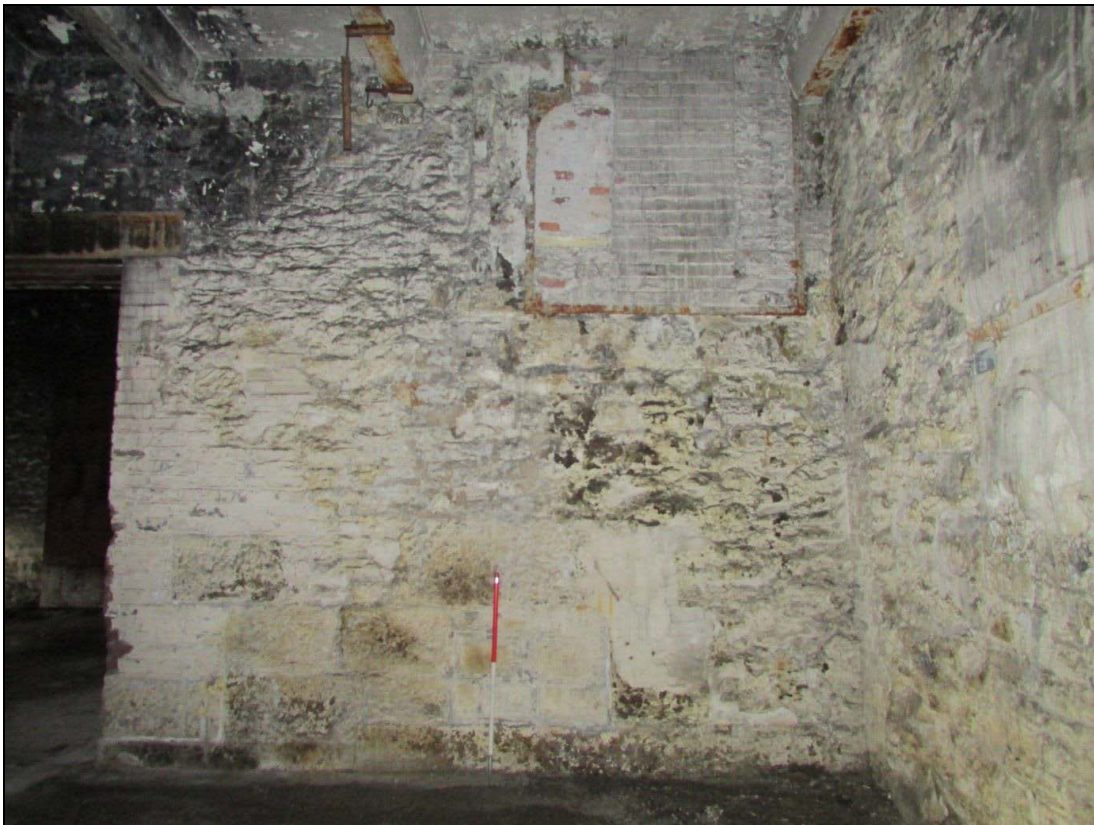
The ground-floor consisted of four separate rooms and the original access appears to have been from the north, with access from the south inserted later. A wall of random and uncoursed stone rubble was aligned north/south across the engine house. Parts of this wall incorporated large stone blocks, which had almost certainly formed the foundation bed for the original beam engine (Plate 38). The western half is divided with a machine-made brick wall which represented a later insertion. The room to the north-west can only be accessed from the arched entrance in the northern elevation. The south-west room has a fireproof ceiling with shallow brick arches and supporting iron beams running east/west. There is an entrance within the southern extreme of the dividing wall, with a stone lintel and frame and blocked with machine-made brick (Plate 39). To the north of this there was an inserted entrance with a metal lintel and shuttering, with machine-made brick constructed to square it off. Another entrance is located to the north, which was also inserted with a metal girder and machine-made brick squaring off the stone.

Plate 38 Although plastered over, the dividing wall of the engine house consists of mixed stone coursing types, including random rubble and coursed ashlar blocks. Also shown is a bearing box for the power transmission

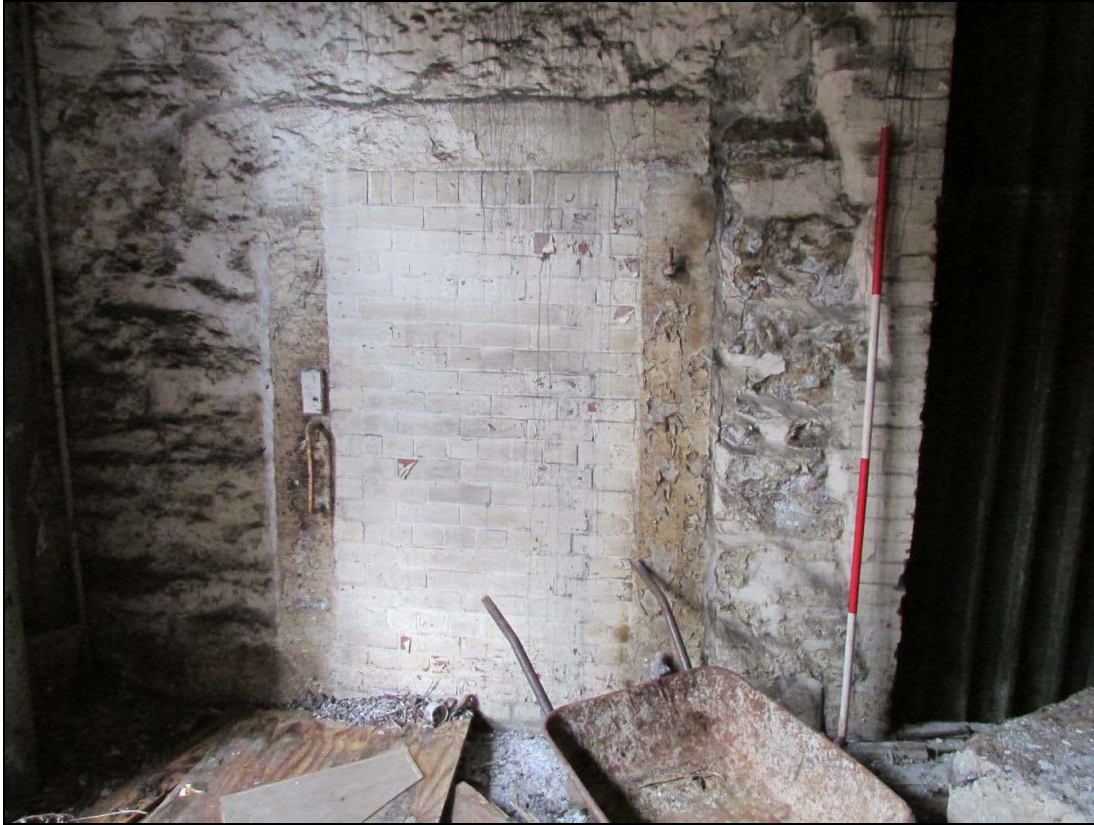
Plate 39 Blocked entrance located within the engine house dividing wall

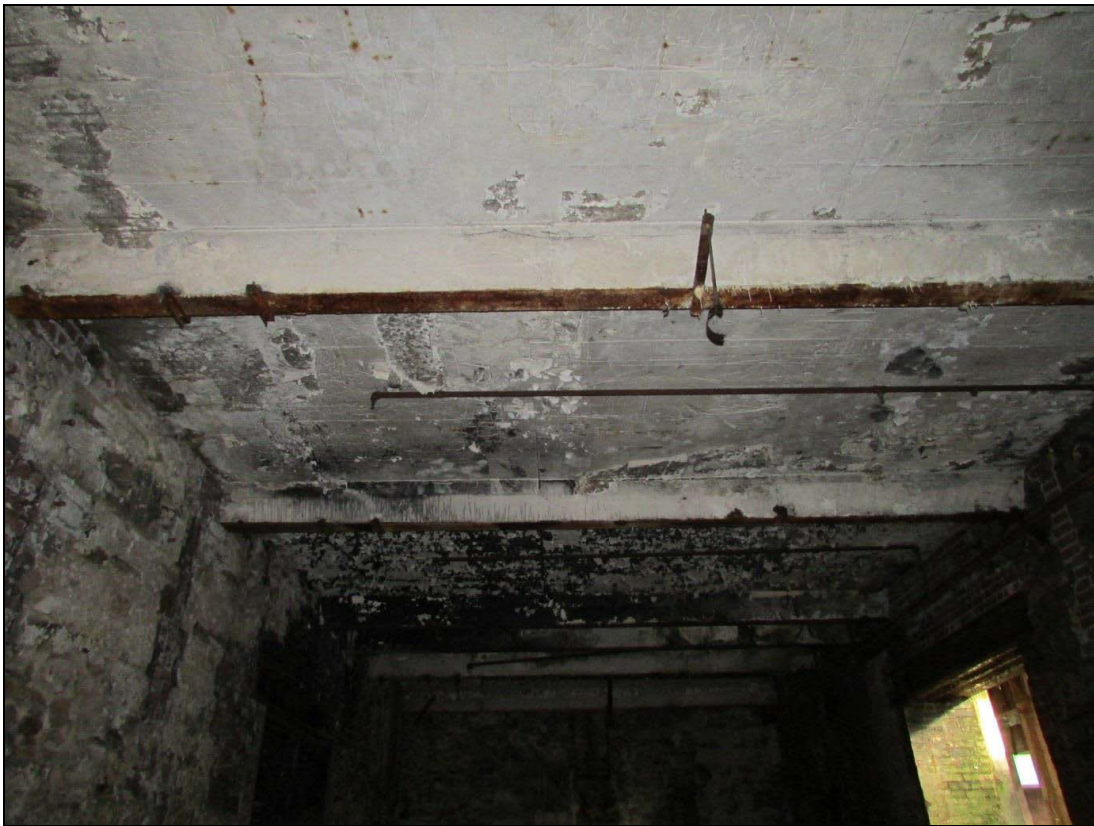
Plate 41 The flat ceiling of the engine house ground-floor, which is probably later in date

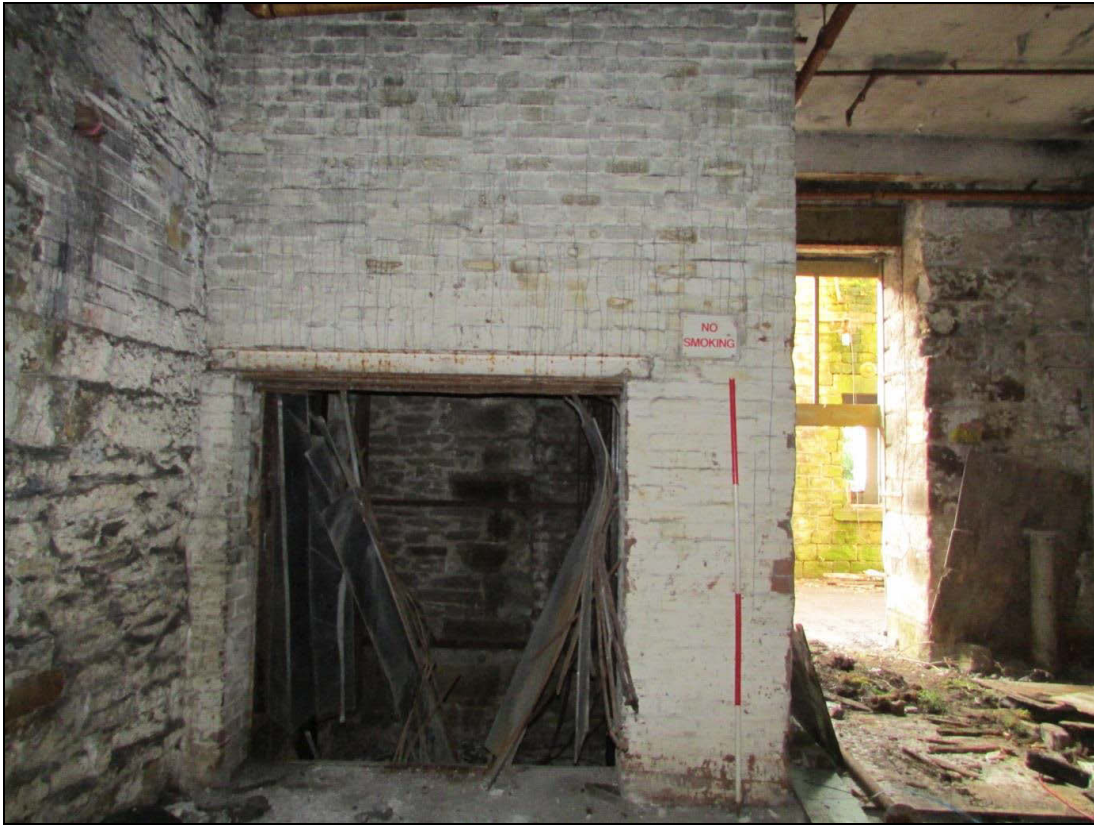
Plate 42 Later 20th century lift shaft inserted into the engine house

A larger, lift shaft was added within the engine house at the southern end and along with the inserted entrances, would have made the movement of goods easier. Consequently, the taking-in doors are likely to have been superseded, however no attempt was made to remove or block these off and retained original hoists and a swivelling crane (see Plate 33). This lift shaft also blocked much of the tall window and a small brick division inserted on the second-floor in front of this window (see Plate 51), appears to be contemporary.

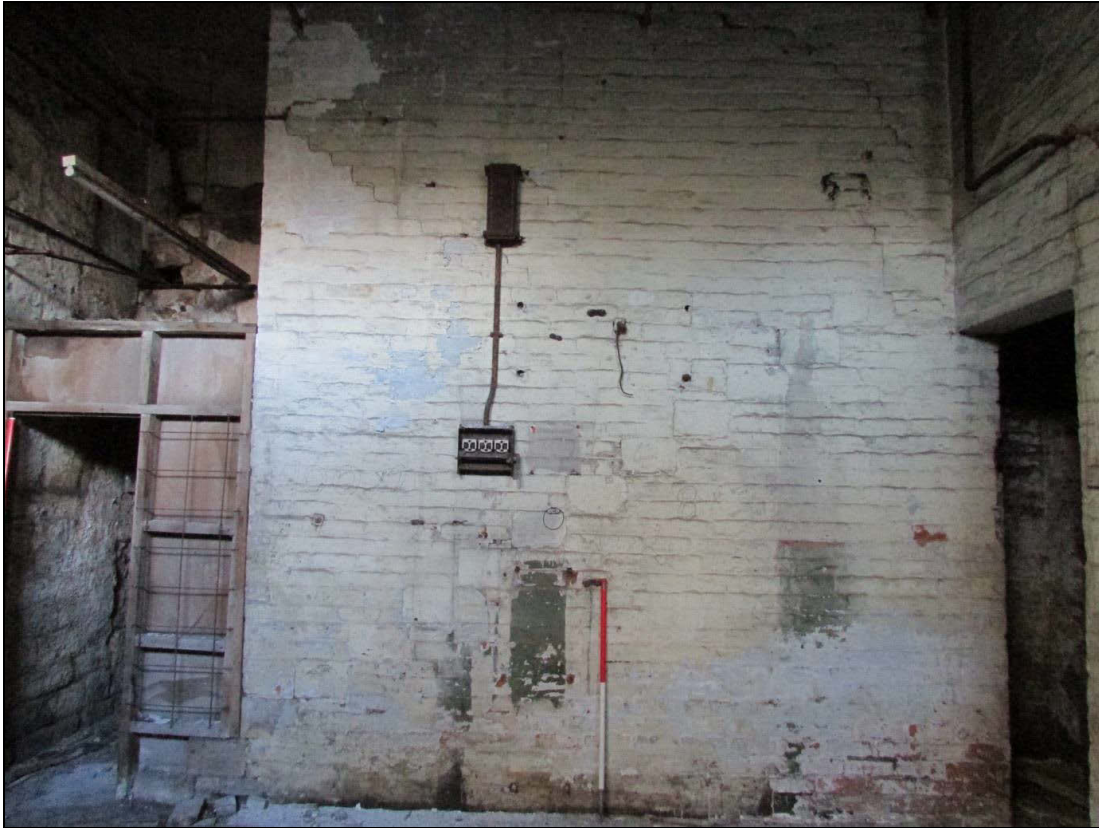
The first-floor is accessed via a series of steps which were located to the north east part of the engine house. These appear to be a later insertion as there is a machine-made brick east/west divide which has the stairs inserted (Plate 44). There is an entrance into the area under the stairs through the later wall and a square, stone lined aperture is partially built over. There are also several stone or concrete blocks which appear to represent elements of a foundation bed for later, electric motors (Plate 45). The eastern wall also contains an entrance with a dressed stone surround and blocked with machine-made brick. The ceiling is fireproof with shallow brick arches and iron beams running north/south at the northern end, with one arch per bay (Plate 46). The orientation is east/west within the rest of the room.

Plate 44 Later staircase inserted into the engine house

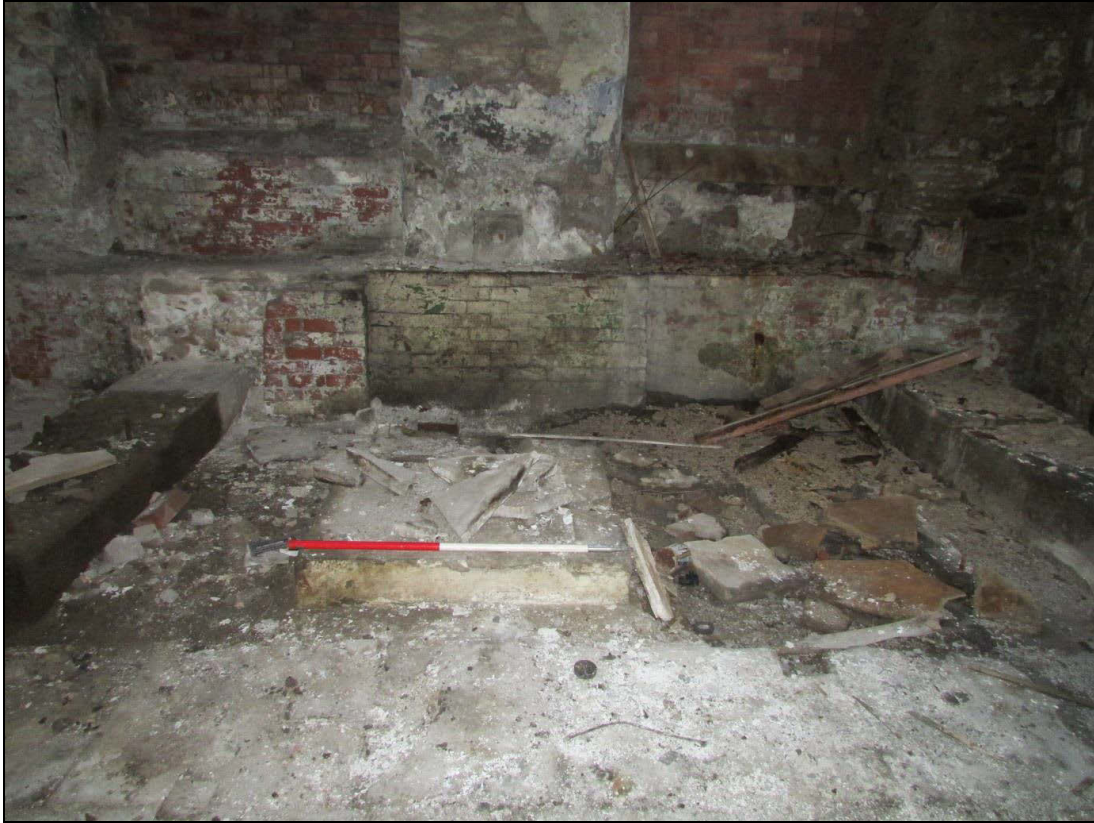
Plate 45 Stone or concrete bedding for later electric motors

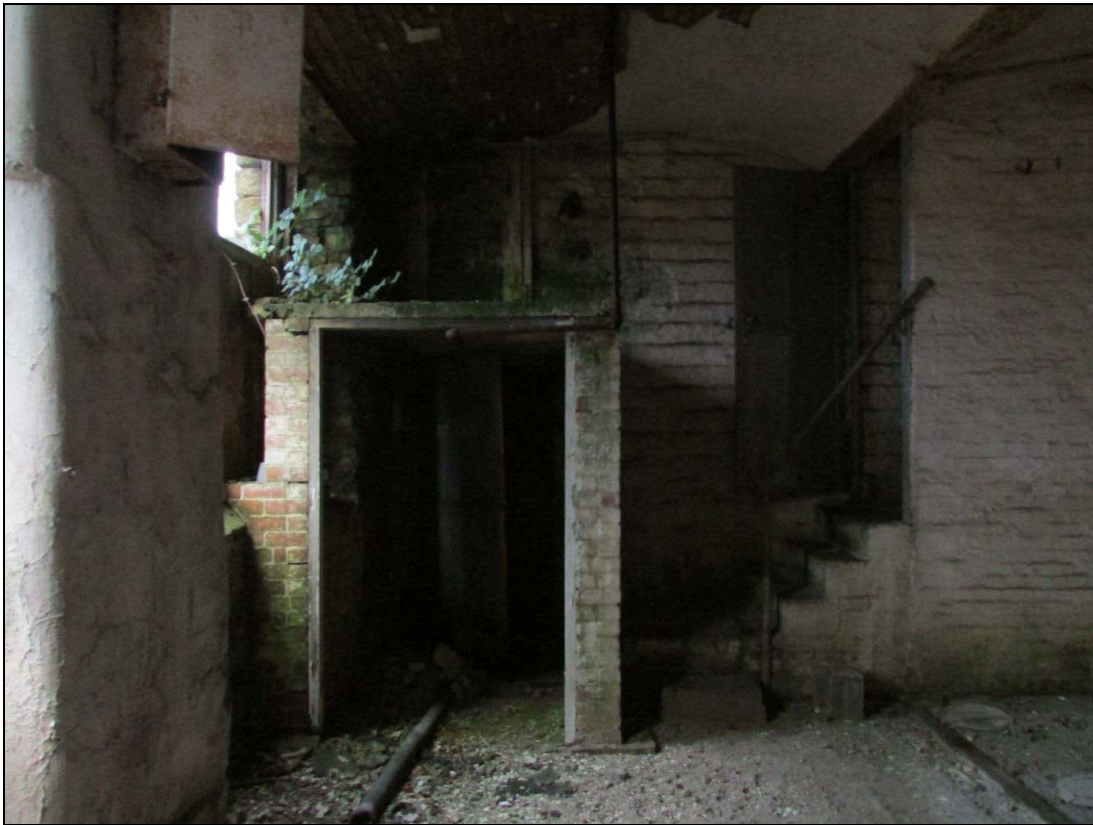
Access is via a series of steps from the ground-floor into a room in the north-eastern part of the engine house. The steps continue to the second-floor from the eastern side and are another later addition, divided with machine-made brick (Plate 47). In the north-eastern corner, there is another machine-made brick sub-division which created a covered walkway. This led to an entrance in the gearing wall, which had been blocked with machine-made brick, although a metal door was still *in situ*.

Plate 47 Later machine made brick divisions (including the stairs to the right) within the first-floor of the engine house

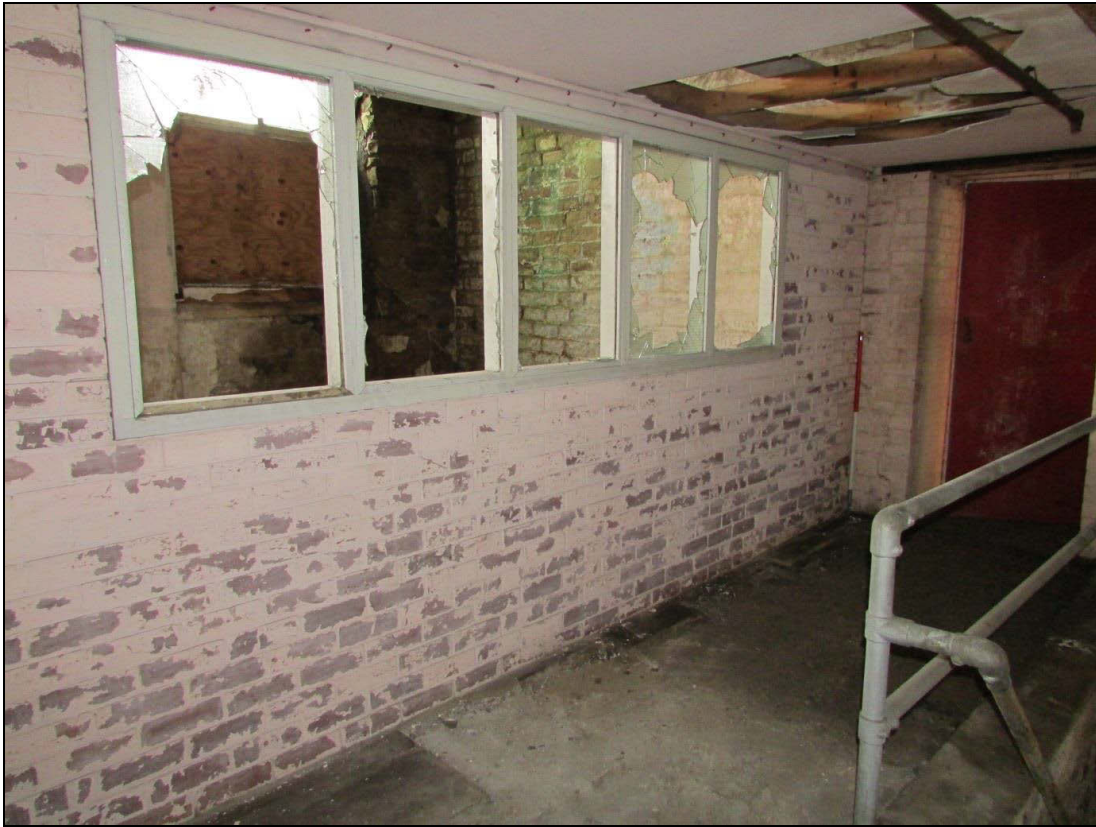
Plate 51 A later brick sub-division on the second-floor of the engine house

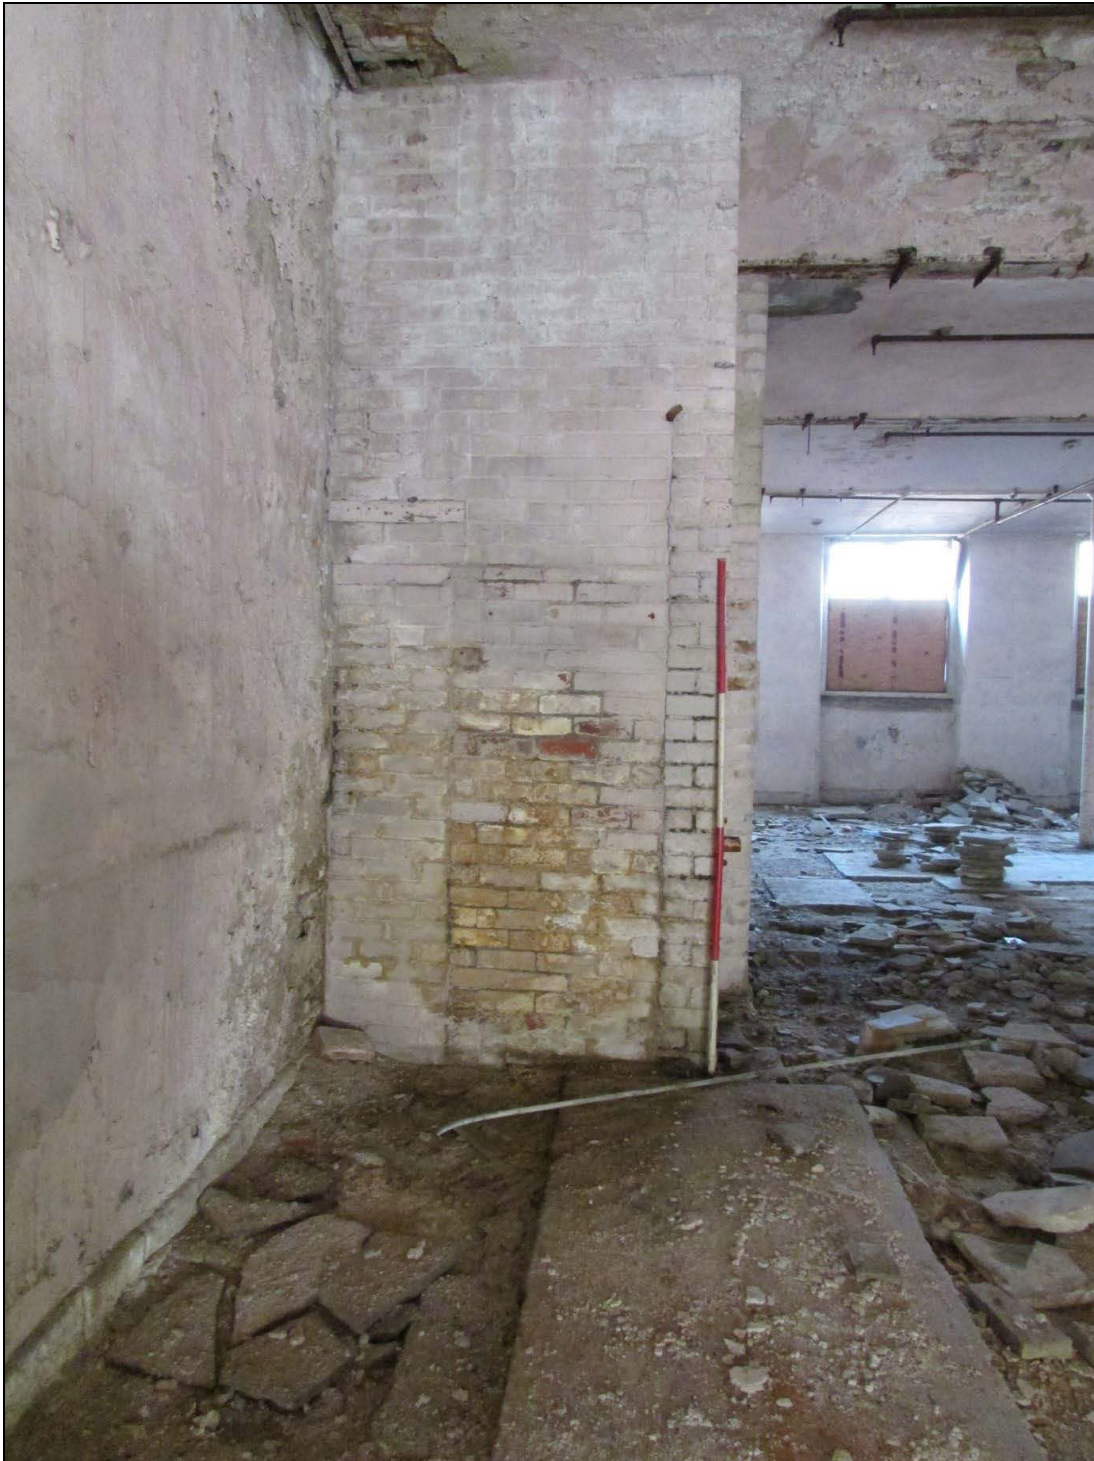
Plate 52 Blocked entrance into a later sub-division, creating a void behind which could not be accessed

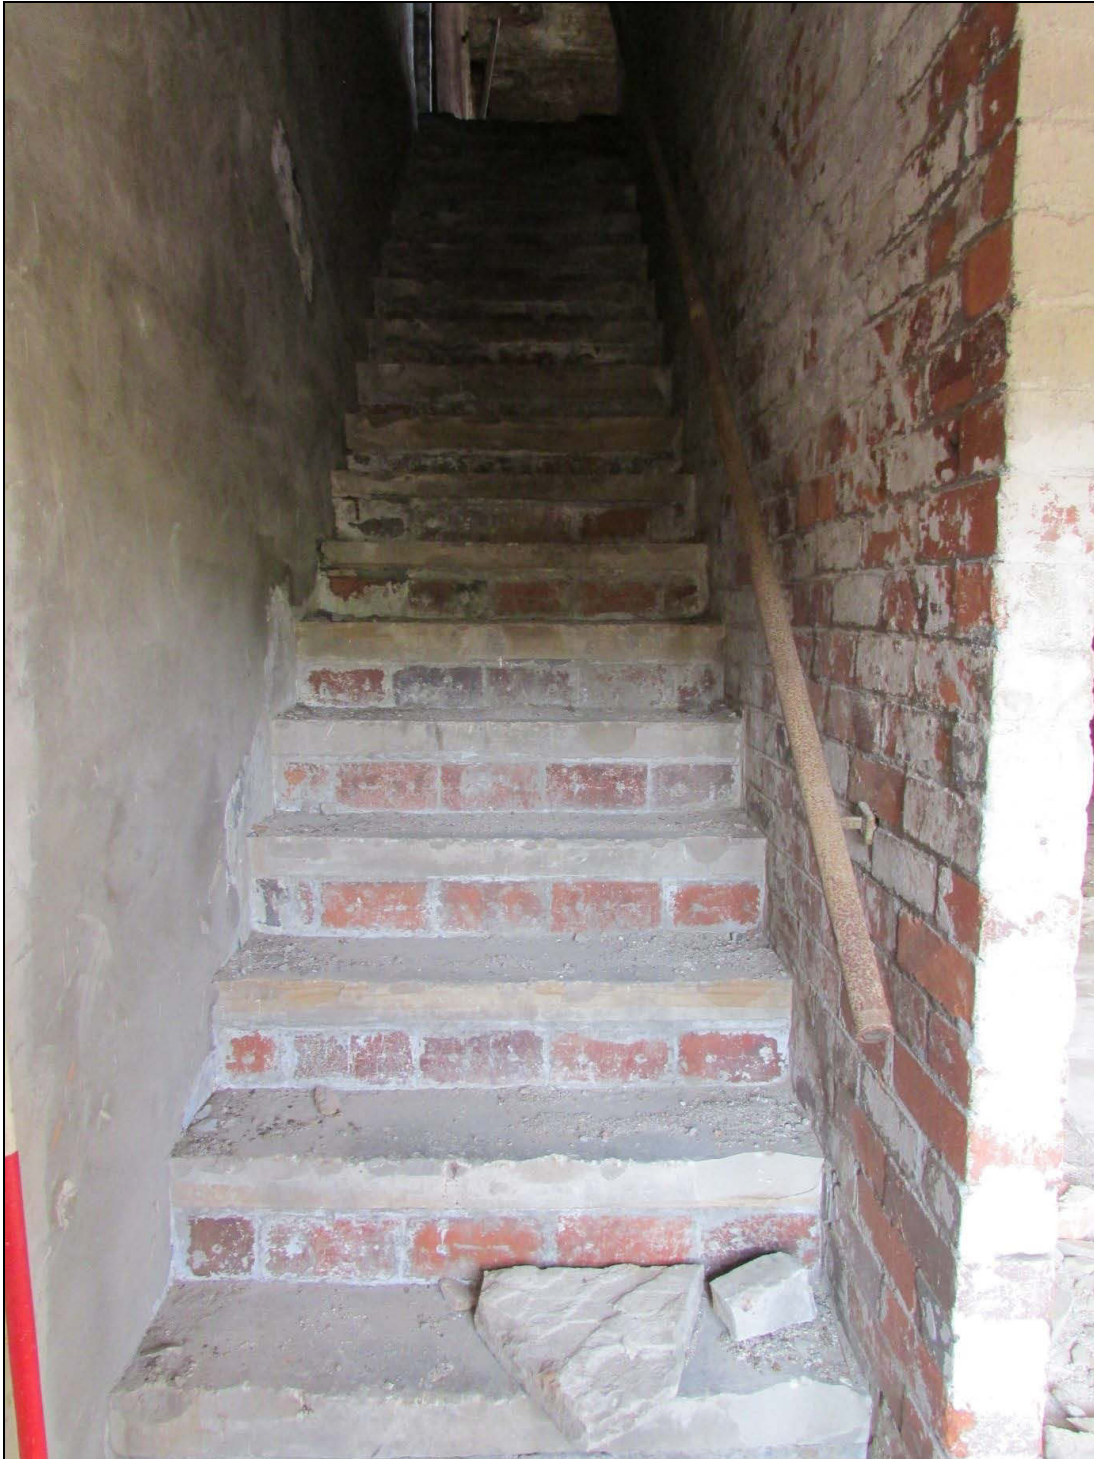
A set of stairs leading to the third-floor was inserted into the south-west corner, constructed from machine-made brick (Plate 53). This lay immediately north of an entrance with dressed stone surround, blocked with machine-made brick. Leading from the eastern taking-in door is the hoist and associated metal fittings *in situ*, which would have facilitated the movement of goods in and out of into the building (Plate 54). A further entrance located at the south end of the engine house dividing wall has been blocked with machine-made brick. To the north of this was a later

Plate 53 Later steps leading from the second to the third-floor of the engine house

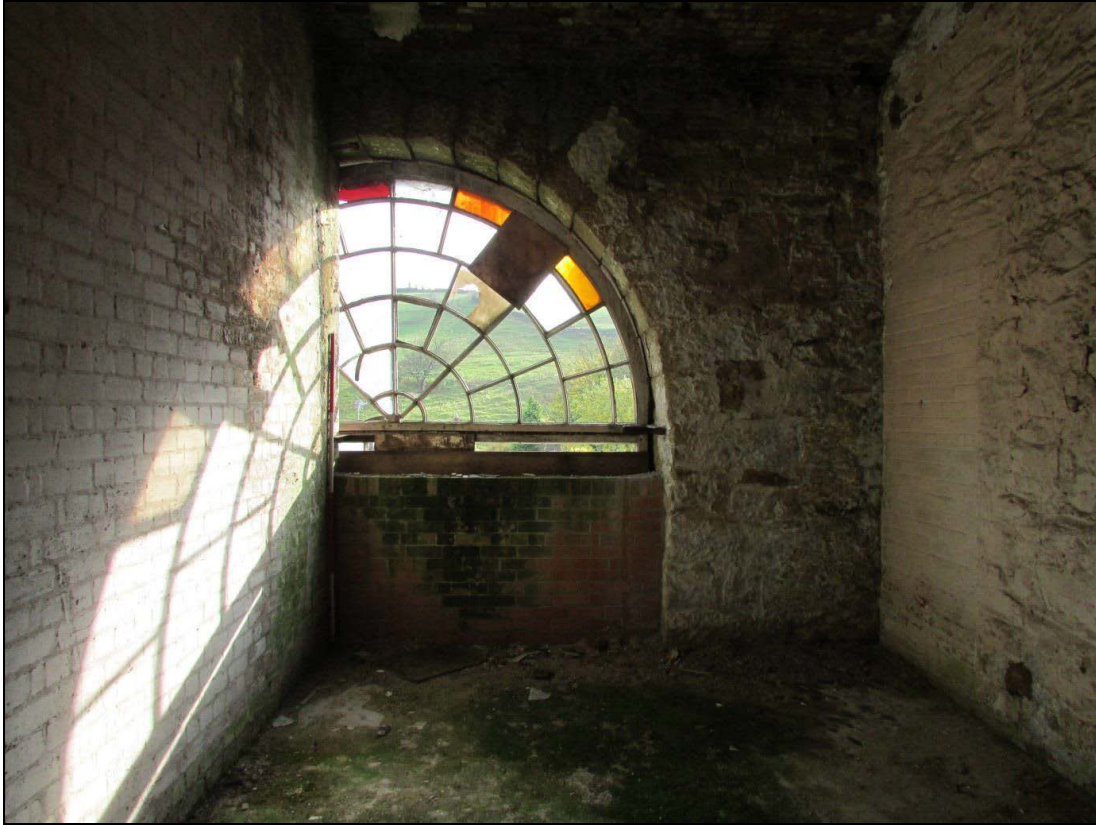
The round-headed window was partially blocked internally by the later lift shaft and also by machine-made brick on the western side to the level of the fanlight (Plate 55). The lift shaft was also partly blocked by a concrete surround with small apertures, suggesting that it had once been screened off. This also meant that anything transported in the lift shaft could only be moved into the spinning mill via an inserted entrance (Plate 56). Further metal fixtures possibly related to the original power system were visible within the gearing wall. These were set on large undressed ashlar blocks built into a wall of small undressed and coursed stone. A later pipe runs west from this through the other wall, where there is a smaller, metal-lined aperture which was blocked subsequently (Plate 57). There were also a series of metal hoist rings built into the ceiling beams, which had probably been intended to facilitate the lifting of engine components for maintenance purposes (Plate 58).

Plate 55 The original fanlight of the engine house was blocked by the lift shaft (to the left) and a c.1.00m high brick partition

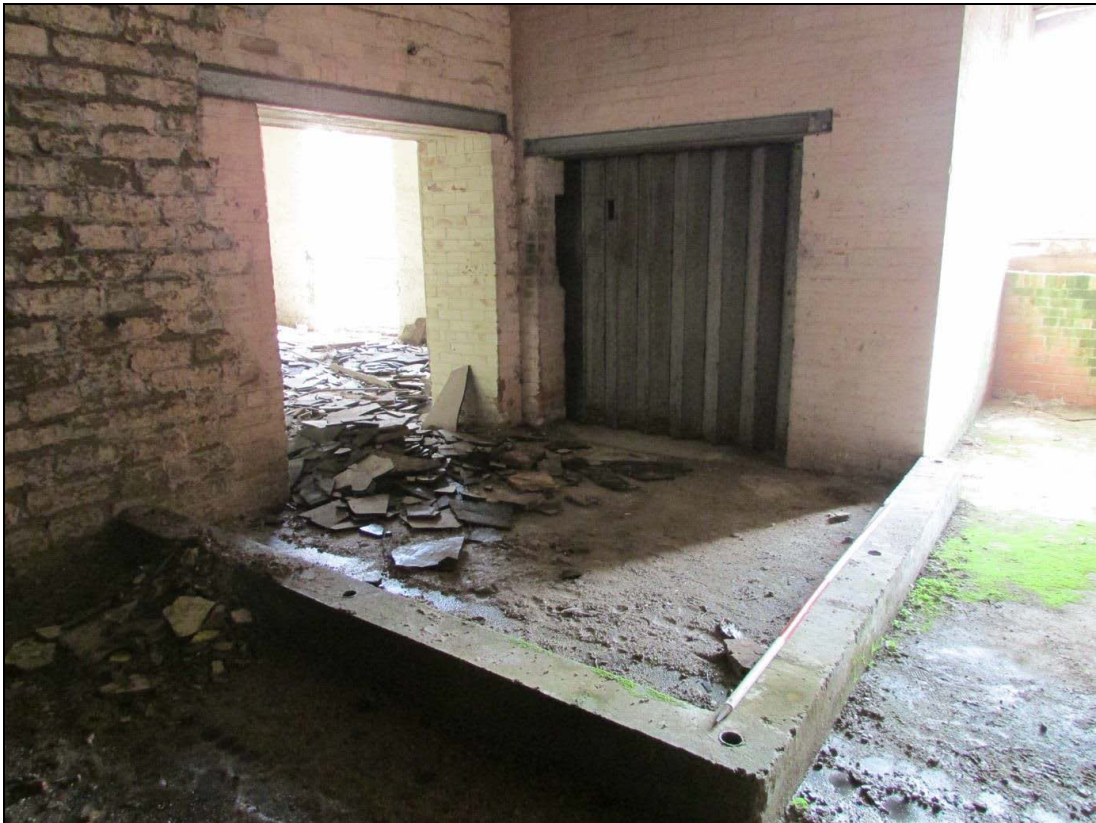
Plate 56 A possible screen around the lift shaft forces movement through the later entrance
