**Archaeological
Building Survey:**

Woods Mill, The
Narrow Spinning
Mill, Glossop

Report No:
2015/25

Document Type: Archaeological Building Survey

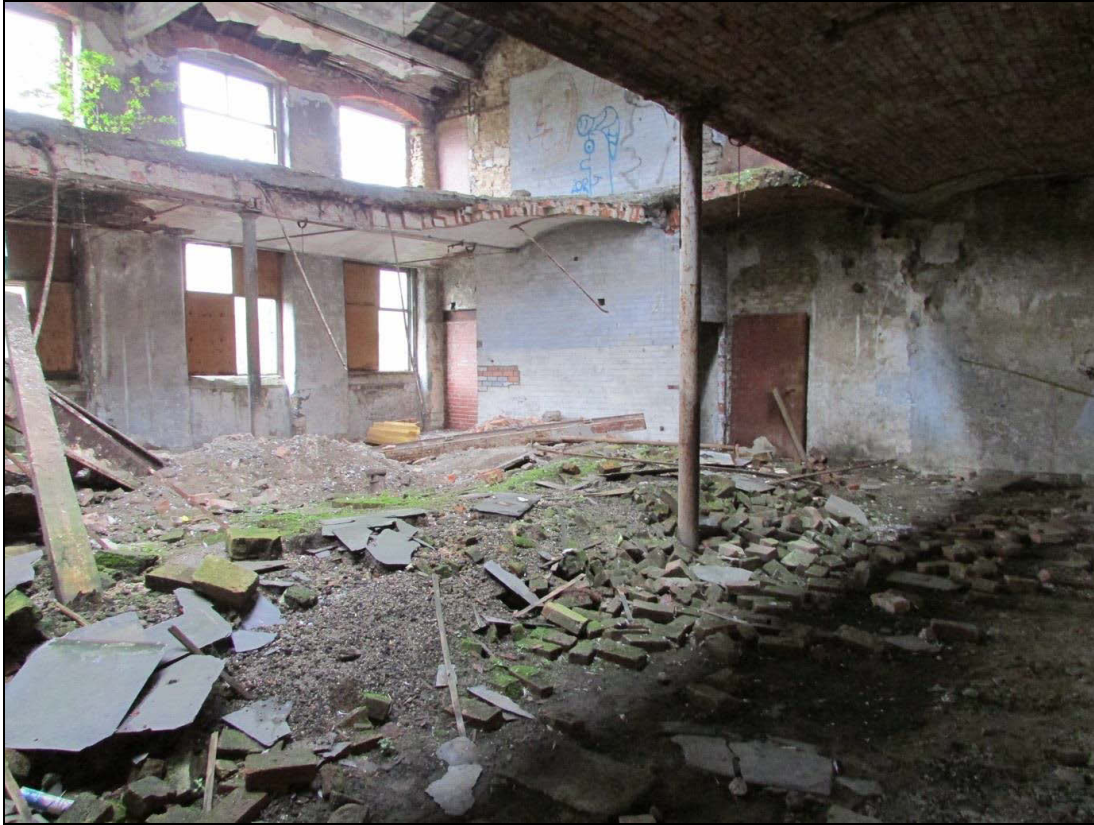
The southern part of this floor could not be accessed due to ceiling collapse (Plate 59) however, unlike the lower floors, this floor was open. As there were no subdividing walls, there is an axial run of iron columns running north/south supporting a fireproof ceiling with shallow brick arches (one per bay) on iron beams running east/west (Plate 60). Visible in the south-west corner was an entrance blocked with machine-made brick, with the later stairs continuing from the floor below immediately north of this. The machine-made brick division continued onto this floor, again with a small projection along the eastern face and the entrance blocked to the south, except on this floor it does not run to meet the northern wall. The lift shaft also continued onto this floor.

Plate 59 Ceiling collapse on the third-floor of the engine house

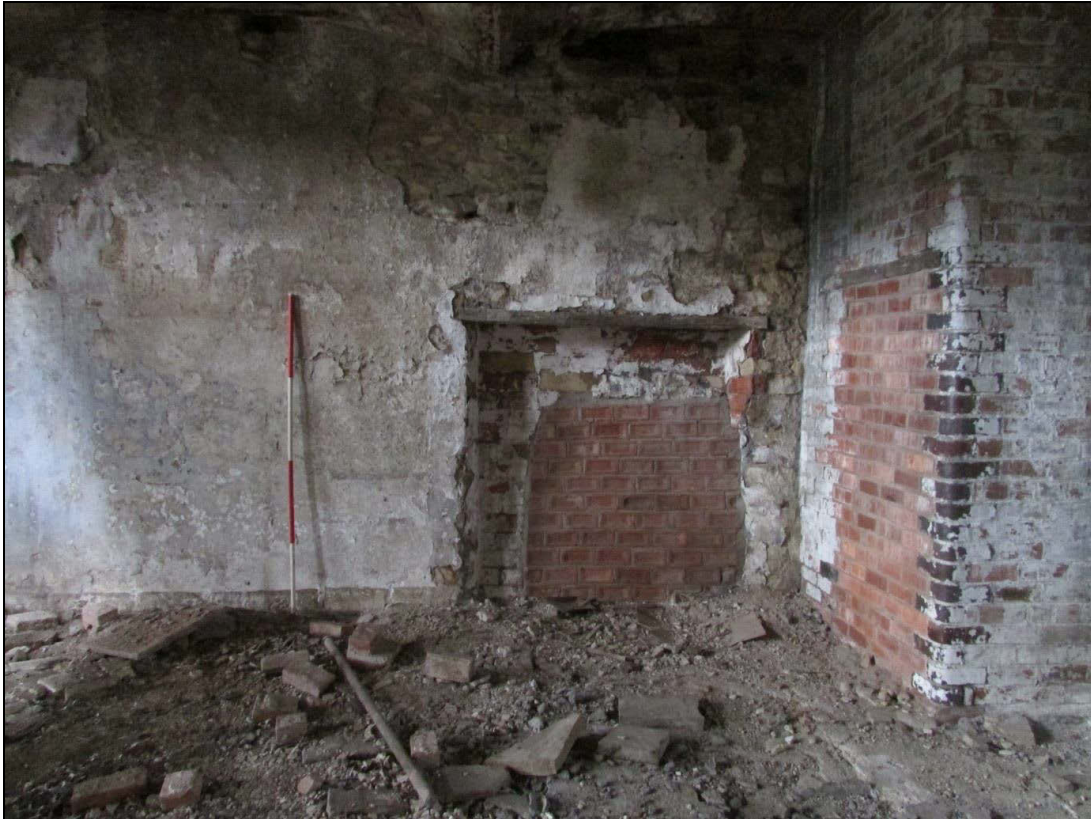
Within the western wall was a recessed feature, partly constructed of hand-made brick and stone and blocked subsequently with machine-made frogged brick. It was supported by a large, flat stone lintel but does not appear to have been an entrance as there is no counterpart blocking visible on the western elevation (Plate 61). Within the eastern wall there are metal brackets, probably associated with the power-transmission system. At the north-east corner of the room was a thin void within the floor measuring 3.30 x 0.80m and appears to have originally been surrounded by stone, although much of it was robbed out. It was lined with iron with a central beam running north/south (Plate 62).

Plate 61 Blocked recess on the third-floor of the engine house. To the right is the blocked entrance into the void

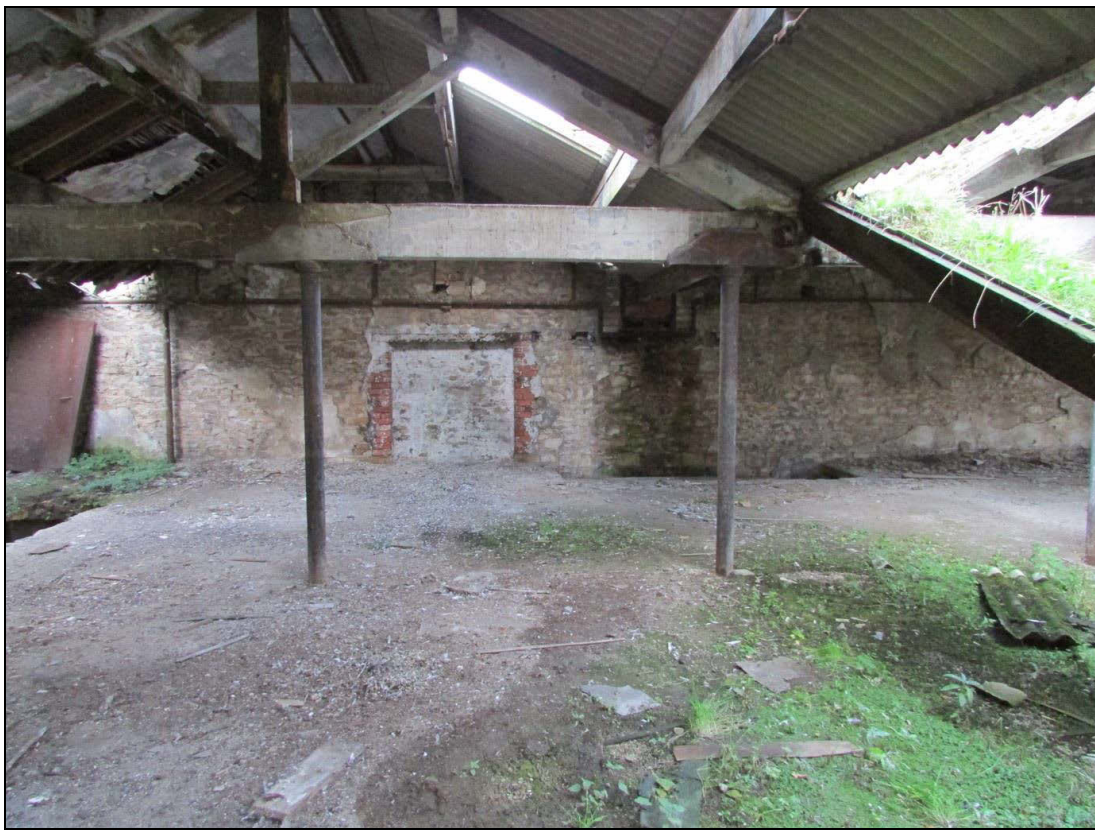
This floor could not be accessed due to health and safety issues, therefore observations and photographs were taken from the gearing wall entrance. Both the floor and roof had collapsed at the southern end of this building and the roof had collapsed at the northern end of the building. This room was again open, therefore there was an axial run of iron columns running north/south supporting the triple-pitched span roof.

Plate 63 General view of the fourth-floor of the engine house

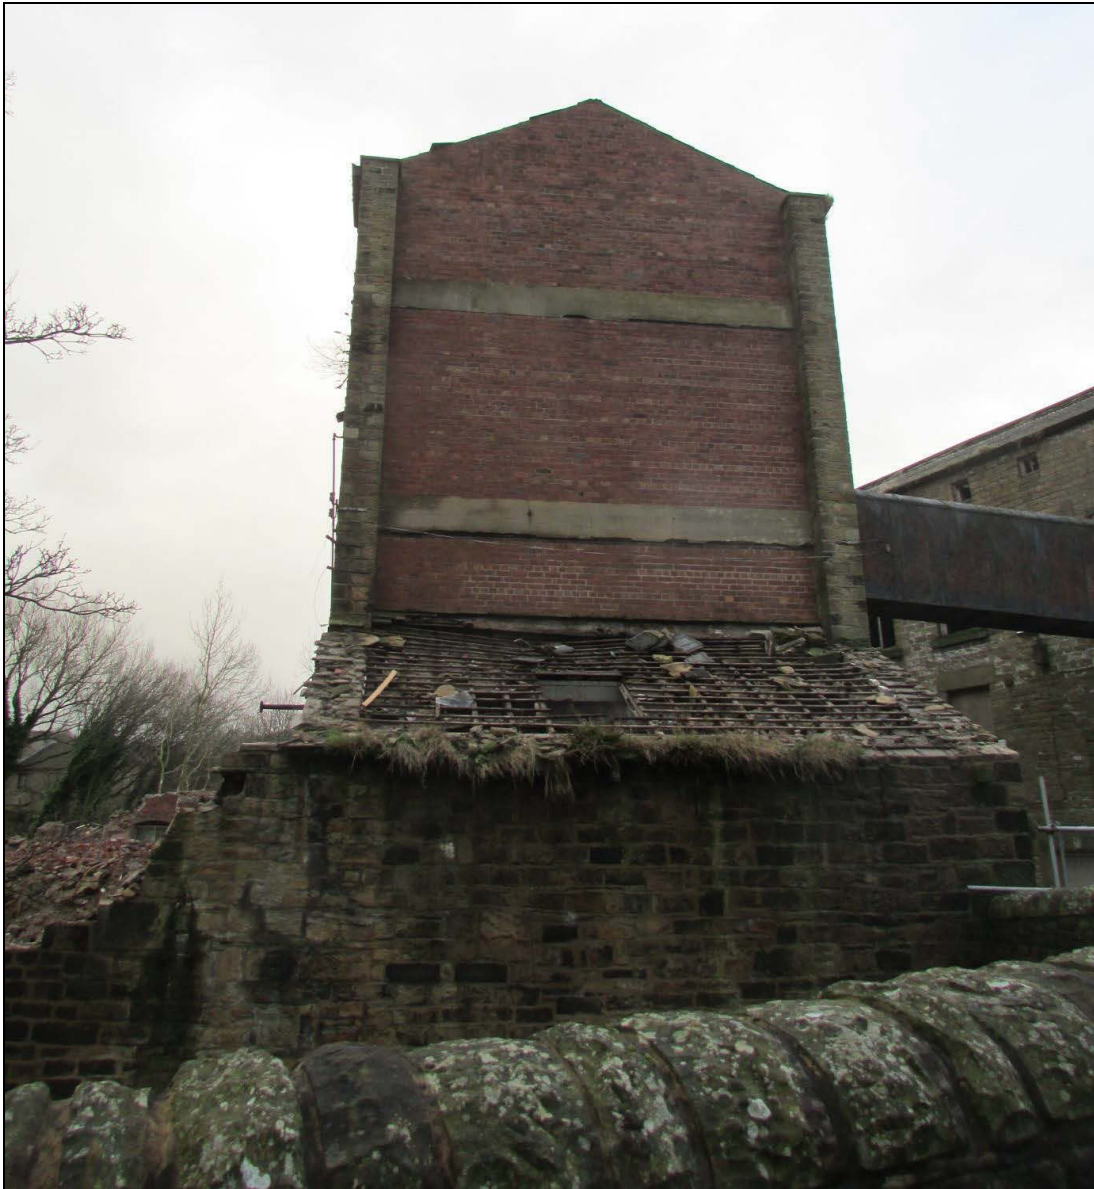
The ground-floor of the office block incorporated part of a one floor lean-to shed and consisted of random coursed undressed stone with a lean to roof and projecting corbels below the roof line for guttering. The rest of the elevation consisted of a machine-made brick wall in English Garden Wall bond built between the stone walls of the rest of the building. The exterior of the first and second-floor appear to have been rendered with concrete. There were no windows in this elevation.

Plate 66 South elevation of the office block, which appears to have been rebuilt along with the stone lean-to on the ground-floor level

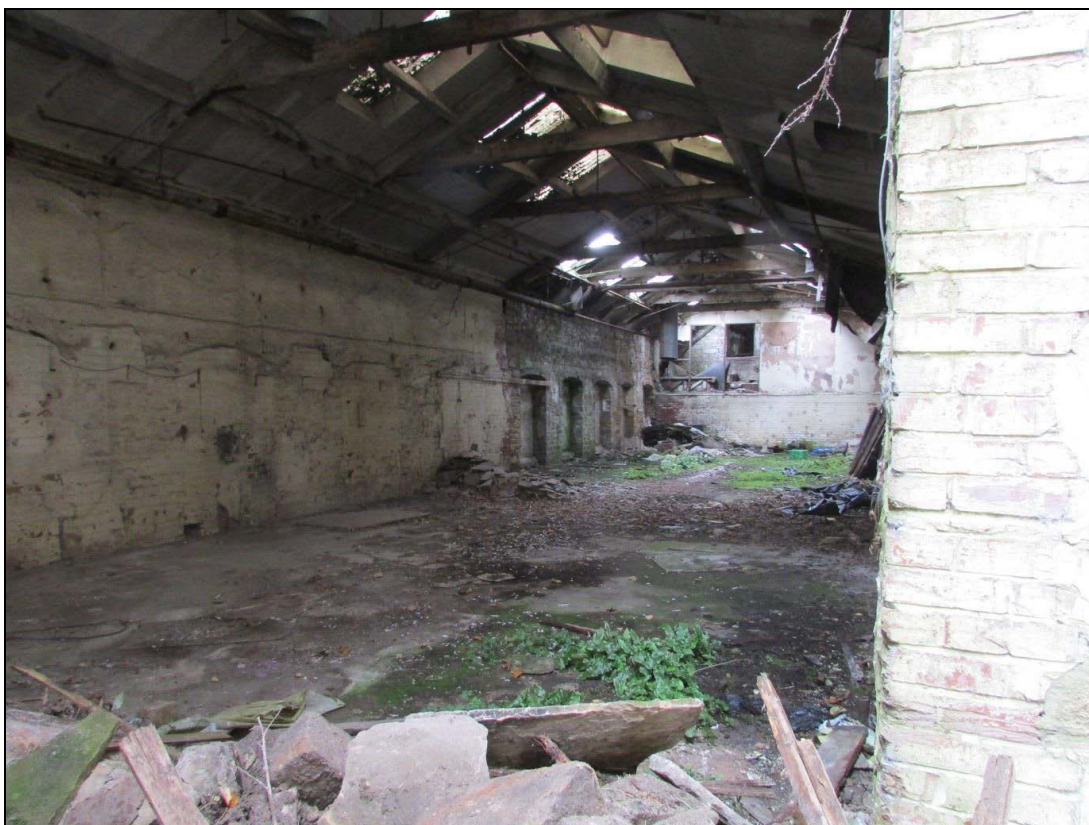
The interior could not be accessed due to the partial roof collapse over the only open entrance into the shed. However, the building was open plan from floor to ceiling, with a machine-made brick sub-division on the eastern side (Plate 80). The interior also incorporated the middle shed, although there was evidence externally to show where the two buildings abutted (Plate 81). The roof was single-span pitched with a timber frame, although the king post appeared to be metal. There were at least three skylights in both pitches of the roof.

Plate 80 General view of the interior of the eastern and middle sheds. A machine made brick and timber division is visible in the background. Also visible are the former windows which were blocked subsequently

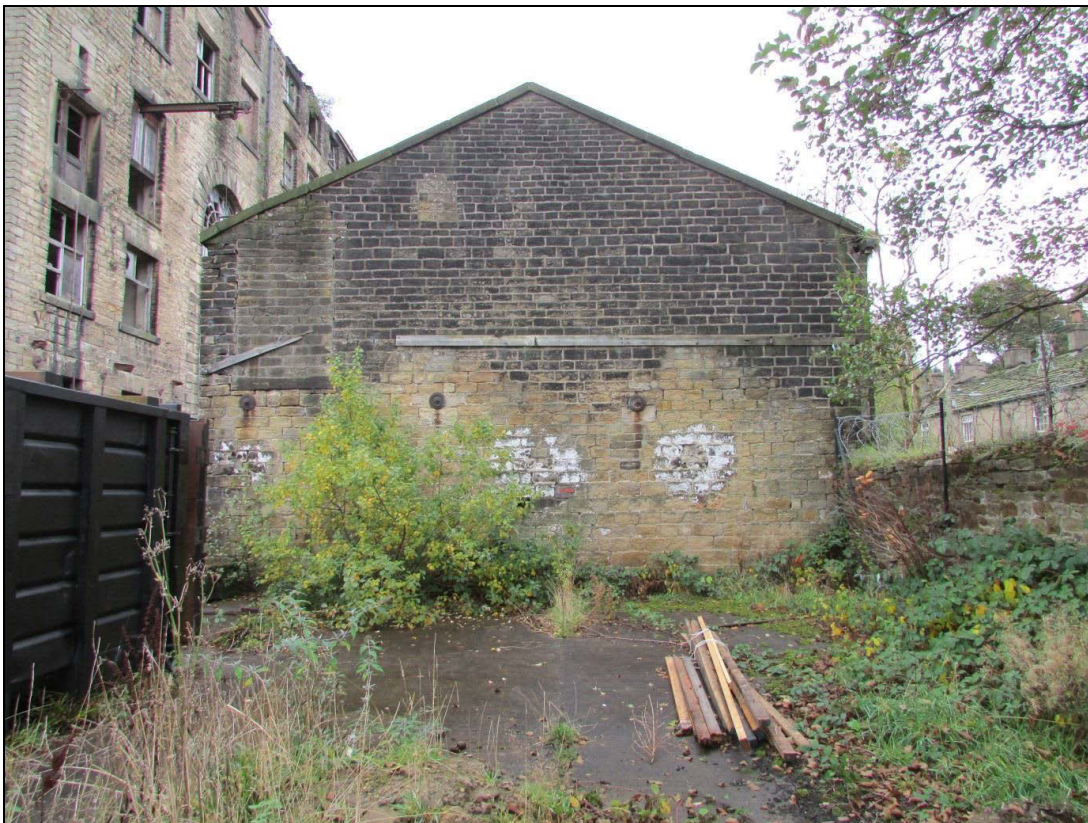
This elevation consisted of small coursed random stones, with a blocked entrance in the upper northern corner. There was a flat stone sill and it was blocked with coursed stone. There were also four tie rod plates, equally spaced horizontally below the door sill. The outline of a double-span asymmetrical roof was visible, indicating the position of a former building appended to the west side.

Plate 85 Western elevation of the west shed. A blocked entrance/window can be seen in the top left corner as well as the outline of where another shed abutted

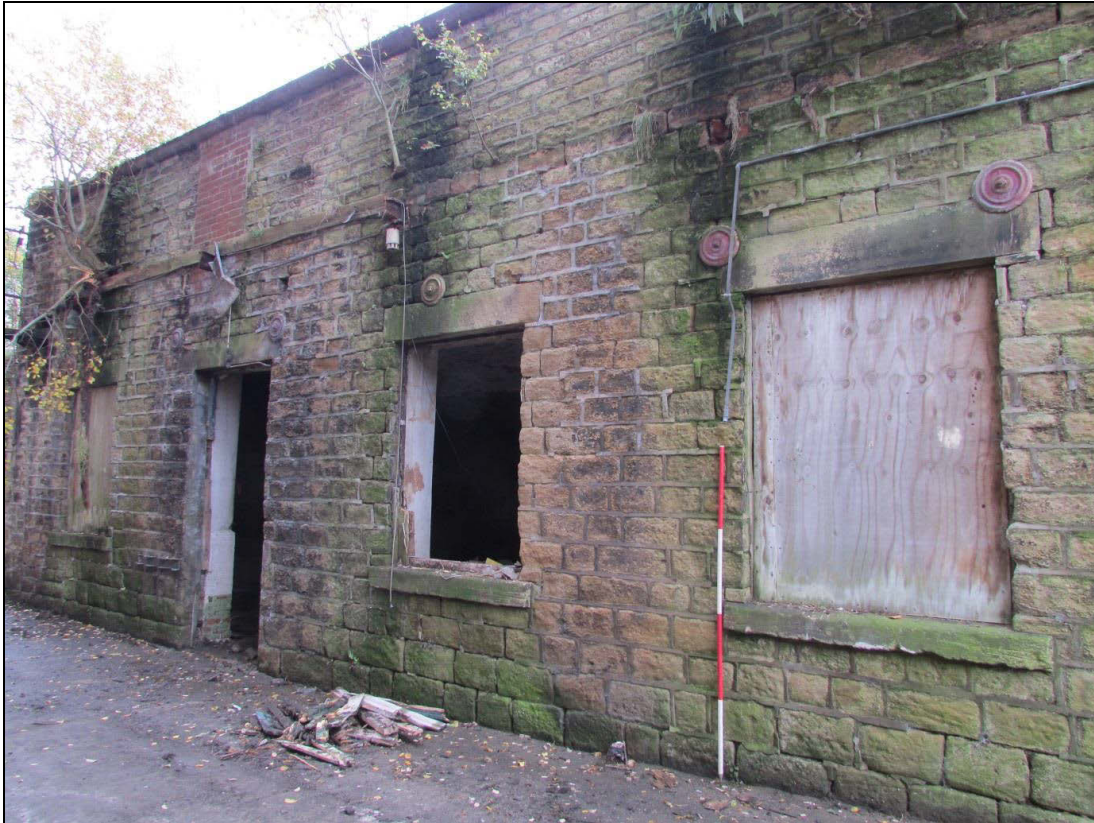
3.7.1.3 North Elevation (Plate 86)

This consisted of small coursed stones with three windows and one entrance. The windows had flat stone lintels with slightly projecting flat sills. The entrance had a flat stone lintel and tie rod plates not equally spaced above the window lintels. Above the entrance is a rectangular aperture, blocked subsequently with machine-made brick (Plate 87). This in turn is sealed with a wooden fixture which runs horizontally along the elevation. This may have been support for a canopy depicted on the architect's plan but no longer present. Also just visible above the ground level is the top part of a segmented arch.

Plate 86 General view of the west shed northern elevation

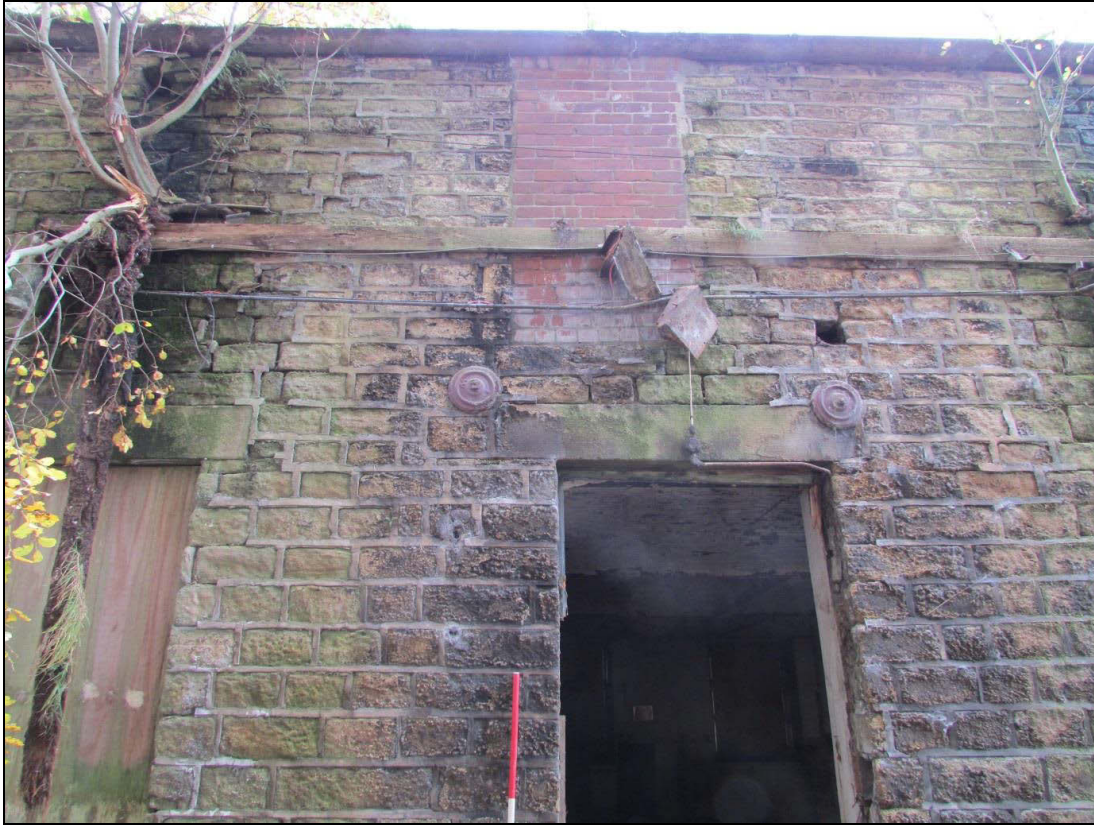
Plate 87 A possible blocked window is visible above the entrance to the west shed

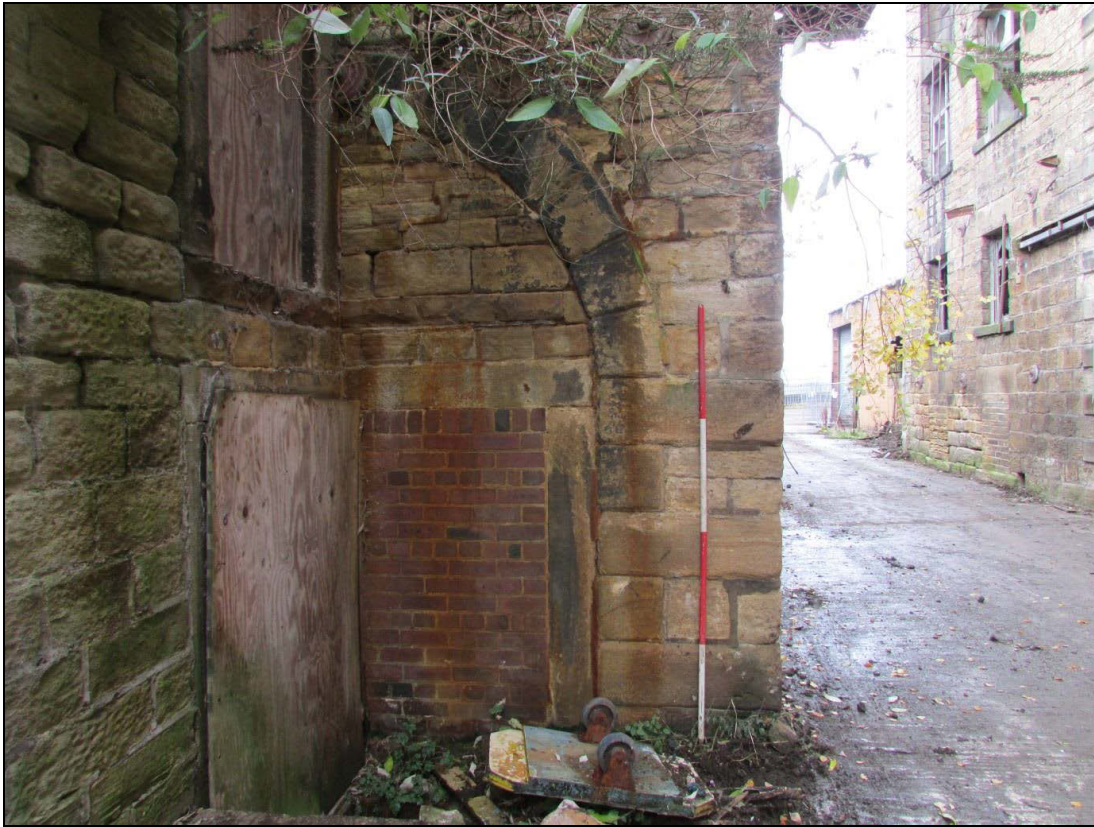
3.7.1.4 East Elevation (Plate 88)

A small portion of this elevation was visible although most was obscured by the middle shed. Part of an arched entrance was visible with a single course of large dressed sandstone ashlar blocks. This appears to have been blocked with coursed stone with a smaller entrance inserted with a dressed sandstone surround. This was blocked subsequently with machine-made brick.

Plate 88 The eastern elevation of the west shed, with a former arched entrance with two phases of blocking evident

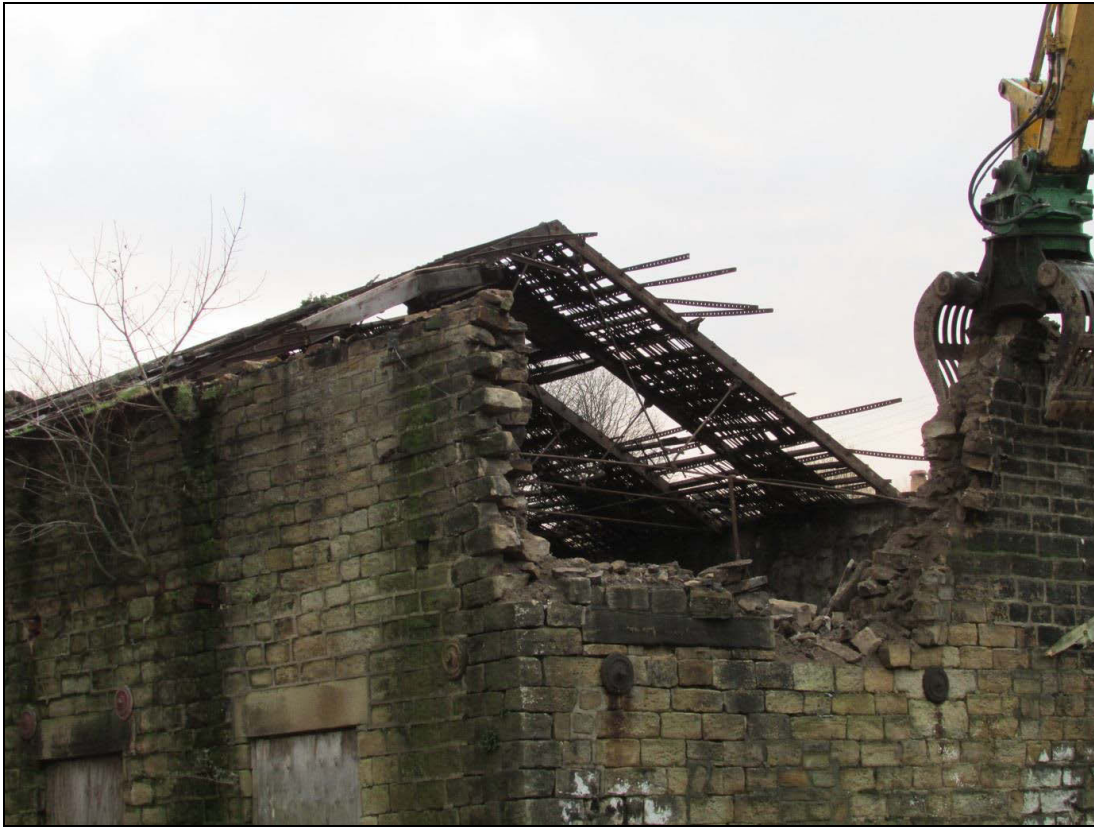
The interior was not accessed due to health and safety concerns, however the previous survey showed that the ground-floor ceiling was fireproof with brick arches supported on iron beams orientated east/west. These were supported by two iron columns with further support of the ceiling provided by iron beams. There were five windows located in the southern elevation which had sloping sills. The roof was pitched and entirely constructed from iron with tie beams and struts also made of iron (Plate 89; Plate 90).

Plate 89 The west shed during demolition. The roof was constructed entirely from iron

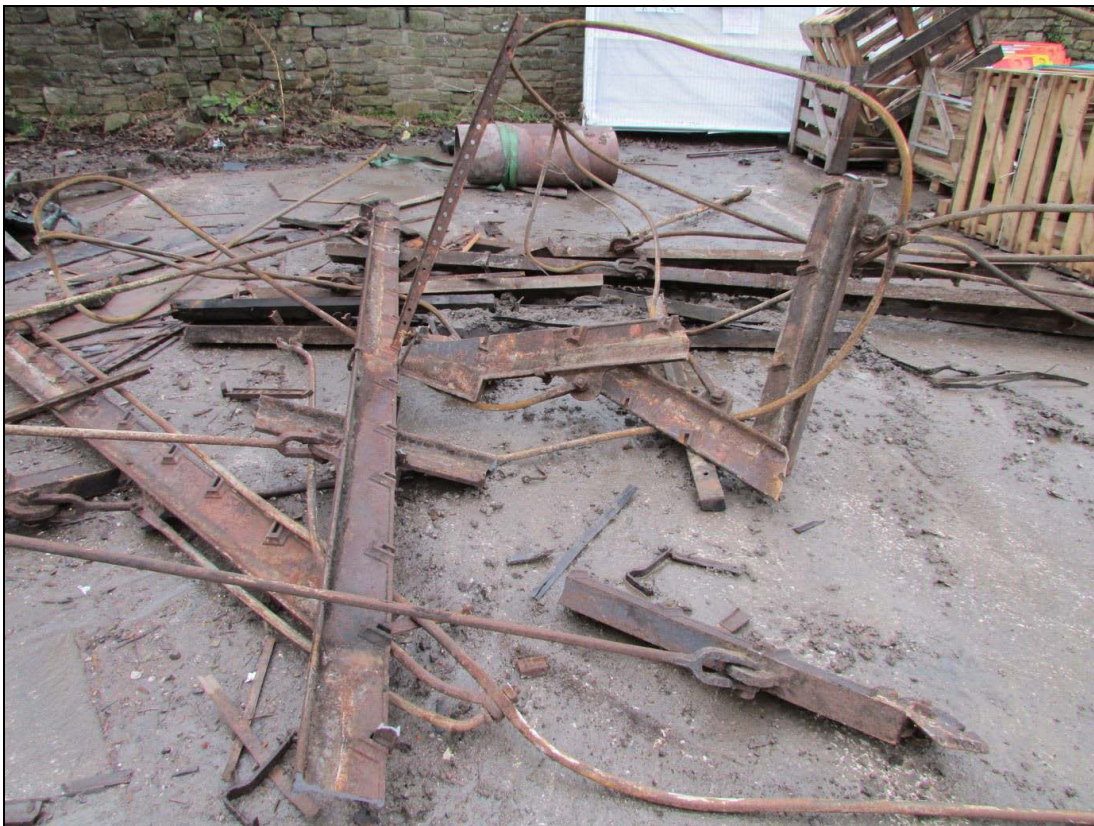
Plate 90 Remnants of the iron roof of the west shed

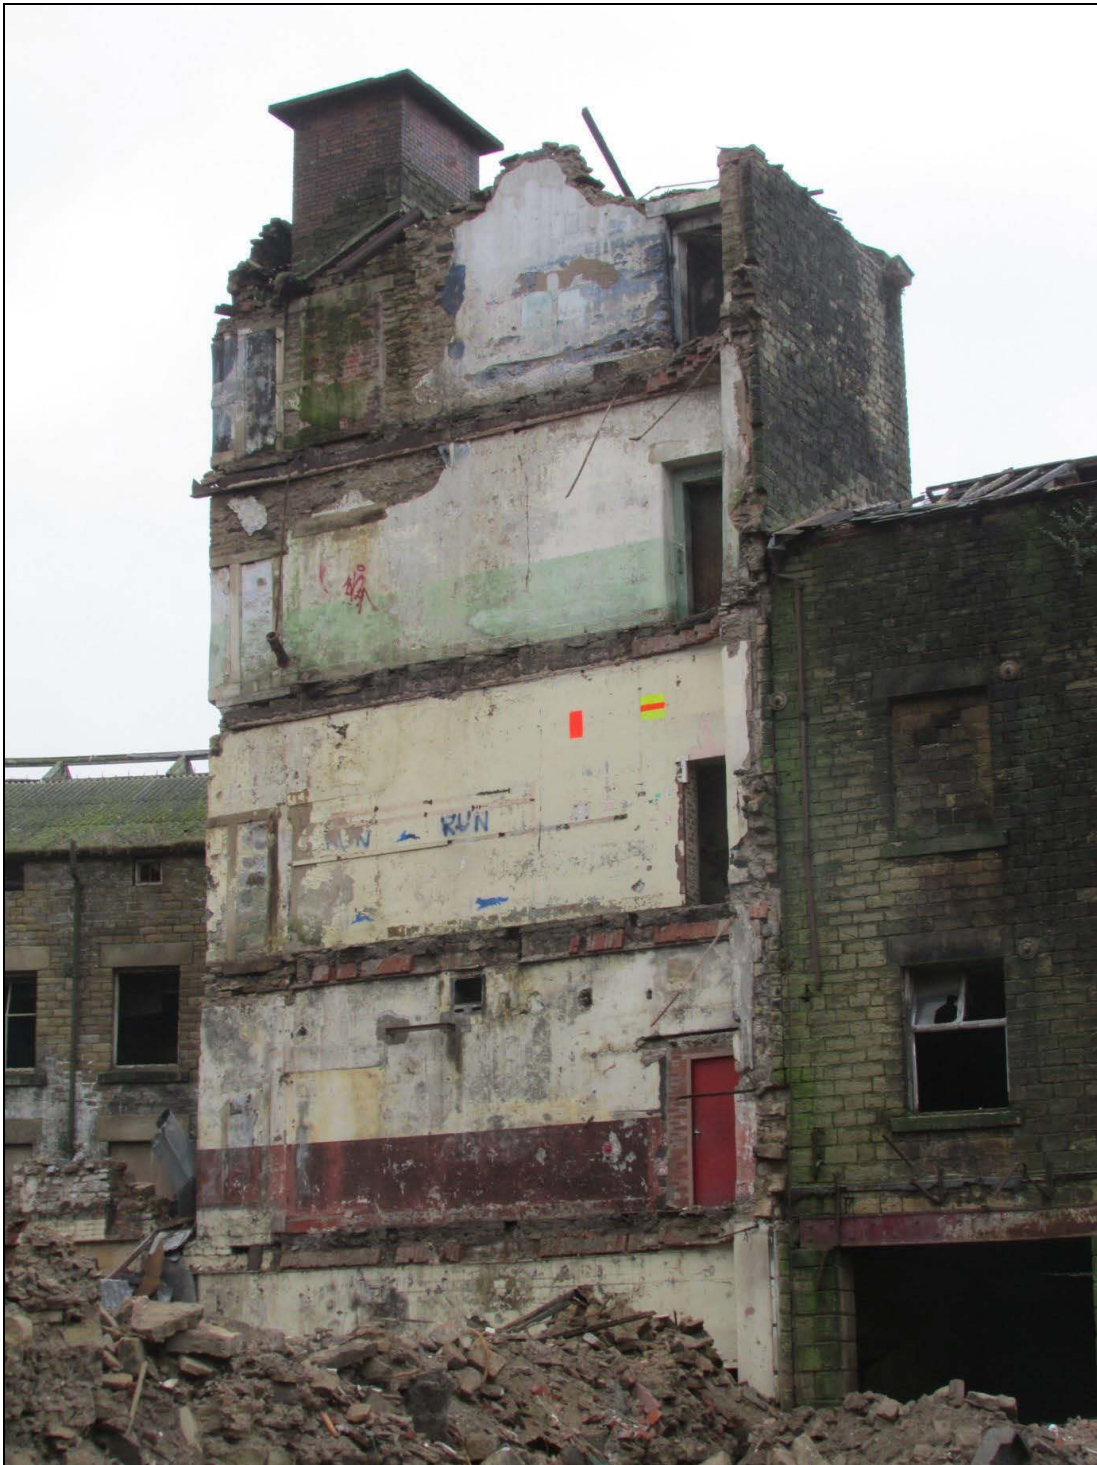
The change to electric appears to be reflected in the reconstruction of the hoist tower as the top of the headgear was partially demolished and reconstructed in brick, with apertures (Plate 91). This is assumed to be down to the change to an electric driven

Plate 91 The demolition of the central part of the mill revealed the phasing of the lift shaft

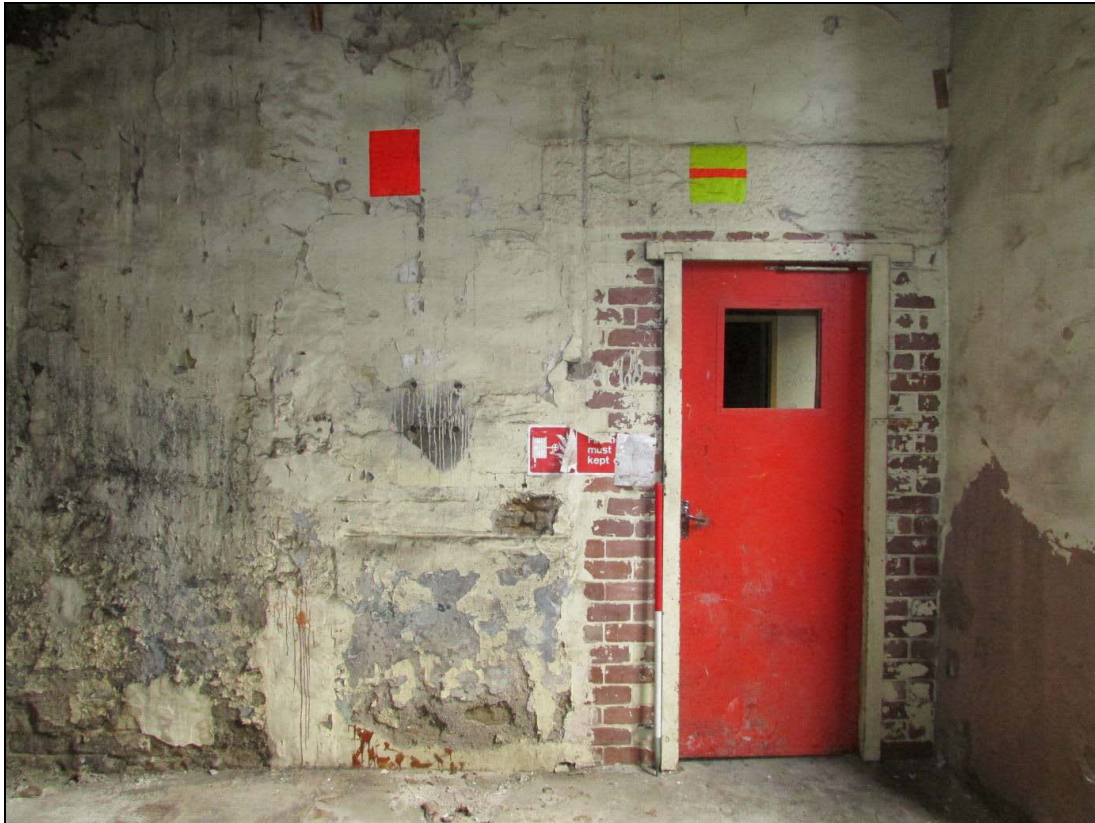
The entrance into the former hoist tower on the ground-floor was modified and made smaller, possibly to utilise the area for storage. Similar materials were used to modify the entrances from the stair tower into the mill. The entrances on all floors (except the fourth-floor) were made smaller by using machine-made brick and inserting fire doors (Plate 92).

Plate 92 The entrance into the spinning mill from the stair tower, modified and made smaller
