SURVEY OF THE 18TH CENTURY MILITARY ROAD NETWORK ON NATIONAL FOREST ESTATE, WEST ARGYLL

Inverawe to Bridge of Orchy

Biddy Simpson December 2012

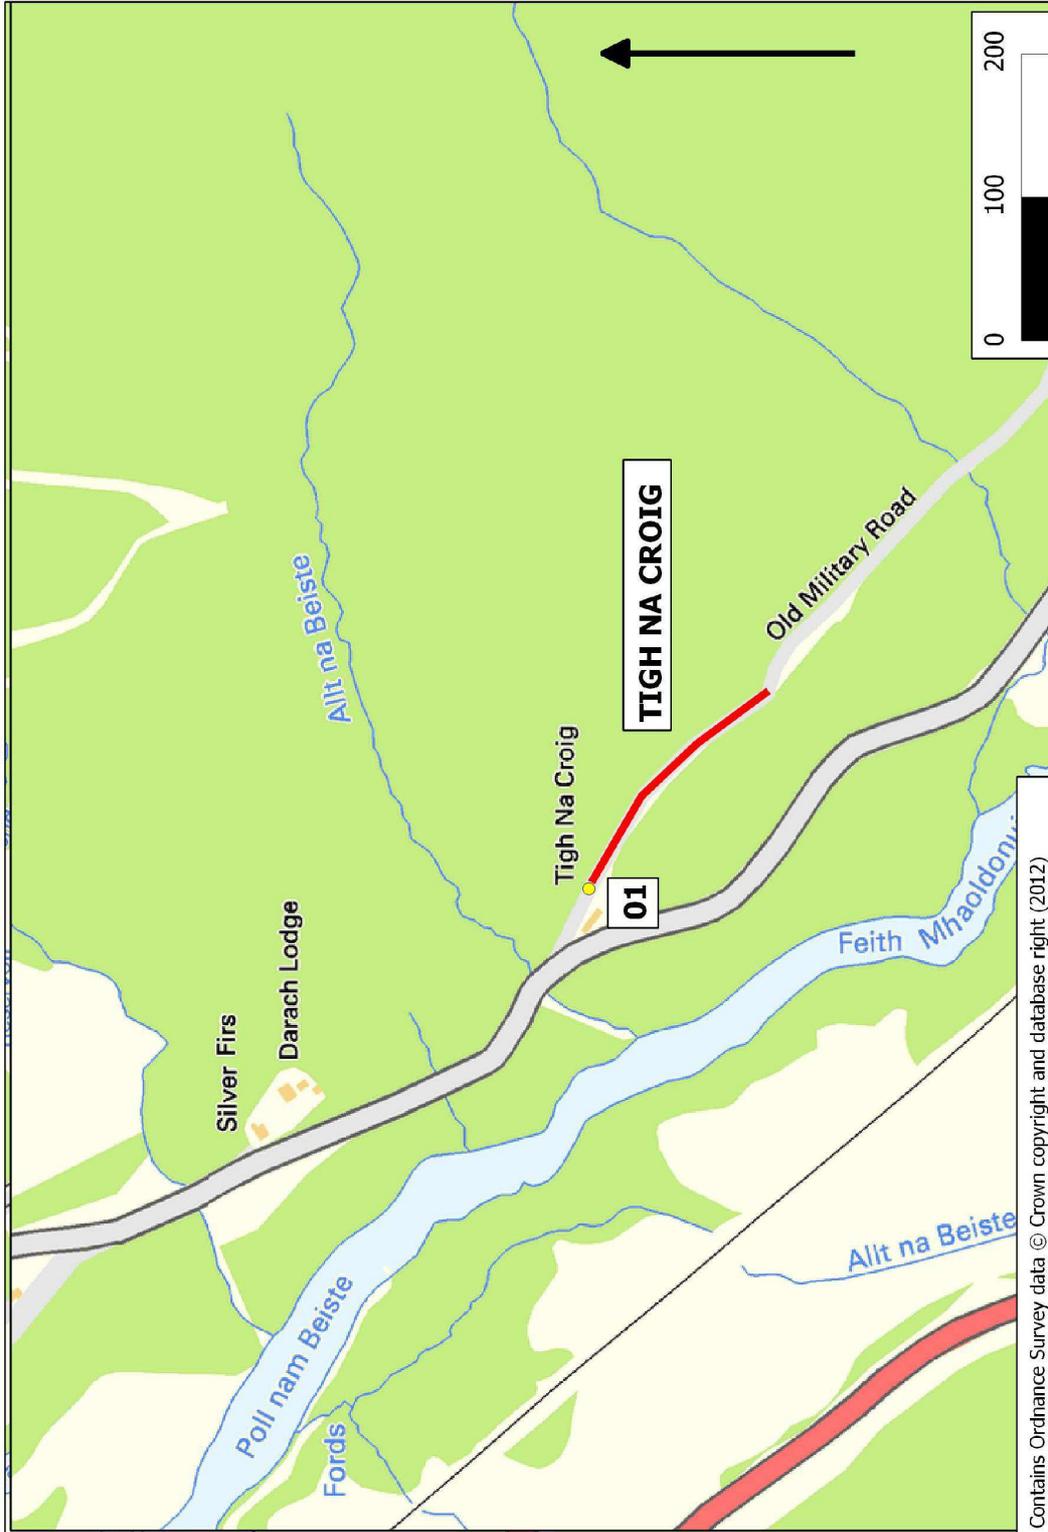
FIG. 2 TIGH NA CROIG, INVERAWE SECTION

A 200m length of fairly well-preserved military road survives towards the eastern side of Inverawe Country Park to the immediate east of Tigh Na Croig (Fig. 2). The military road runs largely parallel to a drystone dyke which encloses an area of ground between the military road and the estate road to the south, which has been densely restocked with trees. Above the military way there is a mature native woodland with some particularly large oaks.

The military road is approximately 4.5 metres wide and terraced into the hillside. No bank is present on its south side. Instead there is a steep drop down towards the drystone dyke. The road is very overgrown with long grasses and regenerated trees along the western half and dense bracken along the eastern half. Piles of rotting, cut branches pepper the length of the section. A number of trees are also growing out of the wall head of the dyke to the south.

A small, unroofed stone-built structure [01] was identified at the west end of the road. It appears to post-date the road and is filled with wood, stone and general rubbish.

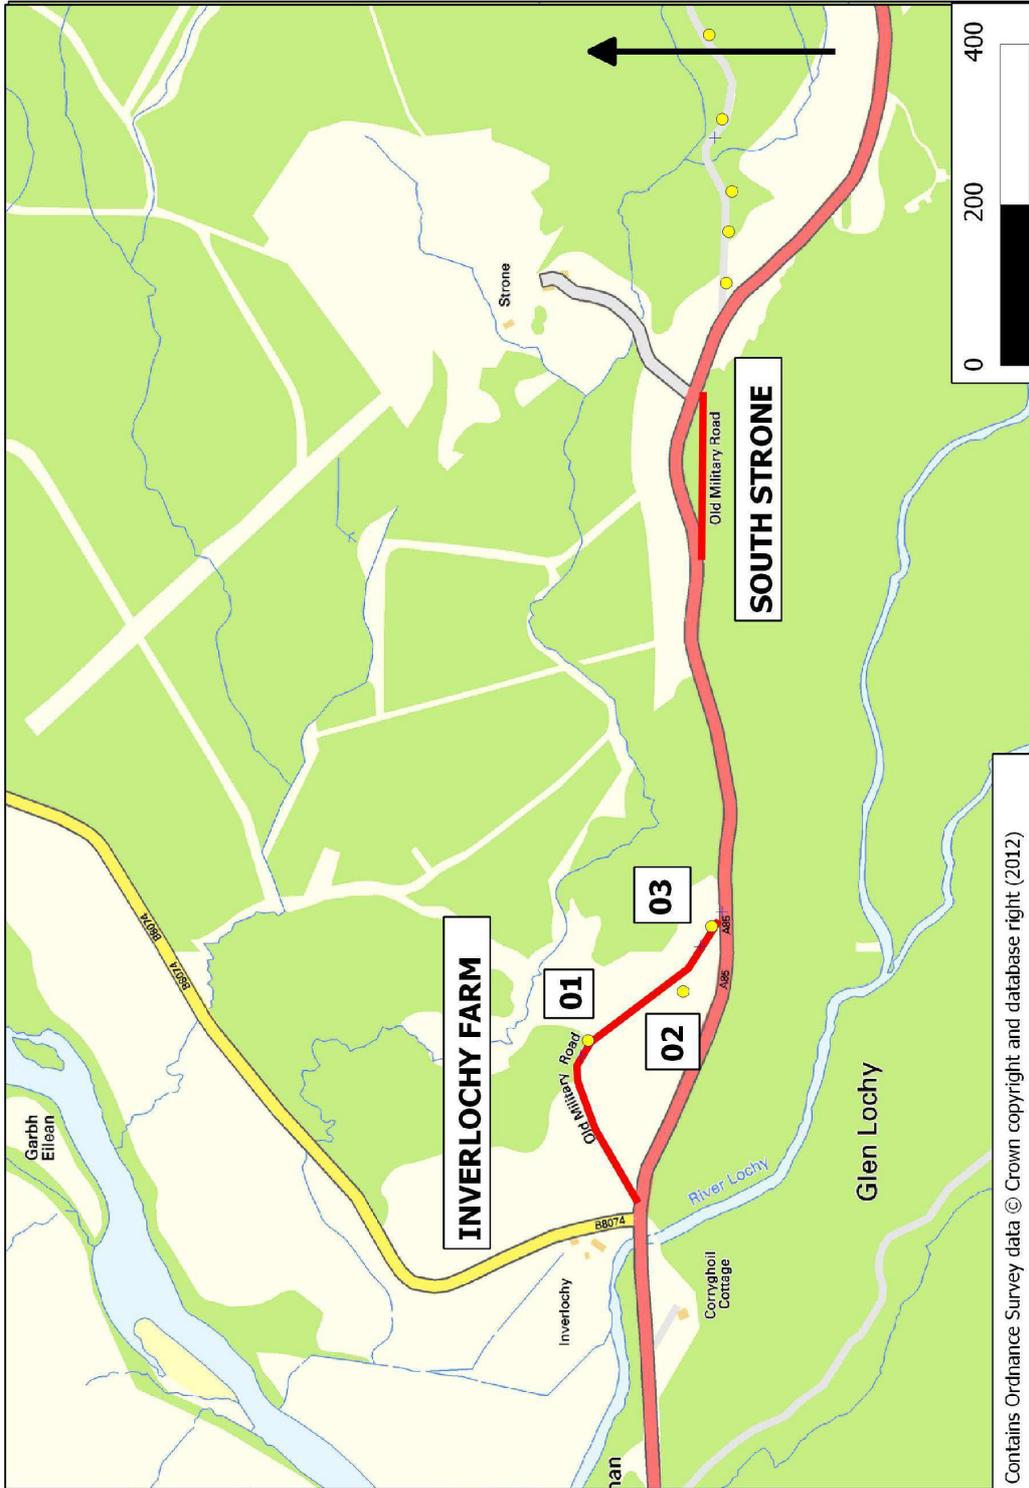
FIG. 3 INVERLOCHY FARM AND SOUTH STRONE SECTIONS

A degraded, curvilinear 450m length of the military way survives on the north side of the A85 (Fig. 3). Although overgrown with grass and bracken, the carriageway is approx five metres in width and clear along its entire length. It appears not to have been disturbed by any later developments, however, a number of young trees have been planted into its banks, which are visible intermittently on either side of the road. A number of quarries have been identified on either side of the road but no further features. The carriageway is particularly boggy at its immediate western and towards its eastern end.

A degraded, short 200m section of the military road survives south of, and approximately three metres below, the existing road level of the A85, just to southeast of Strone (Fig. 3). This section is very overgrown and is almost impassable in places. The carriageway is generally five metres in width with two metre wide banks to either side which are up to one metre high. The entire road is covered in bracken (two metres high in places) and heather. The western end of the section is quite boggy and totally overgrown with scrubby trees. Towards the western end, a drainage ditch and a section of walling lie on the south side of the road, whilst a further drainage ditch appears to have been cut through the carriageway close to the northern bank. Towards the centre of this section an oak and a birch are growing out of the carriageway. Further to the east, material appears to have been dumped onto the carriageway across an area of approximately 20 metres in length and a number of trees have now established themselves in this material.

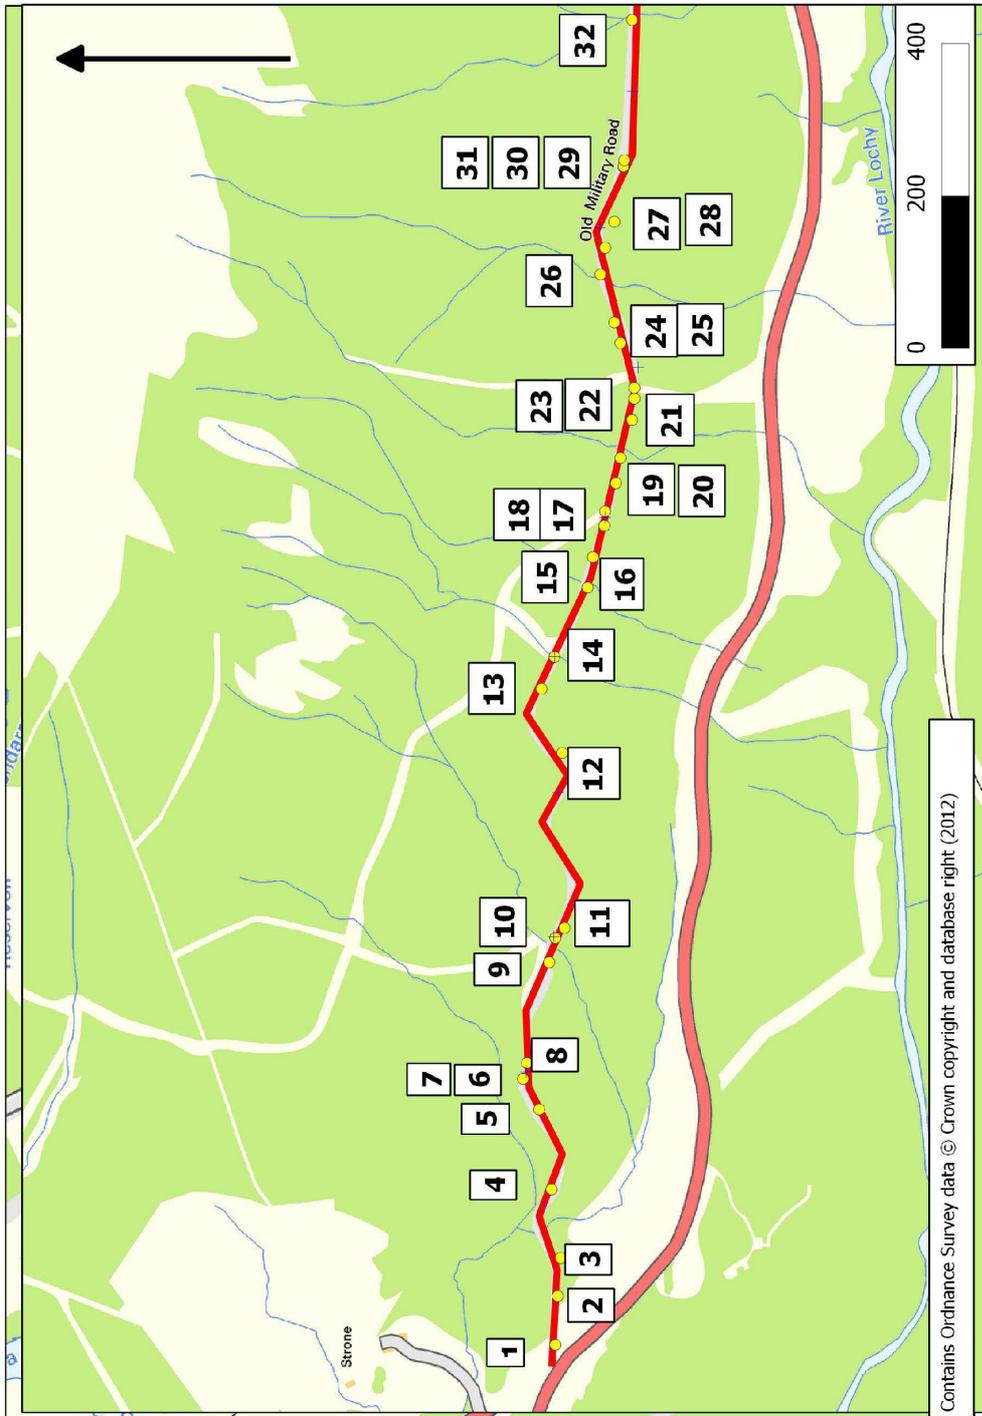
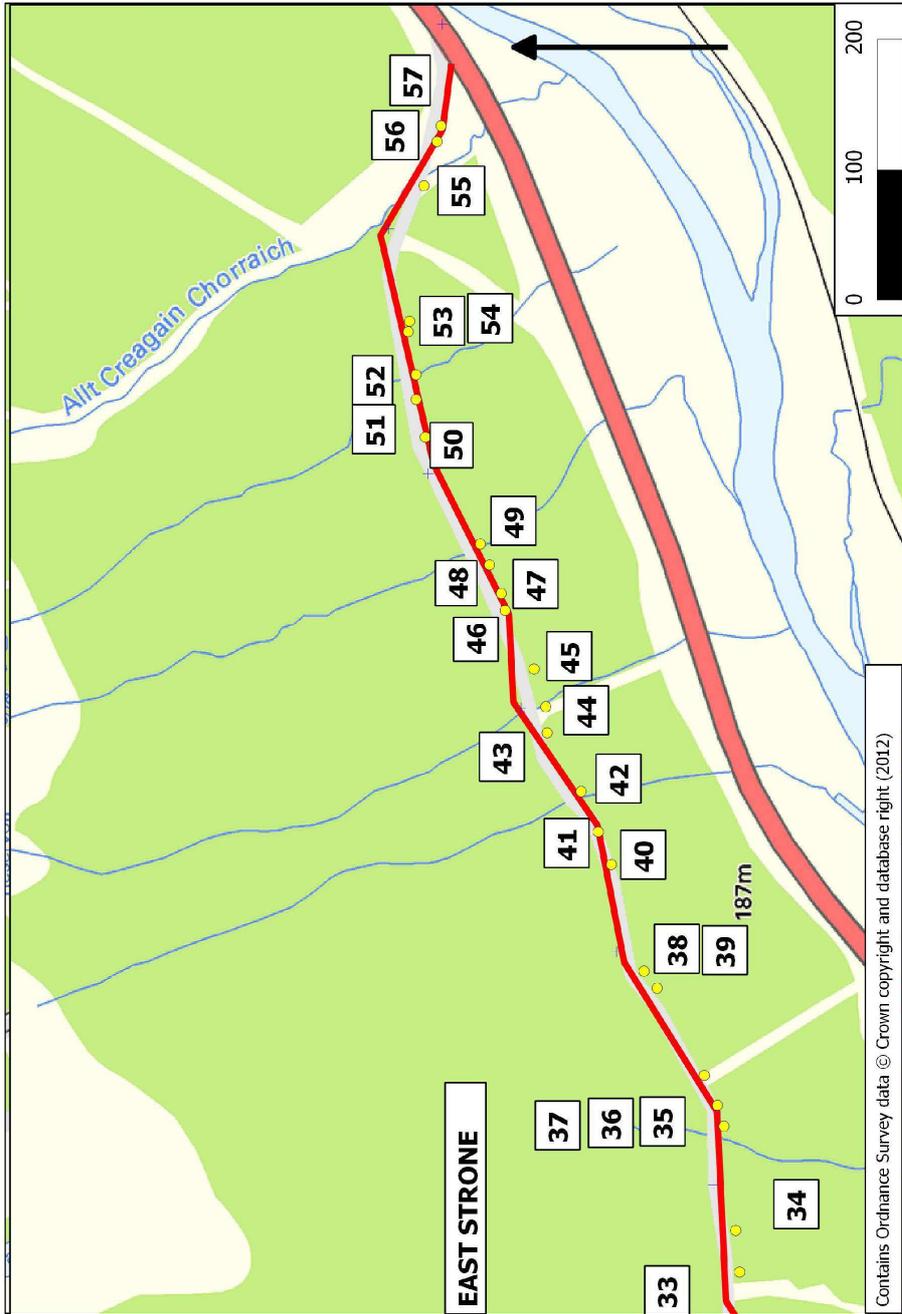
FIG. 4 EAST STRONE SECTION

A three kilometre, predominantly well-preserved section of the military way, survives north of the A85 between Strone and Airigh nan Cioch, starting and ending on the north side of the A85 (Figs. 4-5). The road has been bisected by a substantial forestry extraction road which extends from the north side of the A85 up to meet the military road between sections 09 and 010. This three kilometre stretch passes through mature forest, climbing steadily for the first 1.5km until it reaches a plateau and starts to descend again to meet the A85. The carriageway is on average five metres in width with intermittent banks on either side. It is clearly defined for the entire length but covered in grass, moss, patches of heather and the occasional windblown tree. A number of wet areas along the route showed signs of being used by rutting stags. A number of areas (particularly in the eastern half) have serious drainage issues as a consequence of blocked drains and collapsed culverts (see Sections 2, 5, 9, 11, 12, 14 and 15). The following drainage features have serious issues which need addressing (13, 14, 26, 27, 34, 40, 42, 44, 46, 49, 50, 52 and 55).

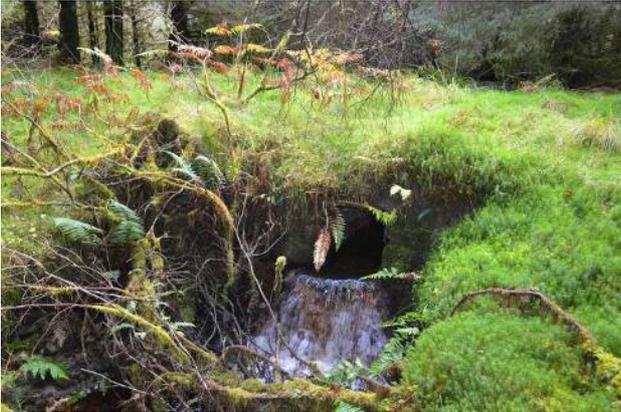
Photo 17: Culvert [02]

The features identified along this stretch of the military road were predominantly quarries (18) and culverts (20) but a number of unclassified drainage features were noted in addition to possible sidings and track ways. All the culverts were drystone built and at least three distinctive types were represented. Culverts [02], [020] and [039] represented a relatively squat, square type with no or very little apron; culverts [010], [032] and [044] represented large types with quite large drystone built aprons spanning the banks of the burn; whilst culvert [014] showed signs of having been extended.

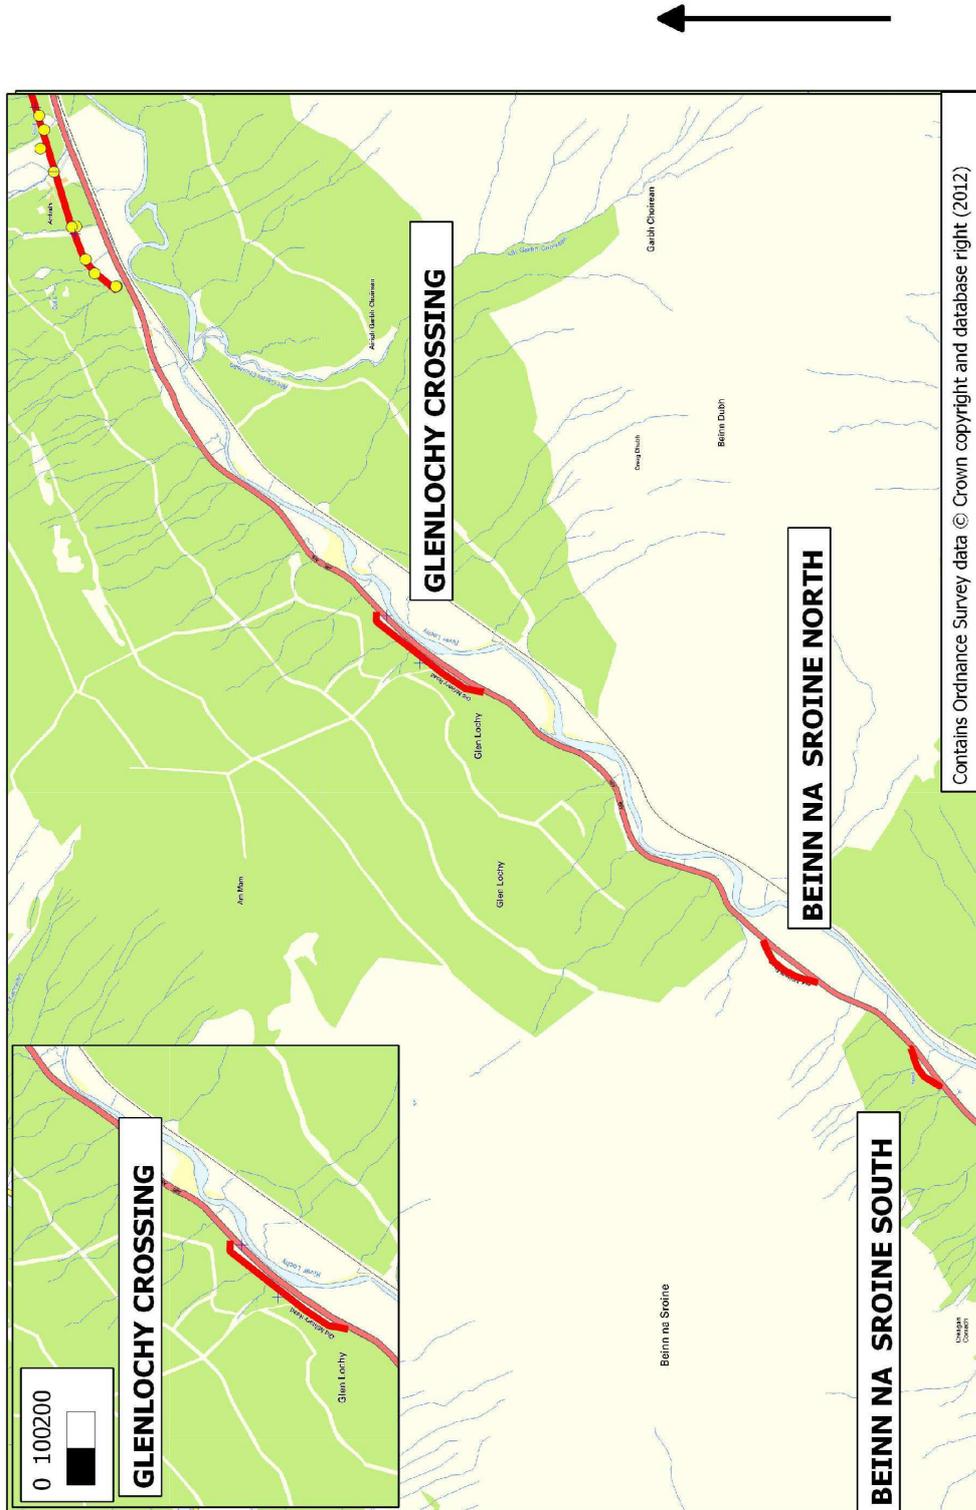
FIG.6 BEINN NA SROINE AND GLENLOCHY CROSSING SECTIONS

A short, curvilinear 200 metre section of degraded military road survives to the north side of the A85, separated from the road by a fence, within an area dense with bracken (Fig. 6). The road is clearly visible as a raised terrace (approximately one metre in height and four metres in width) hugging the foot of the hill with a ditch on its northern side. Towards the eastern end of this section a number of large boulders are apparent to either side of the road. A burn cuts through the road approximately halfway along its length but there is no evidence for any drainage feature, such as a culvert.

A short, curvilinear 200 metre degraded section of military road survives to the north side of the A85 (Fig. 6). The military road is separated from the road by a fence and a massive drainage ditch. Within the fenced area, the area is overgrown with grasses, rushes and bracken making it very difficult to establish the presence of the military road. However, the military road can be seen surviving as a slight raised terrace, hugging the foot of the hill.

On the NMRS and SMR databases, the military road is shown as following the course of the now A85, however, on the modern 1:10,000 Ordnance Survey map of the area a short, linear 400 metre section of the military road is shown surviving on the north side of the A85, opposite Glenloch Crossing, extending from approximately NN 25309 29528 – NN 25531 29840 (Fig. 6).

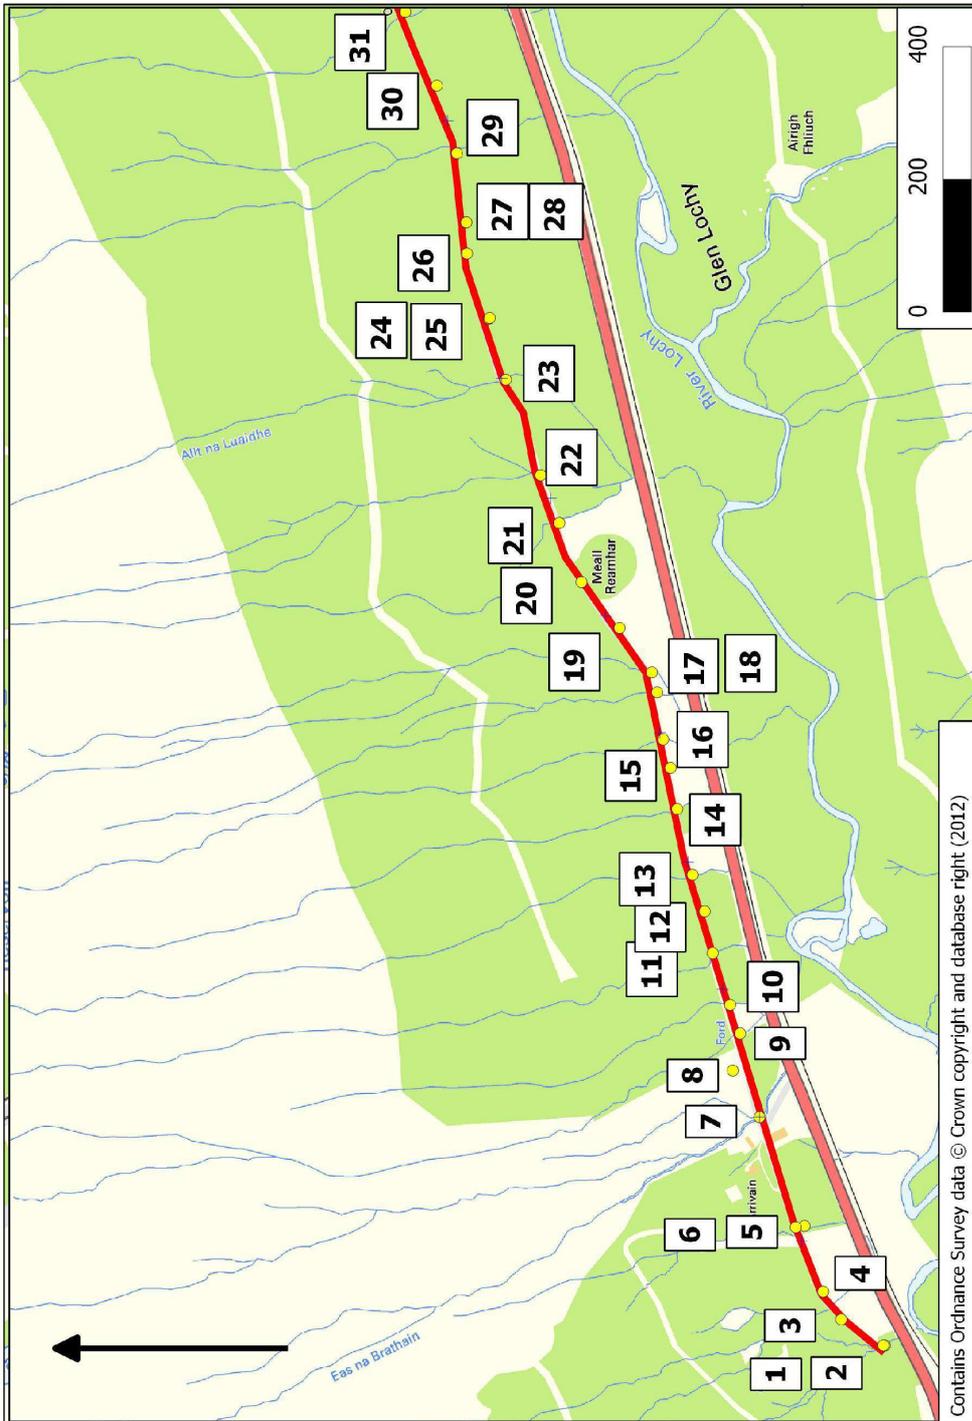
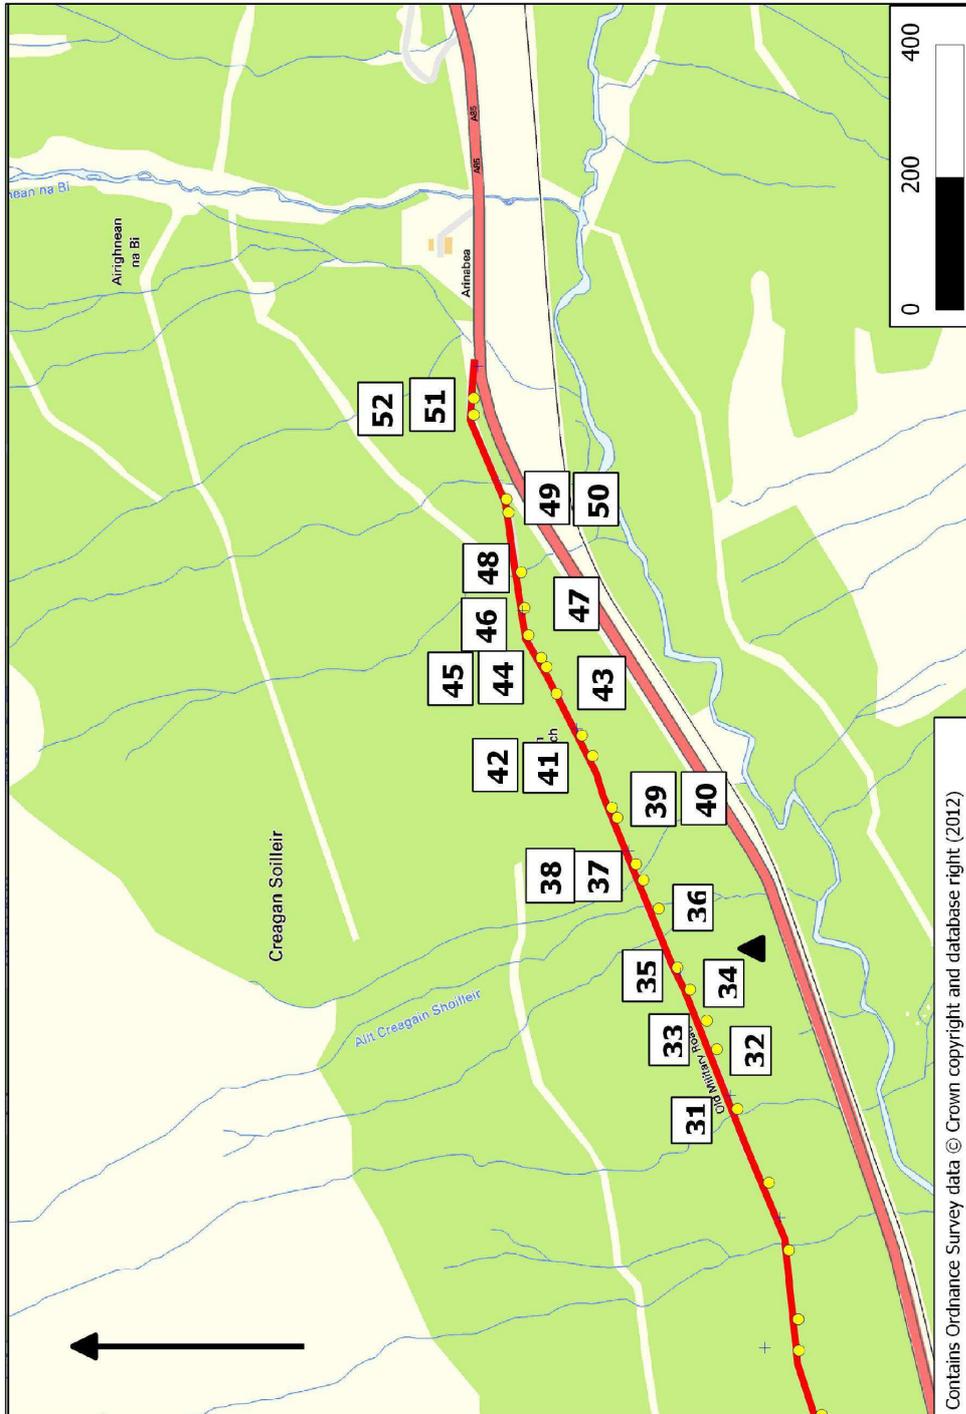
FIG. 7 ARRIVAIN TO ARINABEA SECTION (A)

A number of areas have serious drainage issues as a consequence of blocked drains and collapsed culverts (see Sections 4, 5, 6, 7, 10, 15 and 16). The following drainage features have particular serious issues which need addressing (10, 17, 22, 23, 27, 36, 38, 43, 44 and 46).

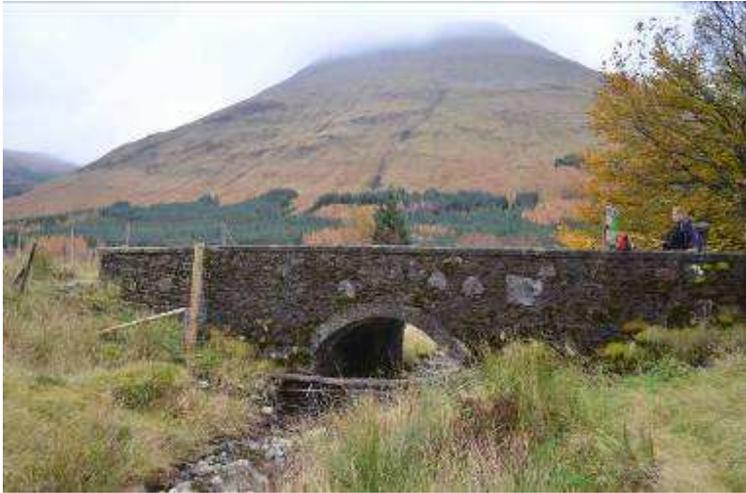
Photo 71: Bridge [07]

This long stretch of the military road stands out from the other eight areas by having five fine bridges and a large number (35) of fine culverts. The five bridges are 19th century Parliamentary bridges but at least two [013] and [029] show possible signs of incorporating earlier material.

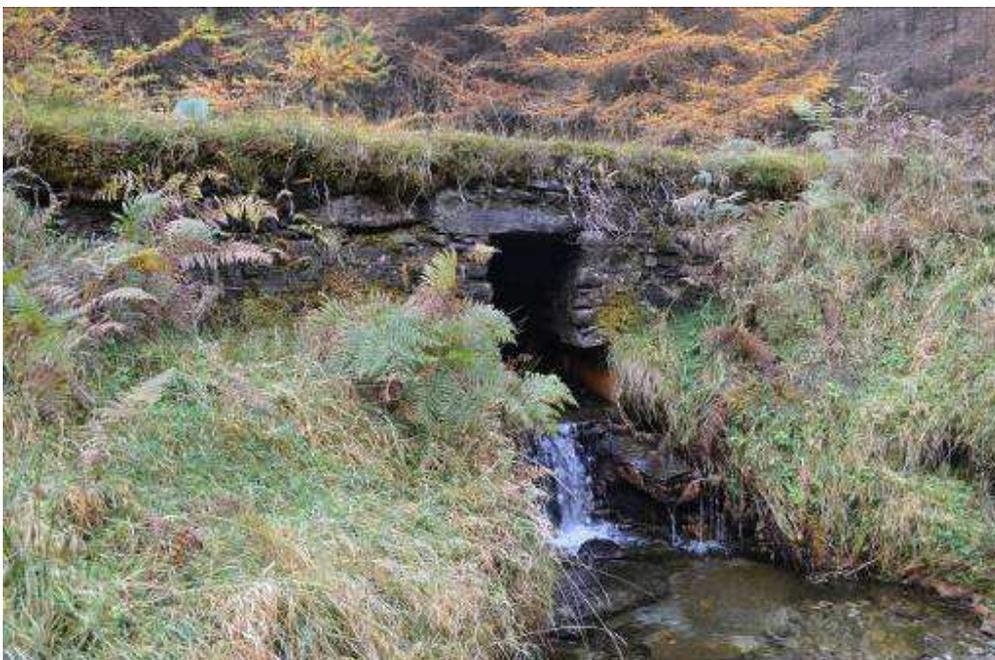
Photo 88: Culvert [036]

Similarly to East Strone, the culverts are predominantly drystone built and at least four distinctive types were represented: the small, fairly squat square/rectangular type with no/very little apron [025], [035], [037], [044] and [048]; the larger type with drystone built aprons which span the banks of the burn [023]; very large bridge-type culverts [088] with very large drystone built aprons and; culverts which show obvious signs of having been extended [09], [022], [026], [035] and [048]. A number of culverts also show signs of having been damaged by either later ceramic pipe insertions and/or flooding.

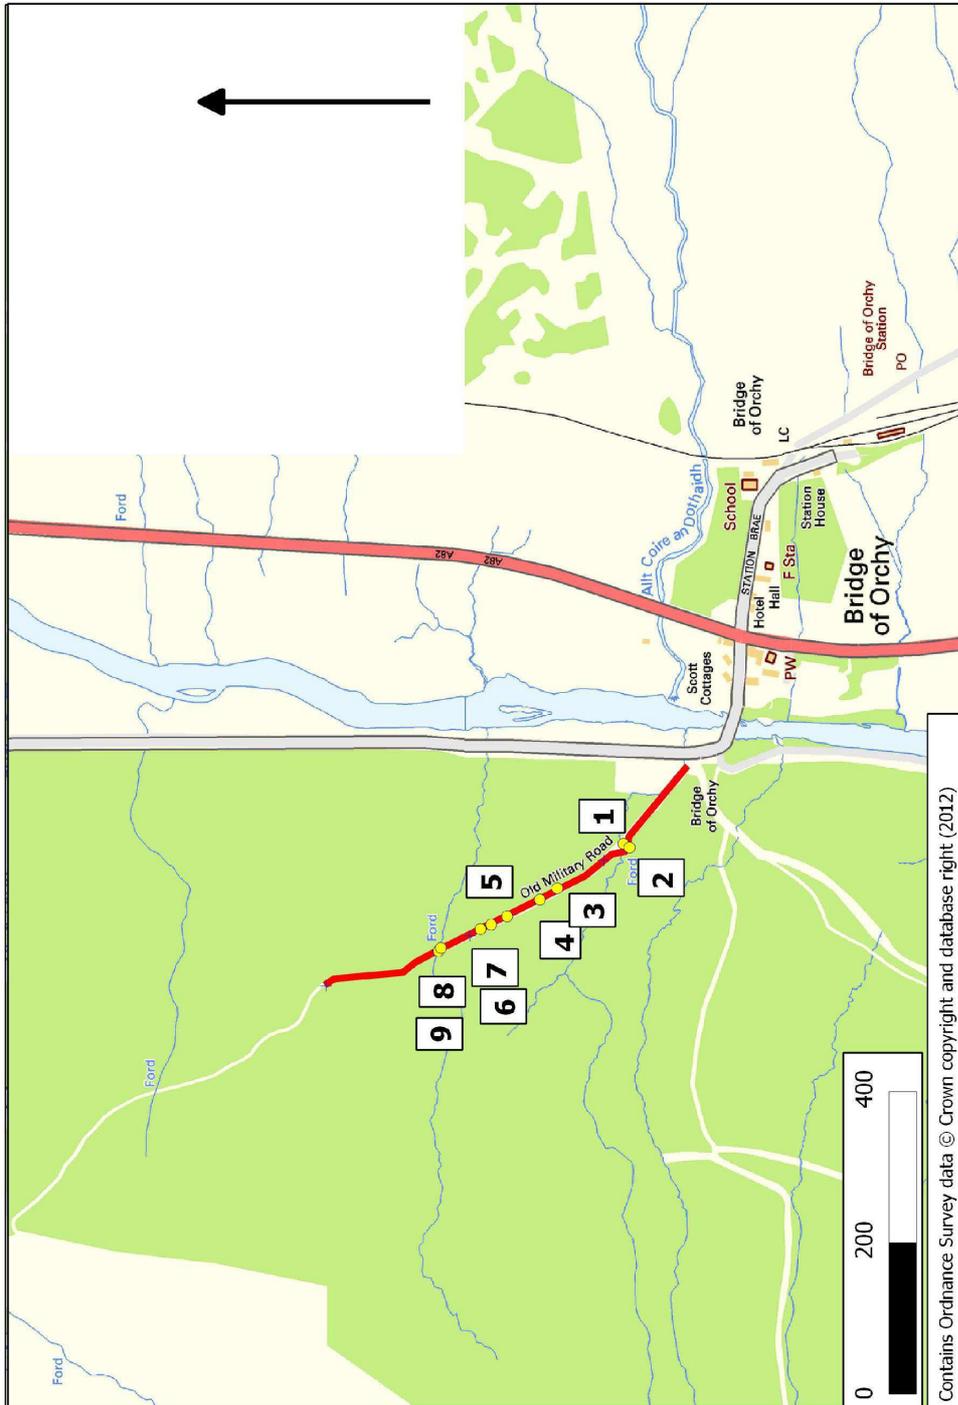
FIG. 9 BRIDGE OF ORCHY SECTION

This section of the Military Road is scheduled (FCS Ref 2858) and is part of the very popular West Highland Way which continues up and over Mam Carraigh to Inveroran on the west shore of Loch Tulla (Fig. 9). The Military Road crosses an area of recently clear felled, but now open heather ground, to the east which is backed to the west by standing conifer plantation. The Military Road survives over this section but has been seriously truncated by the West Highland Way, which has cut into and through the road deposits which make up the Military Road. The road has also suffered severe erosion as a consequence of poor drainage. There are a number of modern and older drainage features across the road in addition to a large stone built culvert/bridge.

Close to the start two stone springers are all that remain of an abandoned bridge. The path has been diverted slightly to the west and the bridge has been superseded by a modern drainage channel. The stone block kerbing at the start of the section (as identified by Atkinson in 1994) could not now be identified.
