Outbuilding at Rams Farm, Fordham, Essex

Historic Building Record

Leigh Alston MA (Oxon), Architectural Historian

April 2019

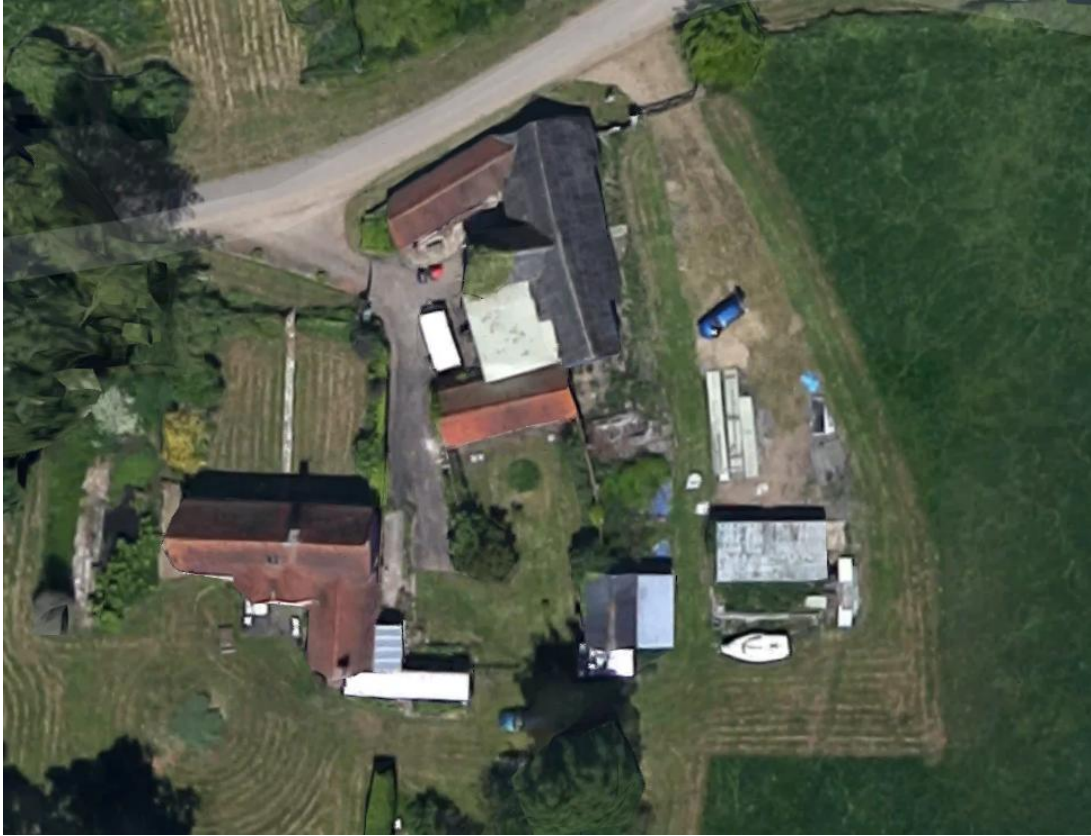
Figure 9
A current aerial view showing the barn terminating at the north-eastern corner of the southern shelter-shed (4) with the detached granary to the south.

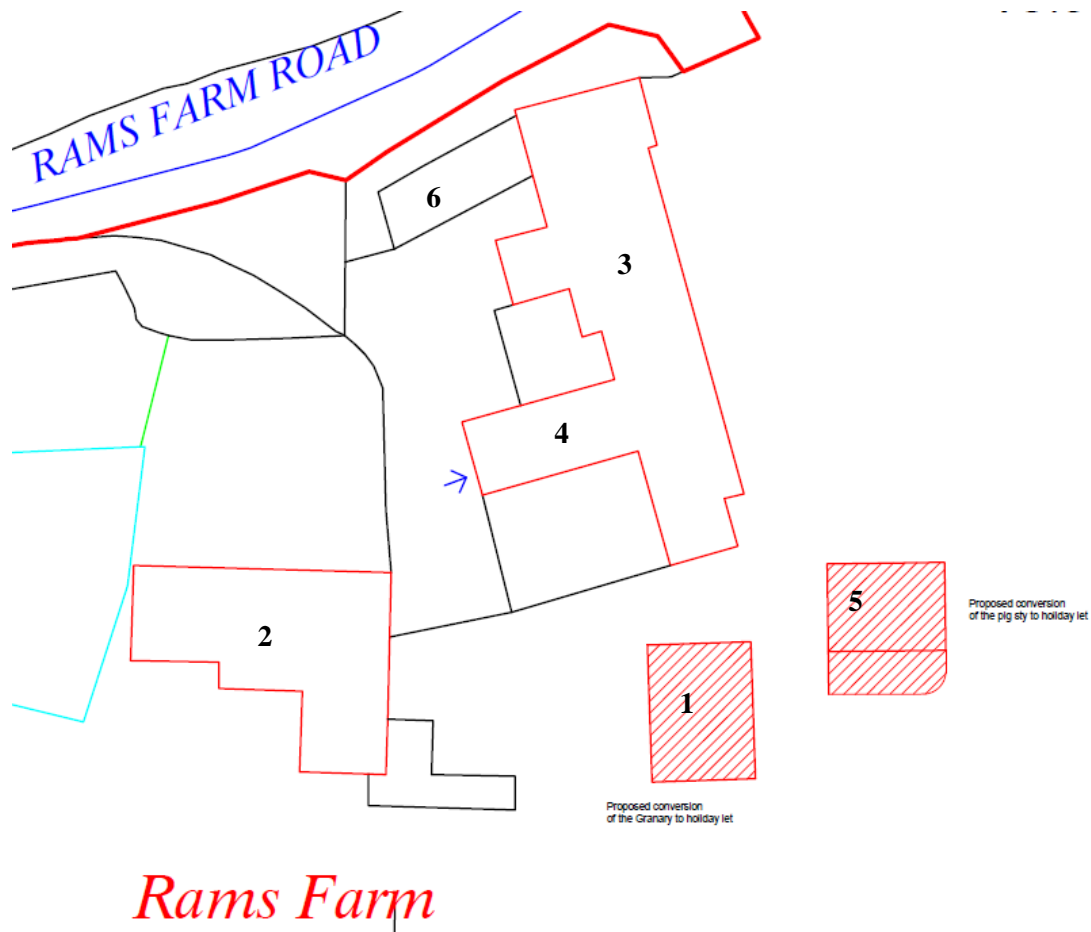
Figure 10

Site plan by Oswick Ltd dated 2016 adapted to identify each key structure with a number for ease of reference in the text and photographic record. The area of the barn has since been truncated to the south and east of the shelter-shed (4) as shown in fig. 9.

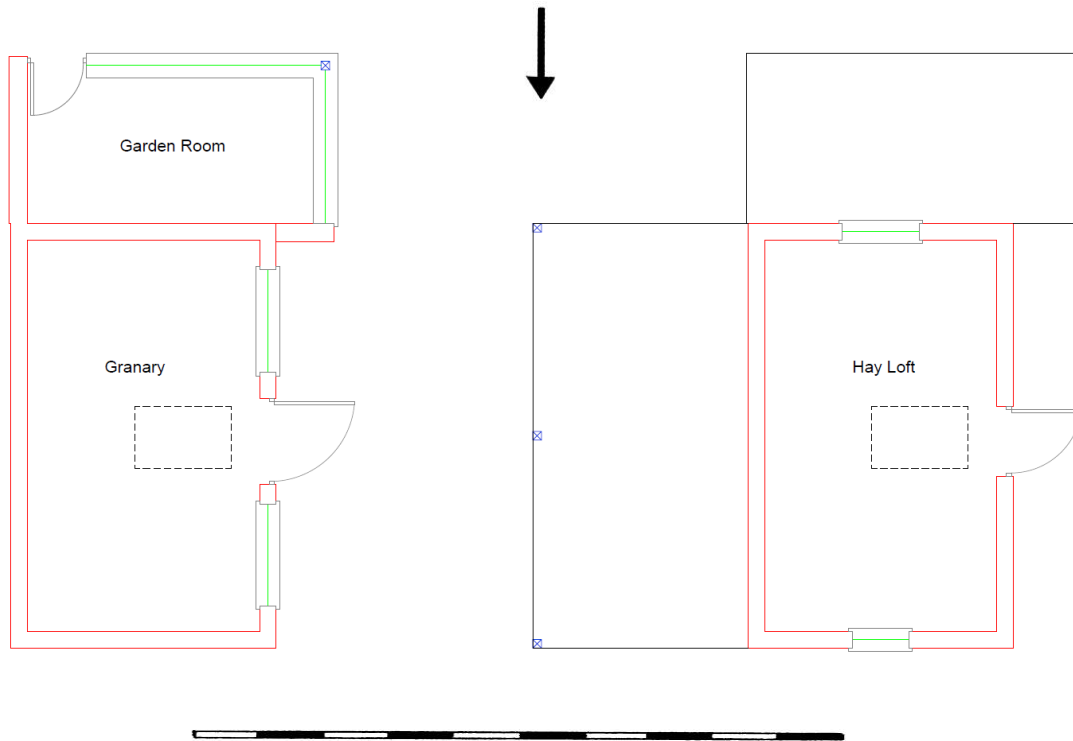
Figure 11
Ground (left) and first-floor plans by Oswick Ltd. Scale in metres. The ‘hay loft’ was in fact a grain store.

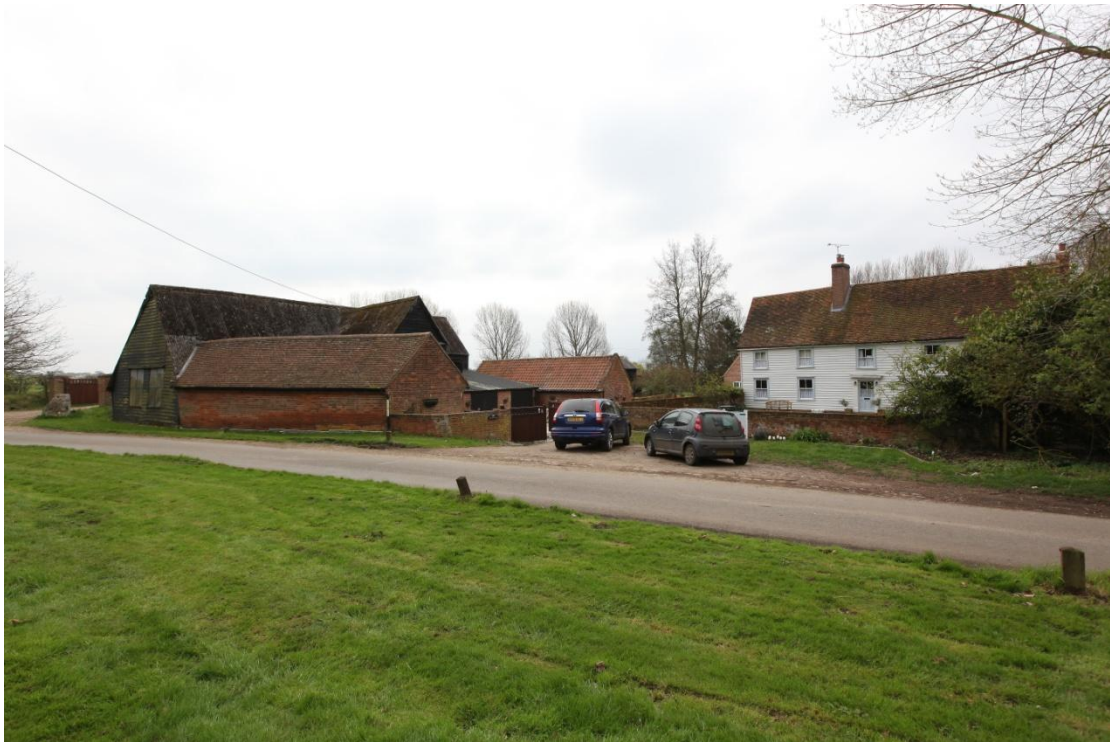
Illus. 1. A general view of the site from the road to the north-west showing the granary (1) in the rear between the listed weatherboarded house (2) on the right and the listed barn (3) to the left.

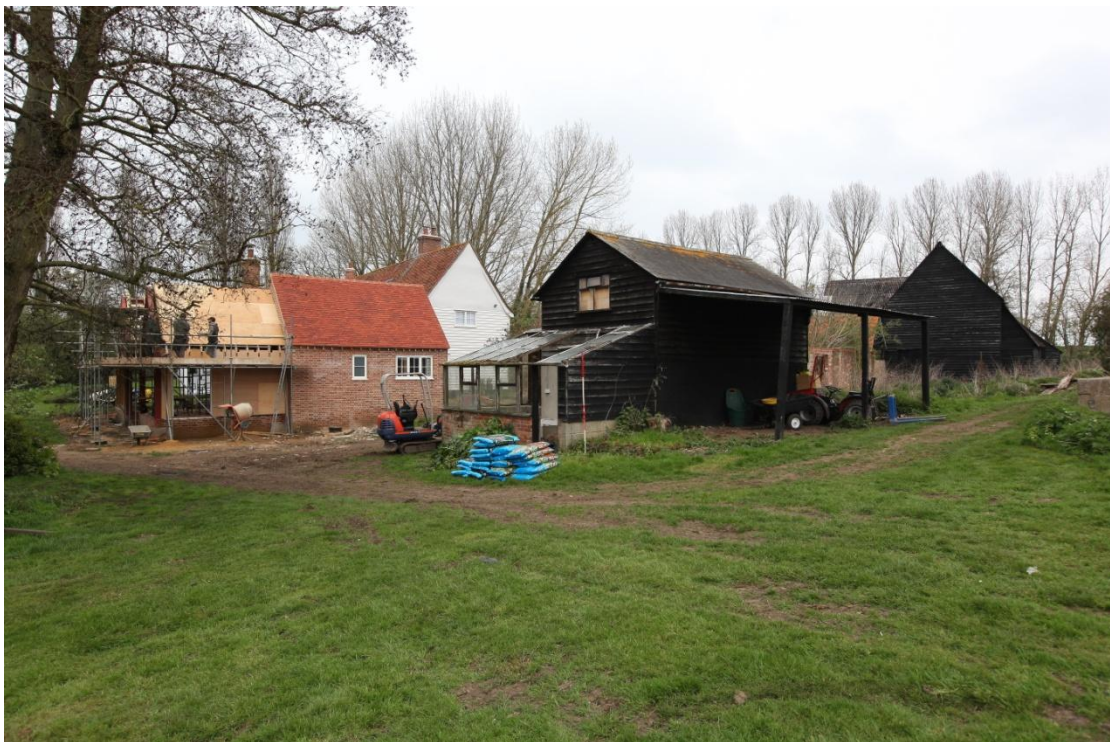
Illus. 2. A general view of the site from the south-east showing the slate-roofed granary (1) in the centre with the house (2) and aisled barn (3) to the left and right respectively.

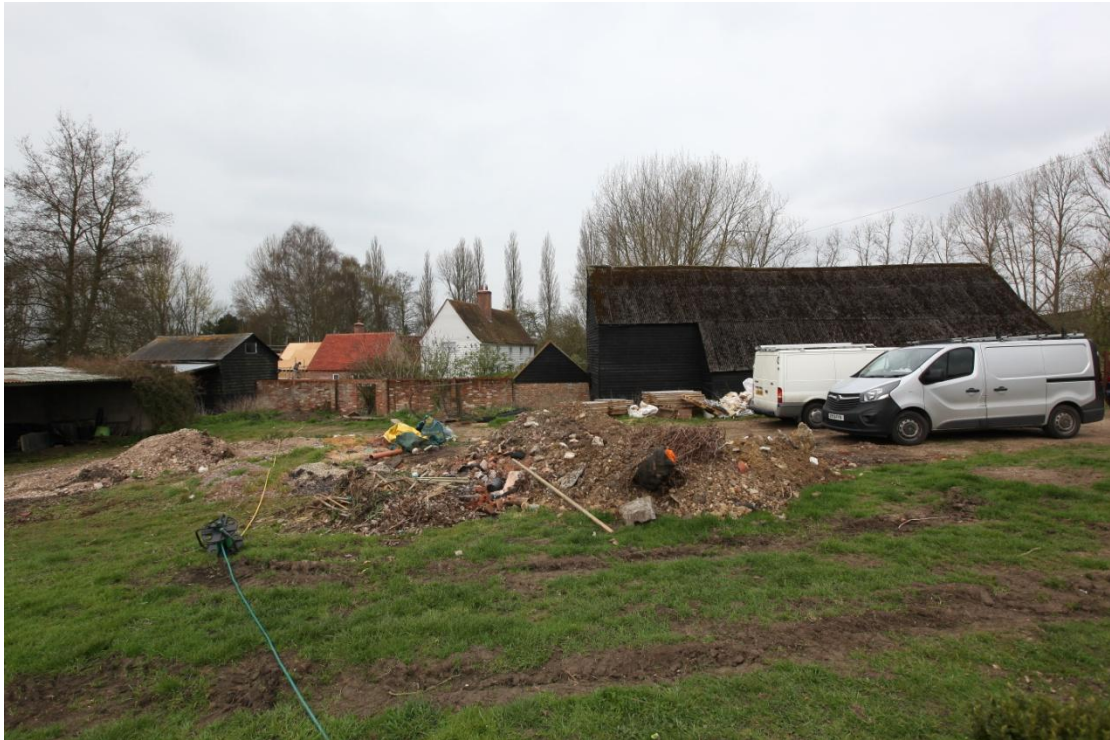
Illus. 3. A general view from the east showing the house (2) and barn (3) with the granary (1) and 20th century cement-block pig sty (5) on the left.

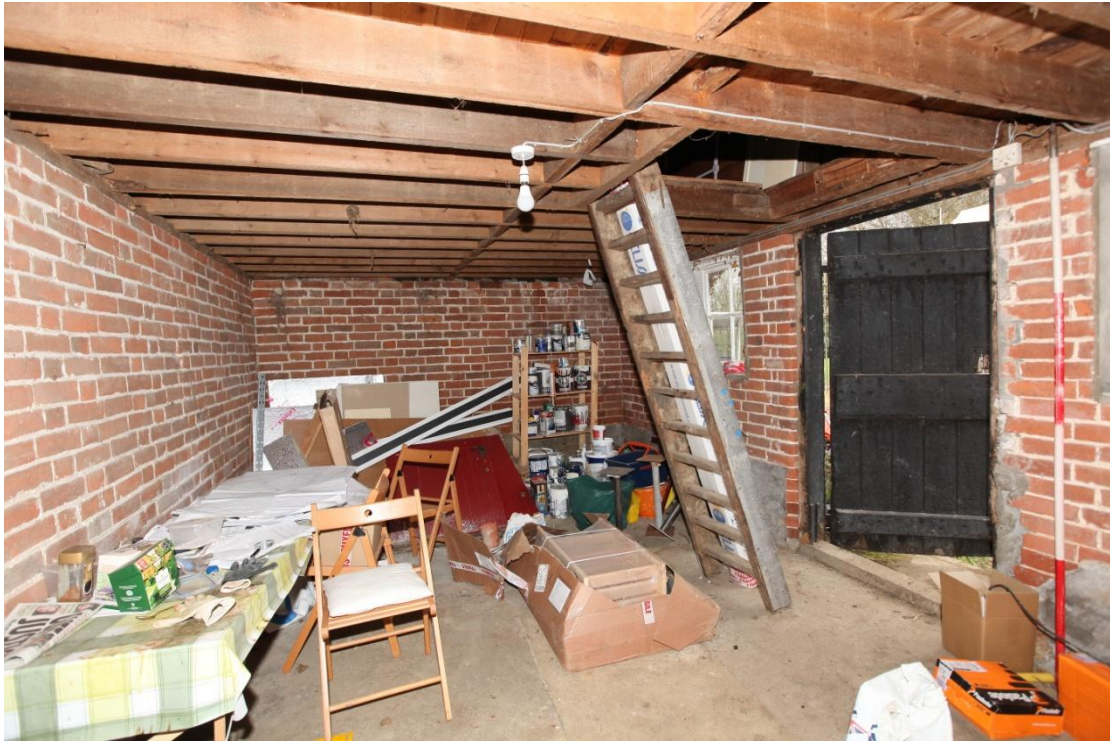
Illus. 9. The lower storey of the granary from the north showing its featureless interior with a concrete floor and ceiling of tall-sectioned softwood joists. This space was probably used for the milling and storage and animal feed.

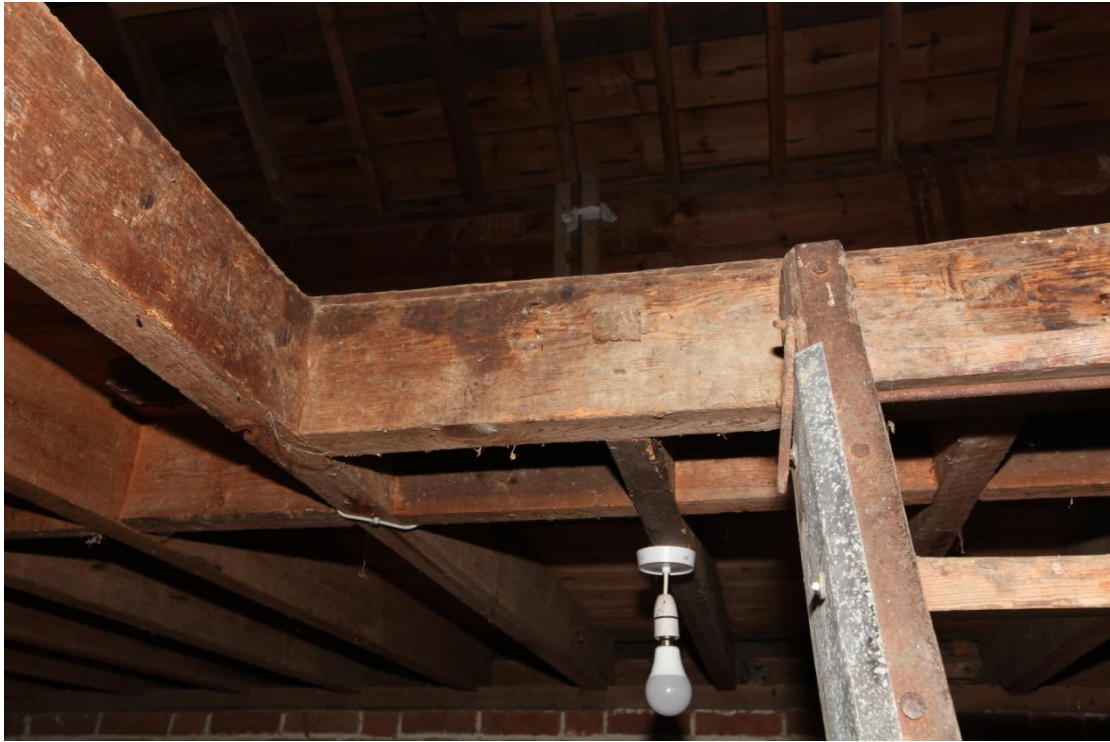
Illus. 11. A detail from the west of the granary's ladder trap showing the apparently original tenons of the framing joists. The trimmer supporting the ladder is through-tenoned and pegged at both ends.

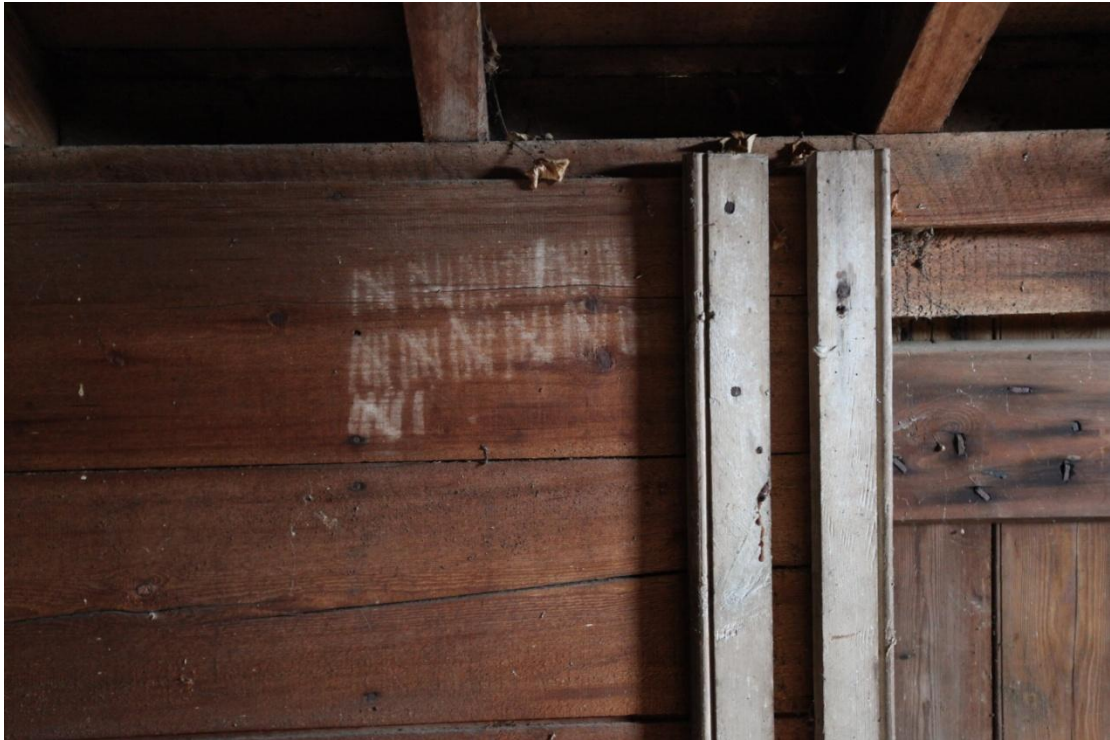
Illus. 15. A detail of the chalk tally marks to the western interior of the grain loft with the central loading door on the right.

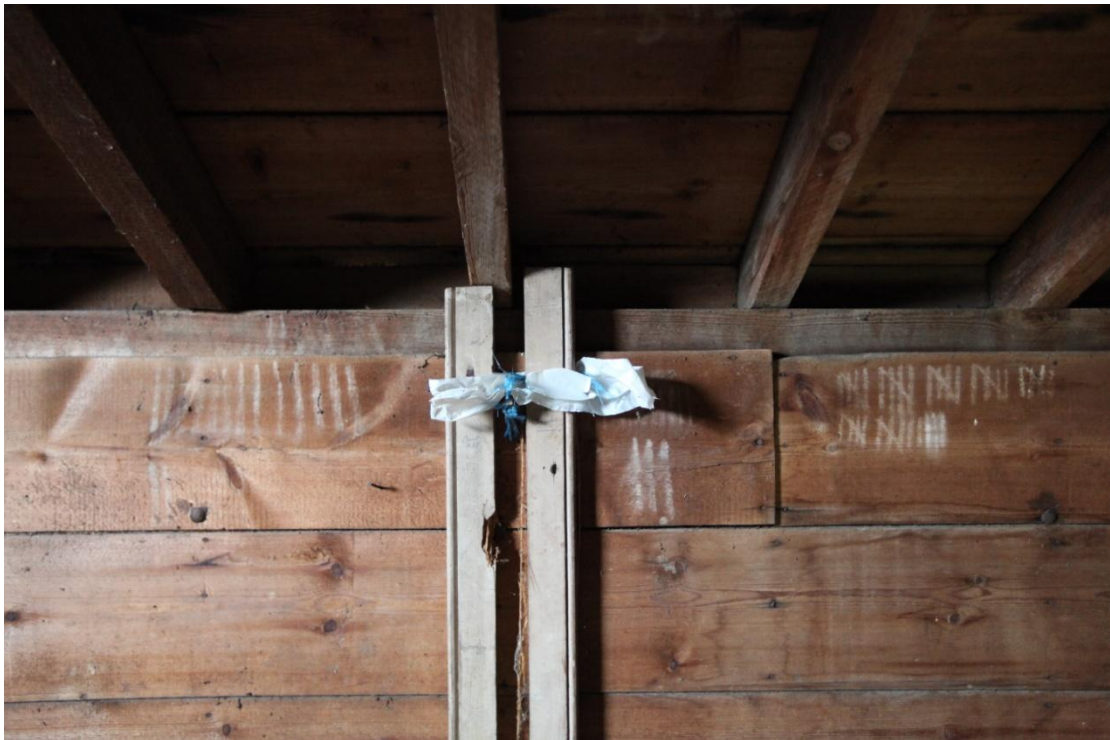
Illus. 16. A detail of the chalk tally marks flanking the northernmost groove of the grain loft's eastern interior.
