# **Historic Building Assessment**

## **5 Carlton Crescent Southampton**

June 2016  
Reference: 16307  
Site Code: SOU 1730

**Oakdene Construction UK Limited  
2 Kings Copse Avenue  
Hedge End  
Southampton  
SO30 0FW**

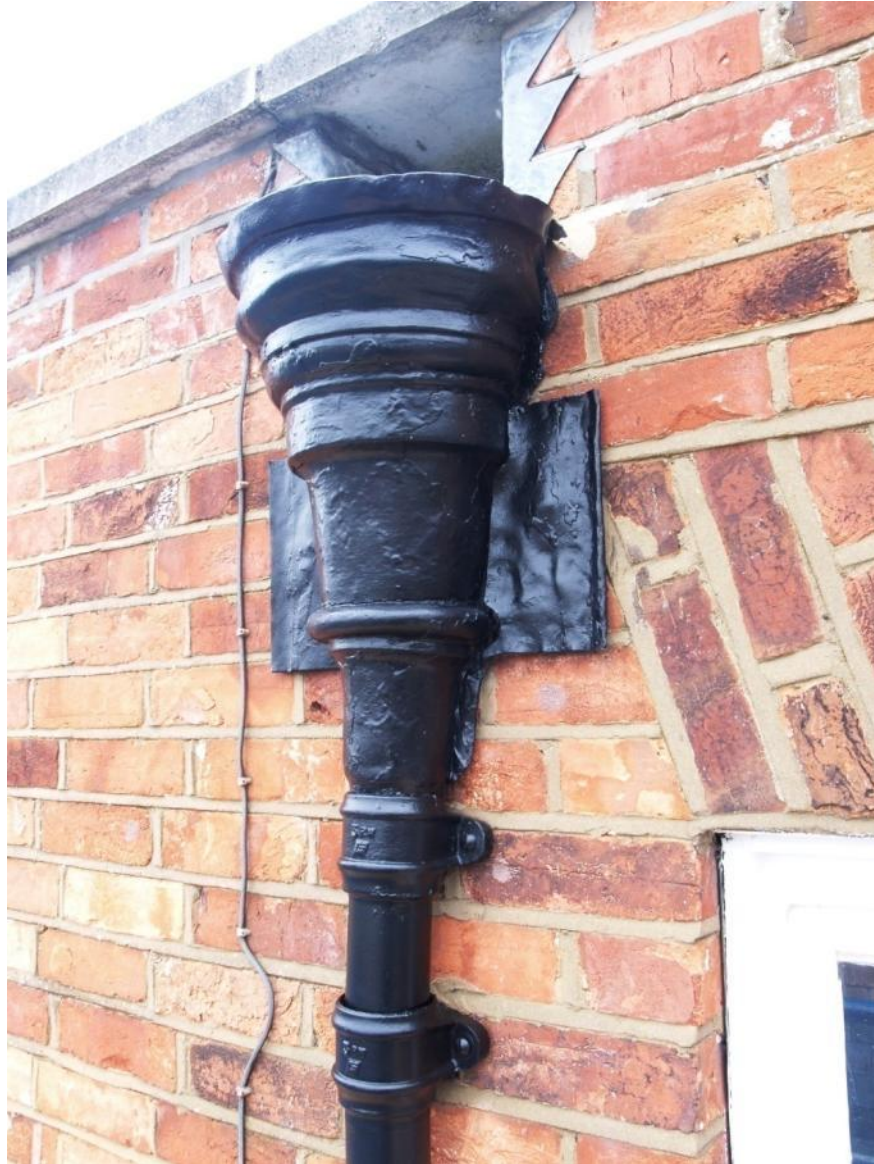
Fig 3.4.2; Hopper head to rear of building

- 3.4.1 The valley gutters all the way round the perimeter of the main roof are lined with lead with steps set within them at reasonable distances and this lead, as seen internally, is supported on modern plywood on softwood bearers.
- 3.4.2 The main roof parapet gutter has outlets to the rear. At the south end the gutter discharges into a large semi conical hopper head of lead that empties into a cast iron downpipe. At the north end this discharges into a smaller more standard modern section or box type hopper head and then connects to a downpipe.
- 3.4.3 All the significant rainwater downpipes around the building are in modern cast iron units that have been painted.
- 3.4.4 The rear lift shaft roof has an eaves with half round section PVCu guttering to the perimeter and similar circular section downpipes.

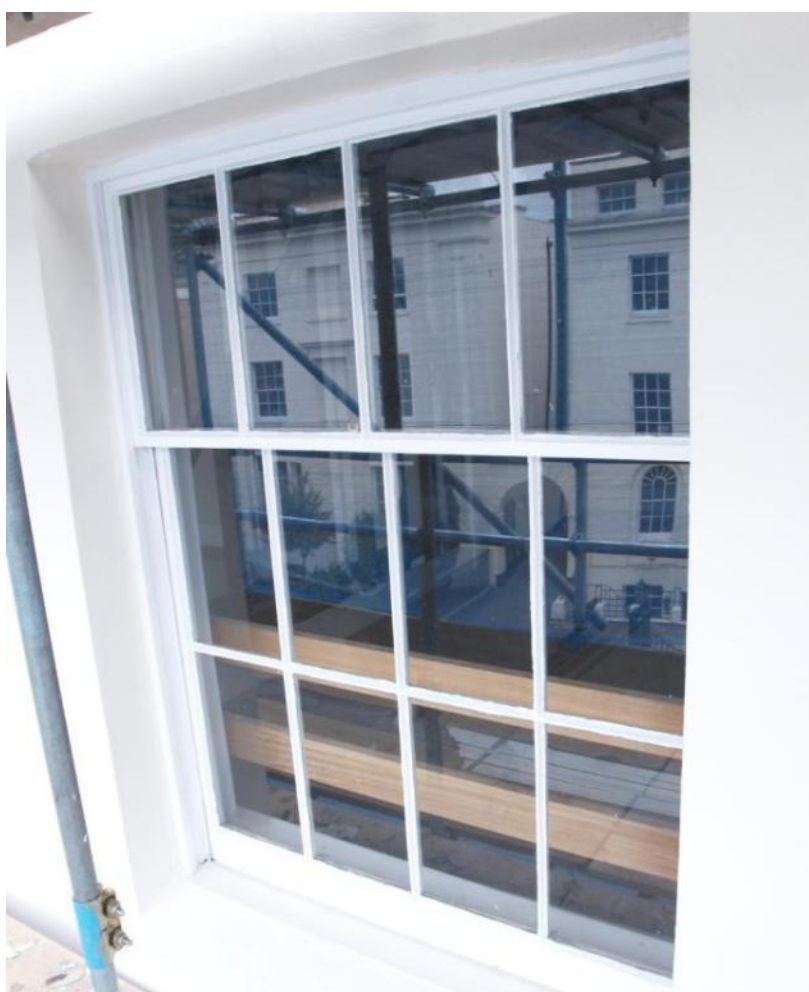
Fig 3.6; Example of front elevation window

- 3.6.12 Front sash window to the south first floor room is single glazed to both upper and lower sashes. The bottom is a sash modern reproduction unit with heavy non

matching glazing bars of an inappropriate section and profile. The upper sash has been much repaired with replacement glazing bars in an appropriate section and non matching to centre rail.

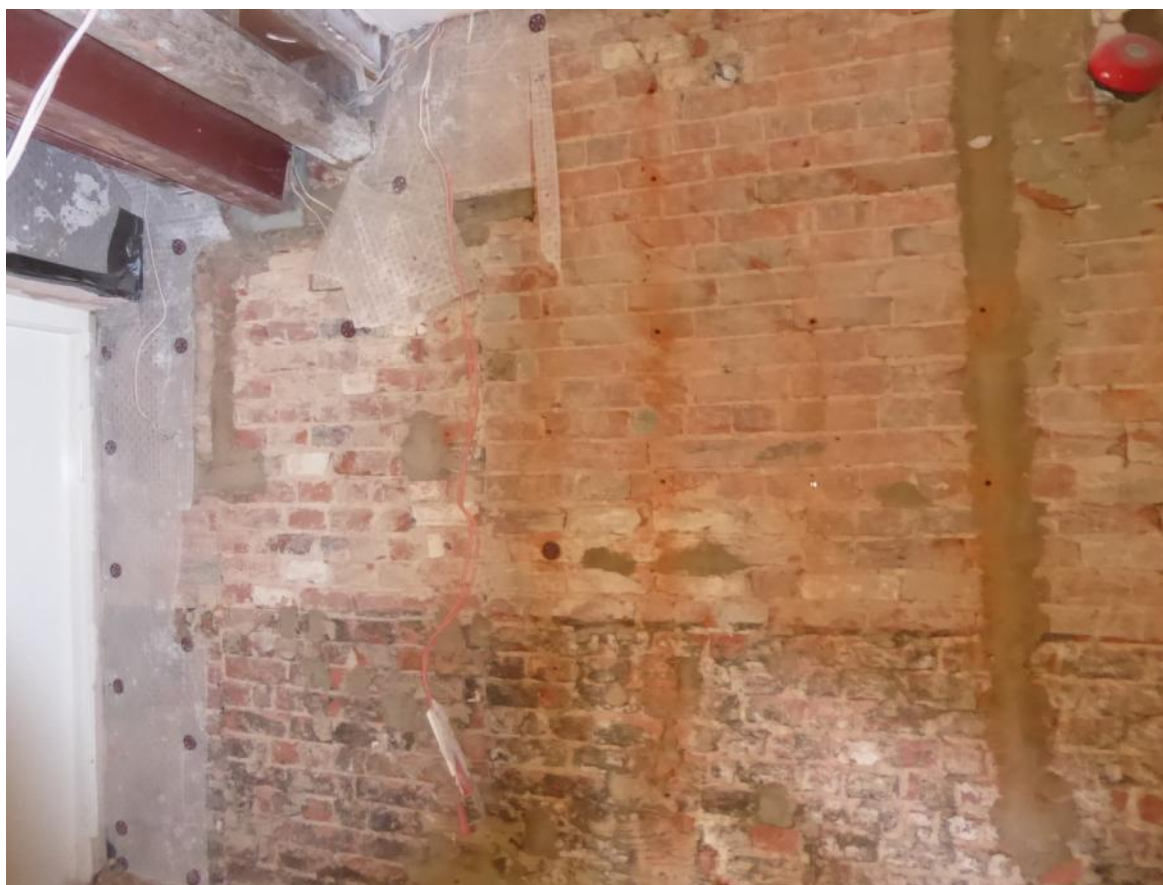
Fig 4.2.4 north wall

- 4.2.1 The floor is of modern concrete construction with the remains of earlier brick wall showing from the alignment to left hand side of door to the front access well.
- 4.2.2 There is evidence for a doorway in the west end of the north wall.
- 4.2.3 The internal walls are dry lined to the south corner room. The front wall has modern hard gypsum type plaster over a DPM where this is visible. Brickwork behind is in traditional clay bricks laid in lime mortar.
- 4.2.4 Evidence for removed resin mortar damp proof tanking is seen to base of the wall to the north front room and also an injected damp proof course is evident to base of the wall.

- 4.2.5 There is a blocked doorway to the north room at the front end of the wall adjacent to front door.

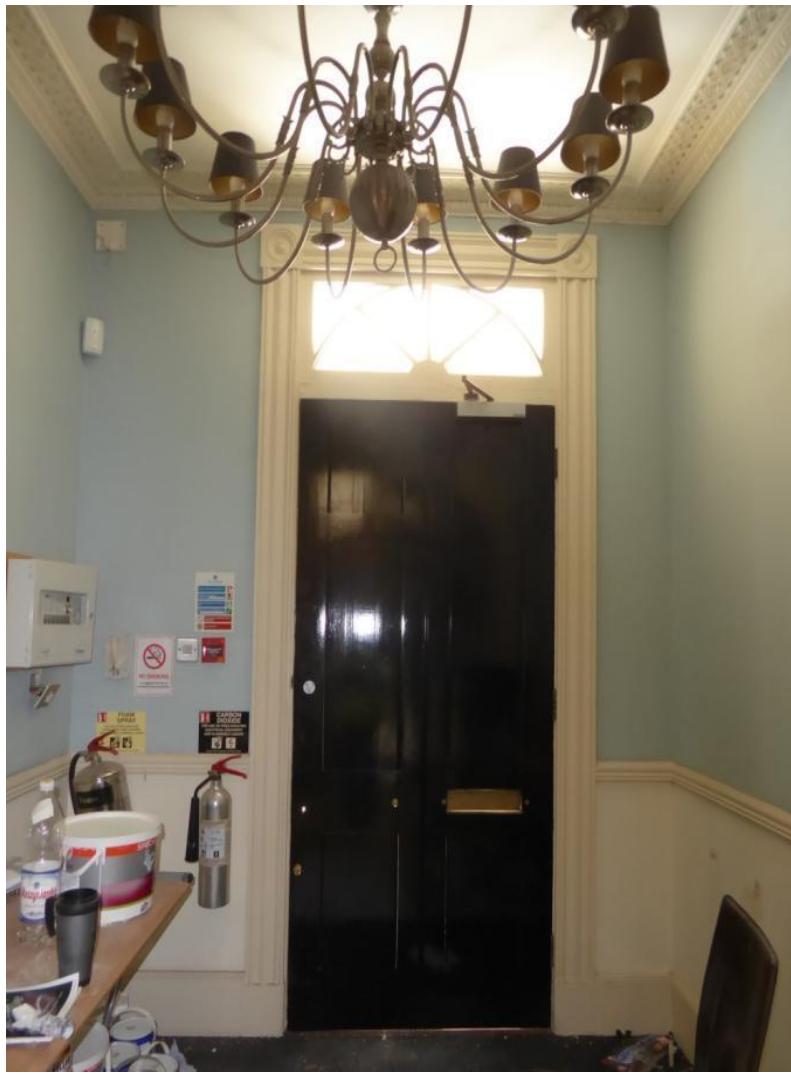
Fig 4.9; general view of front entrance door

- 4.9.5 The fan light to the front door is a modern single glazed unit over the head of modern six panel door with modern ironmongery and other fittings including door close to the top.

- 4.9.6 The moulded plaster cornice around the wall head to the ceiling has an egg and dart mould to the lower section with flat rose design to the corners and diamond fret borders to the sides. This is possibly all new moulding as joints were visible within the construction on individual section panels and in some places where it has been damaged modern support timber was seen behind.
- 4.9.7 In the central and rear section of the hall the walls are all finished with modern paint on a gypsum type plaster over skirting boards that match that to front. A modern standard joinery dado rail runs all the way around central and rear part of hall.
- 4.9.8 The door linings and surrounds are in modern joinery items to all the openings.

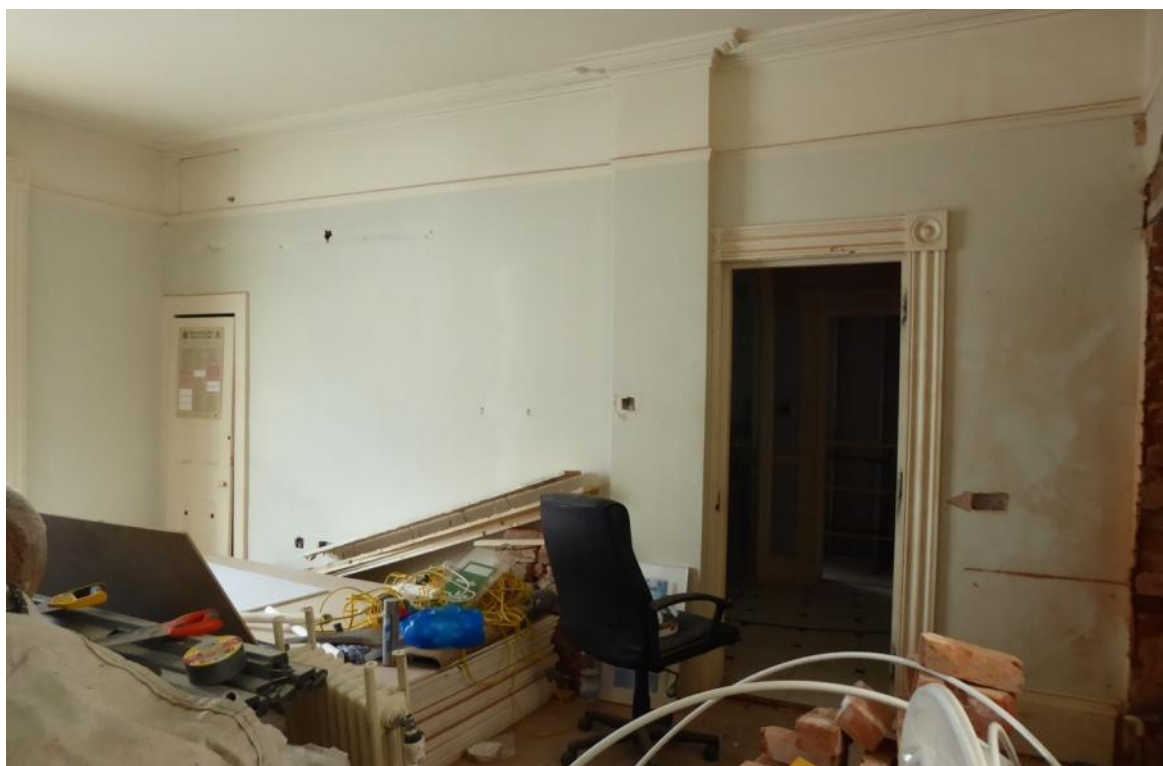
Fig 4.10; general view of south room, ground floor

- 4.10.4 There is a moulded plaster cornice all the way around the ceiling that may be original. Within this the ceiling is of modern plasterboard with ghosting on board joints across surface.

- 4.10.5 The internal reveals of the windows have shutters to the sides that are all fully painted up as the hinges are visible, but the shutters are not operable. The surrounds to the windows are apparently original and are of a type noted elsewhere, but with more original type bases to skirting level.

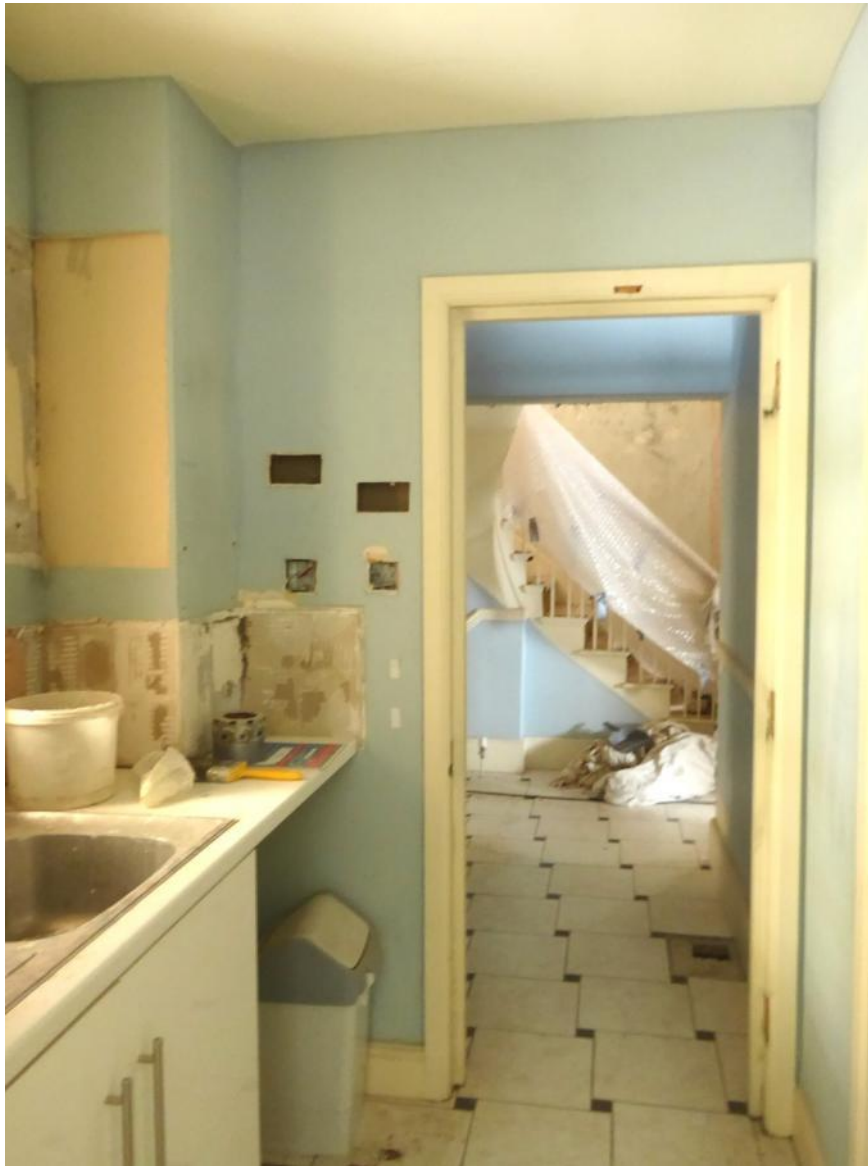
Fig 4.12; general view of ground floor toilet lobby

- 4.12.5 Door linings to the openings off this area to the inner end of the hall are the north front room and the toilets all in standard joinery with quadrant bead architraves to the surrounds. The opening into the toilets is fitted with timber six panel door of possible late 19<sup>th</sup>/early 20<sup>th</sup> century pattern hung on a pair of modern steel butts indicating it has been re-used.

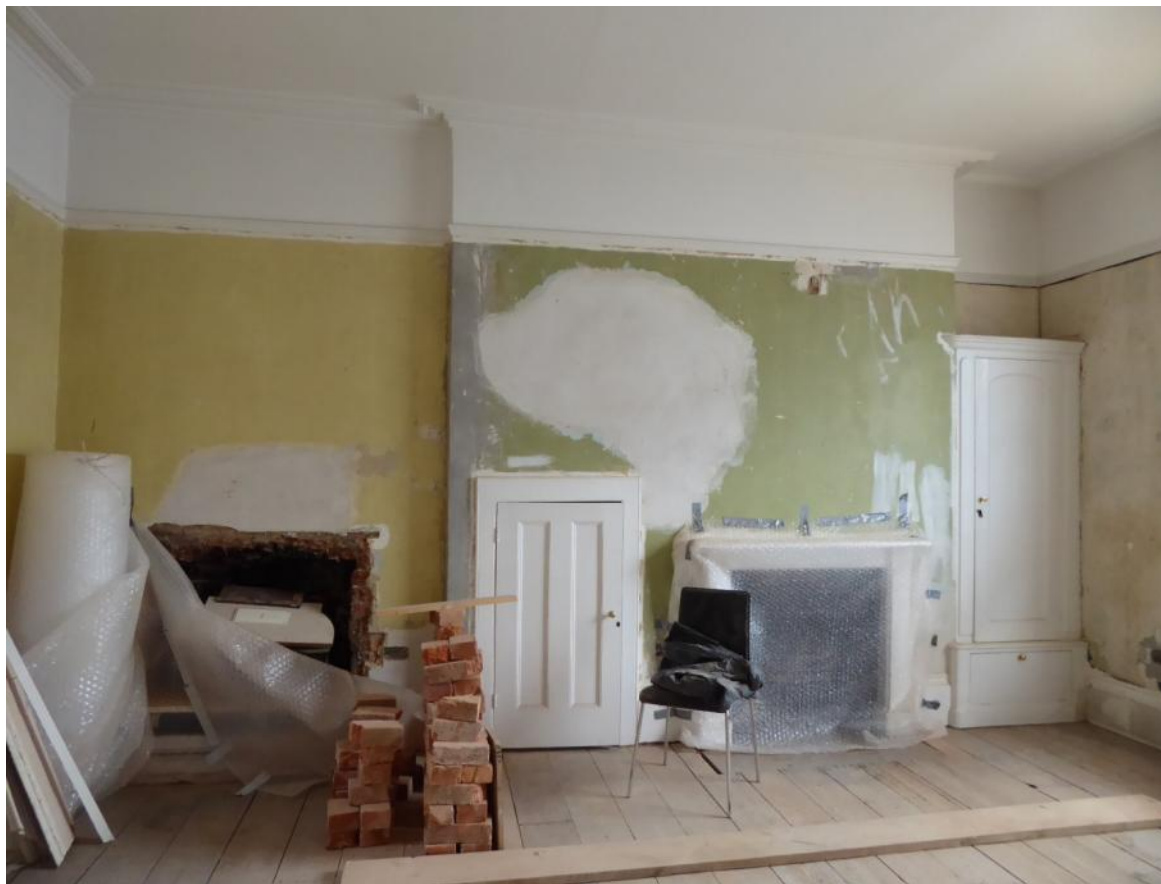
Fig 4.16; view of south wall front south room, first floor

- 4.16.1 The floor is a suspended timber structure with softwood, fairly straight grain boarding approximately 200 mm wide showing signs of historical staining and paint finishes. There are indications of where boards have been lifted and replaced possibly for installation of services within the floor void. Some patch repairs and replacement boarding with alternative forms of timber board have been made within the surface.

- 4.16.2 The walls are all of solid construction with generally original lime plaster finishes to the face that has subsequently has been painted. There are some areas where patch repairs have been undertaken in modern gypsum plaster.
- 4.16.3 There is evidence for where a wall originally divided the room from the rear corner of the chimney breast on the east side and then ran across to meet the north wall and so formed an entrance lobby in this location. This would have also formed a

- 4.16.4 The ceiling is a modern plain soffit with moulded plaster cornice to the surround that appears to be a modern replica as indicated by straight joints running across it in locations, seen as cracking and movement in the structure. This has evidently been altered and adapted as it now follows the present ceiling line around the entrance lobby with no allowance for the removed earlier wall.
- 4.16.5 Where a section of the cornice have been taken down this was shown to be a modern pre cast cornice that has been screwed into position using modern screws with cross heads. This would indicate that most of the cornice round this room has been replaced following the removal of the dividing wall to the rear section.

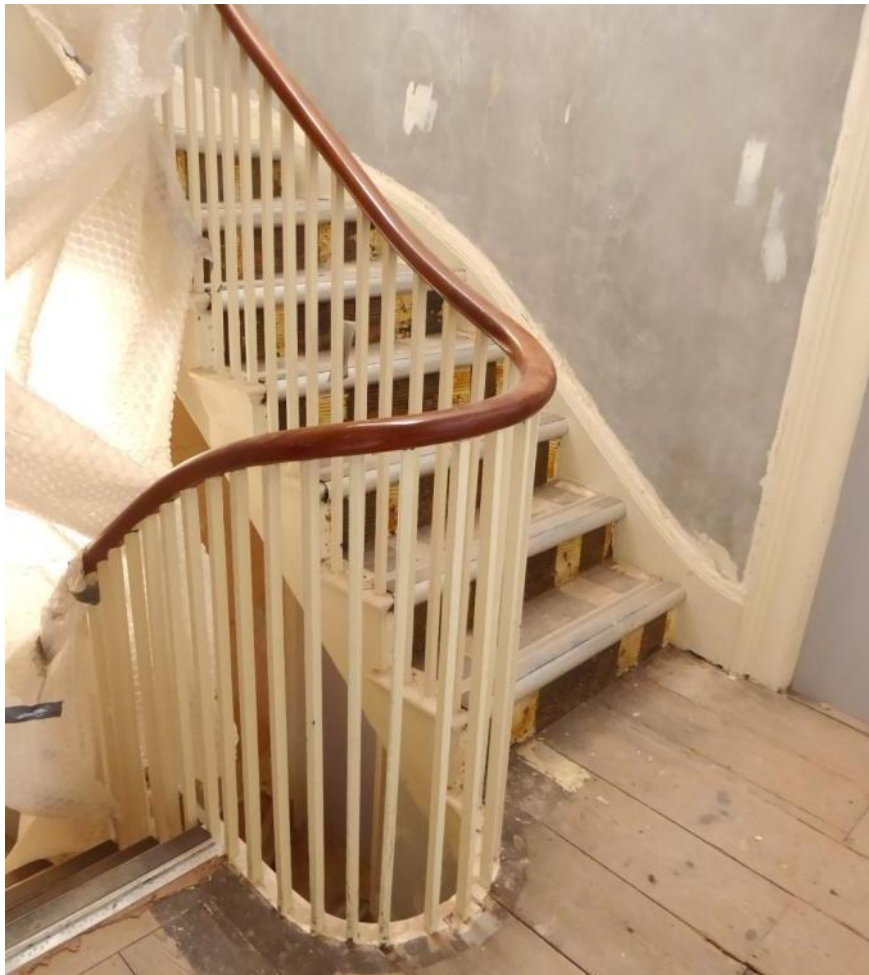
Fig 4.18; general view of first floor landing

- 4.18.2 This has a floor of a suspended timber structure covered with timber boards approximately 200 mm wide although with many replacement boards. Some are of varying widths and somewhat narrower.

- 4.18.3 The walls on either side are of solid construction, but that to the front room is of lath and plaster with a modern skirting board to the base that maintains the profile seen within the string of the main staircase. A change in the plaster construction within the face of this wall shows where the original door to the front room has been blocked up and finished with modern gypsum type plaster in a wall that is otherwise finished with traditional lime plasters.

- 4.18.4 The ceiling is a flat soffit that has possibly been replaced in plasterboard as can be suggested by the straight hairline crack running across from the junction between the lift and the staircase soffit as it follows up to the upper floors.

- 4.18.5 The cornice around the ceiling perimeter is a fairly plain structure with indications of diagonal cut joints running across it, which would be consistent with replaced units in this area.

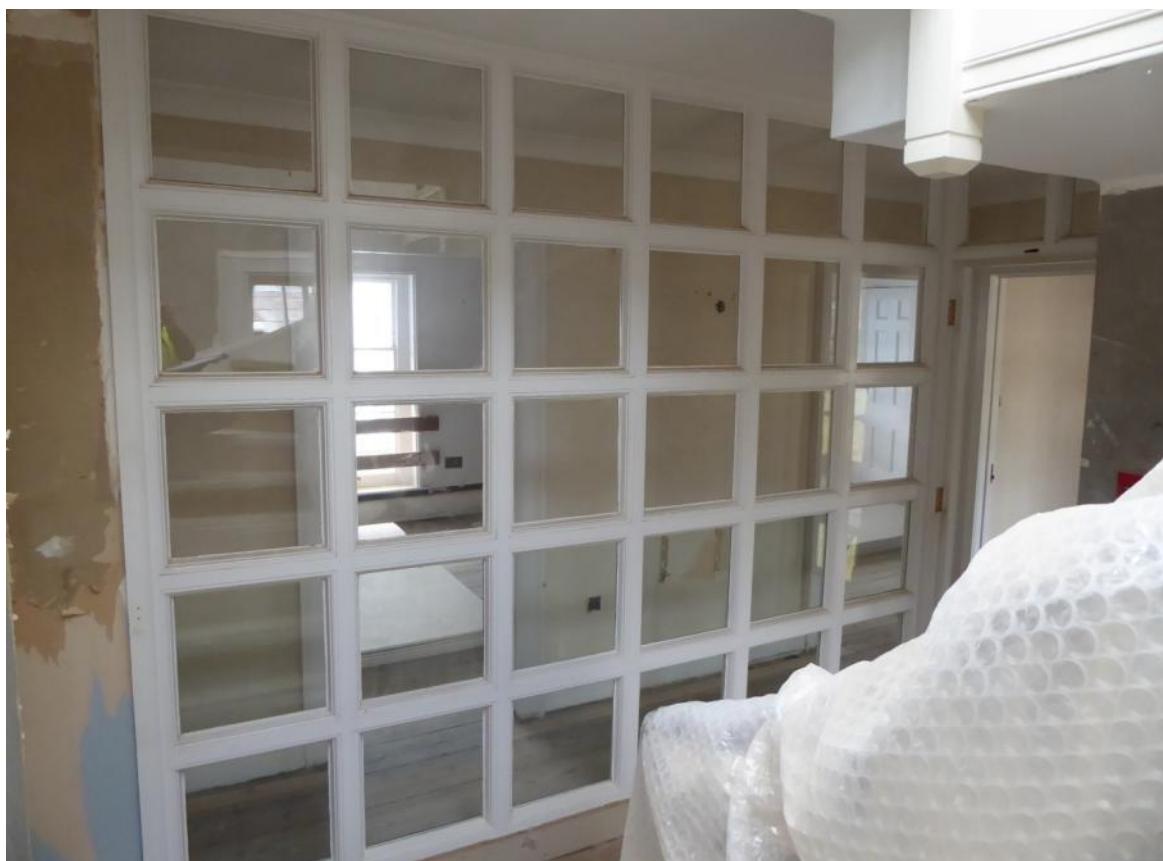
Fig 4.21.1; timber frame glazed screen

- 4.21.1 This area is divided into two longitudinally by a heavy timber frame glazed screen possibly that contains Pyram fire resistant glass within it and designed to form a fire proof barrier in this location.
- 4.21.2 This has a suspended timber structure with floorboards in softwood approximately 175 mm wide and show signs of movement, displacement and alteration.
- 4.21.3 On the landing in the corner adjacent to the stairs to second floor a modern cable duct runs vertically up the wall face.

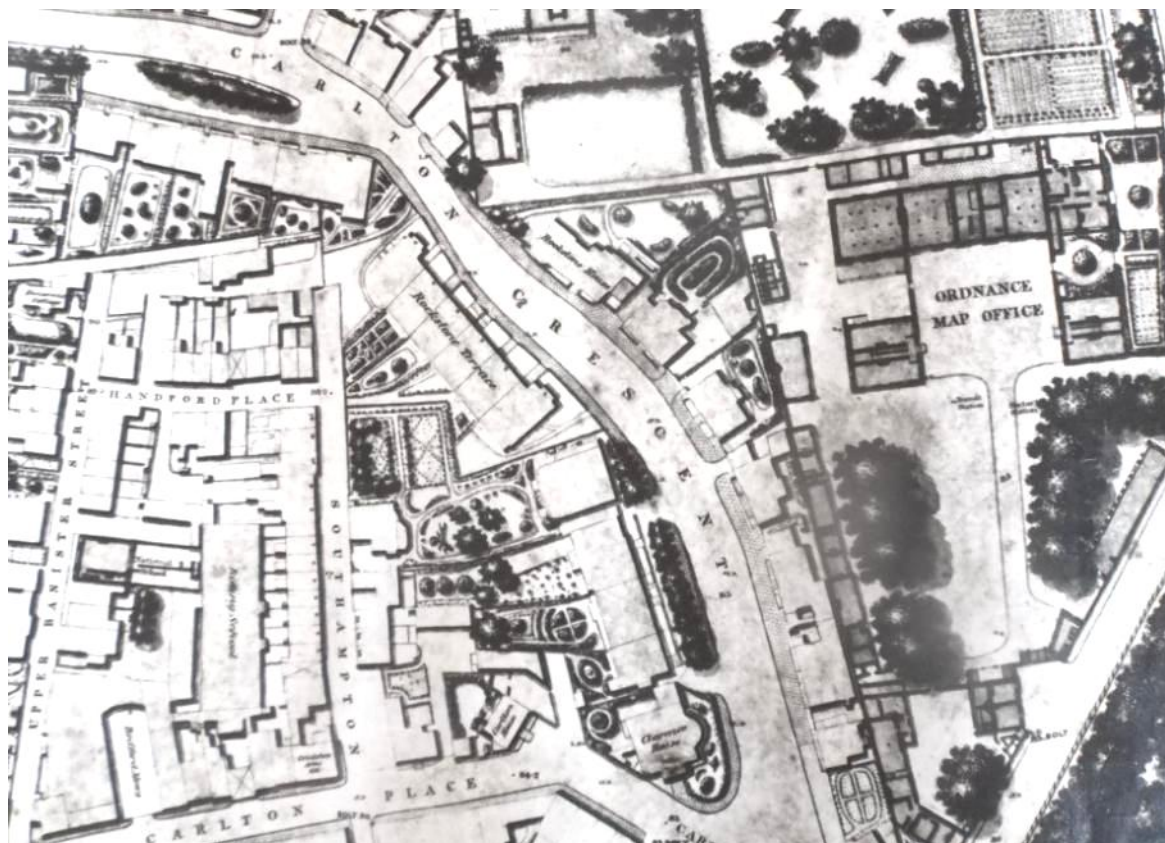
Fig 6.1.10; 1845-6 Royal Engineers Map

- 6.1.10 The 1845-6 Royal Engineers Map, at a scale of sixty inches to one mile, is the first detailed map of the area.
- 6.1.11 Carlton Crescent is clearly marked with buildings along it. N<sup>o</sup> 5 is clearly shown with a similar foot print as it has today and the stairwell at the rear is clearly seen. However, on the north side of the stairwell there appears to be an extension that sits out further than the building on the south side. This could be the lower ground floor extension on the northeast corner that is seen today.
- 6.1.12 Extending across the drive on the north side of the building from the main house is what appears to be an extension to the side boundary. In addition there is a further extension touching the northeast corner of the building and backing onto the wall of the Ordnance Map Office.

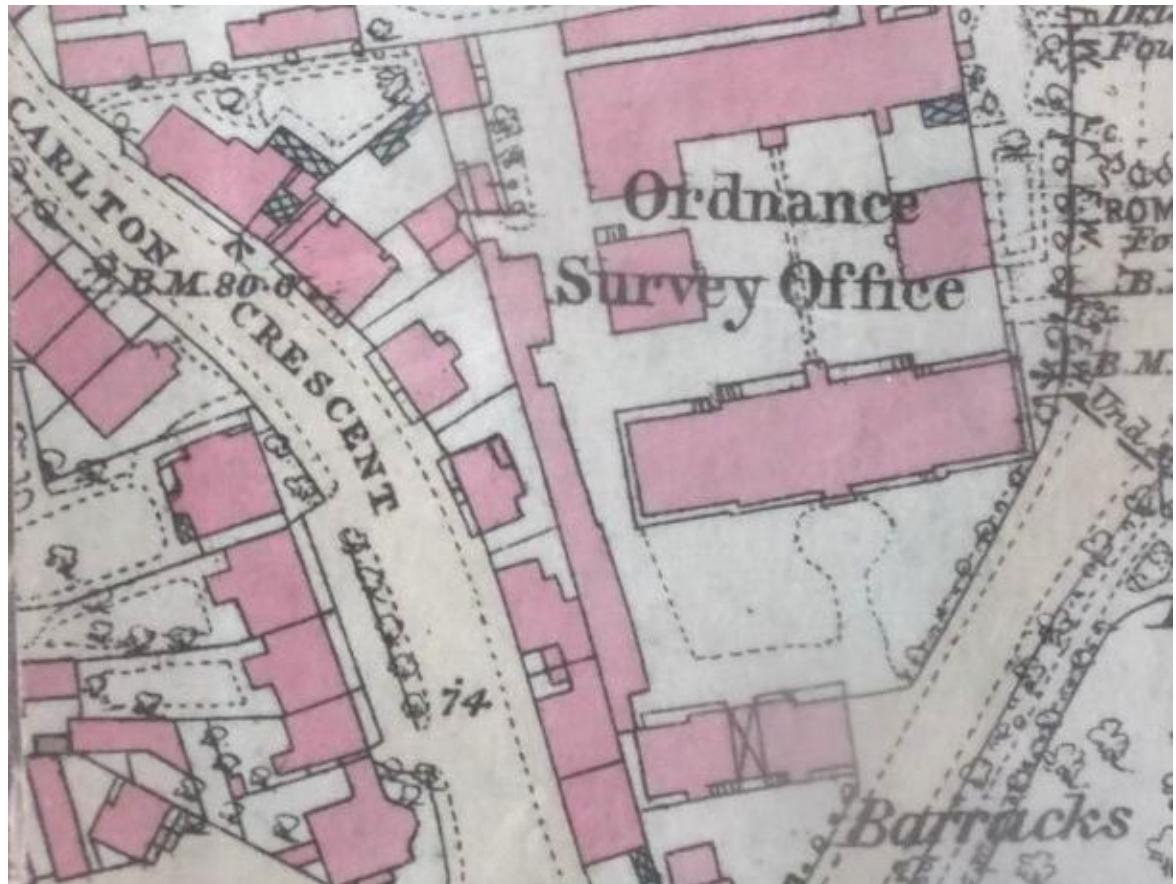
Fig 6.1.14; 1865-8 Ordnance Survey 25" map

- 6.1.14 The first Ordnance Survey (OS) map is from 1865-8 at 25" scale, it clearly shows Carlton Crescent and its buildings.
- 6.1.15 This map is very similar to the Royal Engineers plan from 1845, including the extension on the north side of the rear stairwell. However, by this time the extension on the north side of the main house has disappeared as has that touching onto the northeast corner.

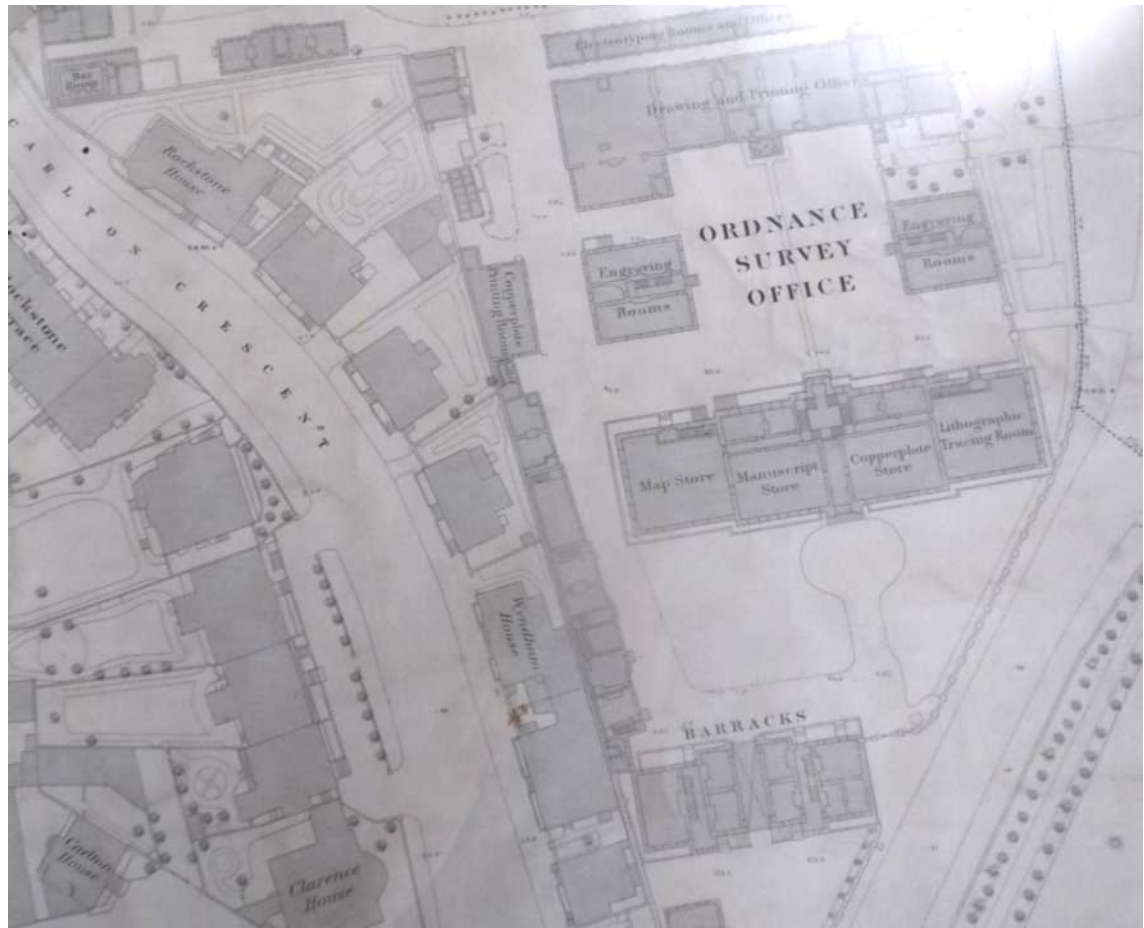
Fig 6.1.16; 1870 OS 50" map

- 6.1.16 The 1870 50" OS map is one of the clearest maps found of the area with N<sup>o</sup> 5 shown clearly. The rear north east attached extension is still shown as a separate line indicating it could have been of a lesser height than the rest of the building.
- 6.1.17 Steps at the south end of the light well to the front of the building are as they are now. Also shown are two small light wells to the rear where now only that at the south end survives.

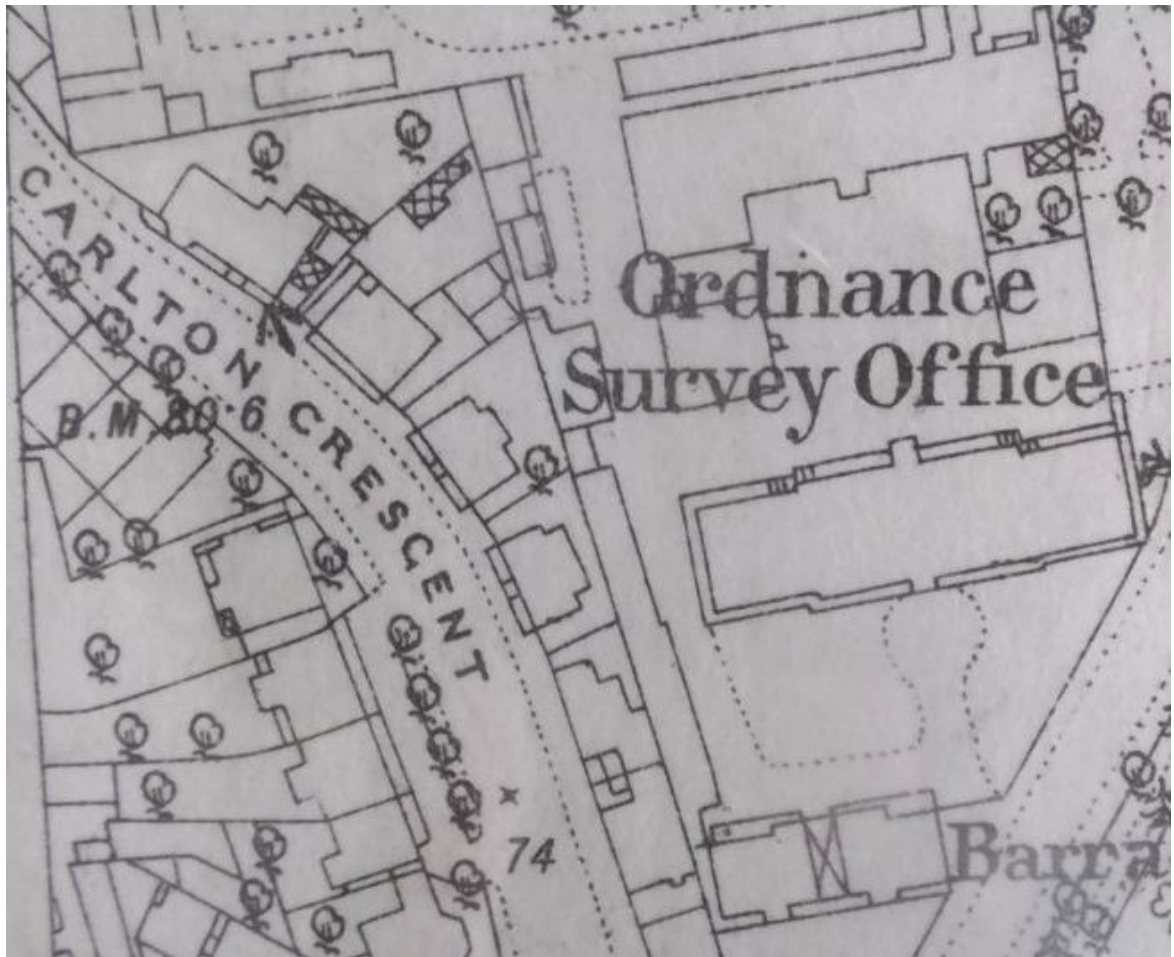
Fig 6.1.18; 1891 OS 25" map

6.1.18 The 1891 OS 25" map is less clear than the 1870 due to its scale.

6.1.19 The light well to the front of the building is still depicted. The extension to the rear appears to extend further to the southeast possibly with the addition of the mezzanine toilet on the south side of the stairwell.

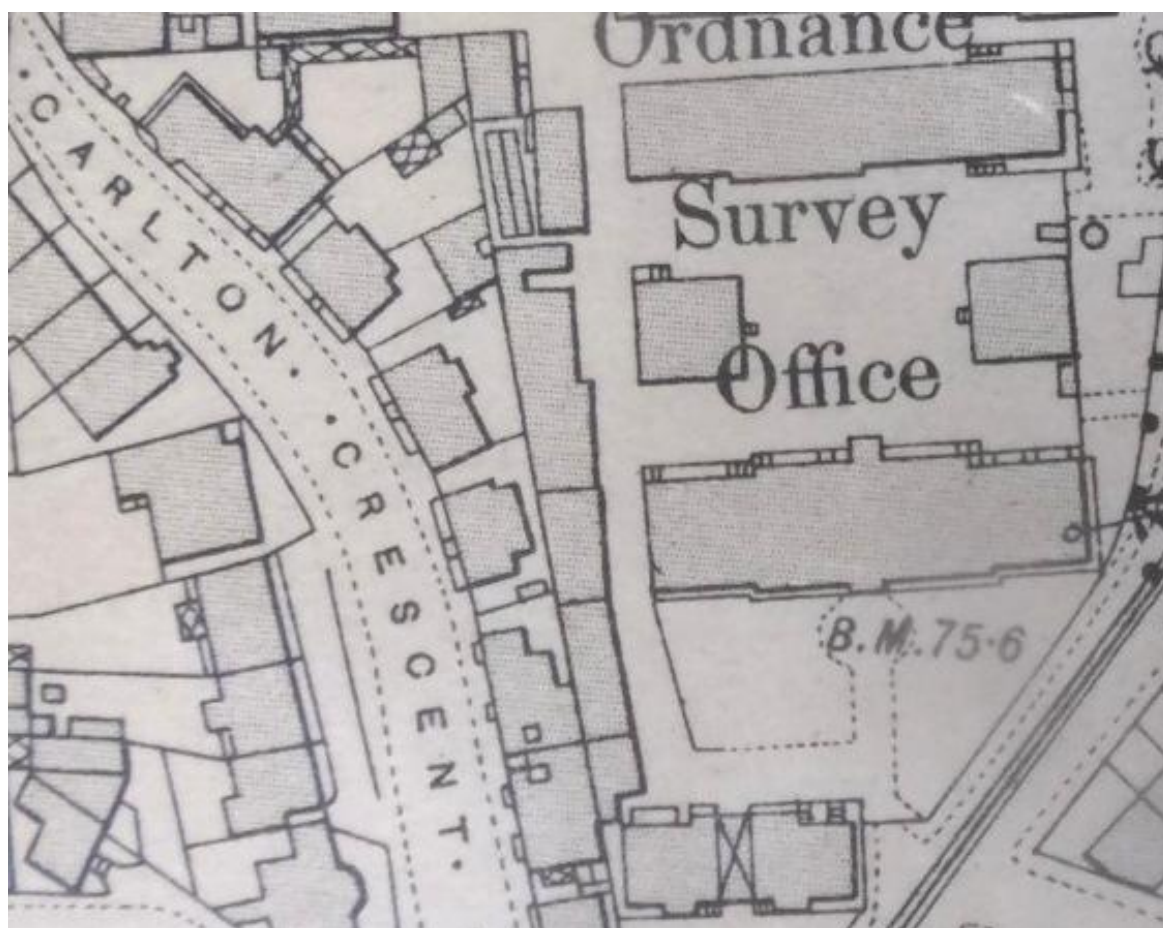
Fig 6.1.21; 1910 OS 25" map

- 6.1.21 Again the 1910 OS 25" map shows little change in comparison to the 1891 and 1897 maps except for drawing style.
- 6.1.22 However, a small outhouse of some form has been added against the south boundary wall, towards the east end. There is no evidence for this on site today.

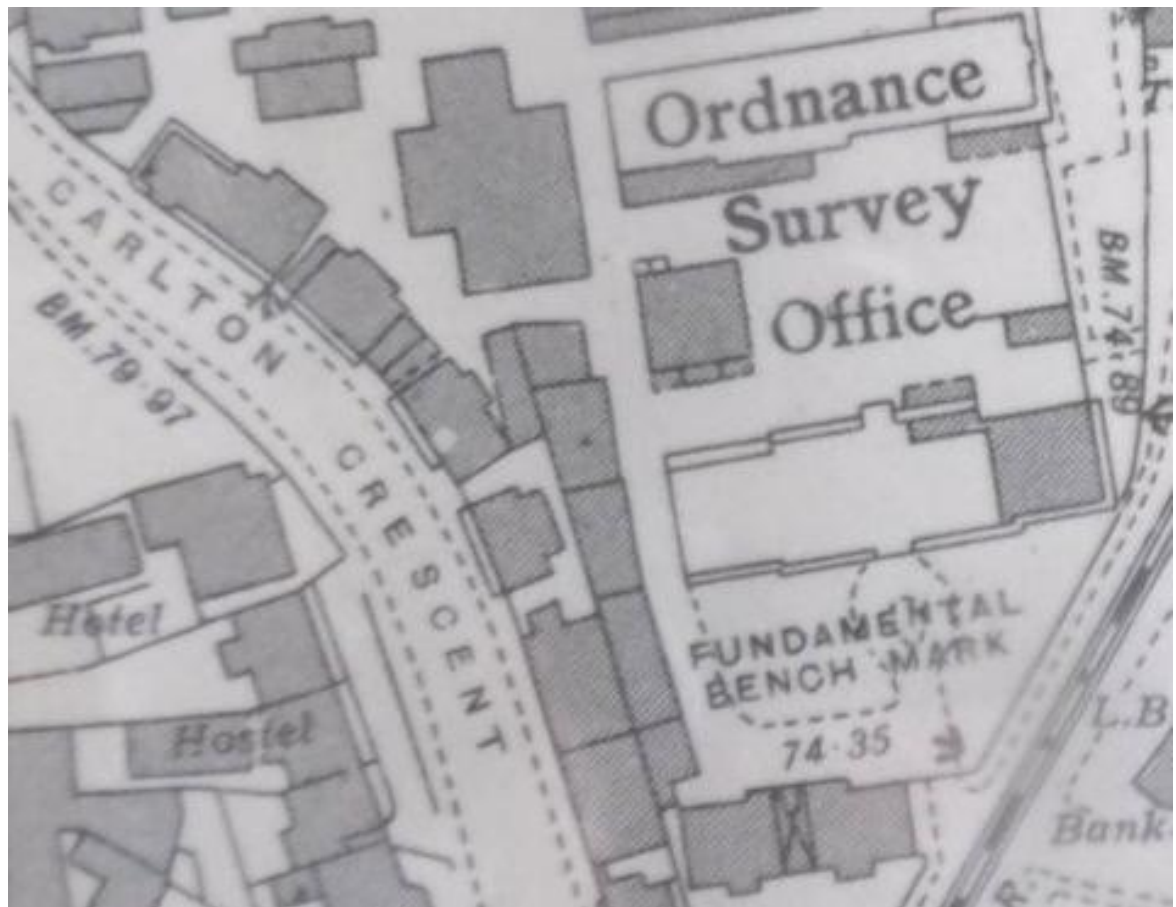
Fig 6.1.24; 1941 OS 25" map

6.1.24 The 1941 OS 25" map shows little change to the main building. The small extension on the south boundary has disappeared along with that boundary. The site is now apparently open to the side of N<sup>o</sup> 4.

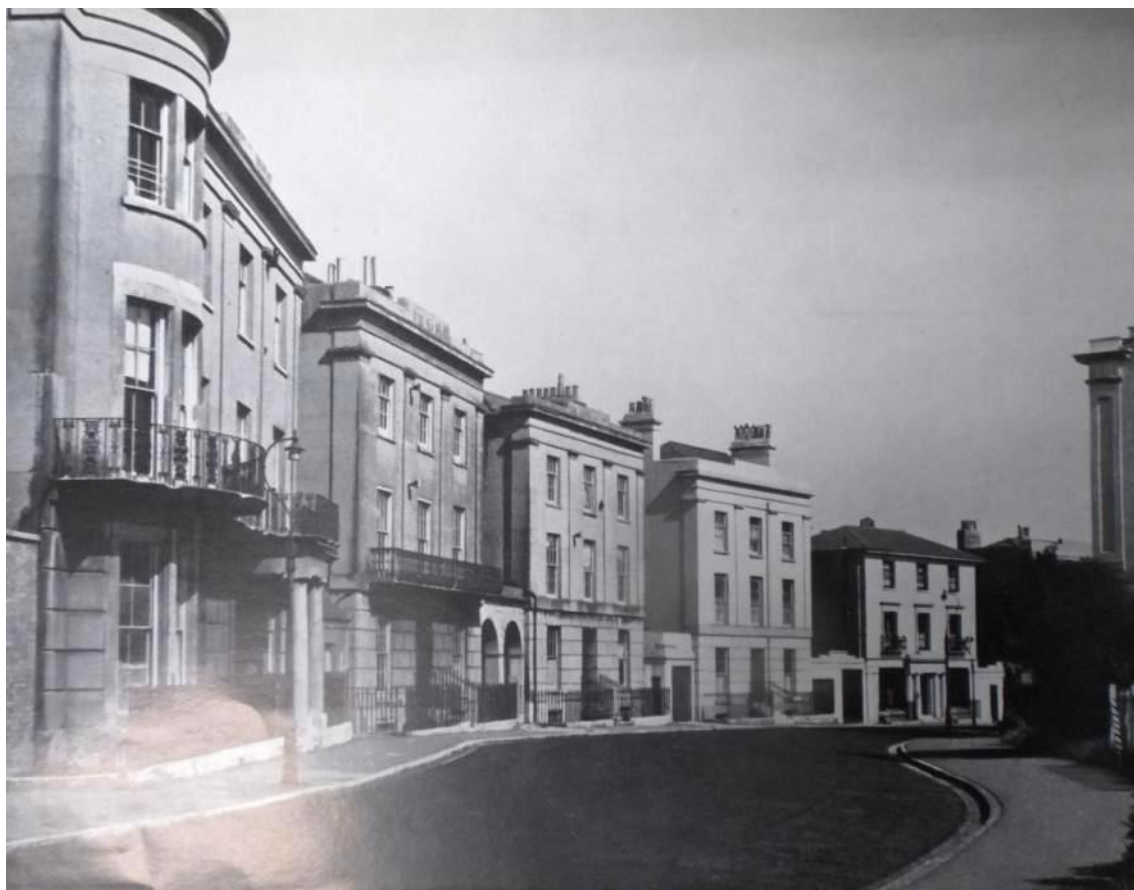
Fig 6.2.2; 1952 Calendar photograph

- 6.2.2 Fig 6.2.2 is a photo of the 'Regency Facade' for a 1952 calendar of Southampton, N° 5 is the fourth building from the left. The calendar was found within the Southampton Archives, however no publisher was found on this item.
- 6.2.3 This photo shows the building with sash windows, rusticated render to the ground floor and plain render above. Pilasters are seen to the first and second floors topped with a cornice to the top of the front facade.

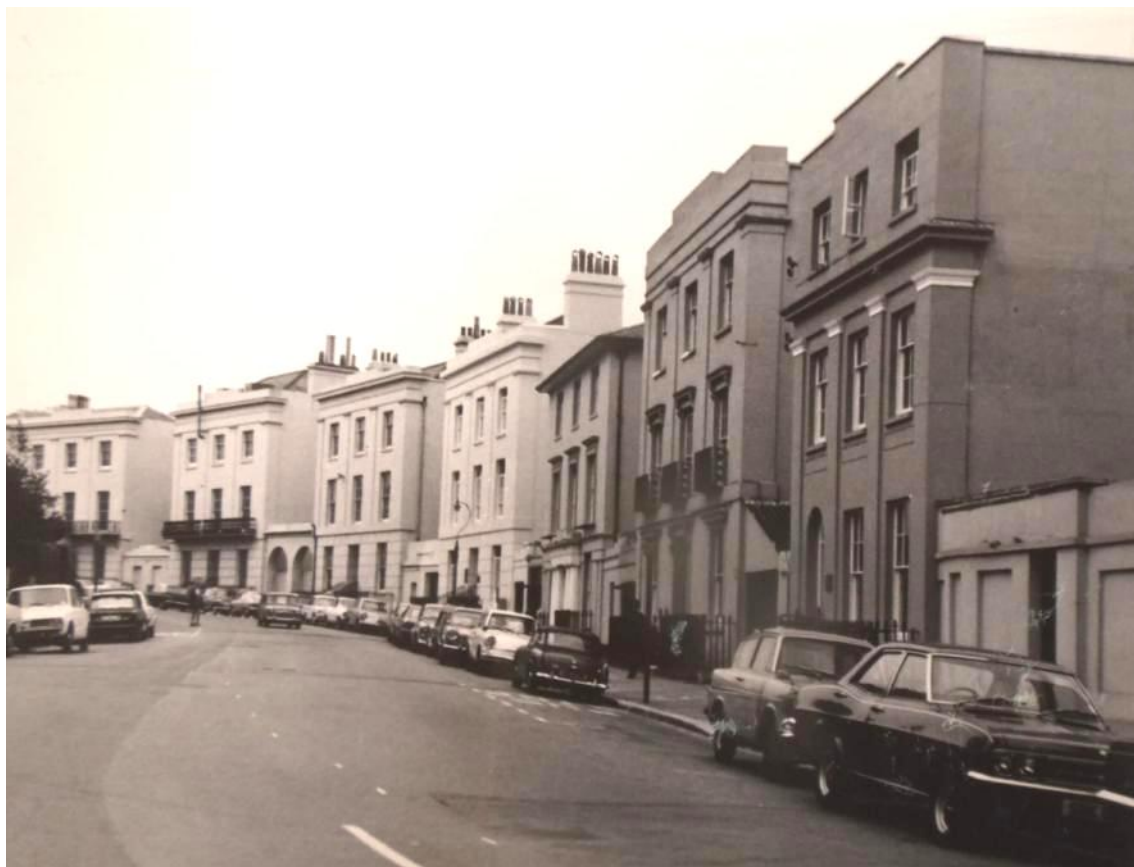
Fig 6.2.4; Photo from planning documents, no date

- 3.5.14 On the front street elevation the three windows to the first floor have modern Juliet balconies. These can be judged as modern from their style and appearance. This has further been confirmed by the lack of Juliet balconies within archives photos found, please see Fig 6.2.4.

- 6.2.4 A photo of Carlton Crescent looking north for the area however no date was found on this photo. Much as Fig 6.2.2 the building could be described in the same manner. The cars to the front of the building would suggest early to mid 1960's date
- 6.2.5 In comparison to the current building no Juliet balconies are seen, nor are there dormer windows to the roof.
