**St Anne's Catholic School
3 Rockstone Place
Southampton
Hampshire**

Historic Building Recording and Watching Brief Report

CA Project: 770750

CA Report: 18322

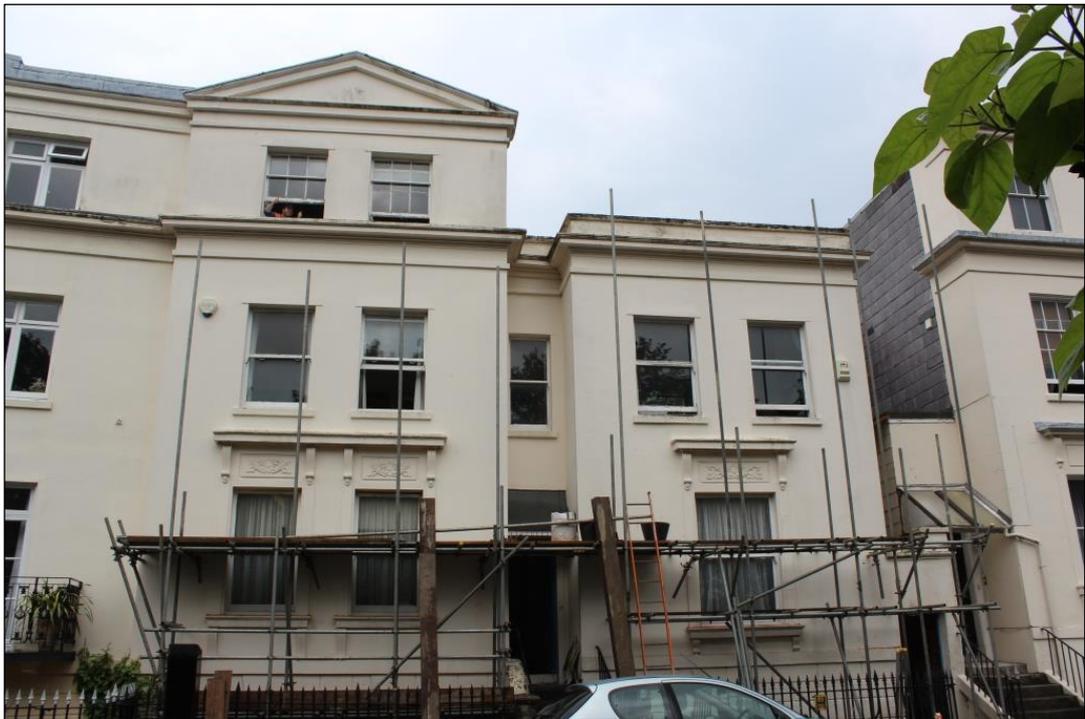
- 4.4. The primary (front) elevation is to the south and faces directly onto Rockstone Place. The south elevation is stuccoed and has two ranges, Range A to the west and Range C to the east, with a connecting section (Range B) set back in the centre (Photograph 1). There is a lightwell surrounding the western (Fig. 5: A) range of the basement, which has a rusticated finish topped by a band. The ground floor is raised above street level.

Photograph 1 South (front) elevation of 3 Rockstone Place

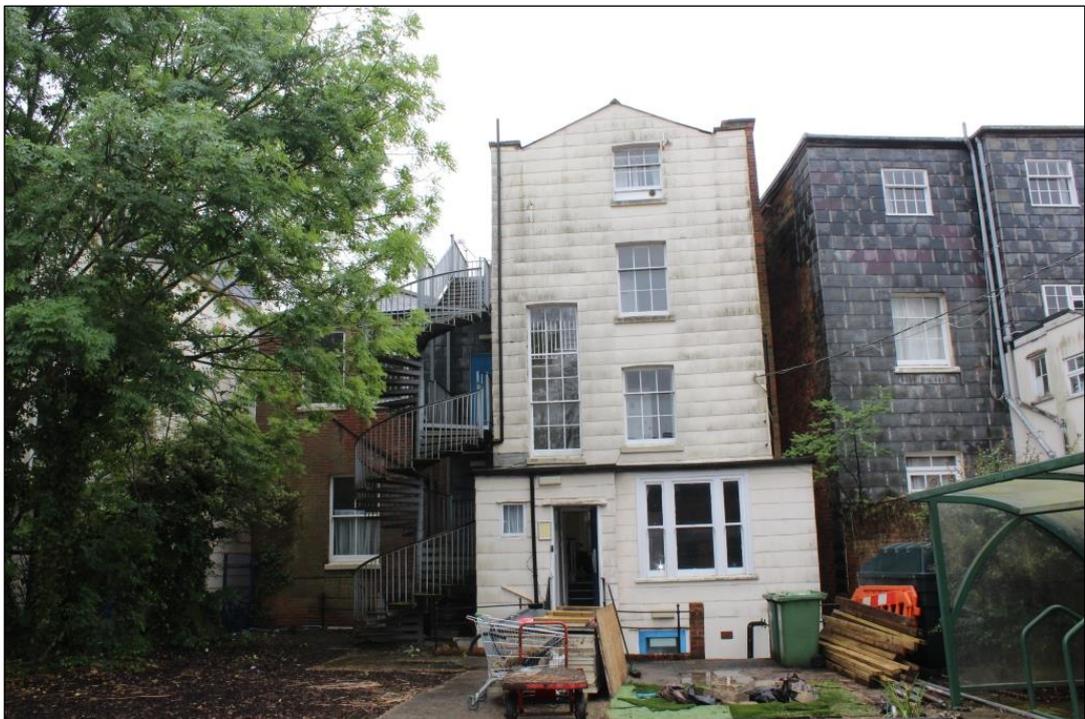
- 4.9. The rear (north) elevation is irregular with two ranges and a light well surrounding the basement of both ranges (Photograph 2). The western range (Fig. 5: E) is set further north, with a projecting section at ground floor and basement. There is a single door at basement level of range E, which is a modern fire escape. The ground floor is raised above ground level and accessed via a set of stone steps and a square headed door to the east of the range. There is a modern tri part window in the western extent of the range at ground floor and a small window to the east of the door. The remainder of range E has a column of three slightly arched head windows, one at each floor offset to the west and an elongated window over first and second floor to the east of the range. Range E is topped by a gable and has been clad in slate and painted white.

Photograph 2 North (rear) elevation

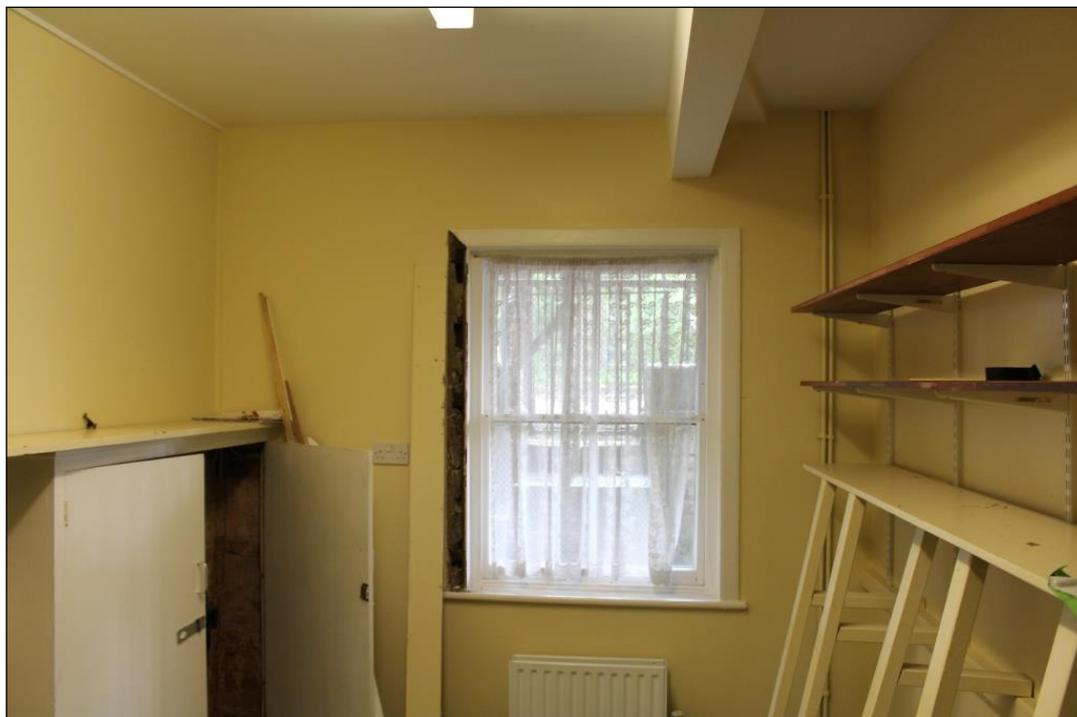
and one to the Boiler room. There is a single window in the centre of the south elevation with a square head (Photograph 3). Across the ceiling is a boxed in feature orientated north to south on the western side. There is a series of shelves along the west wall and cupboards at the lower section of the east wall. There was damp noted around the top of the entrance to the northern projection.

Photograph 3 General view of Music Store with window in the south wall

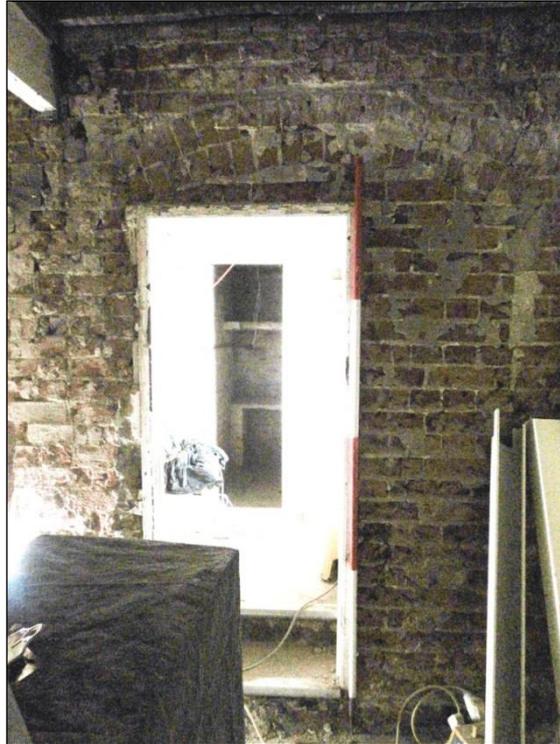
- 4.24. An opening with a segmental arch was noted in the centre of the east wall of the main section of the room (Photograph 6). The segmental arch was formed of two courses of bricks with the header set vertically. The north side of the opening could be identified to the base of the wall, but the southern side continued behind the electrical cupboard and could not be identified with complete certainty. The third blocked up opening was set in the north wall and was partially occupied by the modern doorway leading to Circulation (base of stairs) (Photograph 7). This opening also had a segmental arch head of bricks.

Photograph 7 Blocked in opening with modern doorway in north wall of Music Store

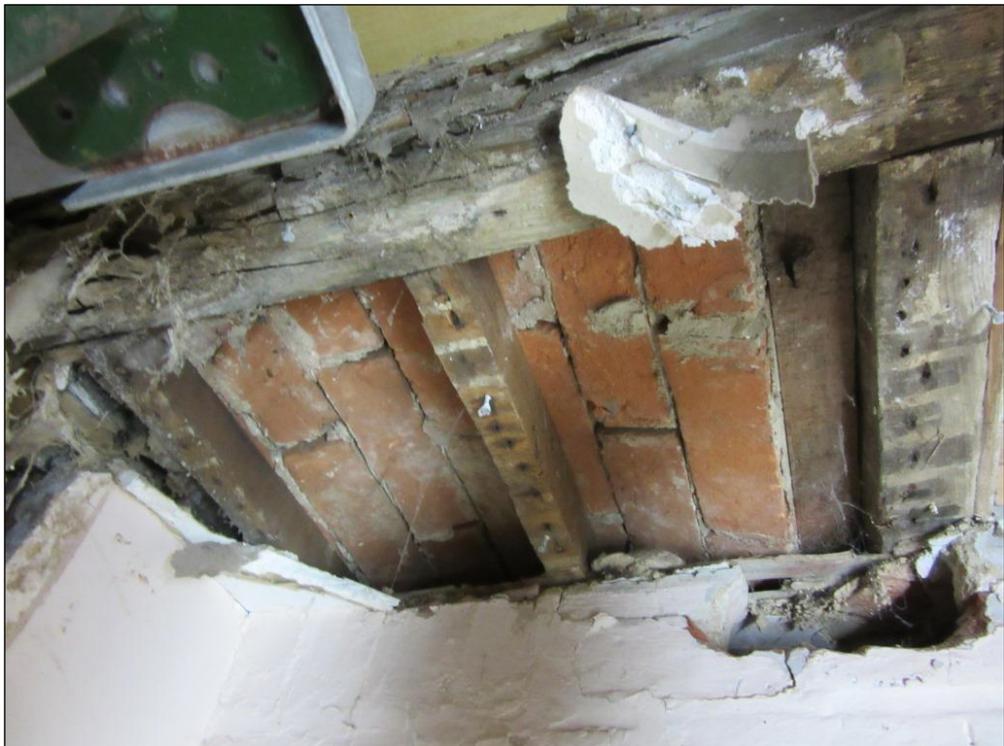
Photograph 9 Vaulted ceiling in Circulation (west) in the north-west corner

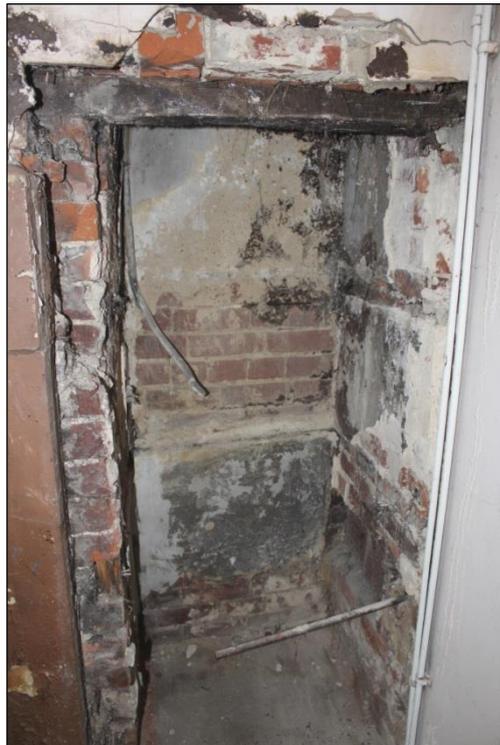
- 4.33. The works within Store 1 comprised removing the plaster from the interior of the cupboard in the north-west corner, exposing the brick (Photograph 10). The top of the door had two timber lintels, both of which were extensively rotted with the front timber collapsing once exposed. The rear timber measured 900x75mm and it is assumed that the front timber was of a similar measurement if not the same. The plaster of on the interior of the cupboard was of dense concrete plaster and the bricks are bright red in colour with sharp edges and bonded with cement mortar.. This would indicate that the cupboard is a later addition or was lined in brick and plaster at a later date.

Photograph 10 Cupboard in north-west corner of Store 1 after stripping of plaster and timber lintel

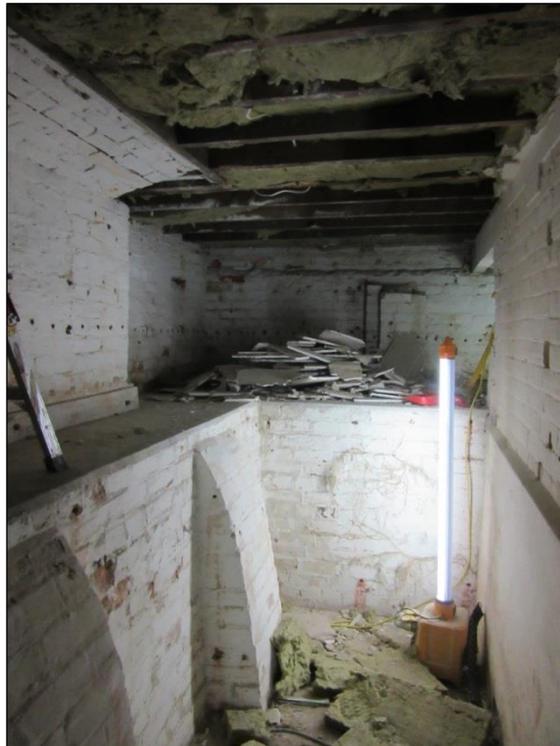
- 4.38. Store 3 is an L-shaped room which runs along the east and south extent of Music Practice. The room was lined with ply-board boxing on all of the walls except the western wall. The southern area is occupied by a raised element, which continues along the eastern edge of the room and part of the northern with buttresses in the centre of the east wall (Photograph 12).

Photograph 12 Brick plinths in Store 3 following the removal of the ply-board boxing

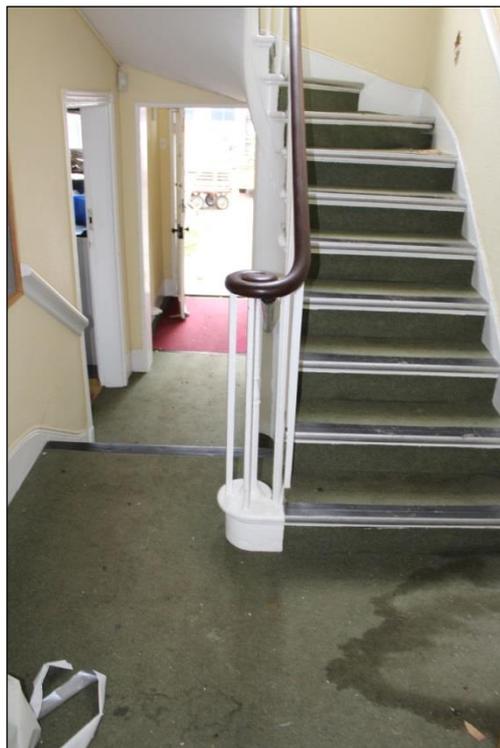
Photograph 13 General view of Lobby with base of staircase

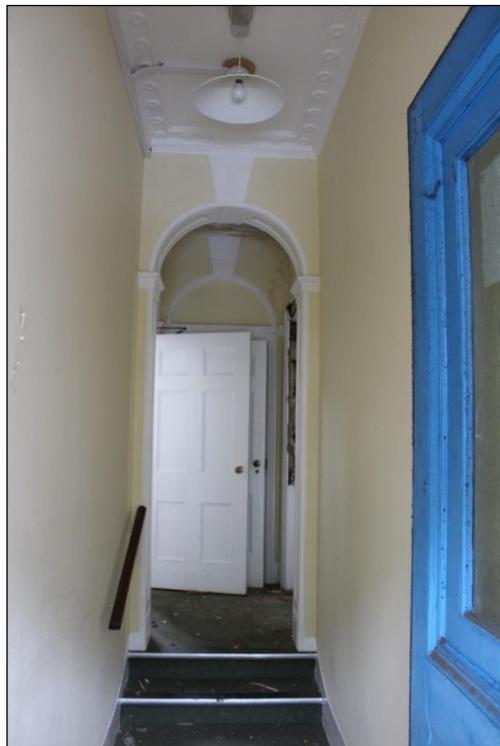
- 4.51. The corridor runs off centre to the east, orientated north to south with the front entrance at the southern extent. The northern part is sectioned off with an architrave formed of a keystone at the centre of an arch on the south side (Photograph 16). There is an additional architrave over the west connecting door to the Lobby and a door in the north wall which opens onto a cupboard. The northern area is raised, with two steps providing access from the southern part of the corridor. There is an additional door in the east part of the northern extent which provides access to Music Practice 2. There is a floral pattern coving surrounding the edge of each section of ceiling and the northern section has been extensively damaged by mould (Photograph 17). The use of flowers in patterns is characteristic of the late Georgian to early Victorian period, with it extending across the ceiling indicating it is of a Victorian (1850s) date (Yorke 2012). Although this coving was probably in place during the use of the building as a dwelling, it had become damaged beyond repair and needed to be replaced.

Photograph 16 General view of ground floor Corridor indicating architrave

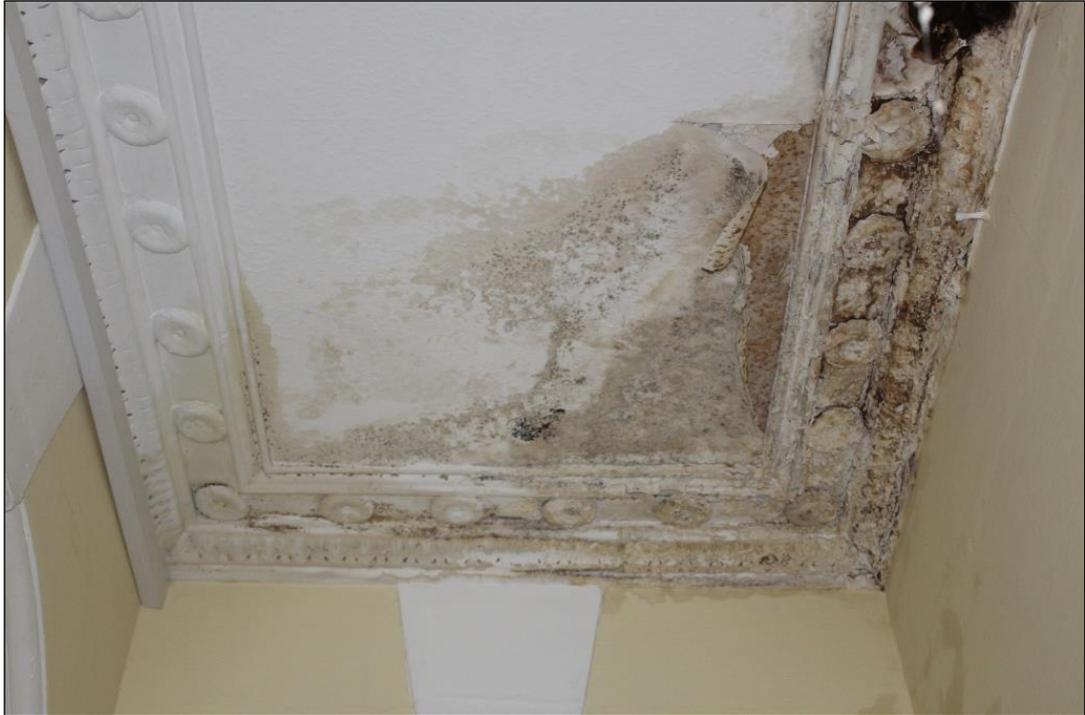
Photograph 17 Ceiling at northern extent of ground floor Corridor indicating detail of coving

- 4.54. The ceiling and coving was removed and noted as comprising lath and plaster over a timber structure. A section of the coving was retained in order for a replica to be moulded.

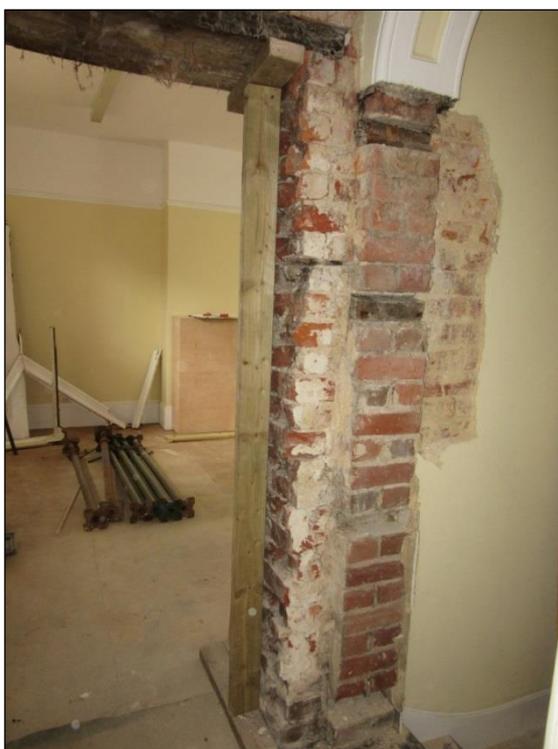
- 4.52. The works were concentrated at the northern extent of the corridor, with a small section of plaster removed from the southern edge of the architrave in order to confirm the mould had not spread further. The vertical section supporting the architrave was constructed of brick, one stretcher wide with timber blocks used at regular intervals (approximately 400mm) instead of bricks (Photograph 18). The plaster surrounding the east door, into Music Practice 2 was removed revealing a timber lintel over the door.

Photograph 18 Exposed brickwork with timber blocks in Corridor

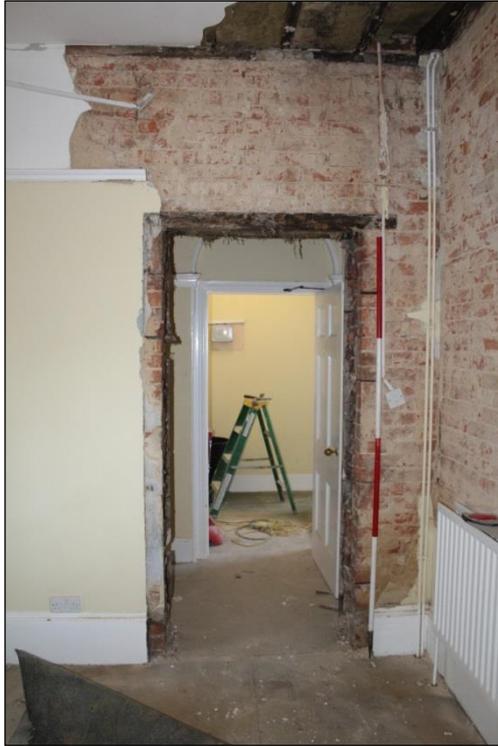
- 4.56. The works were concentrated in the north-west corner of the room ranging from the door in the west wall to the edge of the window in the north wall. No features were exposed in the north wall. A timber lintel was noted over the door in the west wall (Photograph 19). At regular intervals on each side of the door way were thin slots, into which timber pins were placed to hold the decorated panelling that framed the doorway in place.

Photograph 19 Exposed brickwork in north-west corner of ground floor Music Practice 2 showing timber lintel over door
