*Comment on an Historic Building at
Butts Bank Farm, Broadwas, Worcestershire*

A report for Mr and Mrs Barnes

November 2006

Project: PJ 169

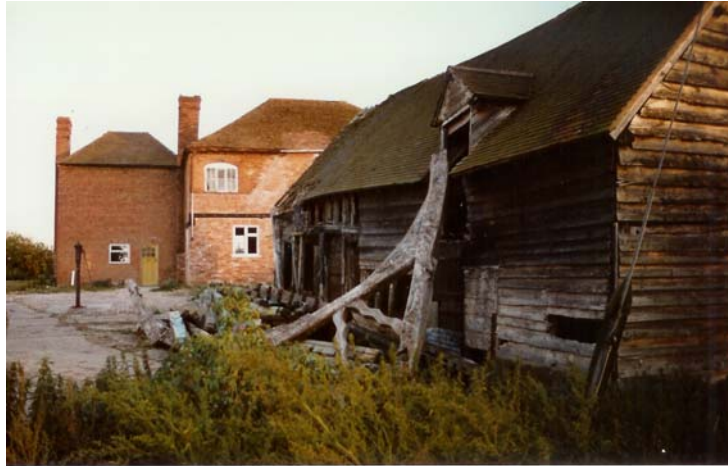
One bay of the timber framed structure and the northern projections were demolished around 1984 by a previous owner in order to 'detach the structure from the present farmhouse' so that windows could be added at the rear. Many of the timbers from the demolished sections are stored inside the building, although unfortunately some appear to be lost. The majority of a well-carpented and substantial cruck frame remains, although one cruck blade is missing (though there may be some remains of this within the building that were not visible).

Plate 1: *The cruck frame removed during the late-20th century stands propped against the building (Photograph by courtesy of Mr and Mrs Barnes)*

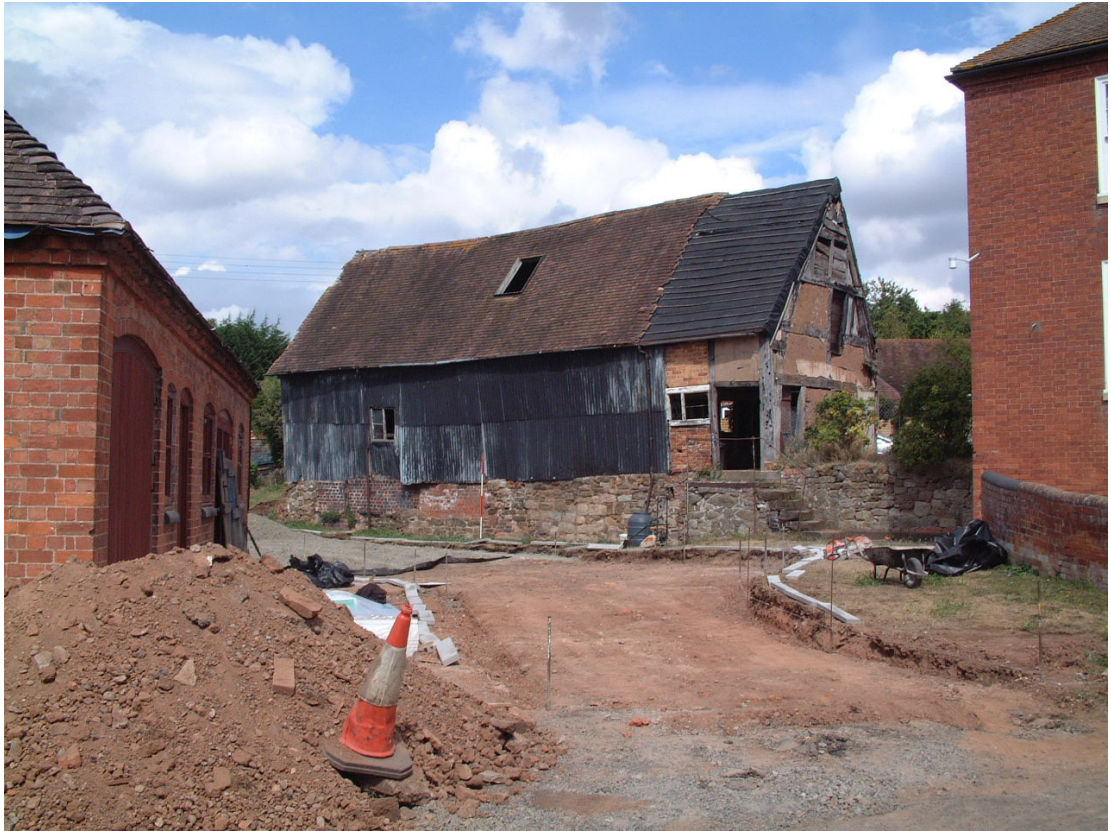
The structure is generally in poor condition and there are many indications of stress, movement and fracture of structural timbers. The remaining wattle and daub panels in the exposed eastern frame (C1) have been exposed to the elements for many years and degradation is clear. The daub is cracking and falling out and some of the wattle lattice, on which the daub is applied, has moved out of its securing holes and is in danger of collapsing outwards.

The southern framing of bay 1 has suffered from wet rot as well as insect boring, as has the wall plate of the northern frame. The framing of the southern elevation is leaning to the south.

Plate 13: *The remaining cruck framed structure looking north*

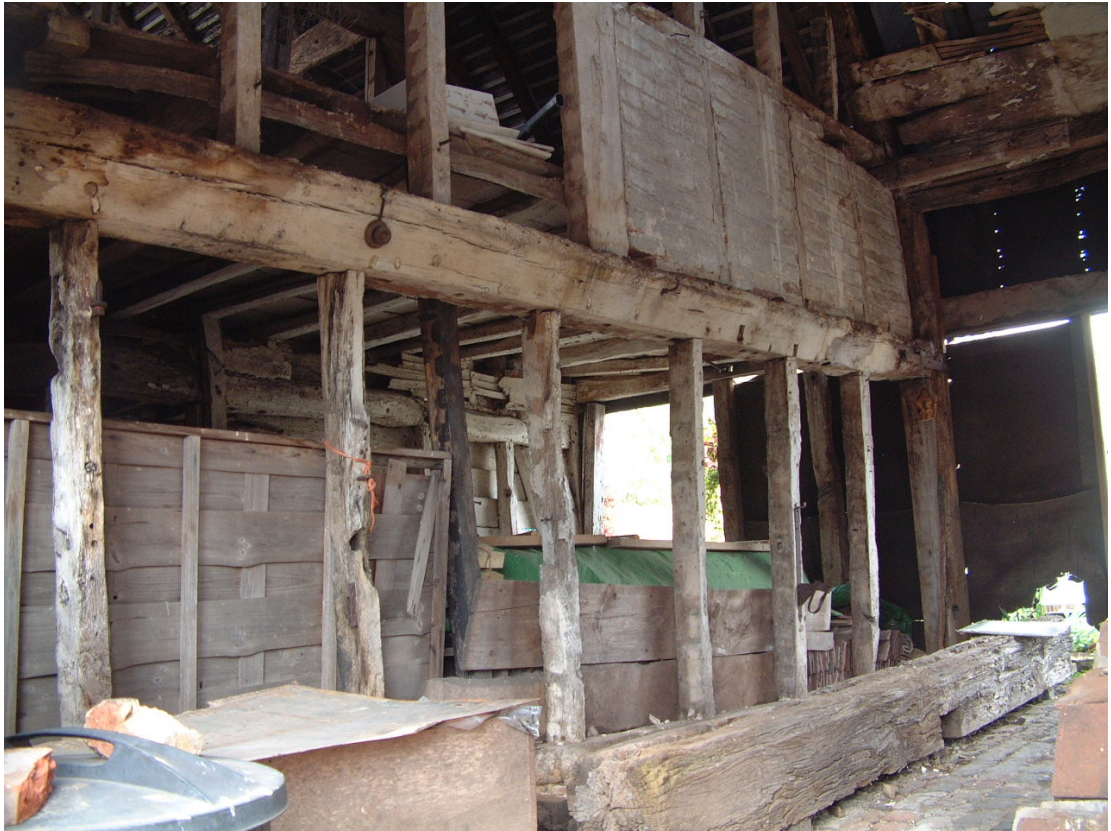
The tiebeam of truss 2 has split from the cruck stud on the southern side and the stud has skewed to the south. The remaining timbers of the frame show similar degradation as to bay 1.

Plate 15: *The inserted 'passage frame' in Bay 1, looking north-west*

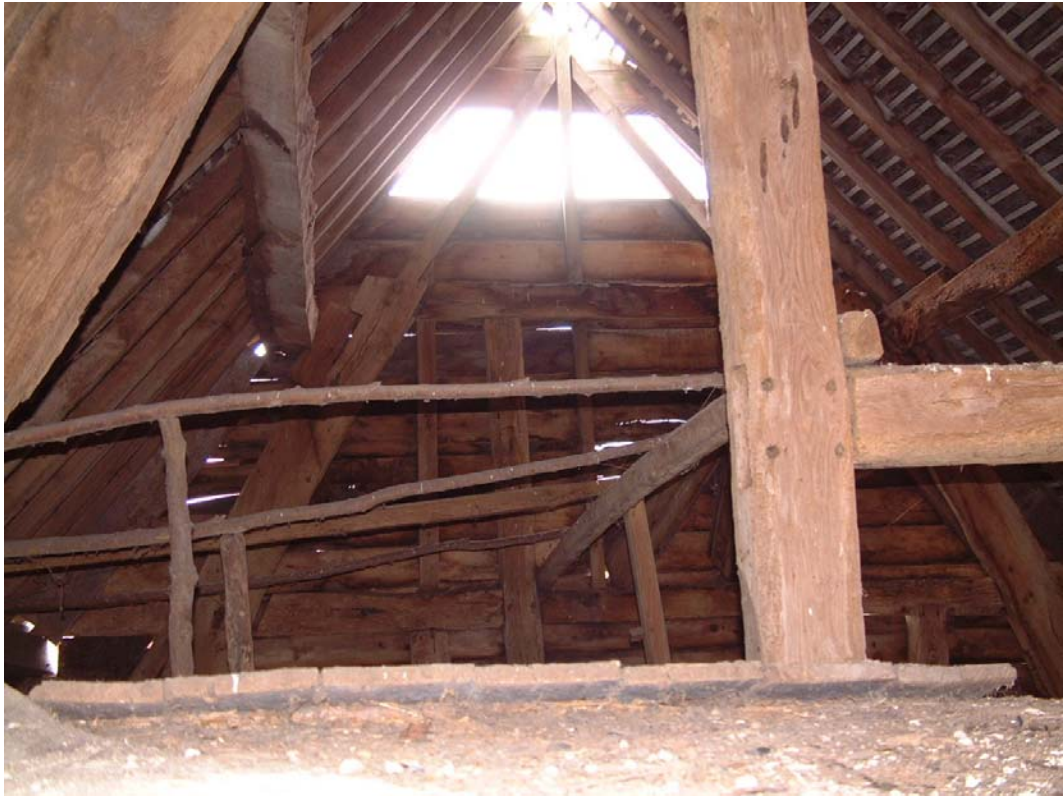
Plate 19: *Base cruck C4, looking west*
