*An Historic Building Recording at  
Boat House Farm, Eastham, Worcestershire*

# A Historic Building Recording at Boat House Farm, Eastham, Worcestershire

*A report for Mr and Mrs Jones*

**Project: PJ 106**

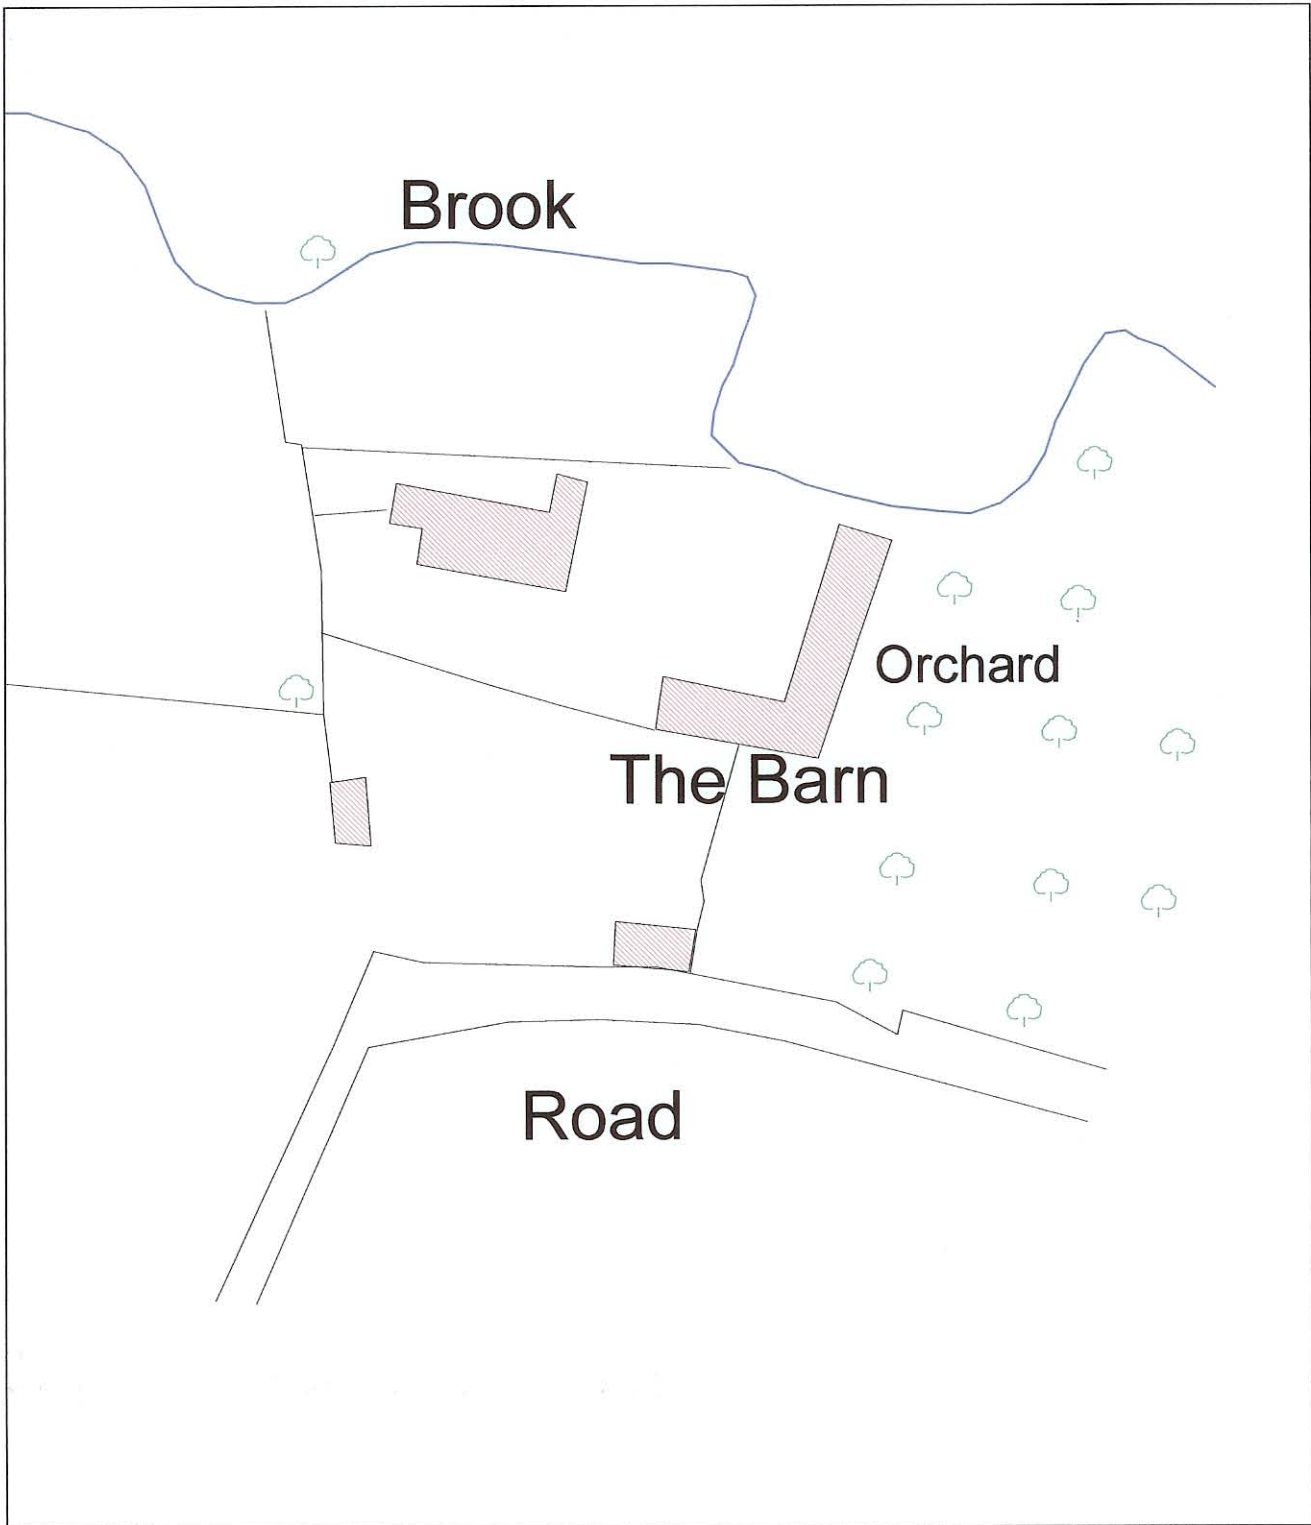
**Figure 2. Extract from Eastham Tithe Apportionment Map (1843)**

The Tithe Apportionment map of 1843 shows the barn to have an east-west projection at the eastern end (Figure 2); this is likely to be another building butting up to the barn. The nature of this building is unclear and it does not survive today. The 1<sup>st</sup> edition Ordnance Survey map of 1888 shows a building added parallel to the barn off the end of the projection forming a range of buildings round an enclosed fold yard (Figure 3). The 2<sup>nd</sup> edition Ordnance Survey map indicates that this building was a shelter shed open onto the fold yard. A further building had been added to the south of the barn (Figure 4), this no longer exists. By 1971 the plan was similar except that the east-west projecting building appears to have been split by a central ?access (Figure 5).

Tithe Apportionment of Eastham (1843) . Scale approx 1:1000. The map shows that the barn and the projecting building at the eastern end were built at least by this time.

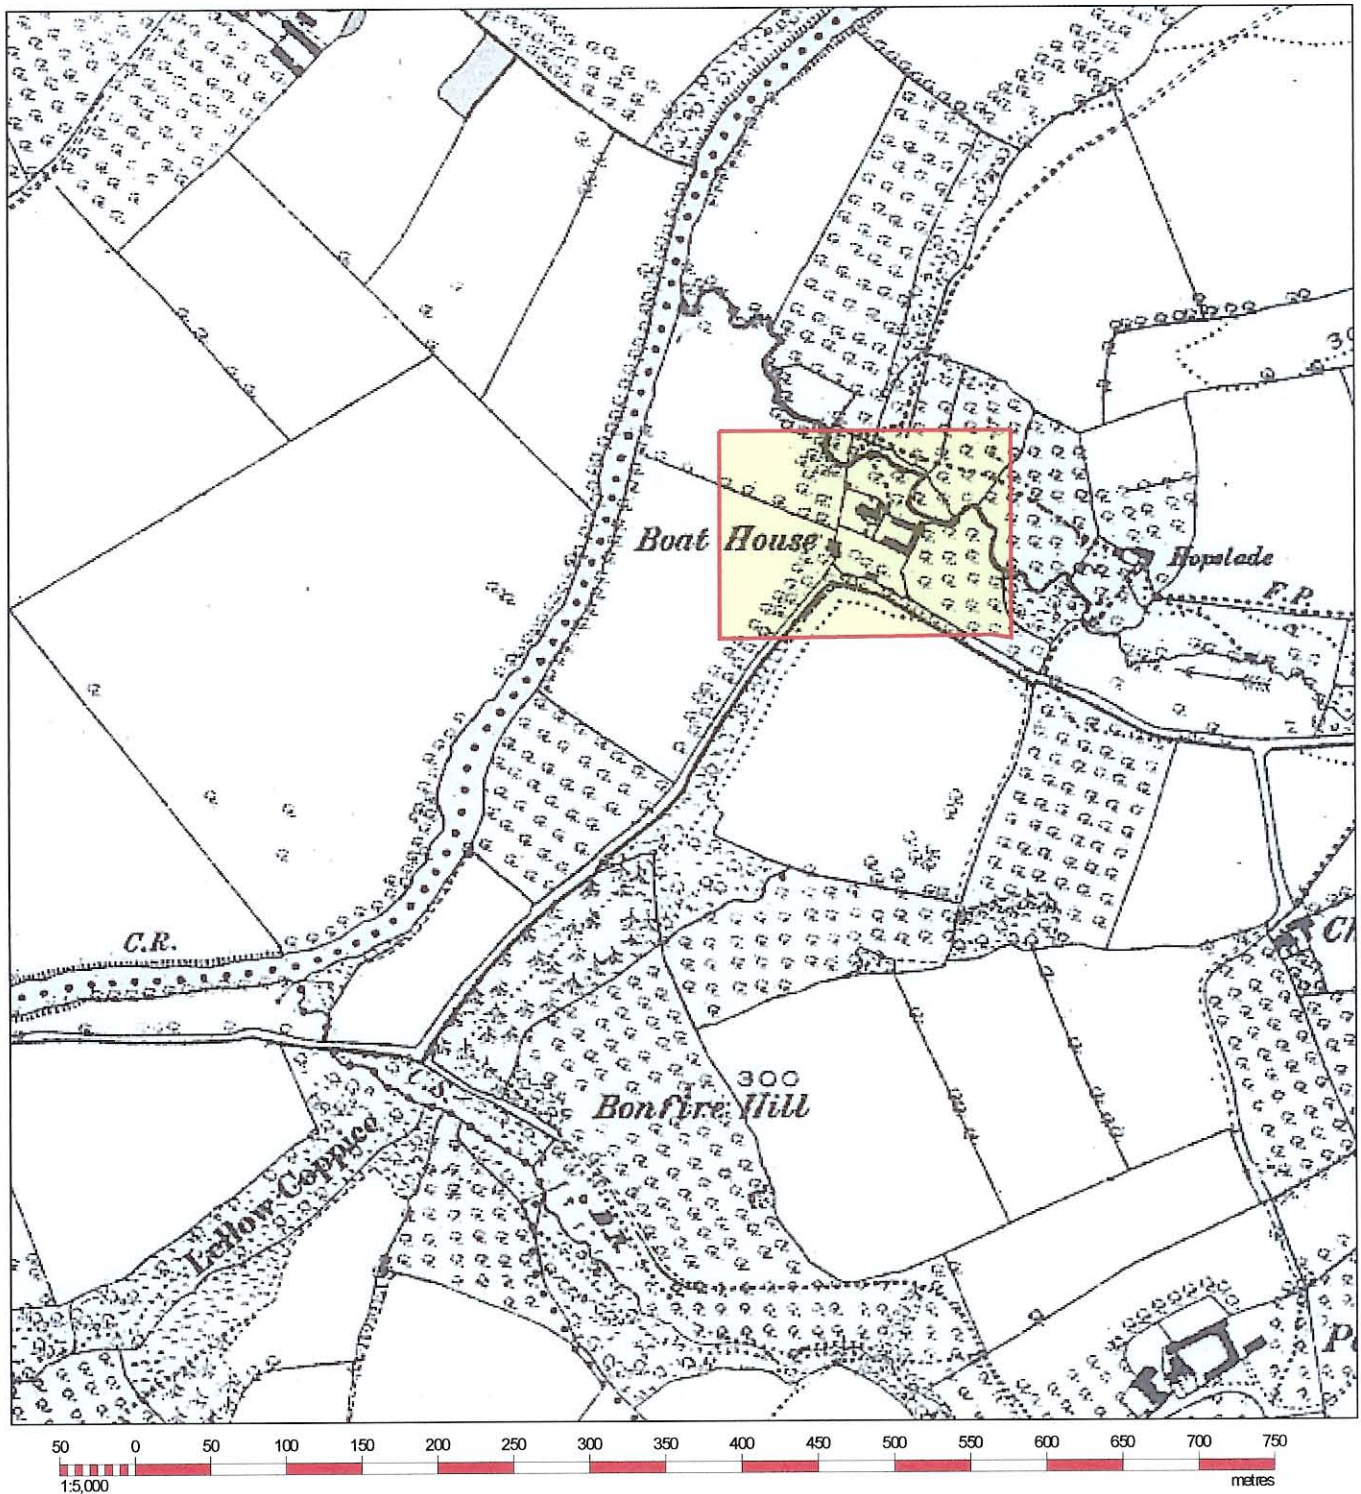
Figure 3. Boat House Farm, Eastham; 1st Edition Ordnance Survey (1888)

The 1st edition Ordnance Survey map shows the animal shed to the north, with adjoining building to the east and a central foldyard.

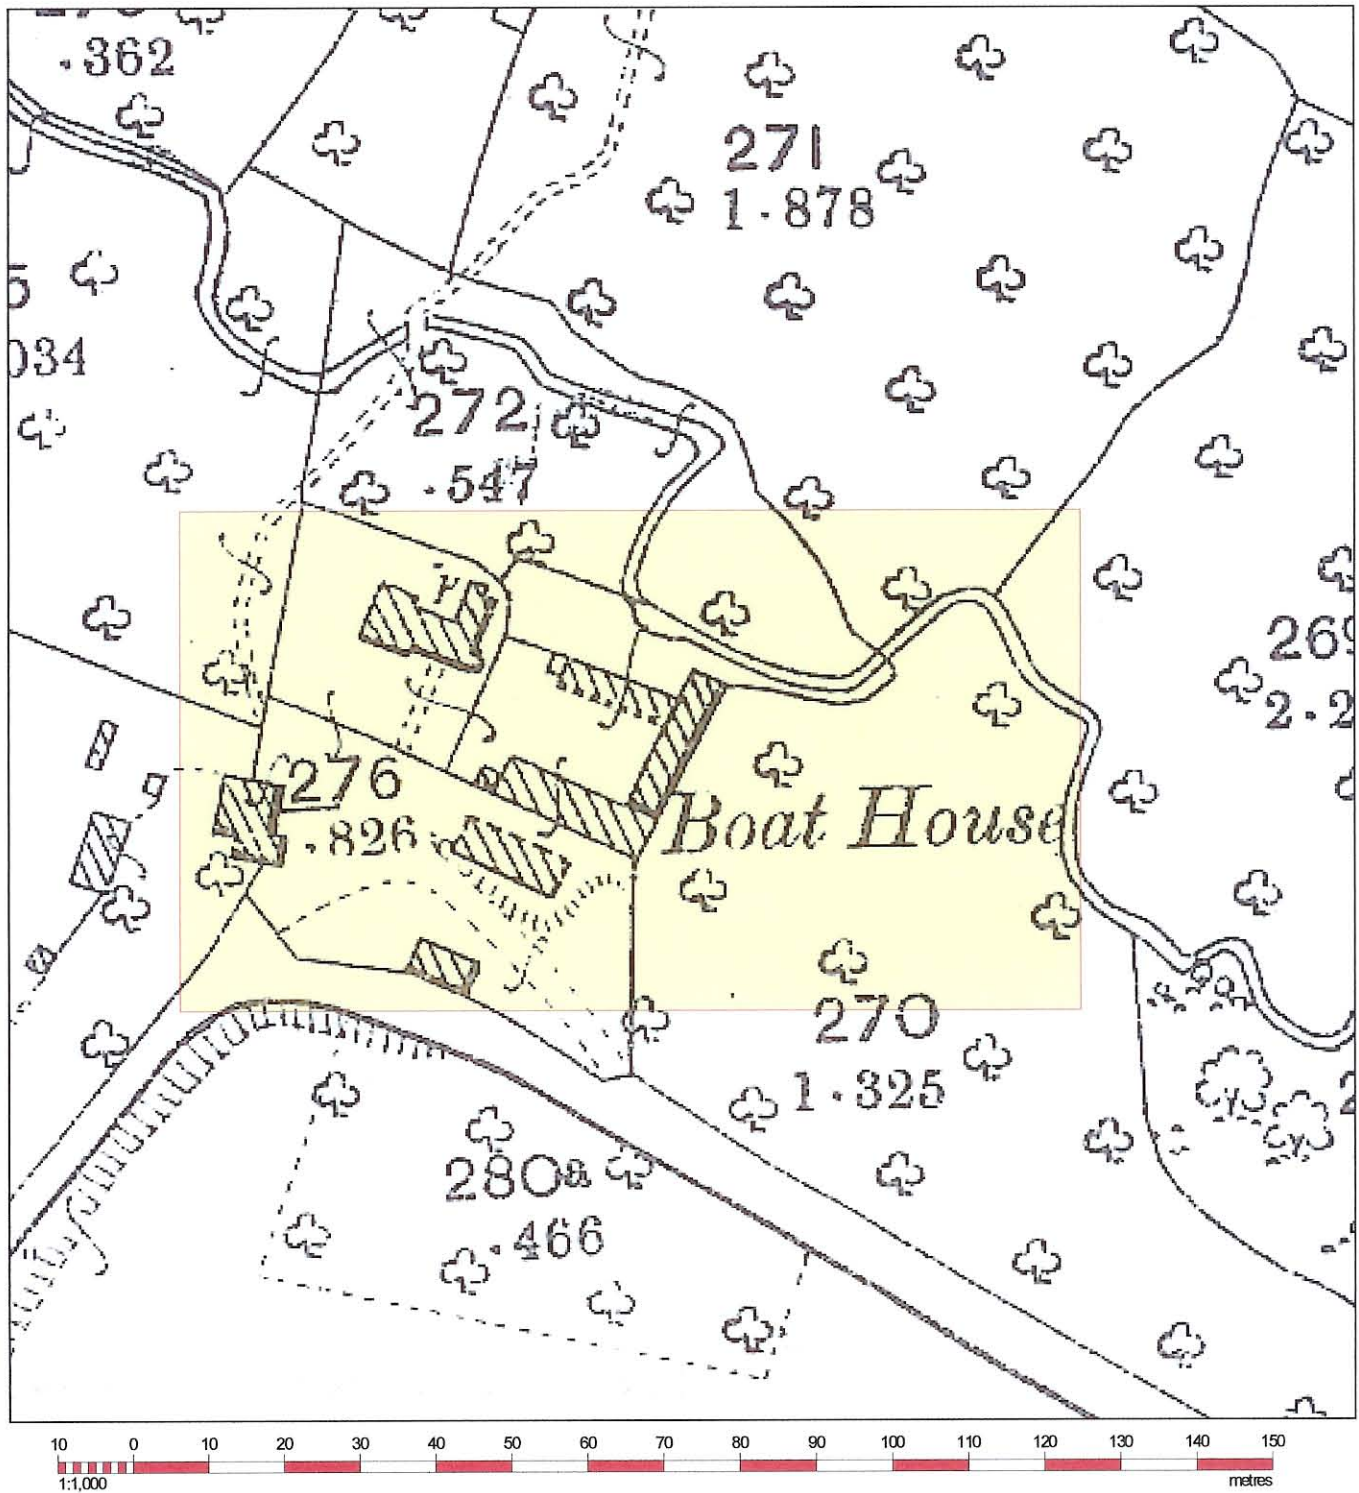
Figure 4. Boat House Farm, Eastham; 2nd Edition Ordnance Survey (1903)

The 2nd edition Ordnance Survey map shows the building to the north clearly having pillars across the southern elevation, evidence that it was open into the central foldyard.

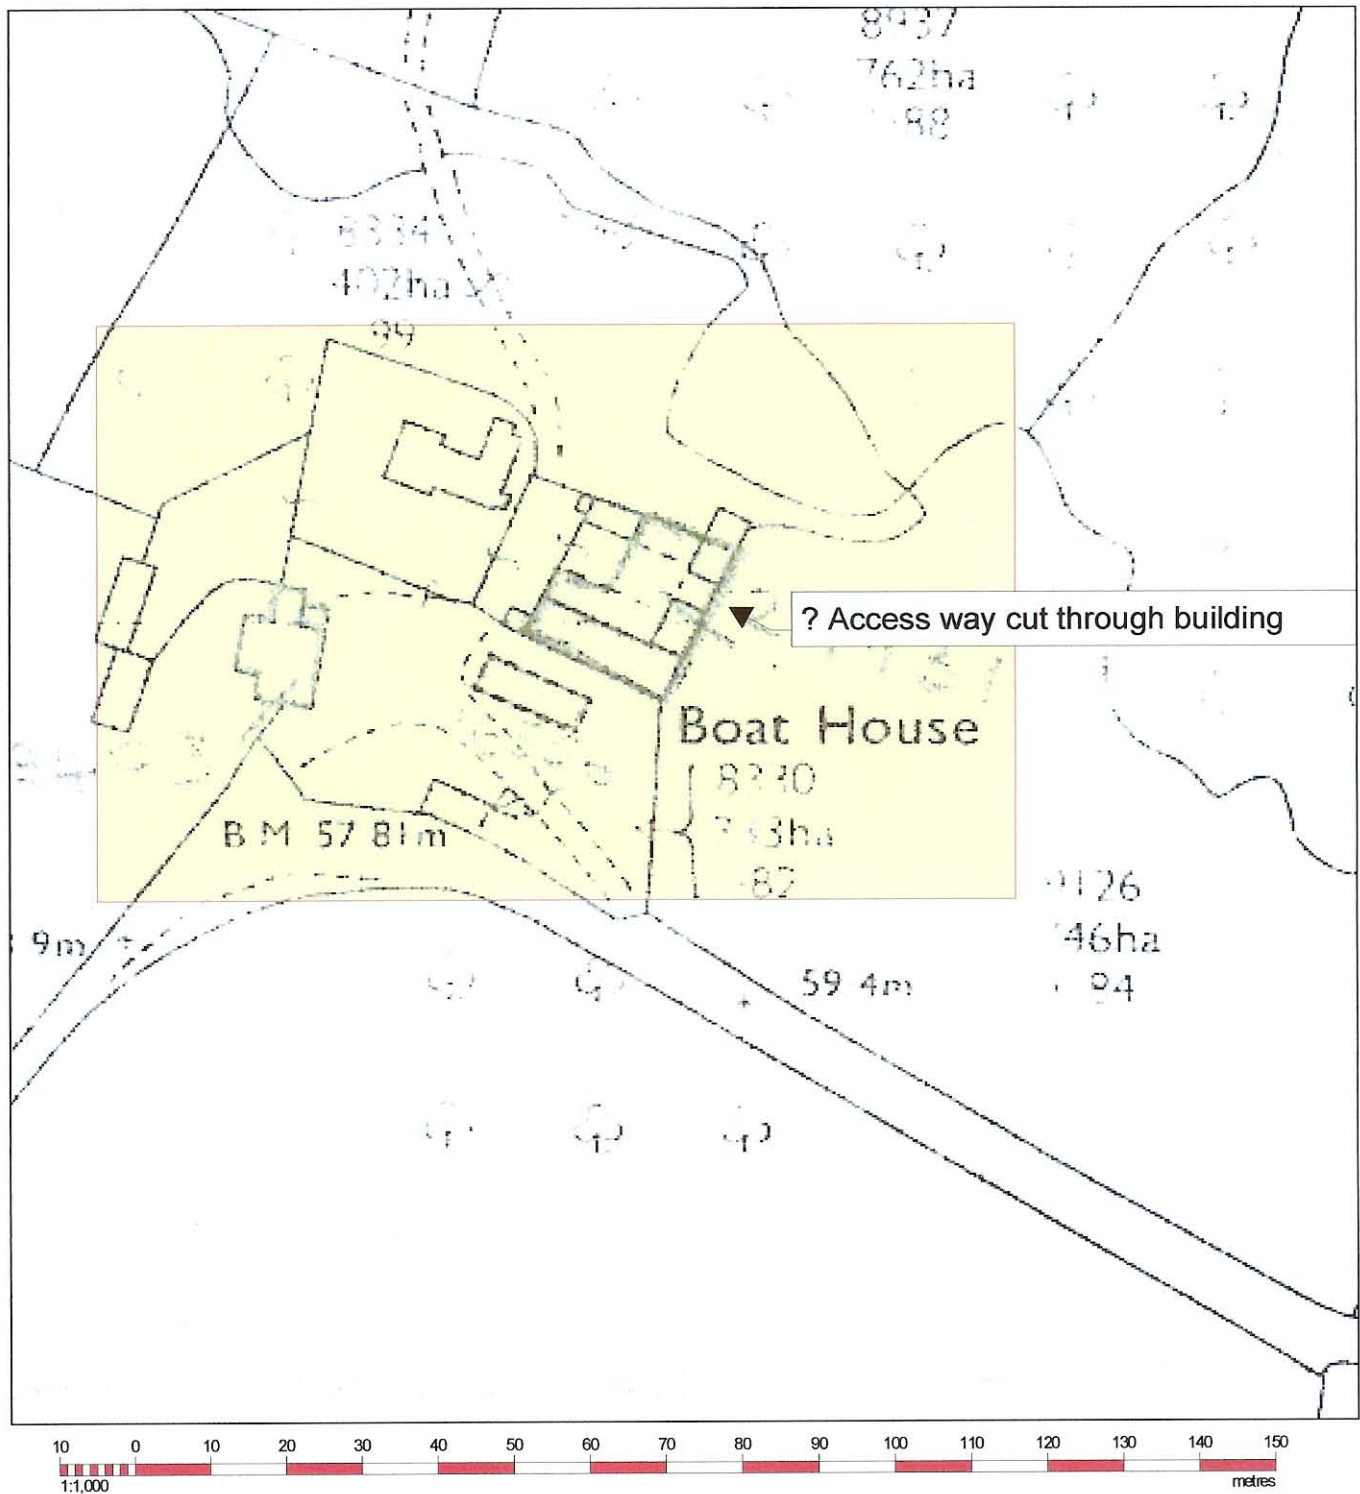
Figure 5. Boat House Farm, Eastham; Ordnance Survey (1971)

The 1971 Ordnance Survey map shows the building on the east apparently cut through the centre.

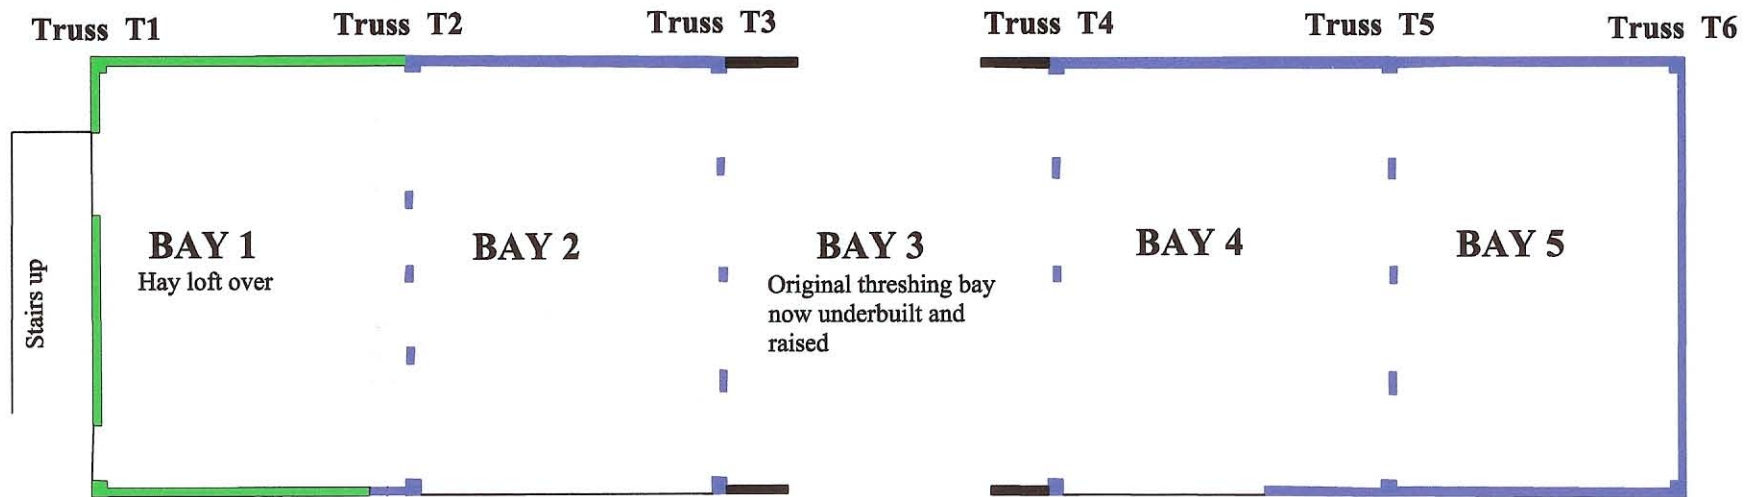
**Figure 6: Building Reference and Phase Plan**

<b>PHASE</b>	<b>FABRIC of BUILDING</b>	<b>DATE</b>	<b>MAP / FIGURE</b>
<b>I</b>	The barn is built as a four bay threshing barn.	?Late 17 <sup>th</sup> century (although the earliest parts of the barn may be earlier)	Figure 6
<b>II</b>	Bay 1 was added at the western end of the barn and roof trusses renewed.	Early 18 <sup>th</sup> century, possibly less than 30 years after the barn built	Figure 2-6
<b>III</b>	The barn was part demolished and underbuilt with a ?19 <sup>th</sup> century brick plinth. The hayloft was probably inserted around this time.	19 <sup>th</sup> century	
<b>IV</b>	The lower floor wood store was added in the 20 <sup>th</sup> century, the barn also received new panel infills of brick	20 <sup>th</sup> century

- Phase 1: c. late 17th century
- Phase 2: c. early 18th century
- Phase 3: 20th century
