***Historic Building Appraisal of a  
Barn Adjacent to Old Farm,  
Eastham, Worcestershire***

*A report for Mr & Mrs Inge*

June 2007

**Project: PJ 188**

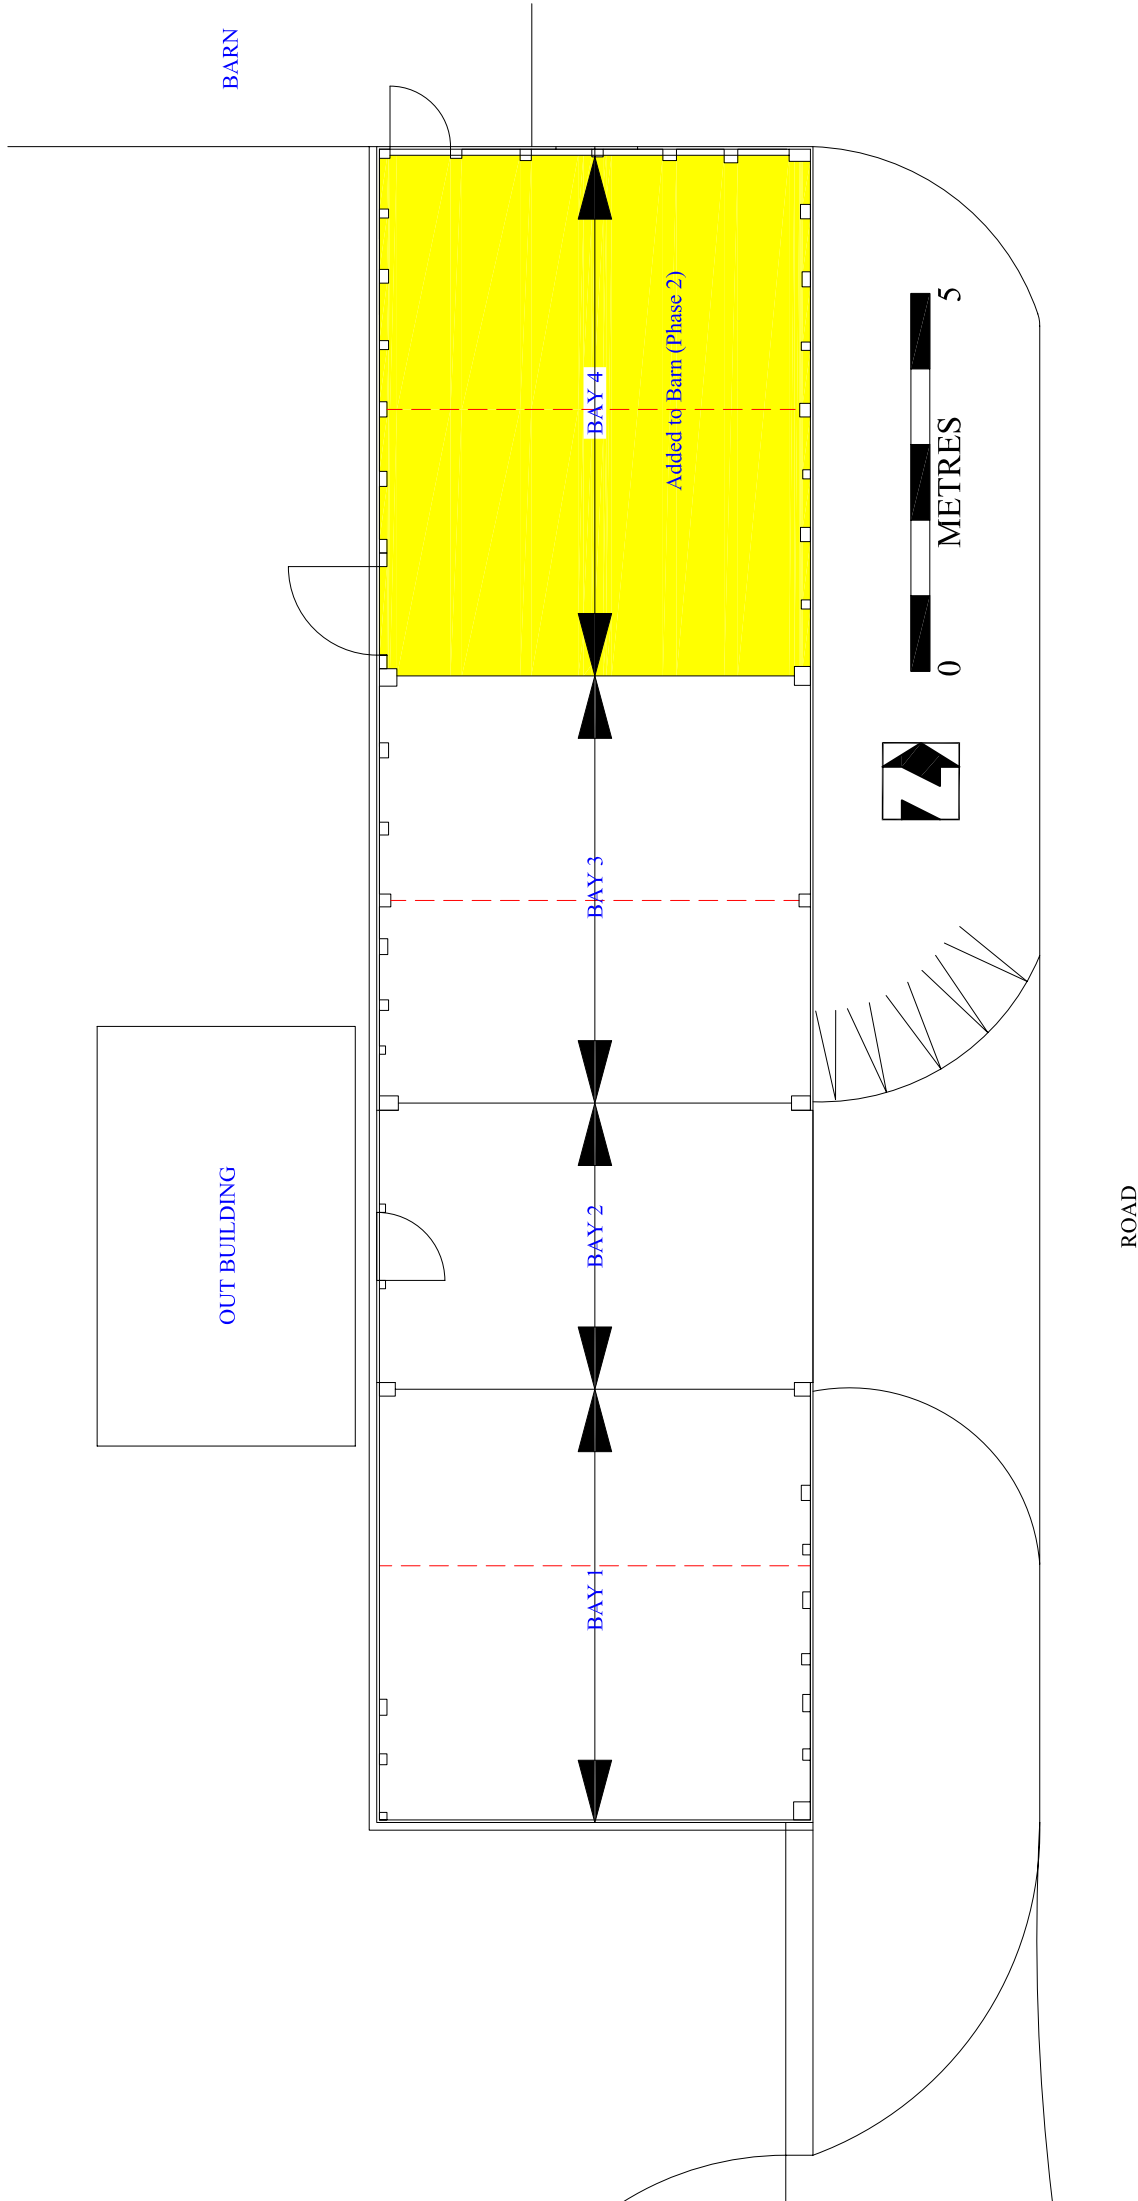
Figure 2: Site Identification Plan (Based on Original Drawing by Barnett Taylor Associates)

*For the purposes of this report the bays of the building are numbered 1-4 starting with the southernmost bay (see Figure 2).*
