ARCHAEOLOGICAL DESK-TOP
ASSESSMENT OF
MUCKNELL FARM
STOULTON
WORCESTERSHIRE

WSM 38291

Archaeological desk-top assessment of Mucknell Farm, Stoulton

WSM 38291
October 2007

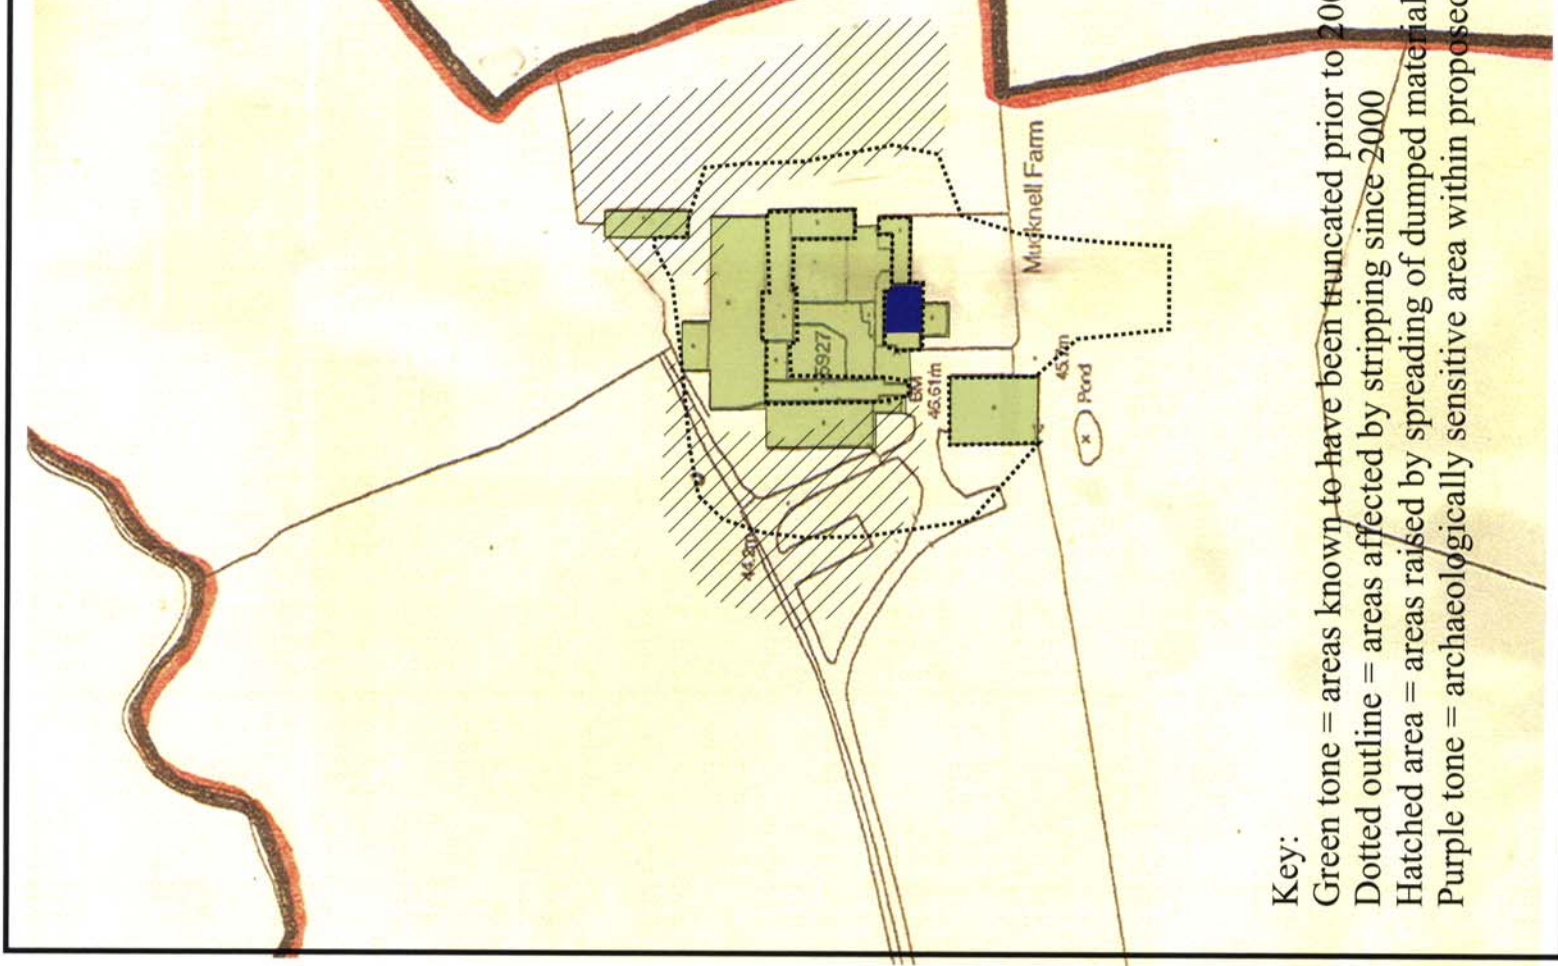
- Green tone = areas known to have been truncated prior to 2000
- Dotted outline = areas affected by stripping since 2000
- Hatched area = areas raised by spreading of dumped material
- Purple tone = archaeologically sensitive area within proposed
