ARCHAEOLOGICAL BUILDING
RECORDING
OF A TIMBER-FRAMED
OUTBUILDING AT THE COVENTRY
ARMS, UPTON SNODSBURY
WORCESTERSHIRE

WSM 33524

Archaeological building recording of a timber framed outbuilding at the Coventry Arms, Upton Snodsbury, Worcester (WSM 33524) January- February 2004

Mike Napthan 7th March, 2004

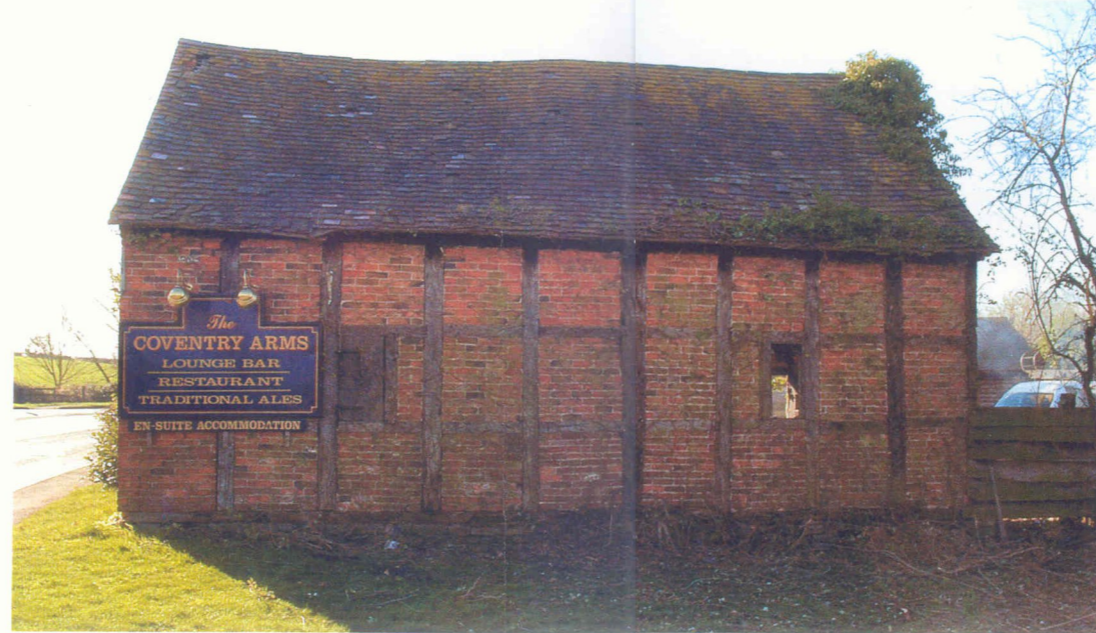
Eastern elevation

6.4.3 The eastern elevation survived almost intact, but showed evidence of alteration or repair in the northern corner of the bay, where there were peg-holes suggesting an empty mortice in the top of the sill beam. As noted above (para 6.2) this is a short (less than 2m long) length of sill-beam which was apparently retained beneath Frame 2 whilst the remainder was replaced. The shuttered window (Figs 6 and 8) appears to be an insertion as the northern window jamb has been cut into the head and foot rails and is not pegged but nailed to the rails.

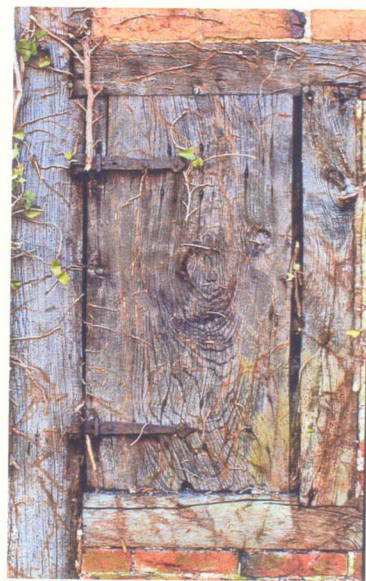
Shutter detail, eastern elevation

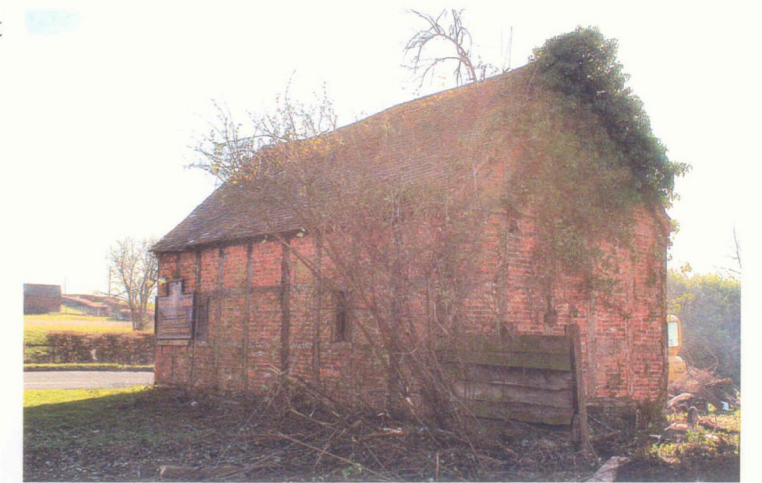
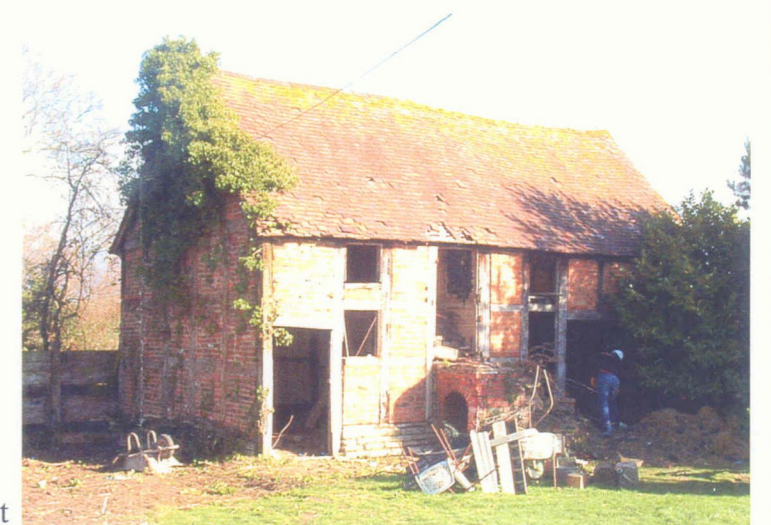
6.4.2 The western elevation was largely open at ground floor level, and appeared to have been previously secured by double doors, part of which survived on the southern side of the opening (obscured by vegetation in the photographs – Fig 6). A door stop was present in the centre of the door head rail soffit. The panel to the north of the doorway was entirely open, having lost any infill and only mortices for the missing rails showed that it was not formerly an opening. At 1st floor level a further open panel may have been used for light or to load goods, but does not appear to have been originally intended for that purpose, and was grooved to accommodate wattle infilling.

View from north-west

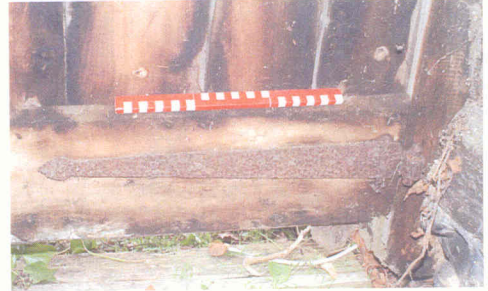
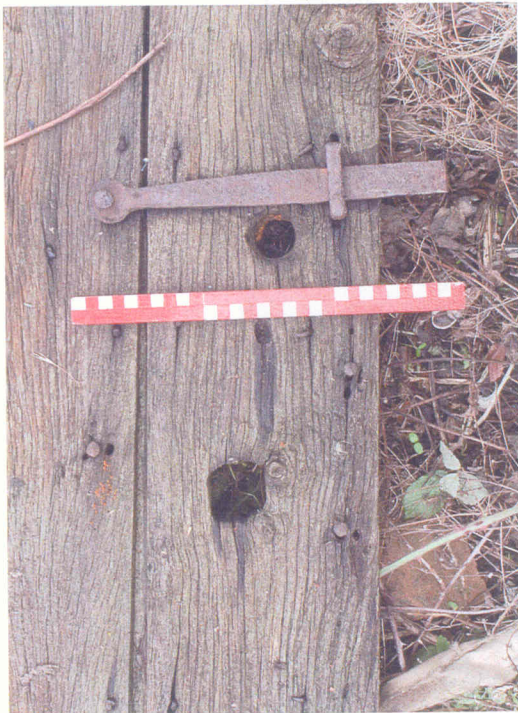
Latch and latch rest 1st floor (L17th - early 18th C)
