# Corseyard Farm 'Coo Palace' Borgue, Dumfries and Galloway

Historic Building Record      February 2018

DGC planning reference: 17/0533/LBC

Listed Building: LB 3381

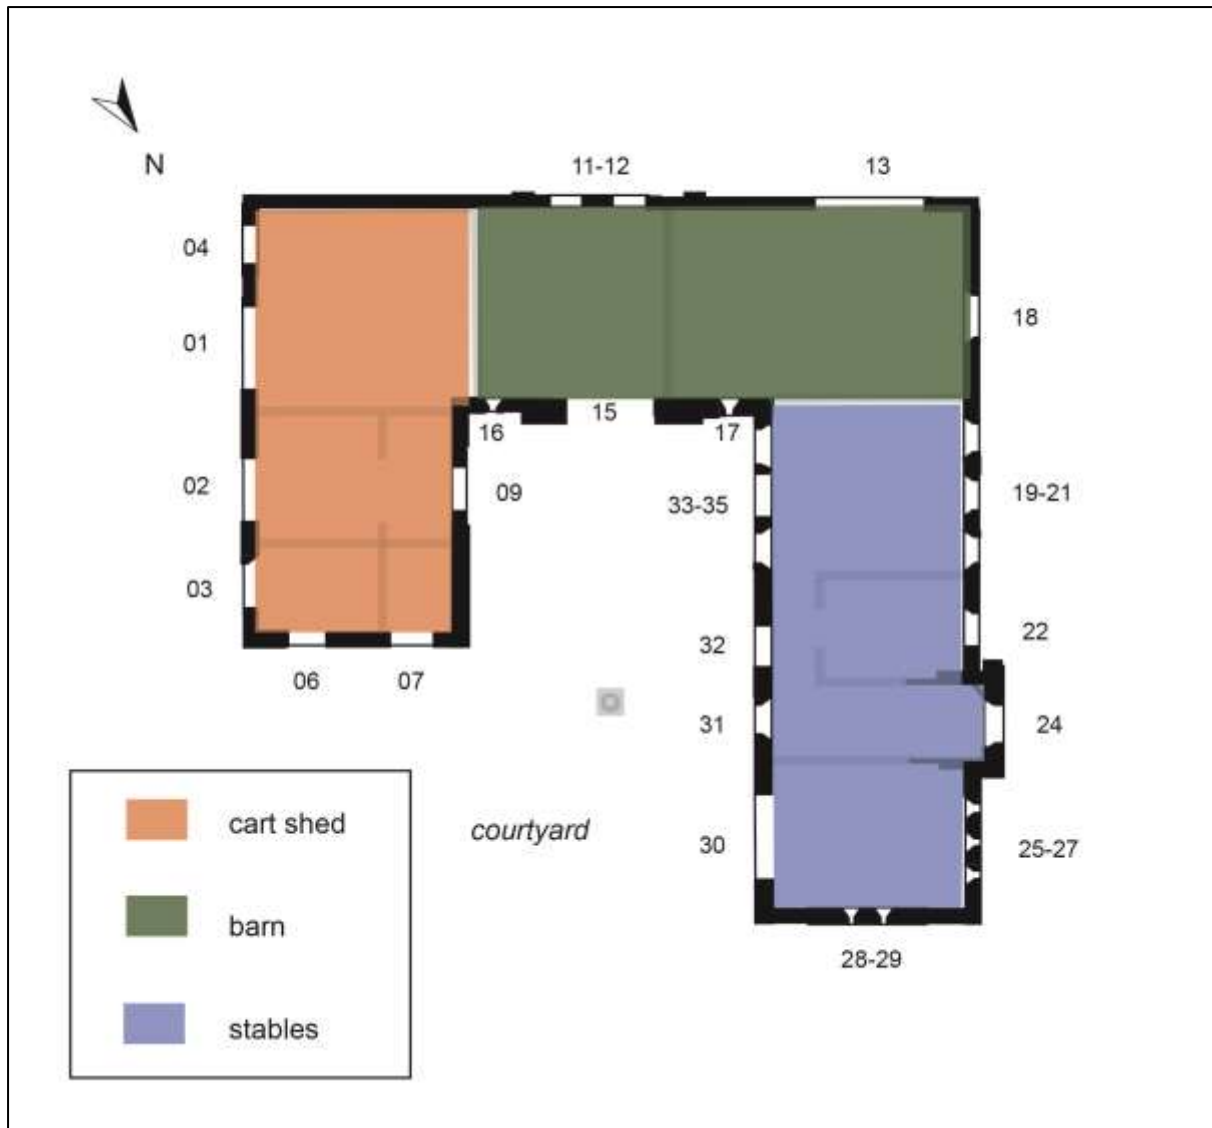
*Fig. 3. Plan of North Range with ID numbers of windows and openings*

- 5.2.4 The east face has a single arched vehicle entrance (08) which corresponds with entrance 02 in the west face. The entrance has been blocked with concrete into which an arched window (09) has been inserted. The surface of the concrete has been scored to replicate the random courses of the surrounding masonry.

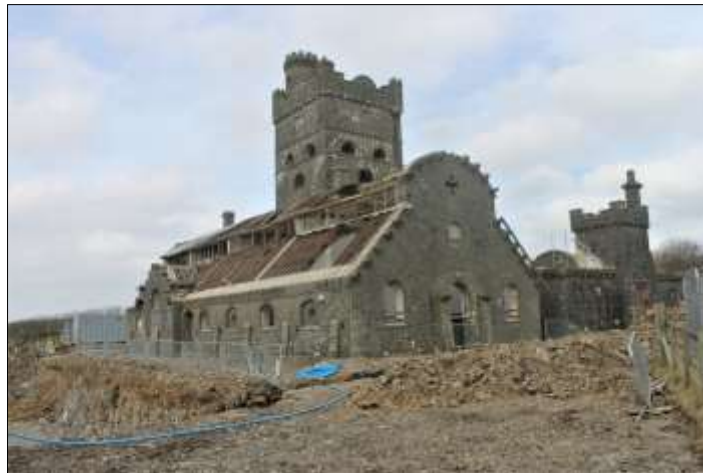
**Plate 1. South Range from the south-east.**

- 5.3.3 The six-bay south face is the longest continuous face in the Coo Palace complex. At the west end is a single arched window (41) set between two half-height buttresses and immediately east is a shallow transept with a low, curved gable containing a high level arched window (42) with a round opening above (42). At ground level is a centrally placed half-height buttress. The south face of the transept reflects the form of the building's larger east and west faces as well as the gables in the North Block. On the east side of the transept is a round headed doorway (44) beyond which is a run of four, symmetrically set arched windows (45-48) with half-height buttresses in between. Windows 46 and 48 are infilled with decorative panels of pebbles set in concrete and which incorporate central iron ventilation grilles. Pebble-impregnated concrete has also been used to form a decorative ground level border at the south-east corner of the building and forms the surround to a number of the down pipe drain heads. Along the whole of the south face at window cill height are 11 ventilation openings of which three still retain part of their original iron grilles.

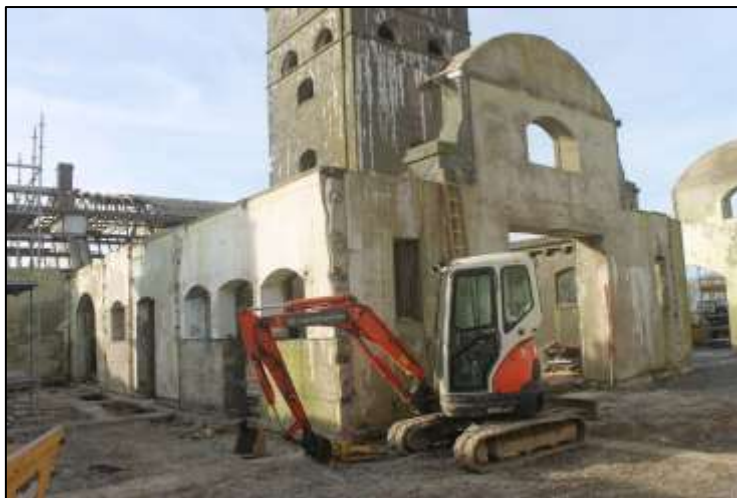
**Plate 6. North Range. Interior of stables (left) and barn (right)**

- 5.2.9 The east face forms the northern end of the North Range's east wall. The only defining feature is a single arched window (18).
- 5.2.10 The internal walls of the barn are cement render over cement leaf and the original concrete shuttering is exposed on the gables above windows 10 and 14. A sub floor concrete foundation immediately east of the vehicle entrance indicates the position of an internal wall division and is matched by another demolished wall to the west that marks the internal division between the cart shed and barn (5.2.6 above).

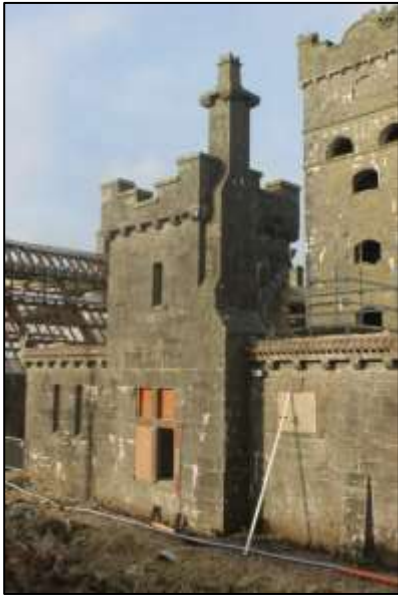
**Plate 7. North Range, east face tower.**

- 5.2.15 The central area, probably the harness room, is defined to the west by doorway 31 and window 32 in the west wall and the square tower to the east. The tower projects internally at the ground floor and comprises a rectangular room with the remains of a brick built fireplace with a stone lintel in the north-east corner and the imprint of panelling on the lower section of the cement rendered walls. A 15-light iron window frame survives within window 24. The room has a concrete ceiling with a loft space above.
- 5.2.16 The southern part of the stables, probably used as a loose box, is a rectangular space accessed by vehicle entrance 30 and lit by slit windows 25-29. The internal walls are cement render on cement leaf.
