Thames Gateway

Report on the investigative conservation of waterlogged finds

Date: 25/01/16

York Archaeological Trust Conservation Report Number 2015/43

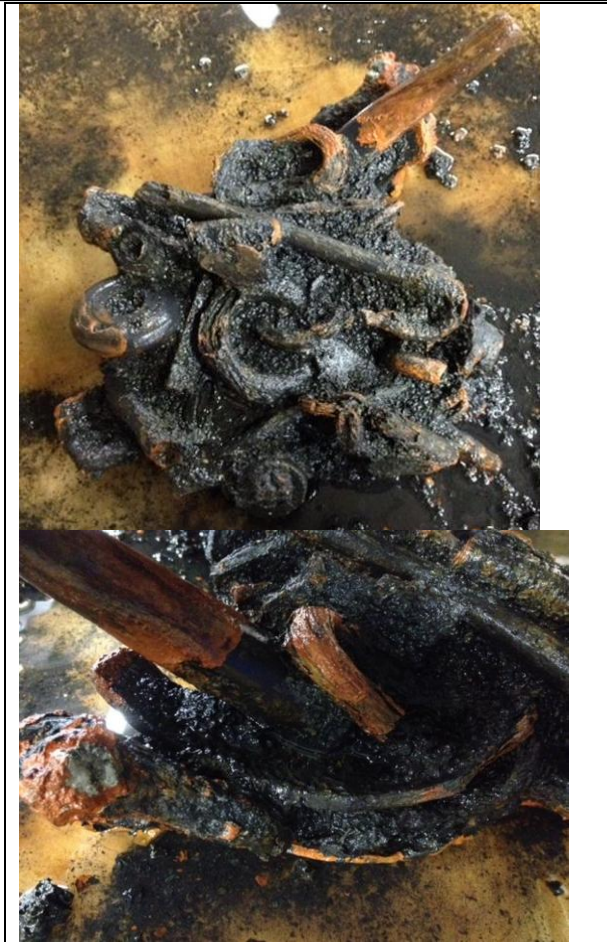
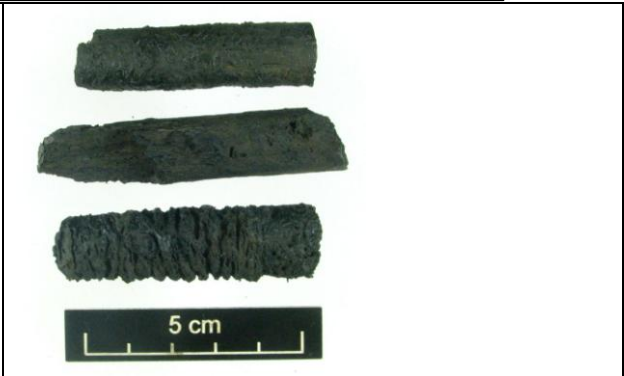
<p>A</p>

<p>Concretion with wood handle protruding</p> <p>This concretion appeared to be a conglomeration of a large collection of iron and wood objects. The most noticeable item is a wooden handle protruding from one side. The concretion was X-rayed and was also found to contain a lead object.</p> <p>Treatment:</p> <p>The concretion was investigated by removing corrosion and concreted material initially from the surface and around the protruding wooding handle. This revealed a plethora of other objects of wood and iron including rings, rods, bars, a shackle, a complete padlock and several other handles. Each object was gradually removed from the conglomeration by continuing to remove the concretion from around each object. The iron objects revealed were found to be completely mineralised and were very fragile and with surfaces that often retained impressions of the concreted material. Each object was labelled with a letter for ease of reference.</p> <p>Once all the objects had been separated out from the concretion they were placed in water baths to check the chloride levels. All the objects were found to be within acceptable limits for chlorides.</p>

<p>The iron objects were dried at this point and could be further treated to remove the last fragments of concretion from the surfaces. This was done using the air abrasive with 29 micron aluminium oxide powder followed by surface treatment using 10% tannic acid w/v in 50:50 Industrial Methylated Spirits and water.</p> <p>The wood objects were pre-treated with 3% ammonium citrate w/v in water by immersion for 2 days then rinsed and put through a PEG treatment regime of 10% PEG400 v/v and 30% PEG 4000 w/v in water with the addition of 0.2% v/v of Linkcide KMC biocide.</p> <p>At this point the object was freeze-dried in the 7.5 litre Birchover unit (run number 9), the run lasting one month.</p> <p>After freeze-drying, the surfaces were cleaned of excess PEG using small amounts of hot water, dried off with paper towelling and further dried with a hot air blower. The surfaces was then coated with 25% PEG 6000.</p> <p>Corrosion and concretion was removed from the surfaces of the lead object (object AA) mechanically using small hand-tools. Some mineralised wood impressions on the surface were left in situ.</p> <p>Cylindrical wood object (found with concretion but separate) Conglomeration of several unknown Fe items</p> <p>A: Fe rod in three fragments one of which has cordage impressions B: Fe nail shank fragment C: Fe rod D: Small Fe eyed bar E: Fe ring fragment F: Fe shackle G: Wood discoidal fitting with perforations H: Fe eyed bar with screw and small wood fragment I: Fe 'U'-shaped loop J: Wood wedge K: Fe ring fragments L: Fe/graphitized nut/washer M: Fe fitting fragments N: Fe and Cu alloy round fitting/nut and small bar fragment O: Fe sheet fragment P: Fe ring fragment</p>

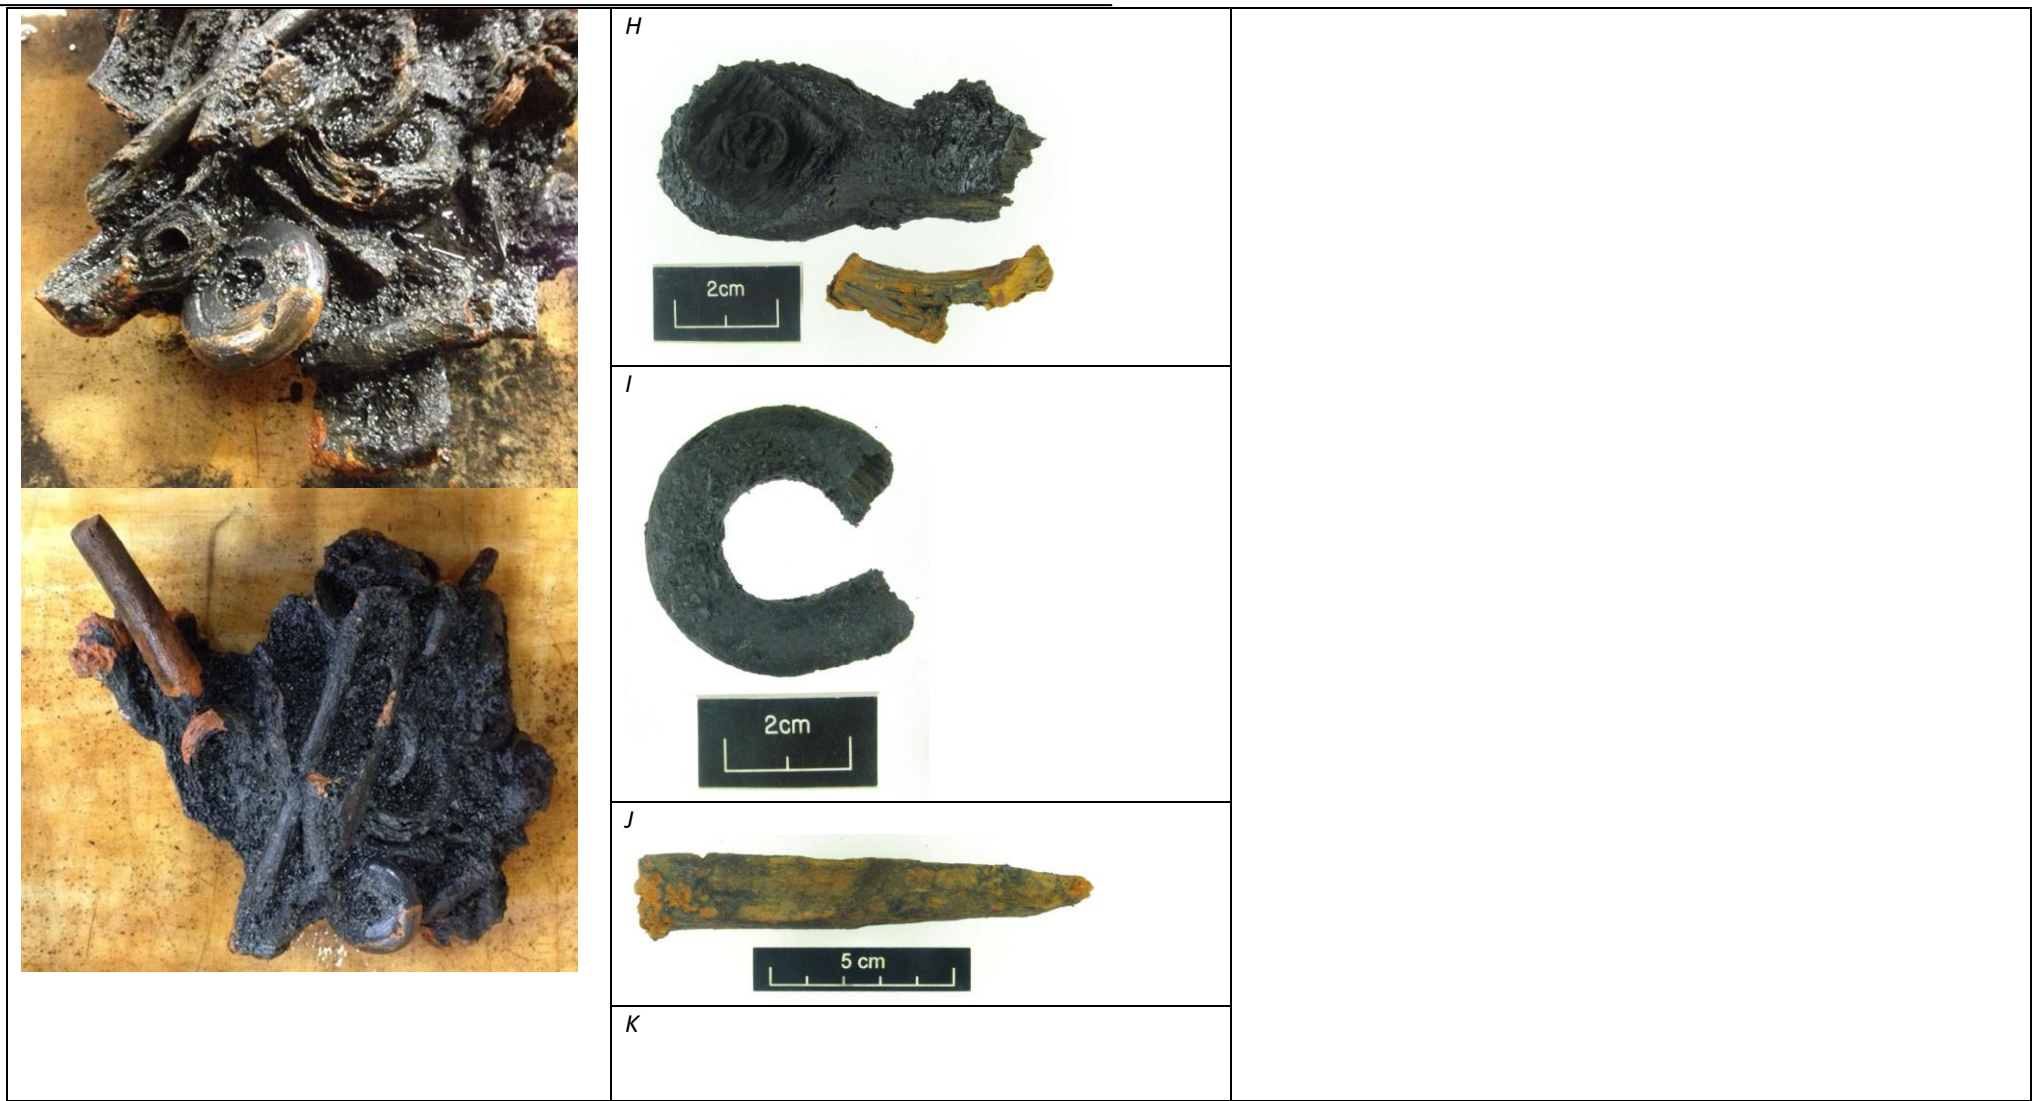
<p>E</p>  	<p>Q: Fe large eyed bar R: Fe eyed loop with ring and curved object S: Fe nail T: Fe nail U: Wood object made from three flat long pieces formed into a triangle V: Fe possible padlock fragment W: Wooden handle X: Fe and Cu alloy padlock Y: Wooden handle Z: Wood and Fe chain links</p>
 	<p>F</p>  	<p>AA: Pb flat object/possible lid, with mineral preserved organic fragments on the obverse. AB: Wooden handle AC: Leather shoe sole toe fragment AD: Fe eyed hook AE: Fe curved plate AF: Fe ring attached to a stone AG: Fe eyed bard with loop AH: Fe rod fragments</p>
	<p>G</p>
