Well House Cottage Wellhouse Lane Headbourne Worthy Winchester

Level 2/3 Historic Building Recording

CA Project: AN0194

August 2020

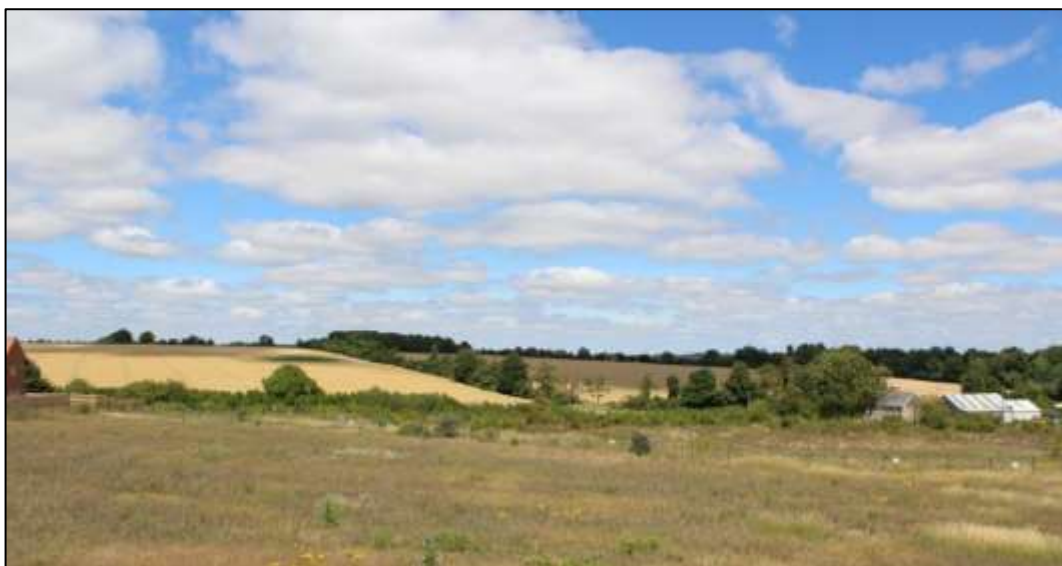
Photo 1 View over Well House Farm from Ranulph Road, Well House Cottage on the right

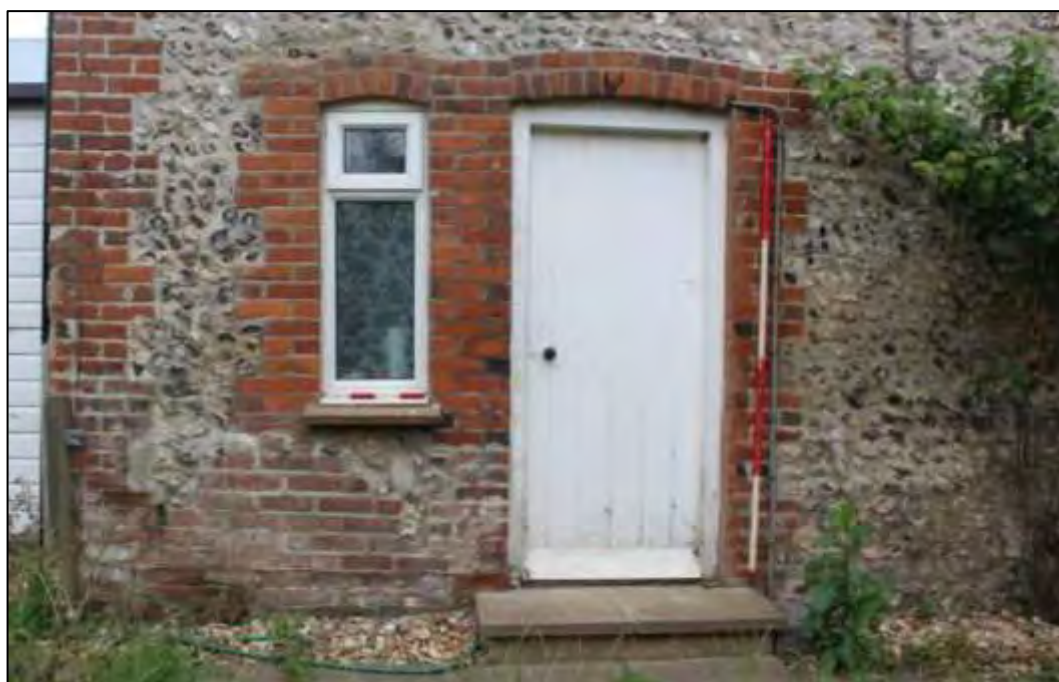
- 4.18. The north gable is similarly constructed in flint with brick detailing and is sparsely fenestrated. At ground floor, a narrow window sits to the east of a door, both with cambered arches over (Photo 3). The door is now blocked internally and is the only remaining traditional timber feature of any age in the cottage. The door position is mirrored on the south elevation by a similar, now altered opening, believed to be the 'back door' to the cottages respectively. Below the window, at the north-east corner of the cottage there appears to have been some rebuilding, or possibly underpinning, as shown by the later brickwork infill (Photo 4).

Photo 4 Detail of door and window in north elevation

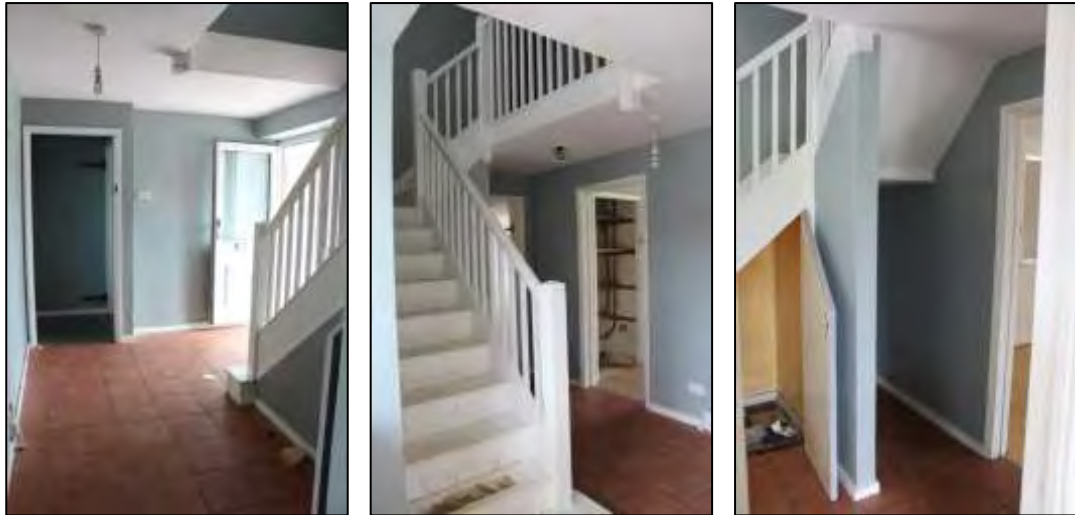
- 4.24. Accessed from the porch (Fig. 3; **C01**), the entrance hall (**C02**) serves as the main circulation space between the rooms on the ground floor and with the first floor (Photos 7 & 8). The stair rises adjacent to the external (east) wall within an open stairwell, and is characteristically of the late-20th century.

- 4.25. A spine wall has been added to support the edge of the upper section of the stair, creating an open 'cupboard' adjacent to the under-stair cupboard (Photo 9). The floor is tiled and apart from narrow late-20th century skirtings and architraves, the hall is devoid of decorations.

Photos 7, 8 & 9 Hallway looking north-east (left) and south-west (centre) and showing the under-stair cupboards

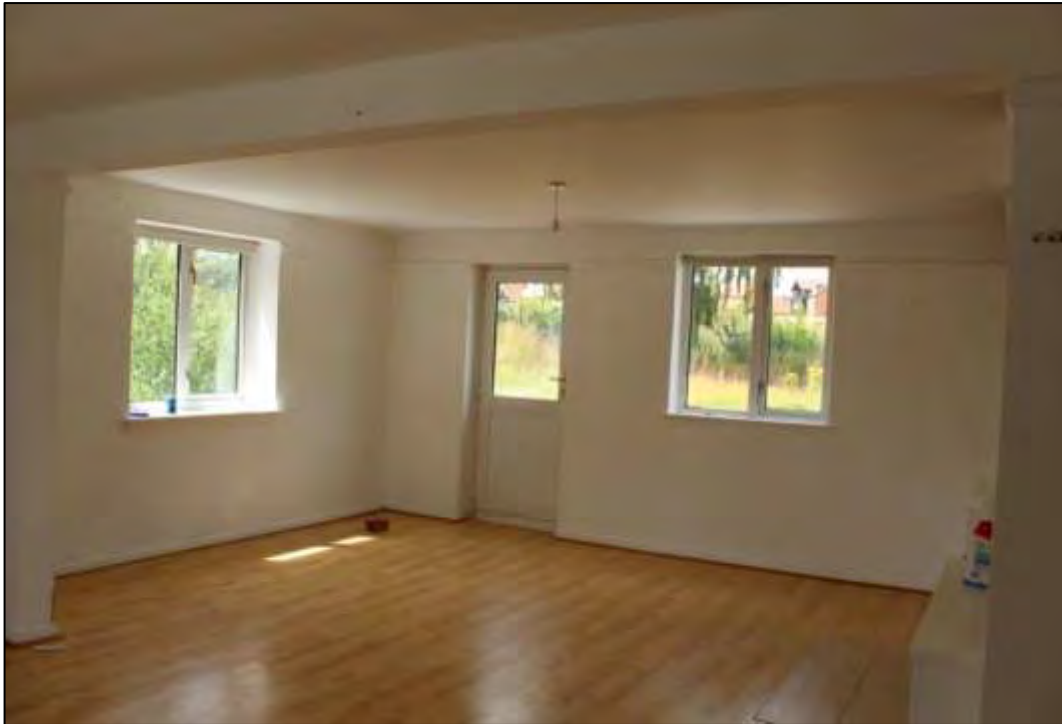
Photo 14 View south-west within the Sitting Room

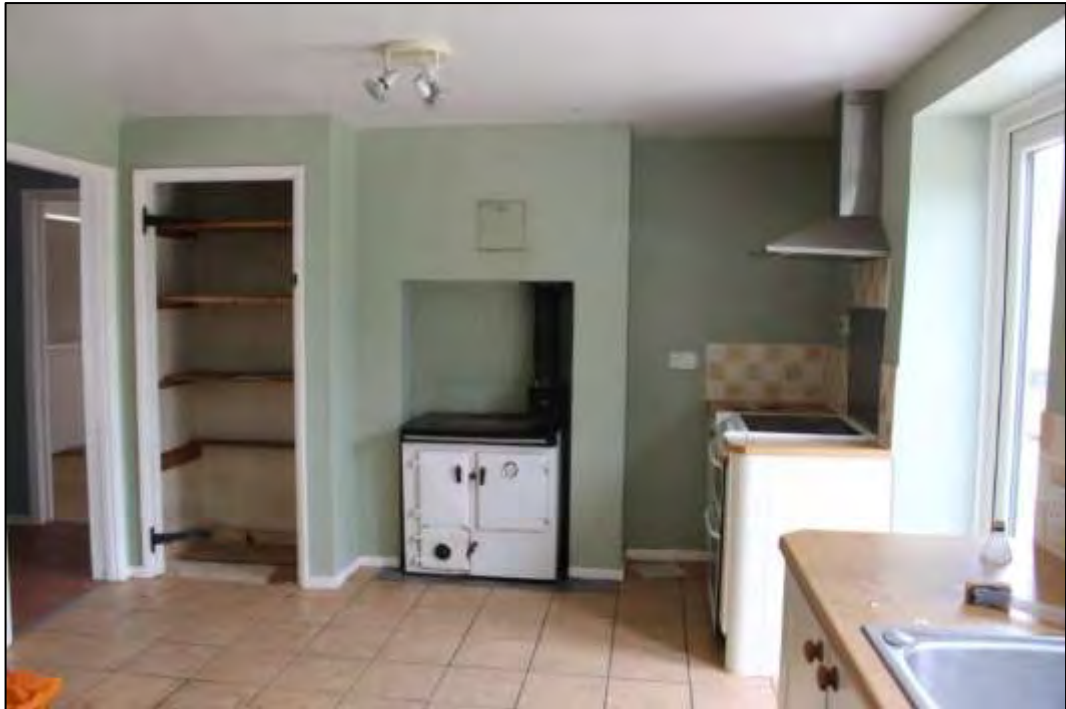
Photo 15 View south within the kitchen

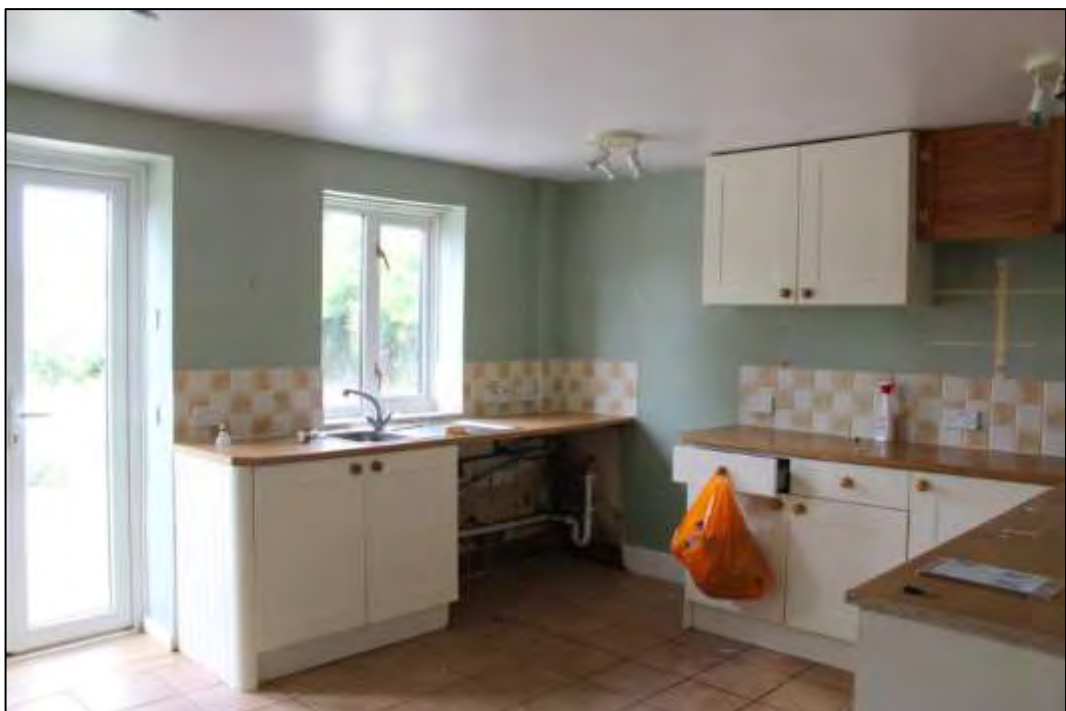
Photo 16 View south within the kitchen

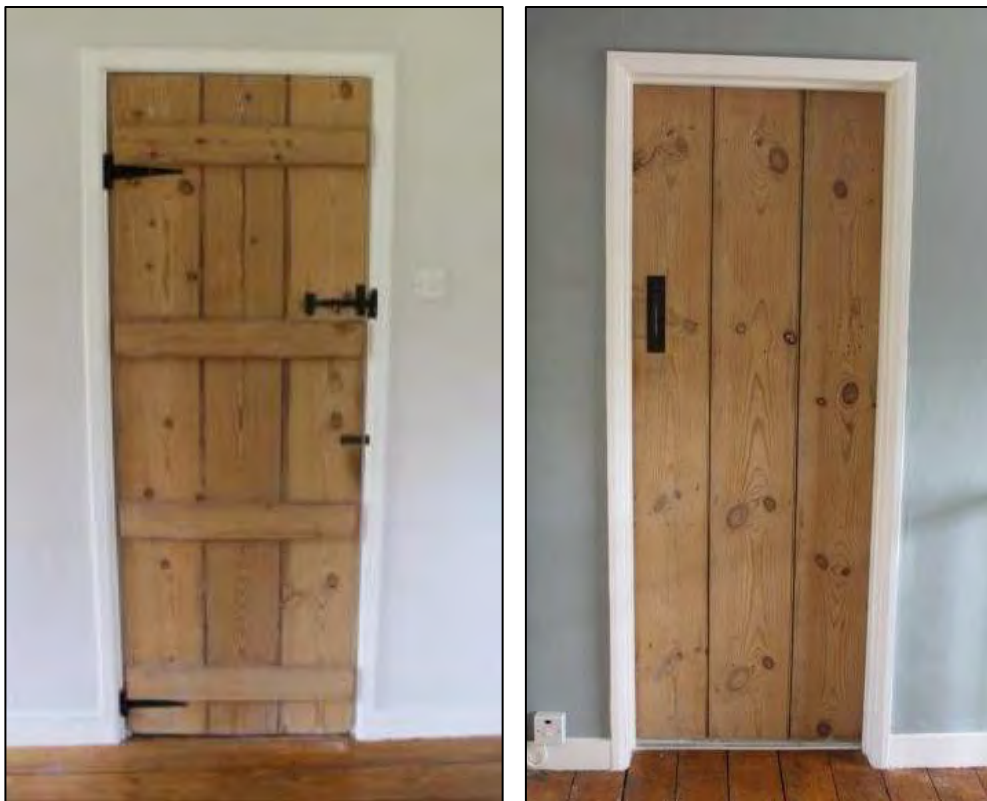
4.34. In contrast to the ground floor, all of the doors are extant at first floor. These comprise timber braced and ledged doors which have been stripped of paint (Photos 17 & 18). The doors have an ad-hoc collection of, presumably reused, hinges and latches which adds to the overall historic character which is more apparent at first floor. With the exception of a small area in the airing cupboard off the hall (Fig. 3; **C13**), the pine floor boards have been stained and have an unfortunate yellowish-orange tint (Photo 19). This treatment has also been applied over the stone hearth surviving in the south bedroom (**C10**; Photo 20).

Photos 17 & 18 Braced and ledged doors used throughout the first floor

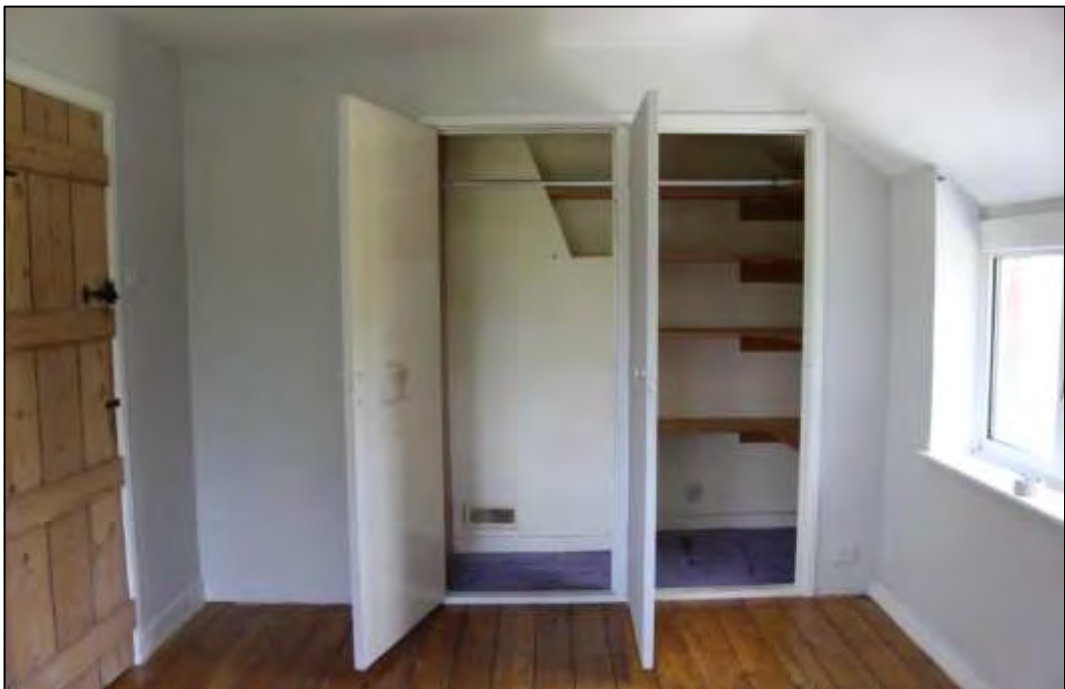
instances, the fireplaces have been blocked, with the flue vented. To the north, late 20th century cupboards have been constructed around the chimney breast (Photo 22) and the floor carpeted, thereby obscured any features, such as the hearth, which might survive (Fig. 3; C11).

Photo 22 'Front' (west) bedroom in the former northern cottage
