THE RUISLIP CHURCH HOUSE (ALMSHOUSES), MIDDLESEX: RESULTS FROM A WATCHING-BRIEF

Colin Bowlt

SUMMARY

This paper gives the results of a survey of a timber-framed building latterly known as 'The Almshouses', Eastcote Road, Ruislip, during its conversion in 1979/80, and its known owners and inhabitants during its 400 years existence. It was originally built as a dwelling house c.1570, converted into ten cottages for the poor in 1616–17, altered in 1939 when accommodation was provided for the sexton, and again in 1956, when modern amenities were installed to avert a demolition order. After years of dereliction the building was restored in 1979/80 and has since been inhabited as four flats and a maisonette. The form of the original structure and the effect of the 1616–17 conversion are discussed.

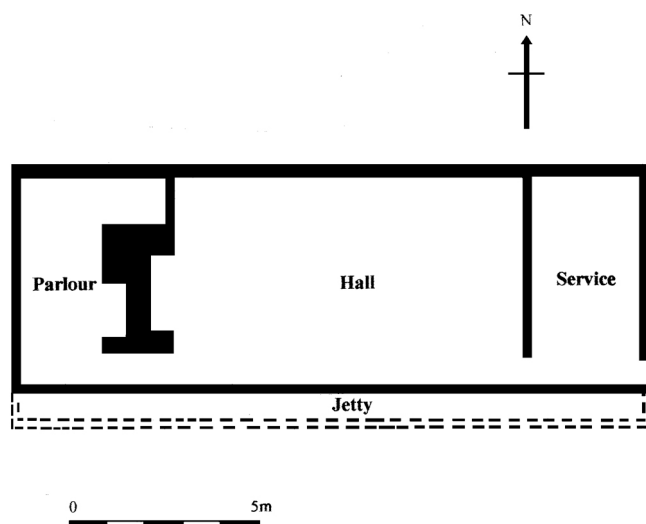
Fig 3. Ground plan of the original building

Internally the original building, presumably a private house of c.1570, was of two stories with a continuous jetty along the south side facing the churchyard. It had a three-cell plan, with three-bay central rooms up and down, and single-bay rooms at either end (Fig 3). At this stage all rooms were through rooms, except the ground floor western bay (parlour), there being no longitudinal internal walling. Originally the building had only the westernmost brick chimney. The other two chimneys appear to have been inserted later, judging from the way the joists have been cut to allow their construction. The western end of the house was thus the upper end, with an eastern service area.

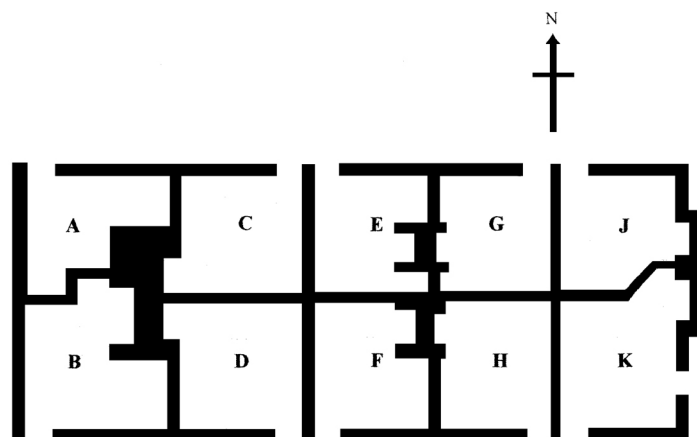
Fig 6. Ground plan after 1616/17 conversion into ten cottages

The original internal walls between AB/CD and GH/JK (see Fig 6) were also arch-braced. Those between GH/JK run from the main post on the northern side and from the original door jambs on the southern side to the mid-rail and the tie-beam on the ground
