Report 2709

**Historic Building Recording at  
East Week Farm, South Tawton, Devon.**

June 2011

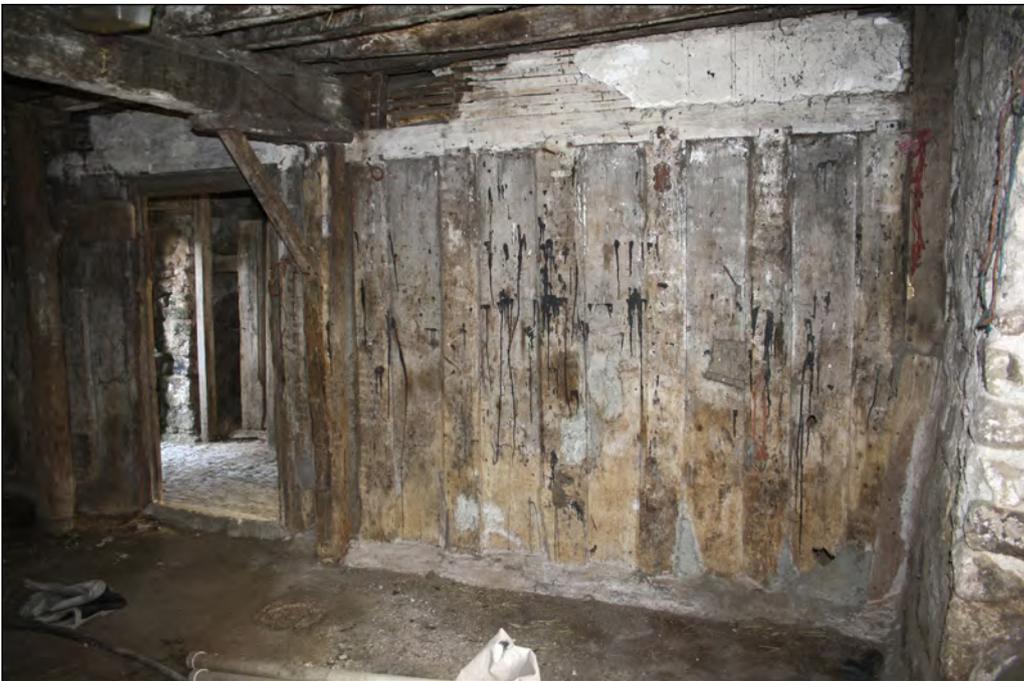
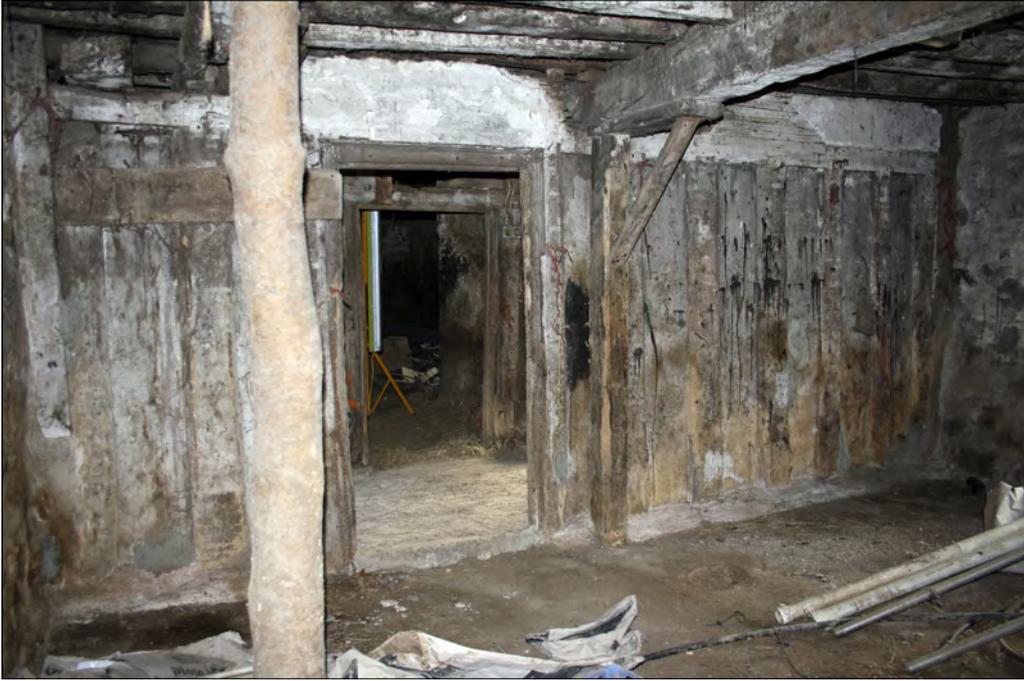
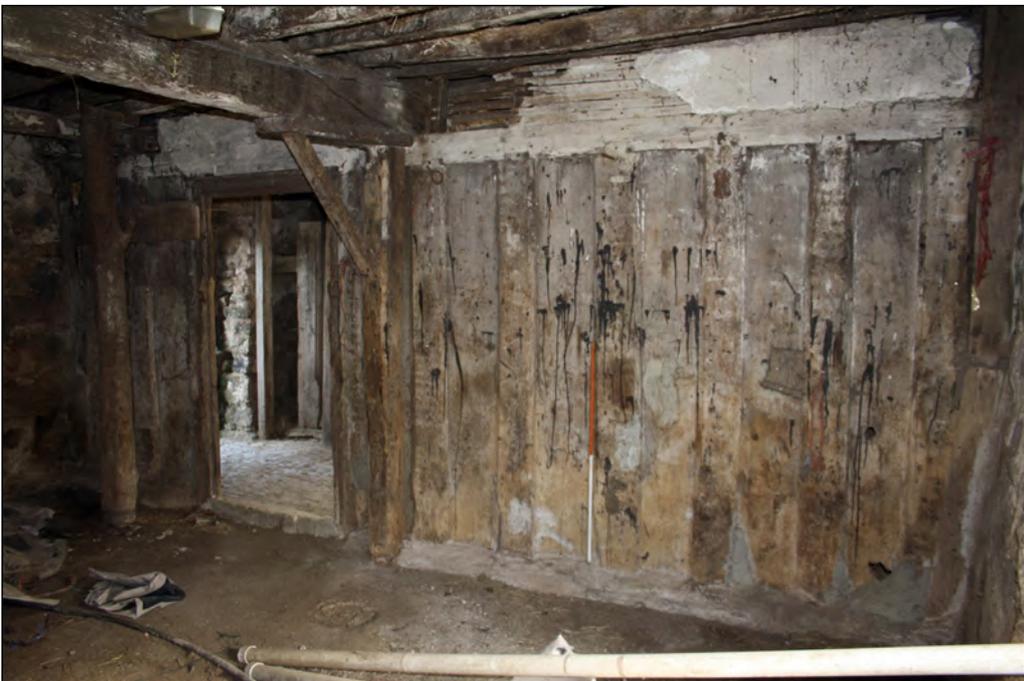
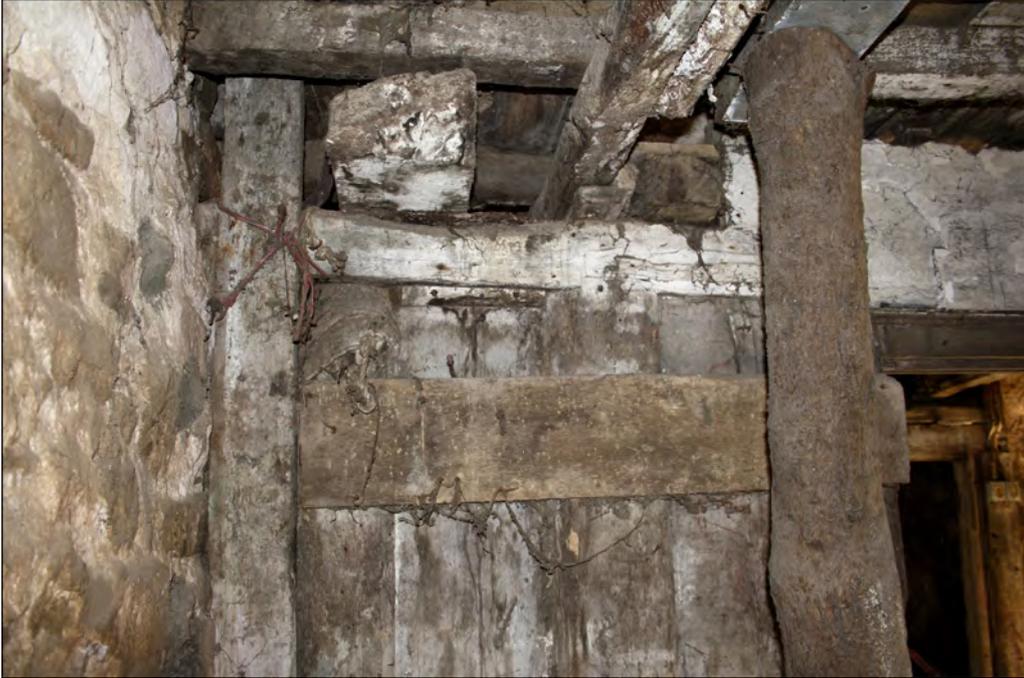
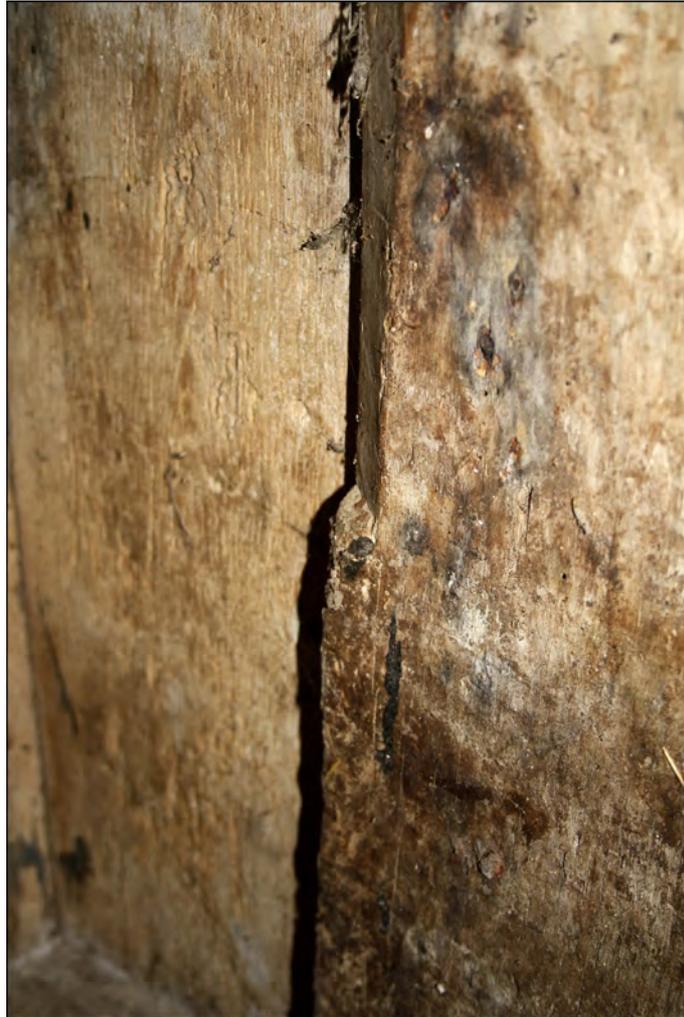
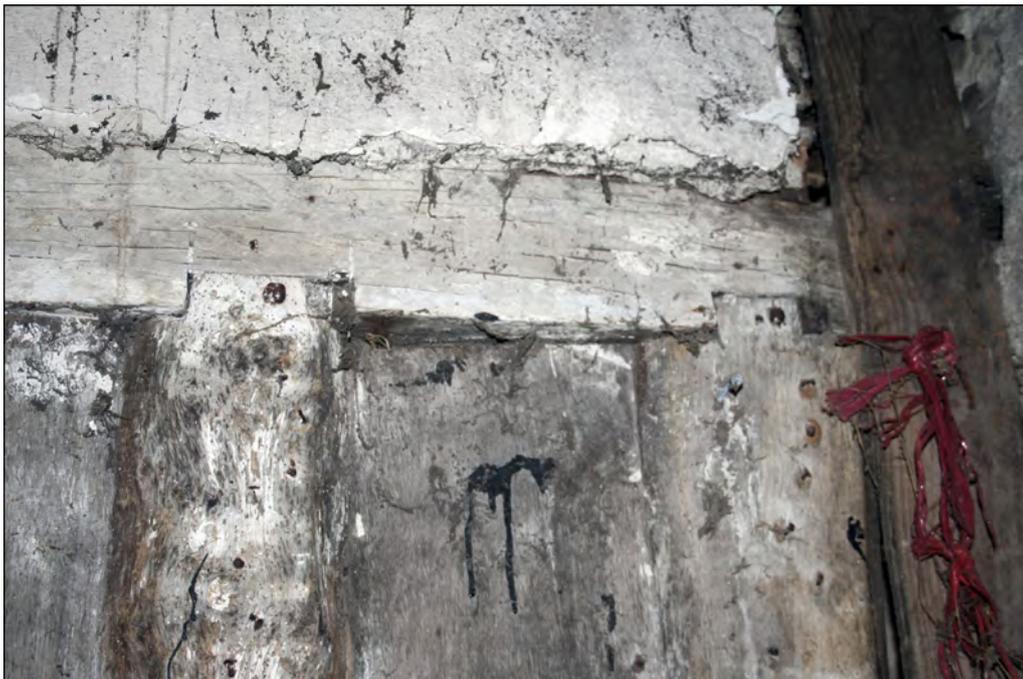
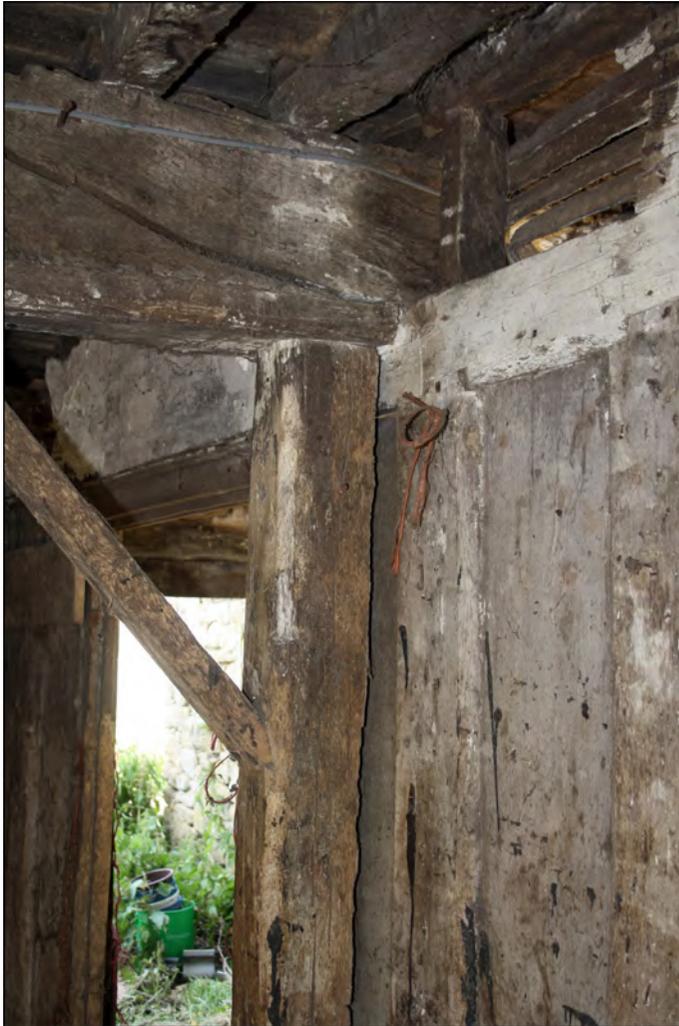
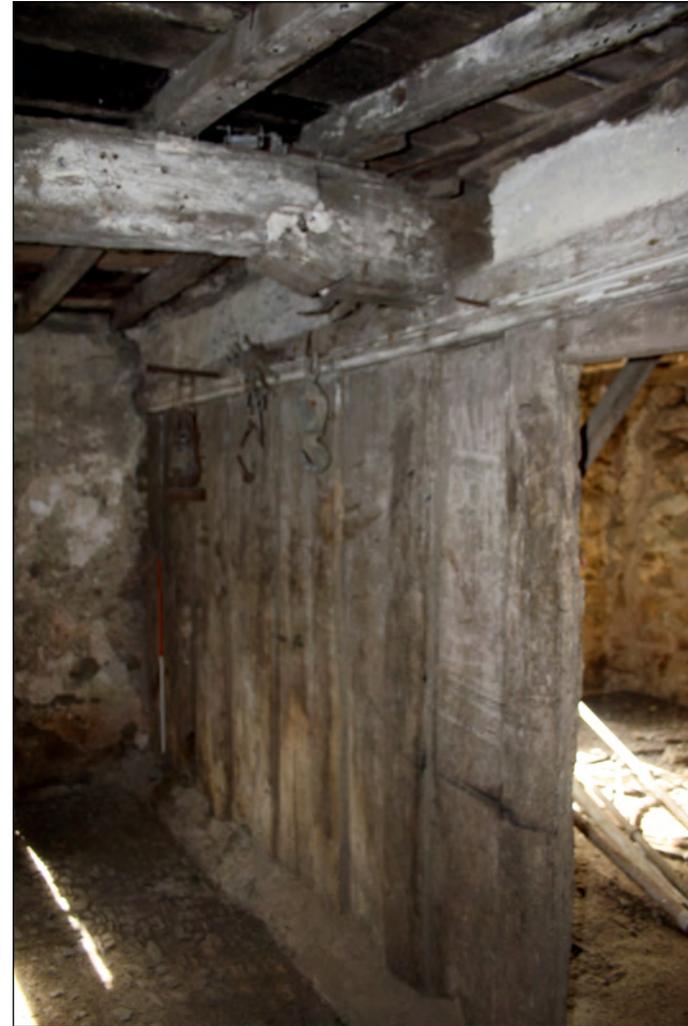
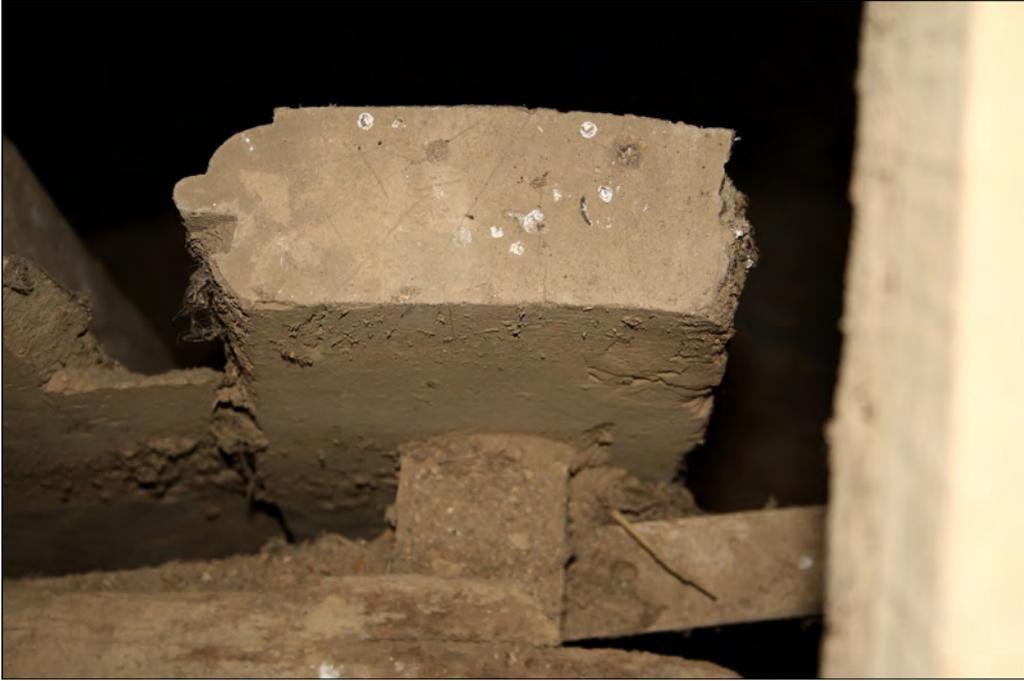
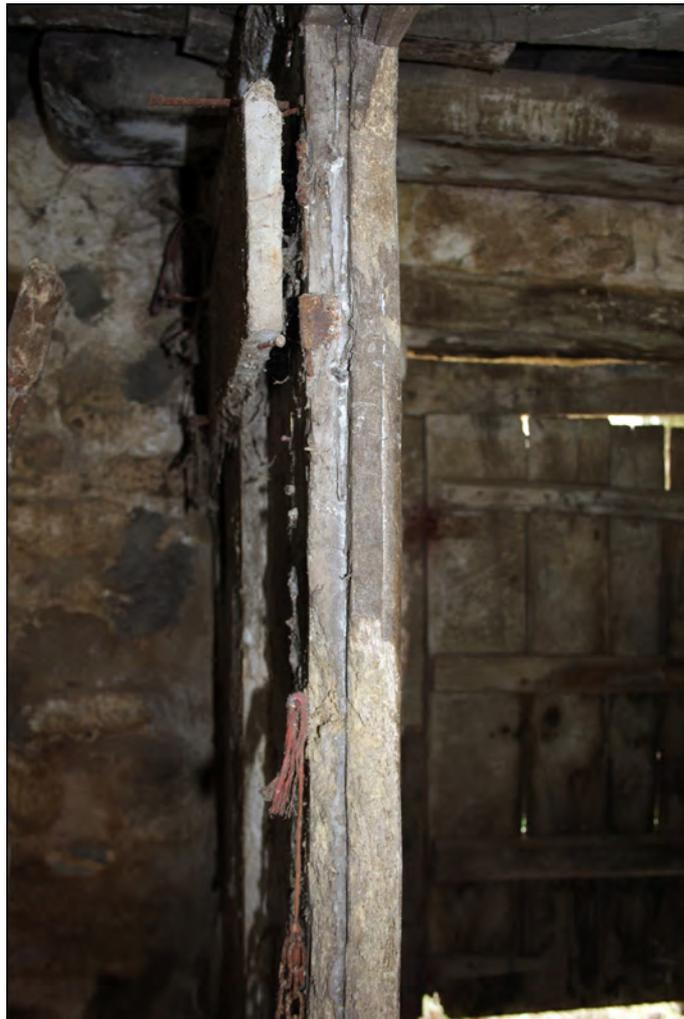
Overall the screens are in fairly poor condition, with large areas cracked and rotten, particularly along the bottom as the bases have been encased in concrete. There has inevitably been some movement in the screens as the timbers have degraded and the floor above has settled. None of the timbers can be reused in their current state and their removal for repair should take into account the different type of fixings used in the screens: the earlier northern screen has pegged mortise and tenon joints where it meets the head beam (NP4) and the later southern screen has been fixed using iron nails.

It is doubtful that any of the timbers will be completely reusable and many will need to be partially or completely replaced, so, given the significance of the screens, it may be desirable to identify the replaced areas somehow (by colour or material?) in order to highlight the important surviving sections.

It is recommended that as the screens are dismantled, details of their construction should be recorded and added to the existing survey drawings.

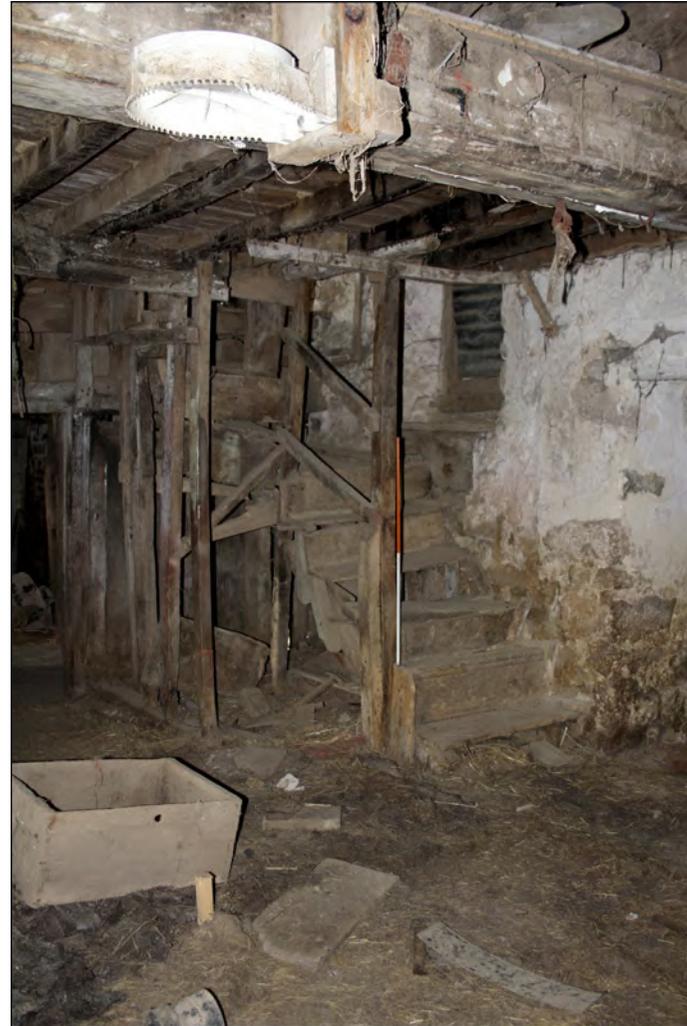
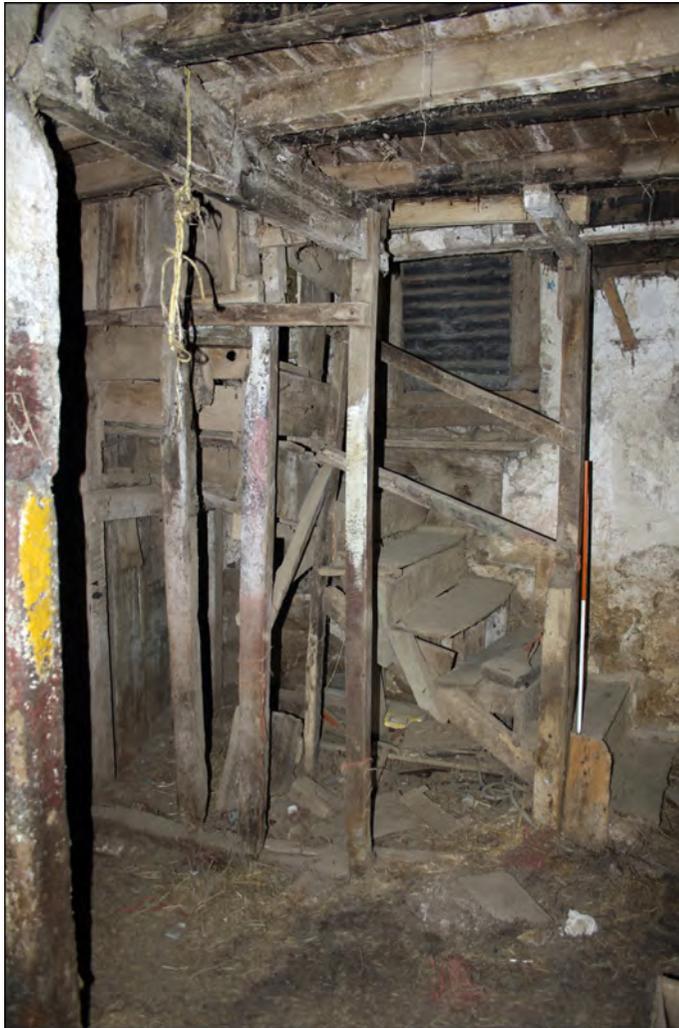
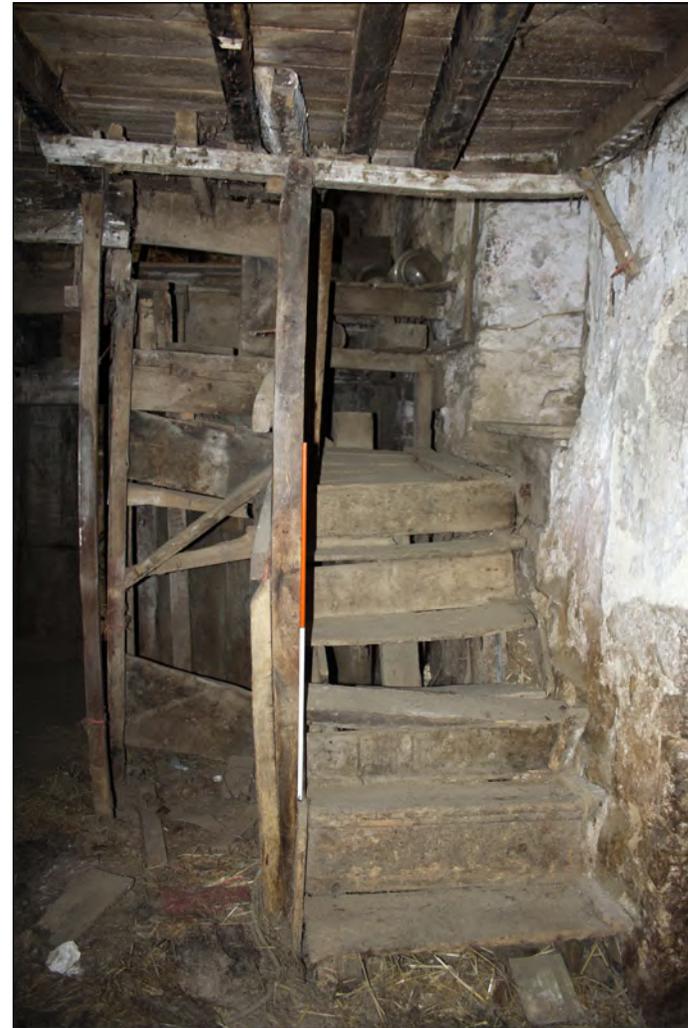
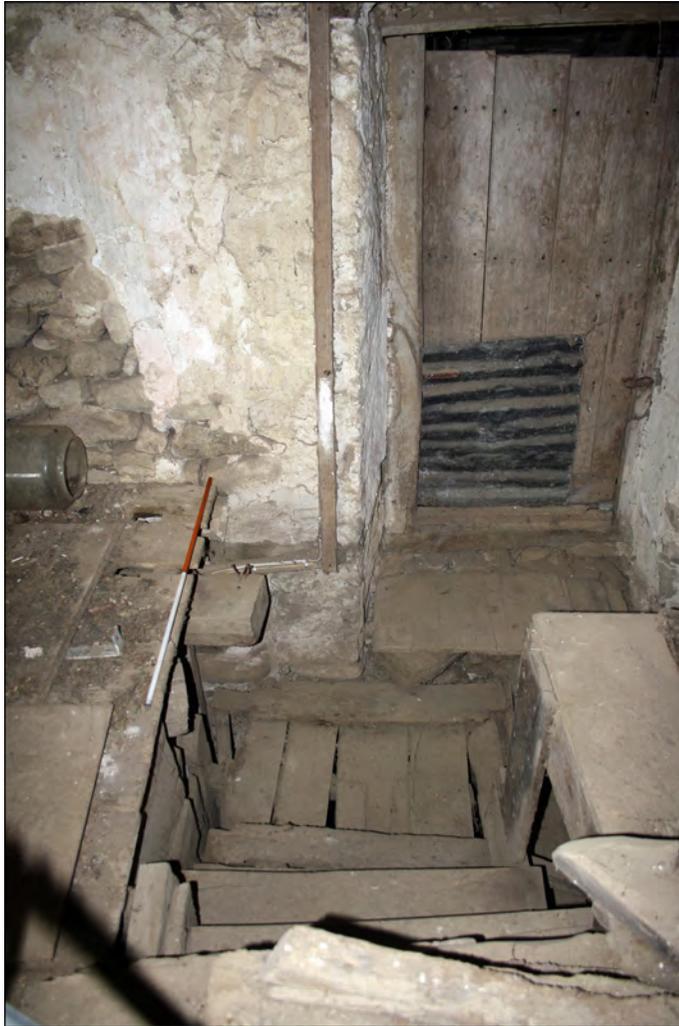
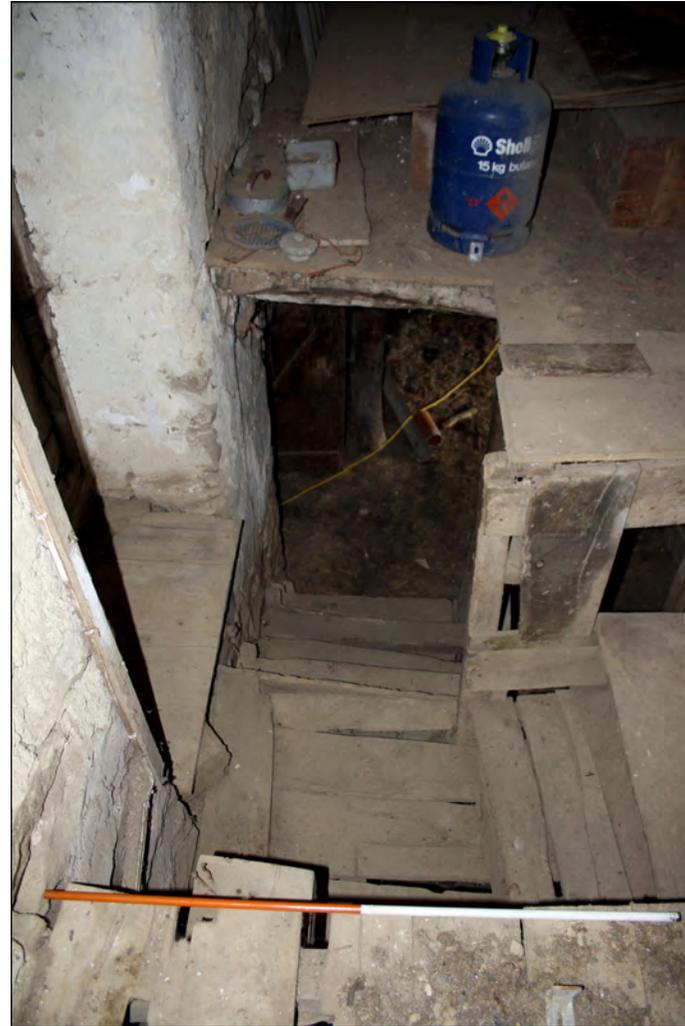
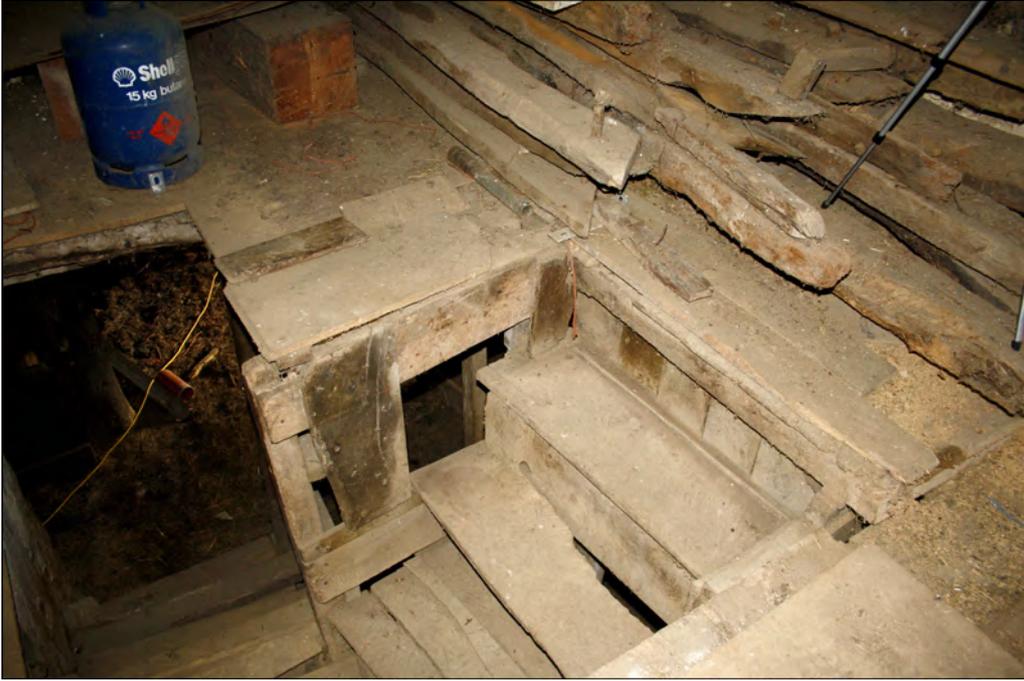
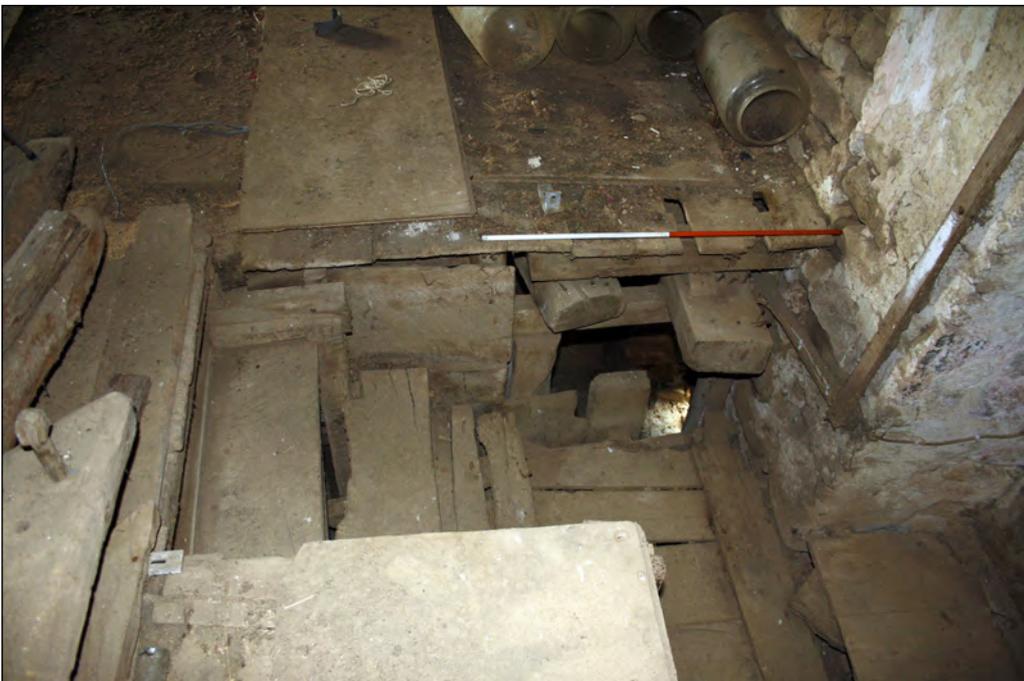
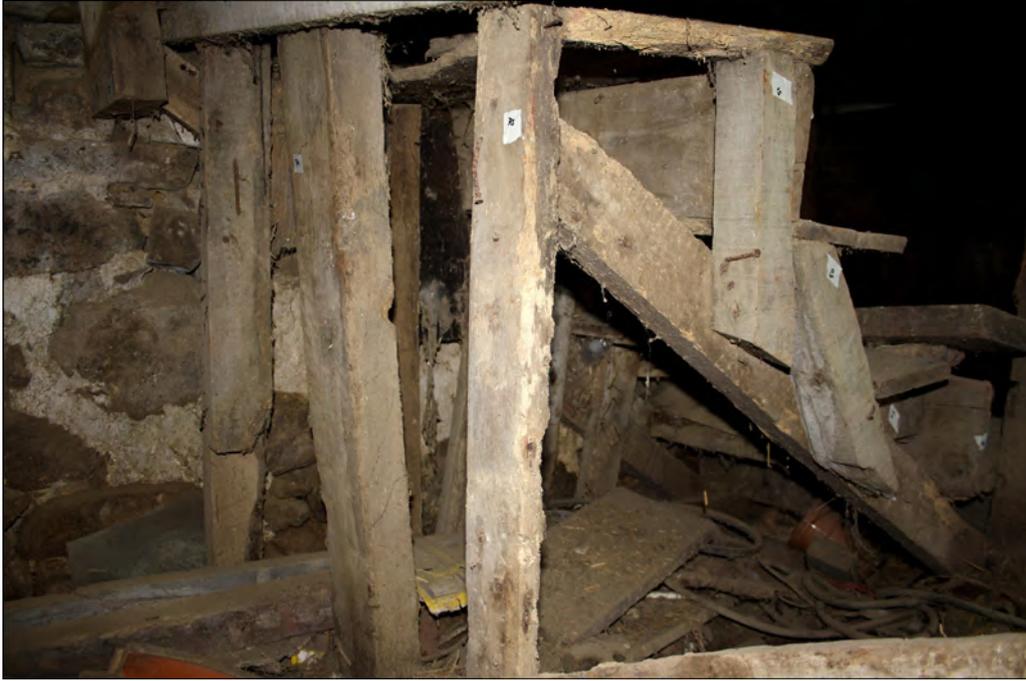
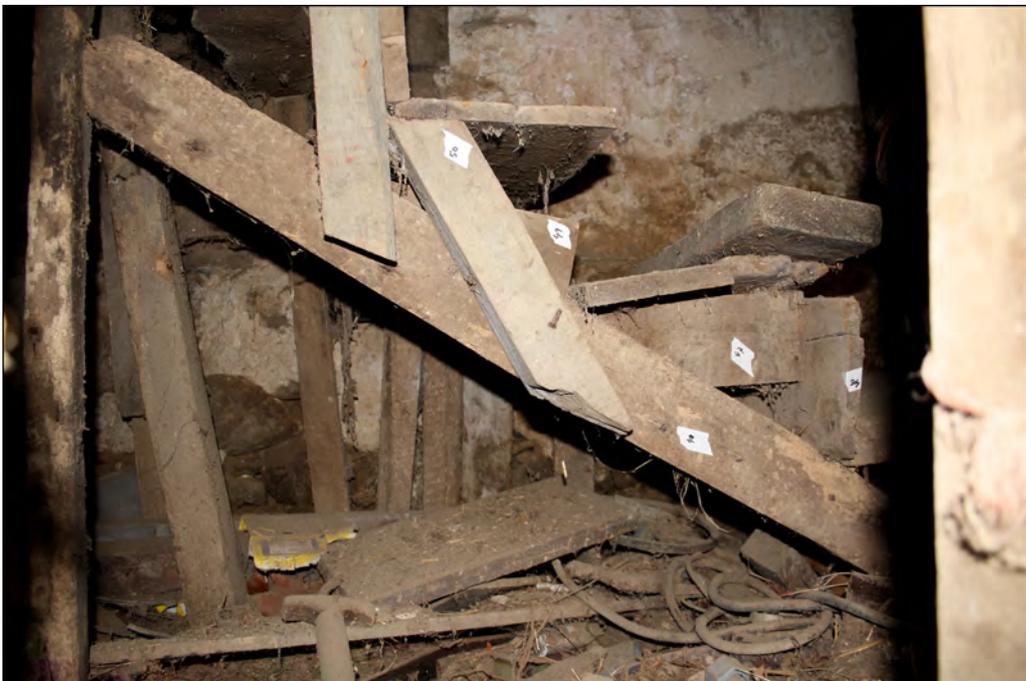
There are no significant features on the surviving staircase and most of the timbers are rotten and will need replacing or substantial repair. Given the doubt over the dating of the stairs there does not seem any reason to rebuild the stairs like-for-like, but the location of the stairs is significant and should be maintained if at all possible within any redesign. If a like-for-like staircase is required the individual timbers in the structure have been numbered to allow their removal repair and reconstruction.
