**Archaeological Historic Building Recording at  
Church Farm Barn, Shelfanger, Norfolk  
(Level 1 Photographic Survey)**

ENF129340

September 2012

*In May 2012 NPS Archaeology undertook a Level 1 photographic survey of a barn at Church Farm, Shelfanger in Norfolk.*

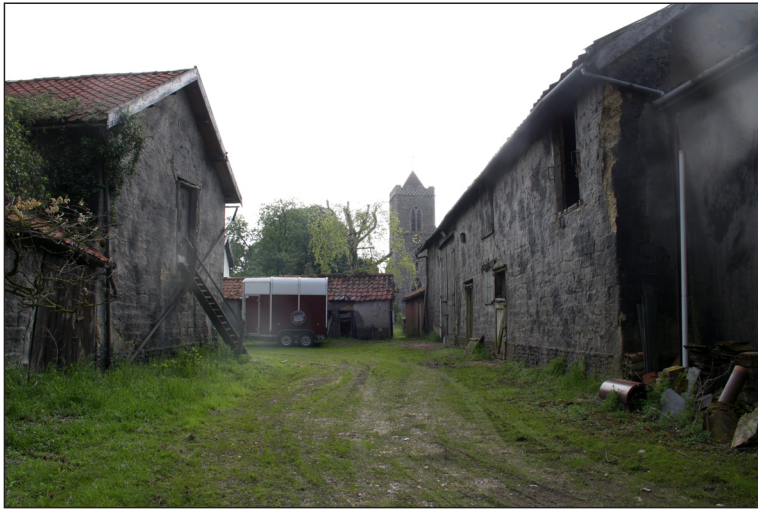
- Plate 1 East facing location photograph. The barn is on the left of the photo
- Plate 2 West facing location photograph. Opposite direction to Plate 1 with the barn on the right
- Plate 3 South-south-east facing photograph looking away from the barn towards modern bungalow
- Plate 4 East facing location photo. The barn is located to the right of this photo and the large house is the old farm house

Plate 1. Church Farm; the barn is to the left. Facing east.

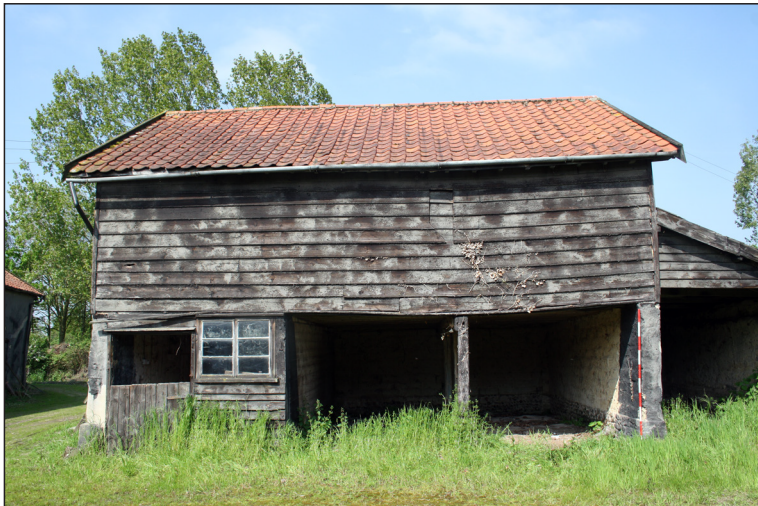
- Plate 11 Front Elevation of the barn showing weather boarding.
- Plate 12 North-west oblique photo showing the two storey hay loft and cart store
- Plate 13 South-west oblique elevation of the barn

Plate 11. Front elevation of the barn showing weather boarding.

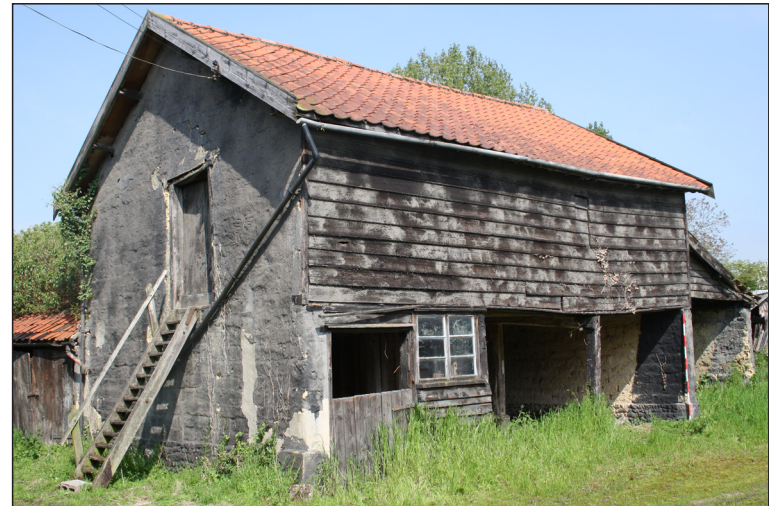
Plate 12. Front elevation of the barn showing the two storey hay loft and cart store. Facing north-west

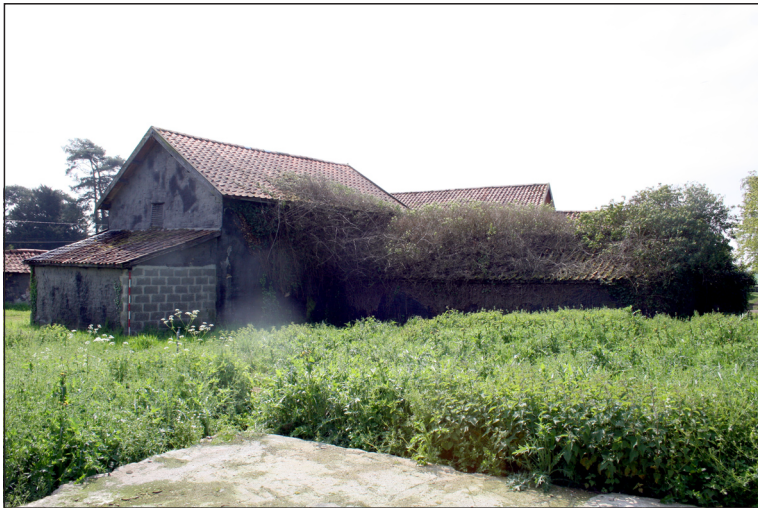
- Plate 14 North elevation of the barn
- Plate 15 South-east oblique shot of the barn. Shows the back of the single storey cow shed and two storey hay loft and cart shed

Plate 15. South-east facing view of the barn.

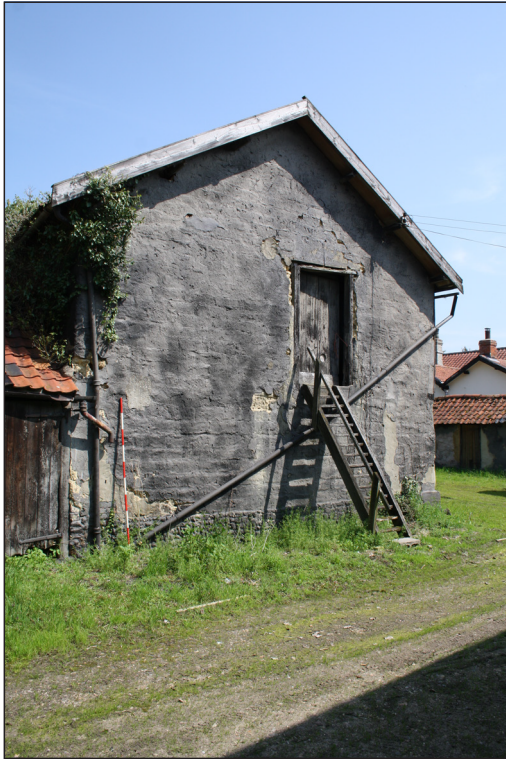
- Plate 21 Due to space constraints a complete, flat elevation photograph was unattainable therefore a slightly oblique photo of the southern elevation of the two storey part has been taken. This shows the steep stairs and entrance into the hay loft

Plate 21. Southern elevation of the two storey part of barn. Facing north-east.

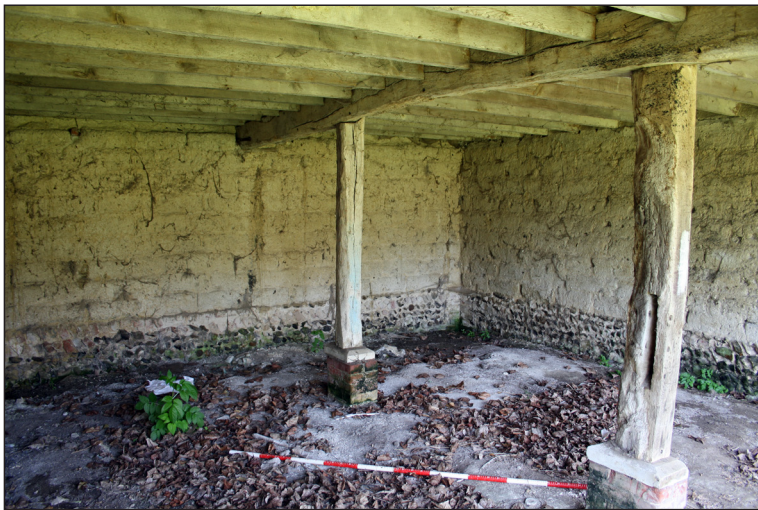
- Plate 27 Interior of cart shed
- Plate 28 Reused post. One of two posts and the central beam all showing signs of reuse
- Plate 29 Evidence of axe and adze marks on the principal beam and posts

Plate 27. Interior of cart shed.

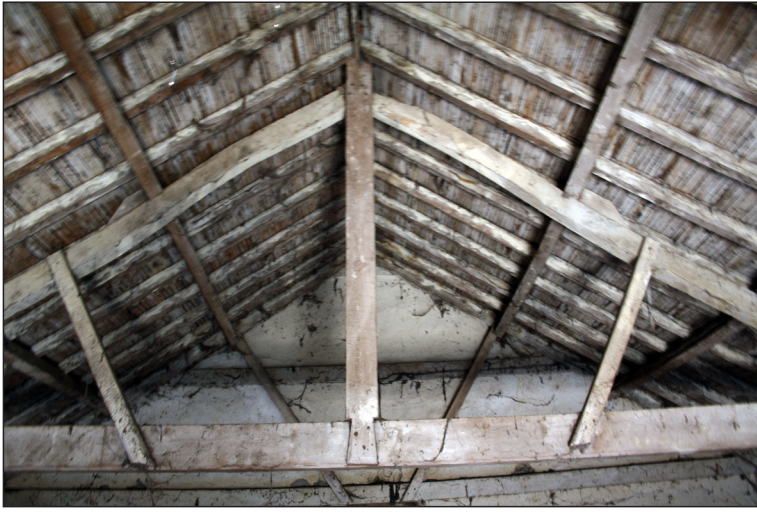
Plate 40. The hayloft roof.

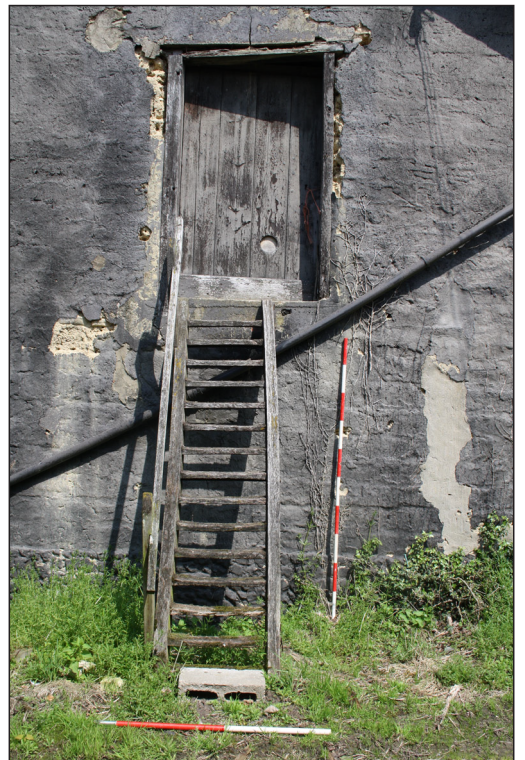
Plate 43. Hayloft door and stairs.
