**NORFOLK ARCHAEOLOGICAL UNIT**

Report No. 1035

**Report on Historic Building Recording at  
Holly Farm Barn, Reedham, Norfolk**

Location: Holly Farm, Holly Farm Road, Reedham  
District: Broadland  
Grid Ref: TG 4270 0155  
HER No: 11580 RED  
Date of work: 17th October 2004

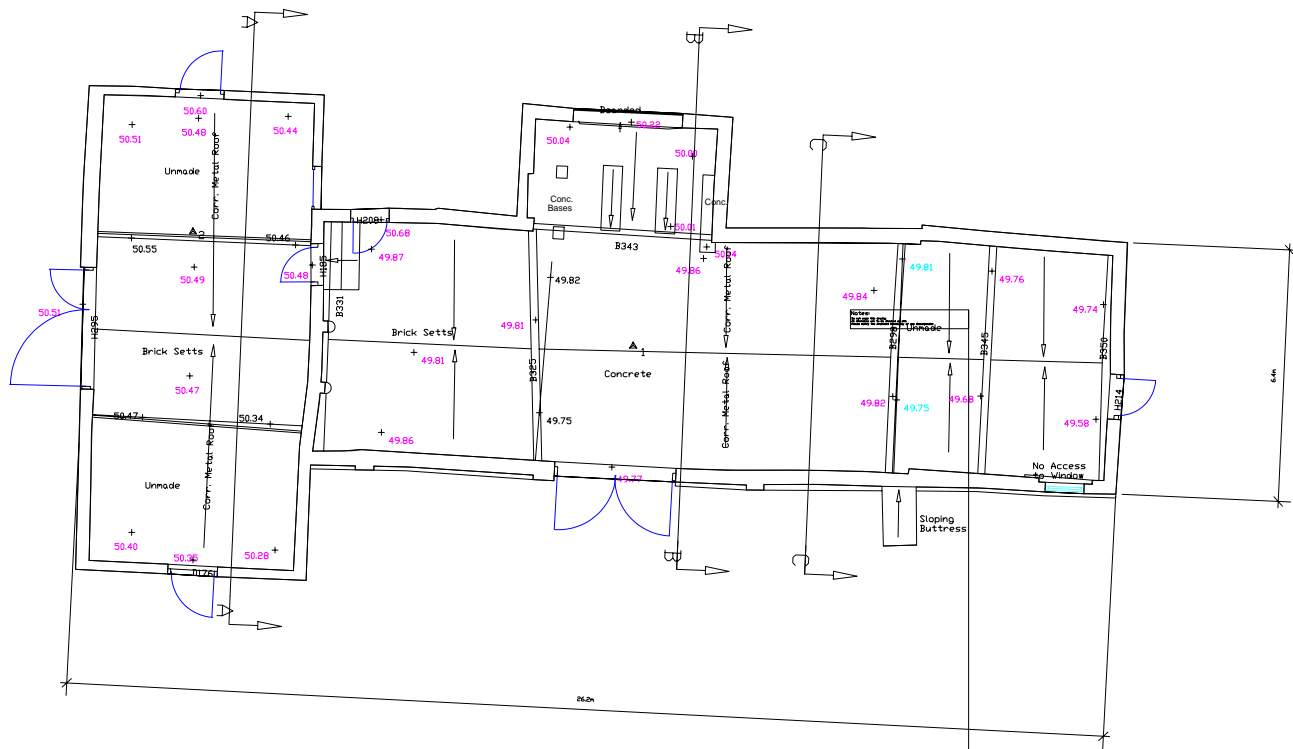
Figure 2. Plan of barn. Scale 1:125

The barn is aligned east-to-west and lies on the northern side of Holly Farm Road, immediately east of the farmhouse. It is a red brick structure measuring 21m x 6.5m in plan (Fig. 2) with a later north-to-south aligned brick extension measuring 12m x 6m at the western end and a projecting cart porch measuring 5.5m x 3m on the northern side. There is a large cart door west of centre in the south wall which is in line with the cart porch at the north. The timber roof is of steep pitch and currently clad in corrugated asbestos sheets. The western gable is of brick with brick coping and the east gable is weatherboarded.

The west gable leans at a noticeable angle to the east and the roof is similarly racked in that direction. There is a large sloping brick buttress supporting the south wall at the point where the removed wall would have met it at the original south-east corner. The later rebuilt sections of the south wall also incorporate shallow buttresses. This all suggests either that the earlier east wall was demolished which caused the racking and other structural problems or that the east gable failed, causing the west gable and roof to rack. Thereafter the opportunity was taken to
