**A Level 2 Historic Building Recording Survey at
Creake Abbey Farm, North Creake, Norfolk.**

July 2010

Location: Creake Abbey Farm, North Creake, Norfolk
District: King's Lynn and West Norfolk
Grid Ref: TF 856 395
OASIS Ref.: 79418
Client: Mr Anthony Scott
Dates of Fieldwork: 24 June 2010

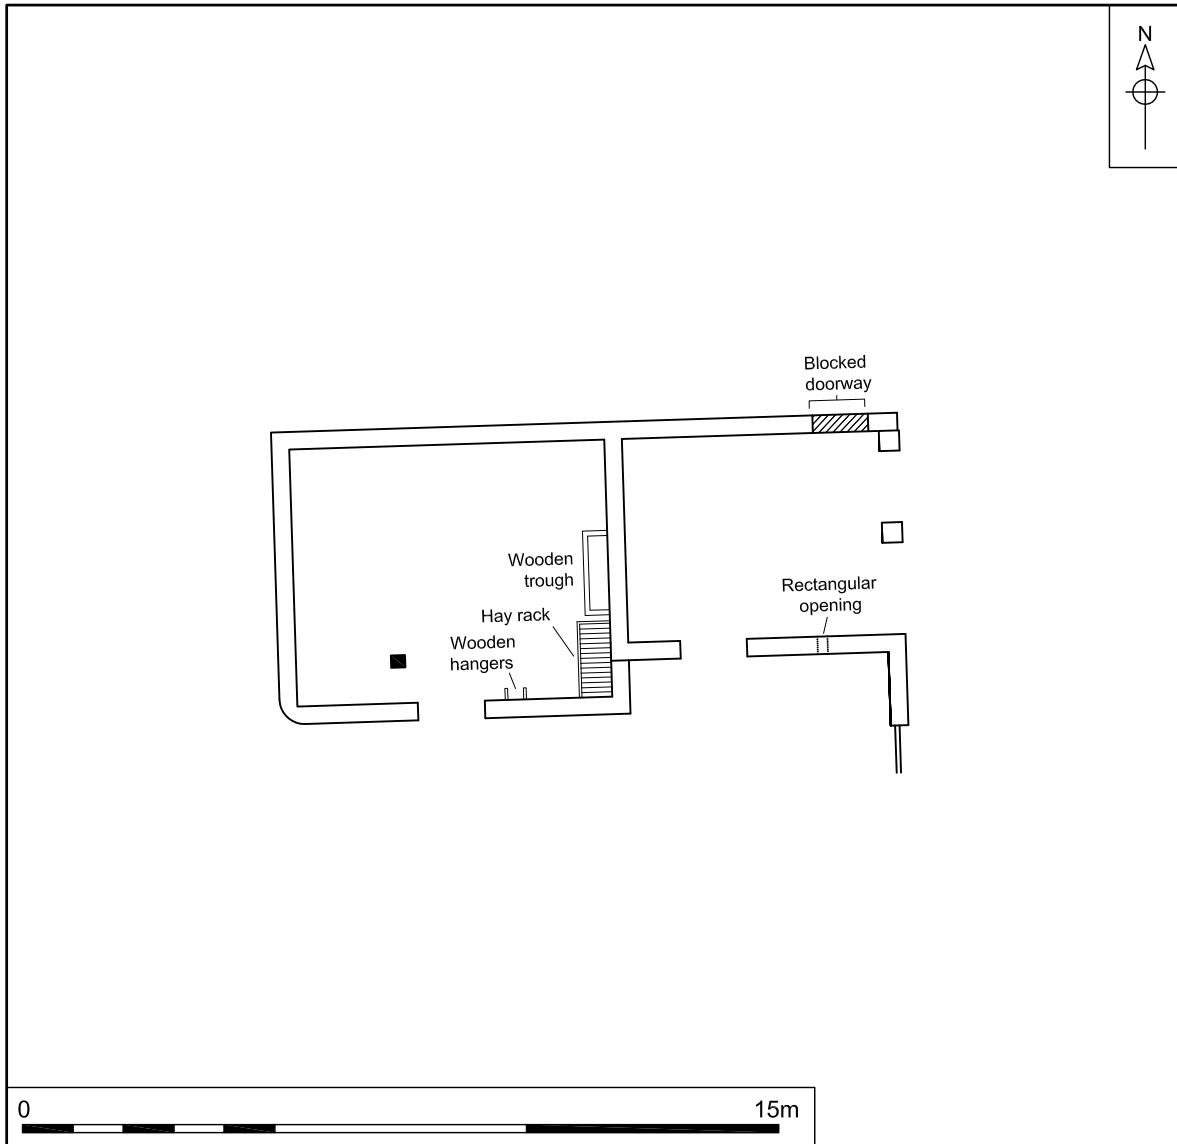
Figure 3. Plan of Building B1. Scale 1:150

Building B1, a rectangular structure, formed the northern limit of the yard projecting west away from the north-western corner of Building B2 at a right angle on a roughly east - west alignment (Plate 1). It had a length of 12.1m and width of 4.74m and was constructed of un-coursed flints in a lime mortar with soft red brick dressings. Numerous brick headers were also dispersed throughout the walling as well as fragments of shelly, yellowish white limestone some of which obviously had been moulded and presumably came from Creake Abbey to the north. The western elevation was gabled while its rounded south western corner appeared to have been adapted to allow the entry of farm machinery and equipment into the yard without damage to the structure (Plate 2). Internally there were two independent cells separated by a flint and brick cross wall near the centre of the building. The eastern cell was the slightly smaller of the two and was accessed from the southern wall via a door just to the east of the internal cross wall. A second door had clearly been provided in the eastern end of the northern wall but had subsequently been in-filled using modern brick (Plate 3). The eastern wall probably belonged to Building B2 but had in any case been taken down to allow entry to the northern cell of Building B2 to the east with modern brick pillars providing the necessary structural support to the roof (Plate 4). The remaining walls had been whitewashed and a concrete floor installed but little else remained to indicate its function. One slightly unusual feature was a small square opening towards the centre of the southern elevation just beneath the eaves into which a small section of a log had been inserted presumably to block it up. The remnants of a small pen constructed of concrete and wire fencing were visible just outside the eastern cells entrance (Plate 1).

The western cell had been extended to the south by approximately 1m and the roof carried on over this extension as a cat slide above a dentil cornice (Plate 1). At the centre of the southern wall of this extension a wide doorway provided entry to the interior from where a wooden hay rack was observed to be attached to the southern corner of the eastern wall (Plate 5). A little further to the north it was accompanied by a wooden trough that rose upon posts from the concrete floor. Immediately to the east of the entrance two wooden pegs were set into the southern wall upon which equipment might be hung (Plate 6). As with the eastern cell all the walls had been internally whitewashed.

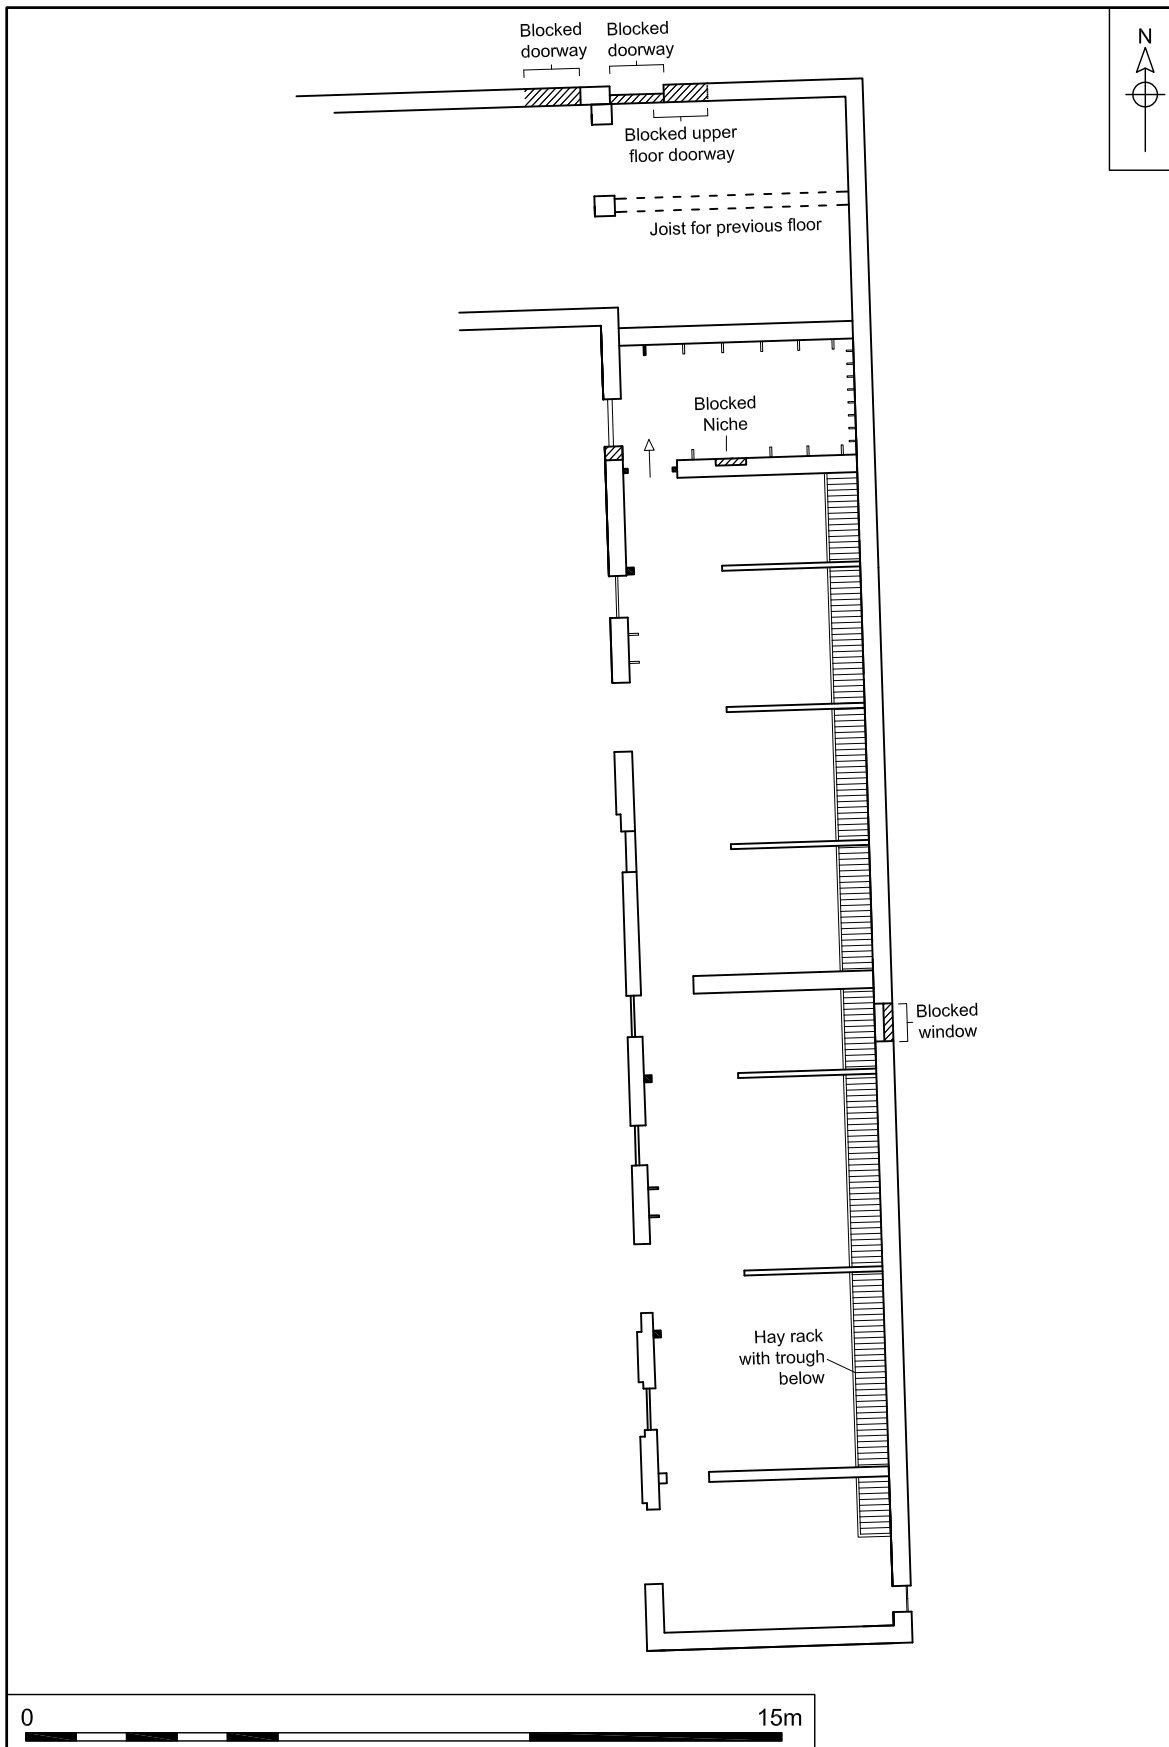
Figure 4. Plan of Building B2. Scale 1:150

Building B2 was the largest of the structures surveyed and measured some 31m long and 5.3m wide with a north-east alignment that demarcated the eastern extent of the yard (Plate 7). Its construction was similar to that of the previously discussed building but, excluding the dressings, there were very few bricks used in the external walling. Internally the walls were constructed quite differently however with flint and brick headers set in courses on the diagonal in almost equal proportions using a lime mortar which was then finished with a coat of whitewash (Plate 8). The roof, hipped to the south and gabled to the north had a covering of red pan-tiles with a ridge ventilator at the southern end. Numerous repairs and alterations had clearly been made to the building in particular to the southern wall where the quoins had been rebuilt in modern brick (Plate 9). Three doorways were arranged along the western elevation, two within the southern third and the other towards the centre although the evidence suggests this may not always have been the case. Six rectangular windows were located at regular intervals across the same elevation but it is likely that at least three of these began life as a doorway. The eastern elevation contained just two small, high windows, one at the southern end and a second towards the centre however the latter had been blocked up while the former looked at least from the interior as if it was a later addition (Plate 10). Proximity to the river and vegetation prevented closer external examination. The northern elevation was gabled with two doorways in the western half, one on ground floor and a second at first floor height (Plate 11). Both had been bricked up at some point in the 20th century. The portion of walling to the west of the upper doorway was the only external area of Building B2 to contain any significant quantity of brick and was almost certainly rebuilt, perhaps upon the insertion of the first floor doorway which did not fit comfortably into its space.

The northern end of the building shows perhaps the most evidence of adaptation within Building B2 and was probably built as a rectangular room 7.1m long with a doorway for cattle at the southern end of the west wall perhaps flanked by a window to the north (as in Figure 4). In the northern elevation a second door for human access was located to the west with the western wall being almost certainly continuous at this time. The insertion of the northern cross-wall reduced the length of the room by 2.3m and also took away its cattle entrance. It is possible that at this time the western wall was taken down to retain access to the yard via Building B1. At some point an additional floor was installed in the roof space which required punching out a new doorway in the upper gable and the installation of a cross-joint to take the floor boards. Such a floor would probably be used to store feed to keep it clear of the damp ground and reduce spoilage. The subsequent removal of the first floor led to the blocking up of the upper doorway. The blocking of the lower doorway must have taken place after the removal of the western wall, thereby re-establishing access to the cattle yard. The small room to the south created by the insertion of the northern cross-wall looks very much like a tack room and this in combination with the height of the hay racks and width of the stall divisions suggests that the buildings function changed from cattle shed to stable.

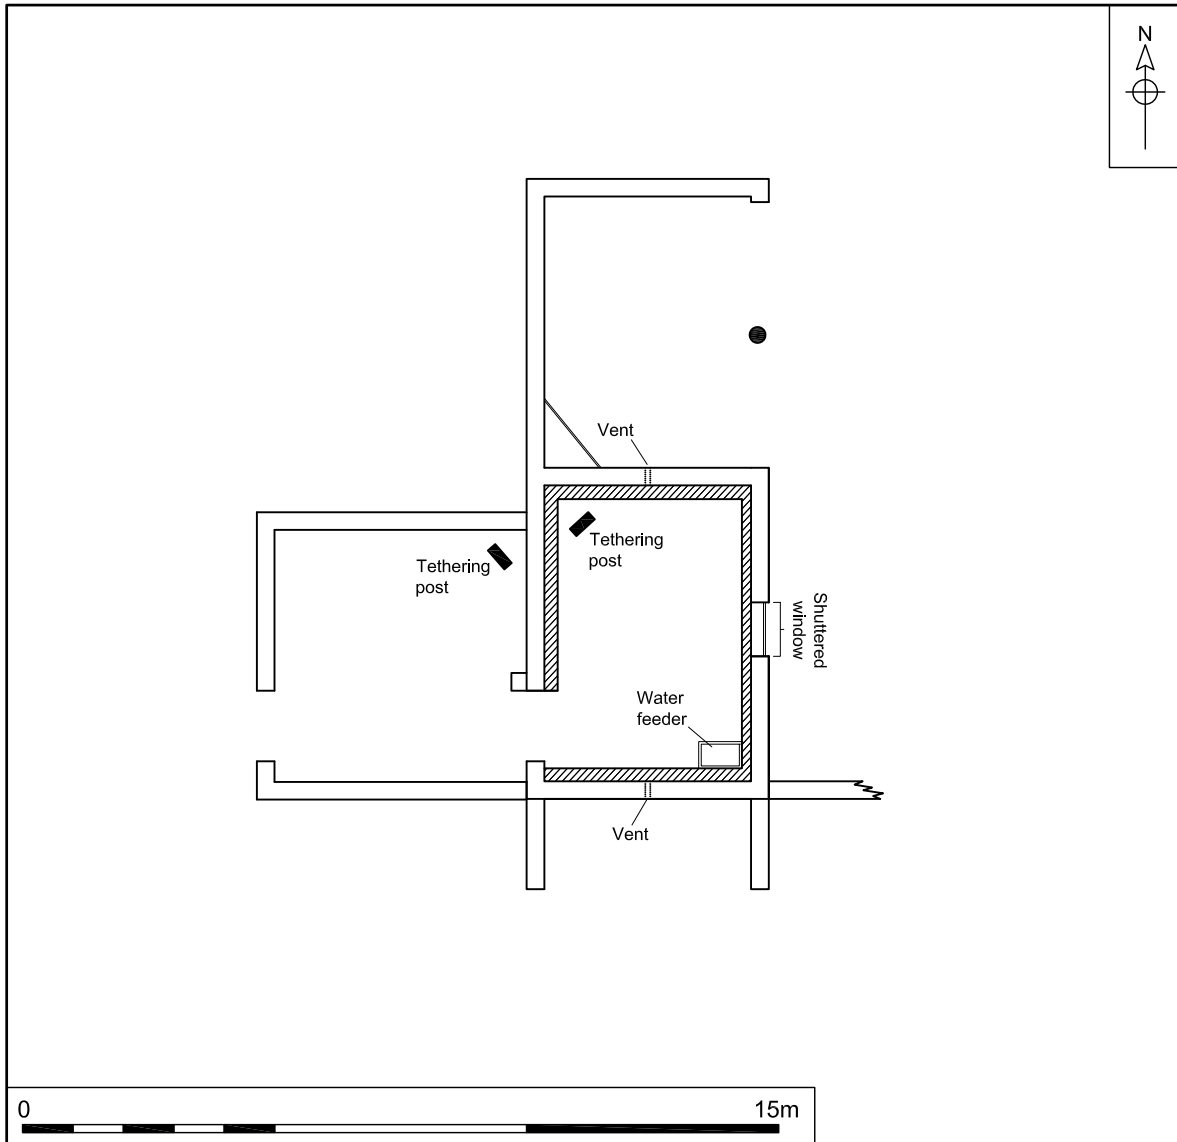
Figure 5. Plan of Building B3. Scale 1:150

Building B3 was of rectangular design 12.3m long and 4.8m wide on a north - south alignment forming the south-western boundary of the farm's eastern yard (Plate 20). It was constructed of the same materials as Building B1 excepting the upper gable to the north which was of corrugated iron (Plate 21). Two modern triangular concrete buttresses projected from the southern wall no doubt providing additional support where necessary (Plate 20). A central flint cross wall divided the structure into two distinct and roughly equal spaces between which there was no direct access. Entry to the southern cell was provided by a wide doorway located at the southern end of the western elevation with a second doorway in the centre of the eastern elevation having been converted into a shuttered window (Plates 22 and 23). Ventilation slots were visible in both the apexes of the southern gable and the cross wall while a sturdy tethering post stood in the north-western corner (Plates 24 and 25). Concrete blocks had been used internally to reinforce each of the four walls up to the wall plates and a steel water feeder sat in the south eastern corner upon a concrete floor into which drainage channels had been formed. A modern concrete pen approximately 5m square had been constructed externally projecting from the western elevation with a second tethering post positioned in its north eastern corner (Plate 22). The northern cell was open to the east with a single wooden post supporting the wall plate at the centre point. A diagonal low partition had been erected in the south-western corner as a hay feeder while the floor appeared to be of dirt, although a significant quantity of manure lay upon it (Plate 26). As with the other structures the roof was covered in red pan-tiles.

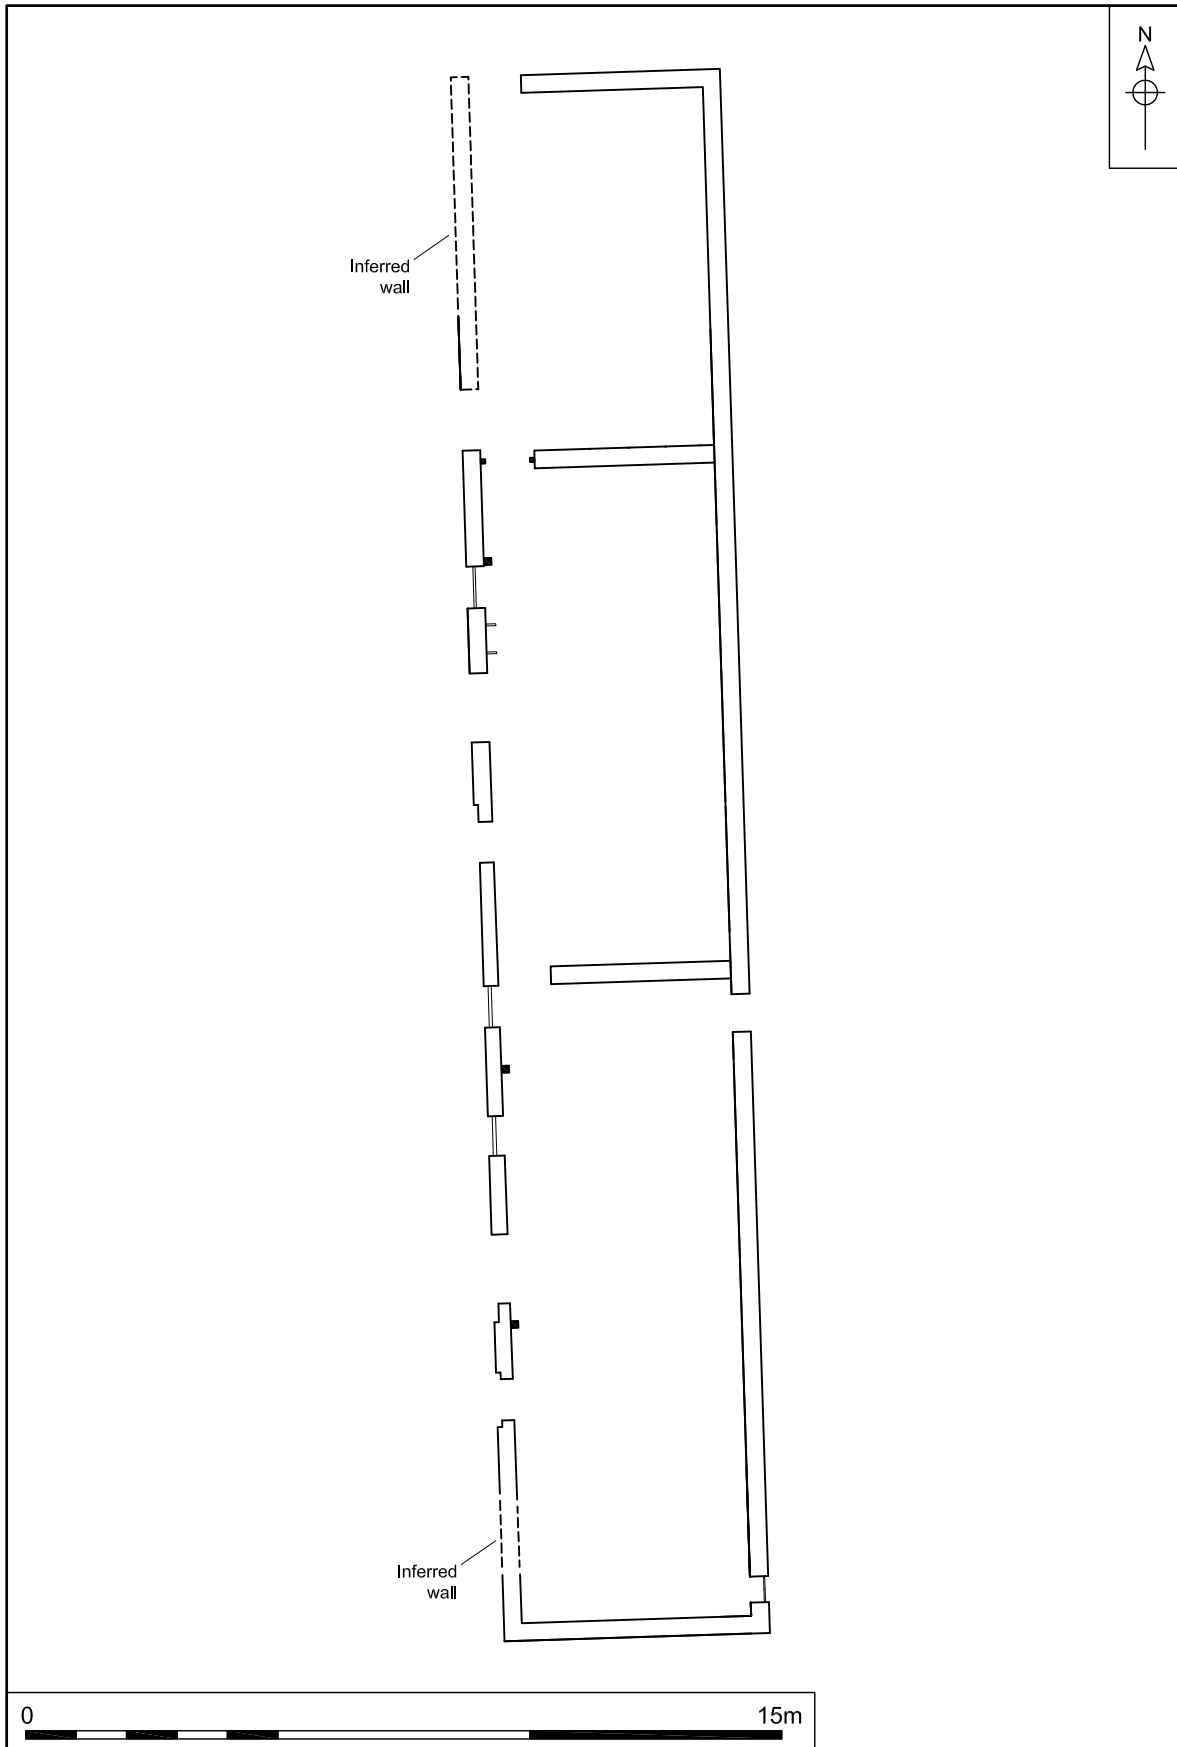
Figure 6. Building B2, original plan form 1. Scale 1:150

Building B2 has evidently undergone numerous alterations since its construction; two probable plan layouts based upon the surviving evidence can be surmised. The first is of three cells divided by the two current central walls leaving two larger southern cells and a third slightly smaller room at the northern end into which the doorway in the northern gable opened (Figure 6). Such a design would have maximised the efficiency of feeding and mucking out the livestock. The second plan form is suggested by the original location of the doors with each doorway serving its own area separated by a subsequently-removed cross-wall (Figure 7). If the second-most southerly cross-wall is interpreted as a slightly later addition this would divide the building into five equal spaces each served by its own door and window. Such a design is often seen in 19th-century cattle sheds in Norfolk and it would explain the numerous original doorways which have been blocked up after the removal of these partitions, perhaps to improve efficiency.
