NORFOLK ARCHAEOLOGICAL UNIT

Report No.1066

**Historic Building Survey at Primrose Farm Barn
Shelton Green, Shelton, Norfolk**

May 2005

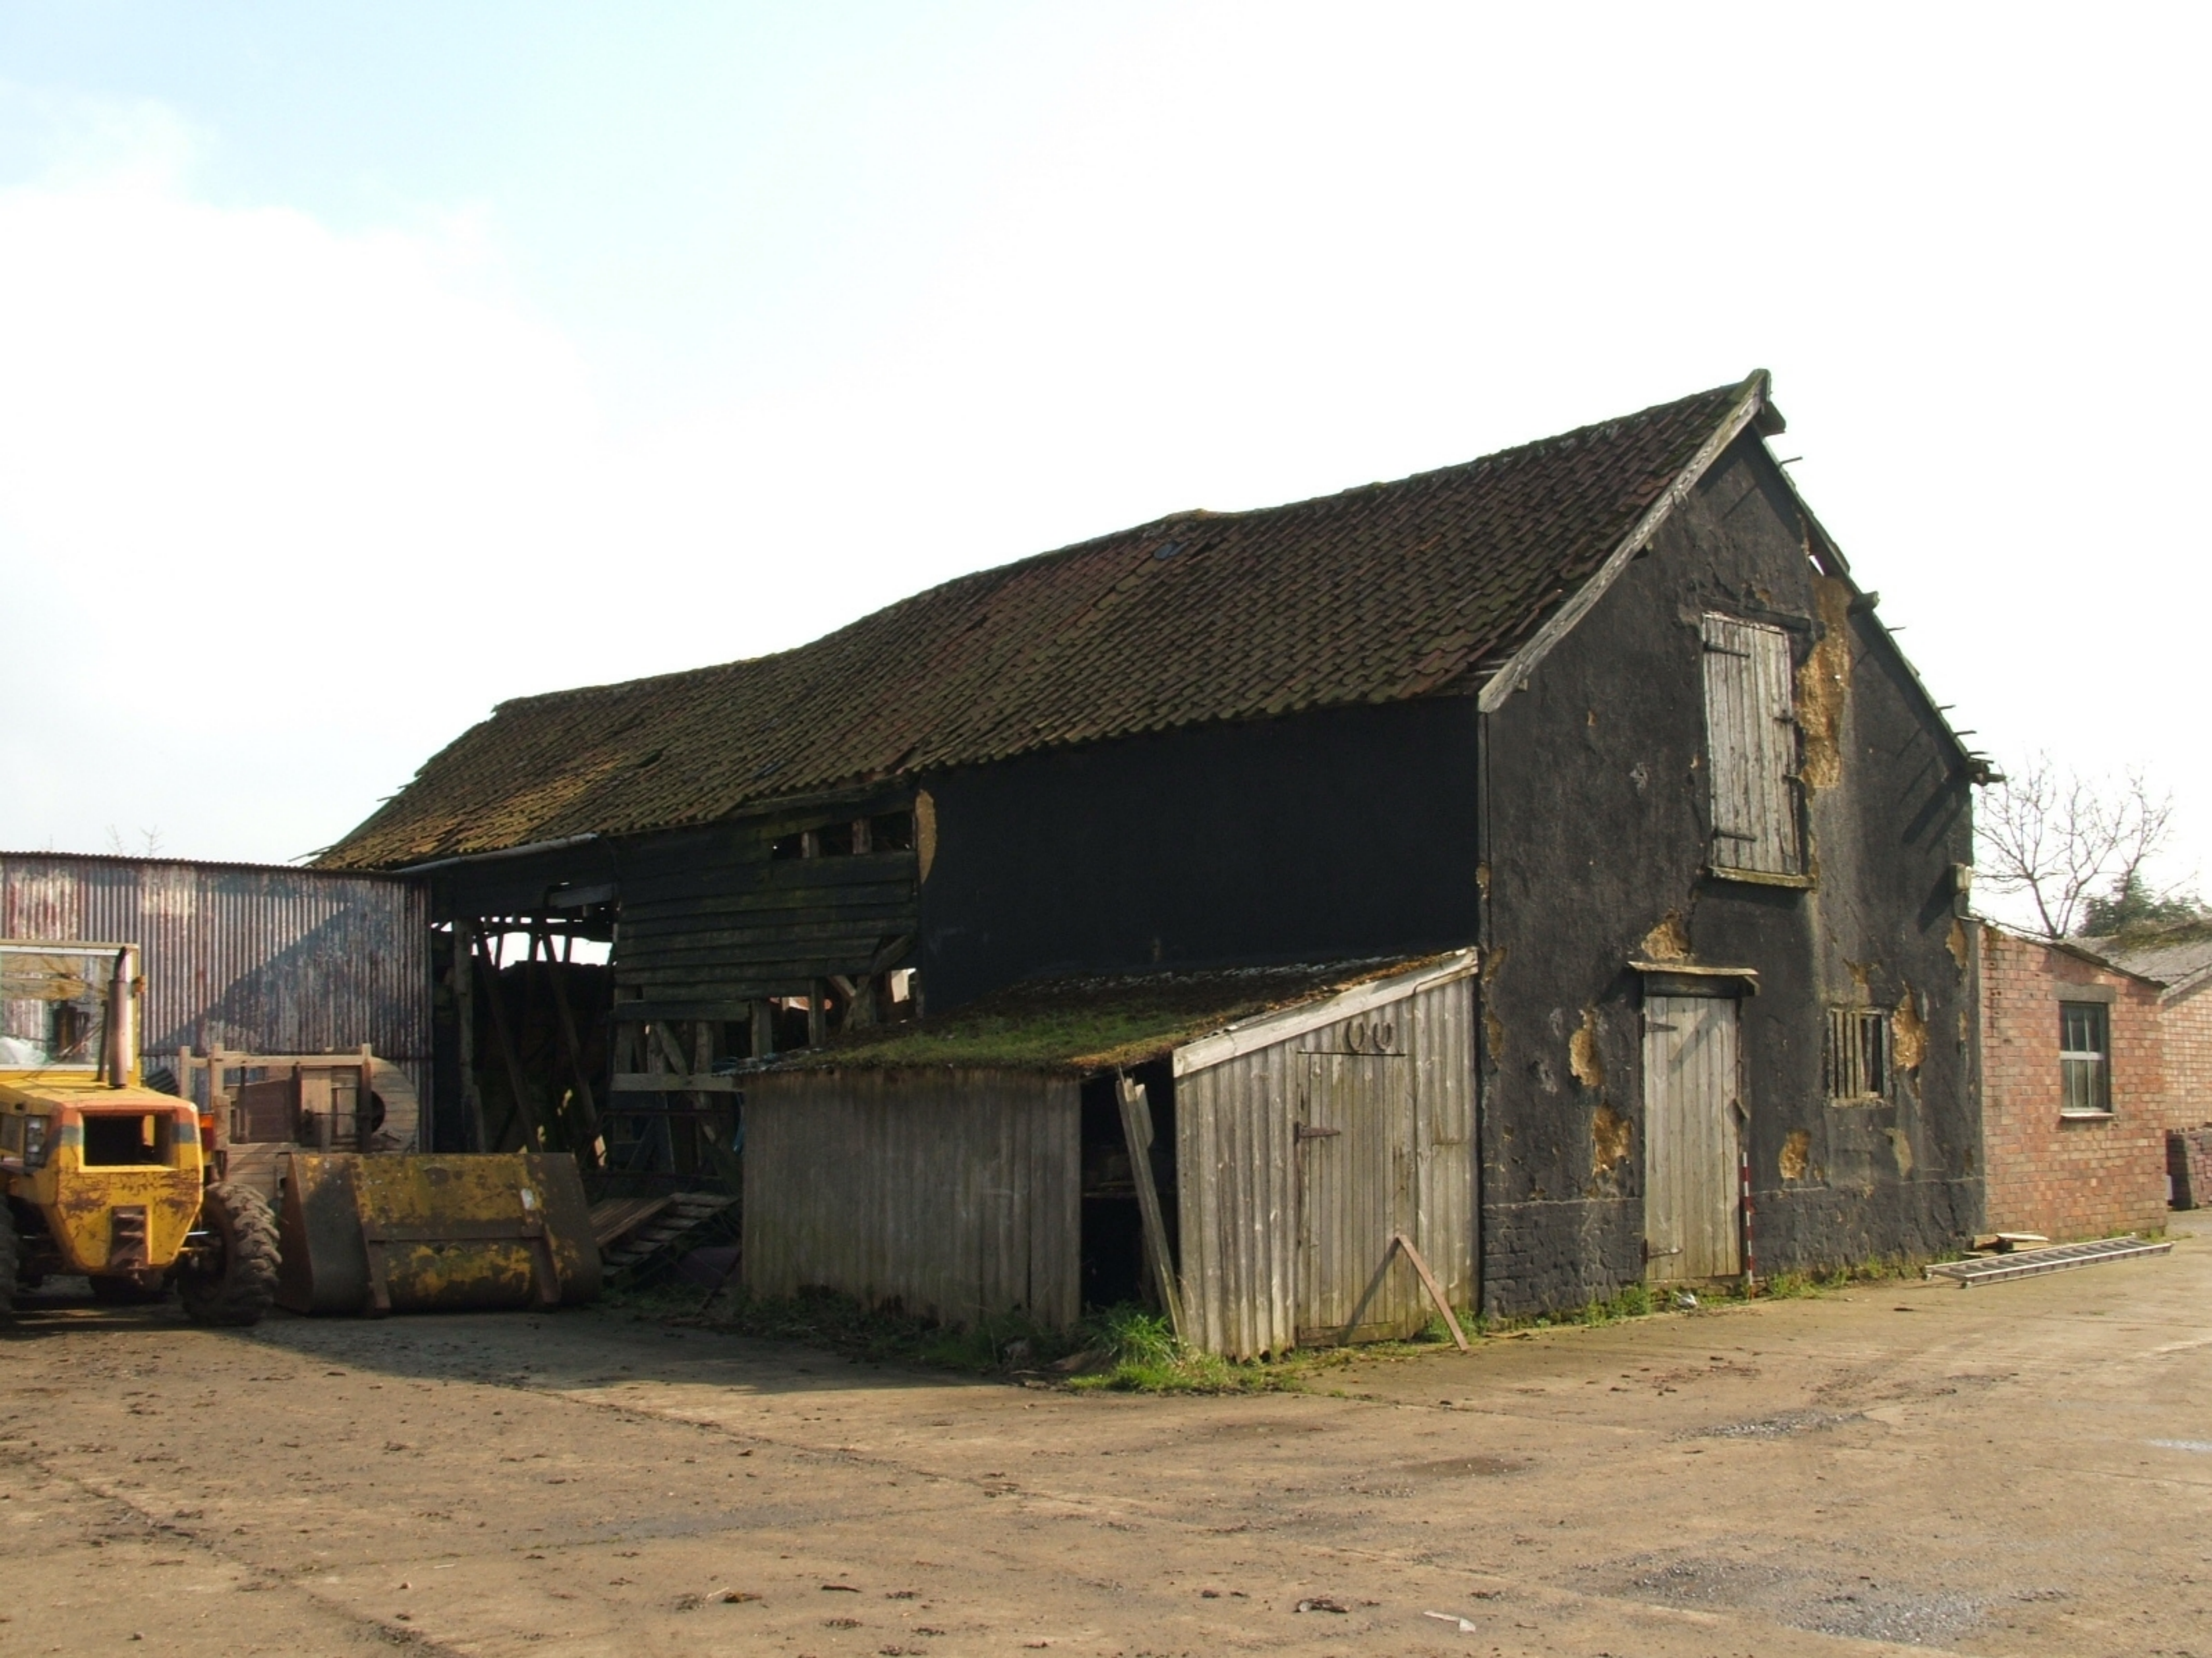
Plate 1. Exterior looking south-east

The barn (Plates 1 and 2) is situated north-east of the farmhouse and is aligned east-to-west. It is of timber-framed construction consisting of three bays (or steads) sitting on a low brick plinth, weatherboarded externally with pantiles cladding the roof.

The western extension (Plate 1) is constructed of clay lump on a low brick plinth; it is of the same height and width as the original barn and essentially extended the barn by an extra bay 5.5m long. It was probably constructed during the 19th

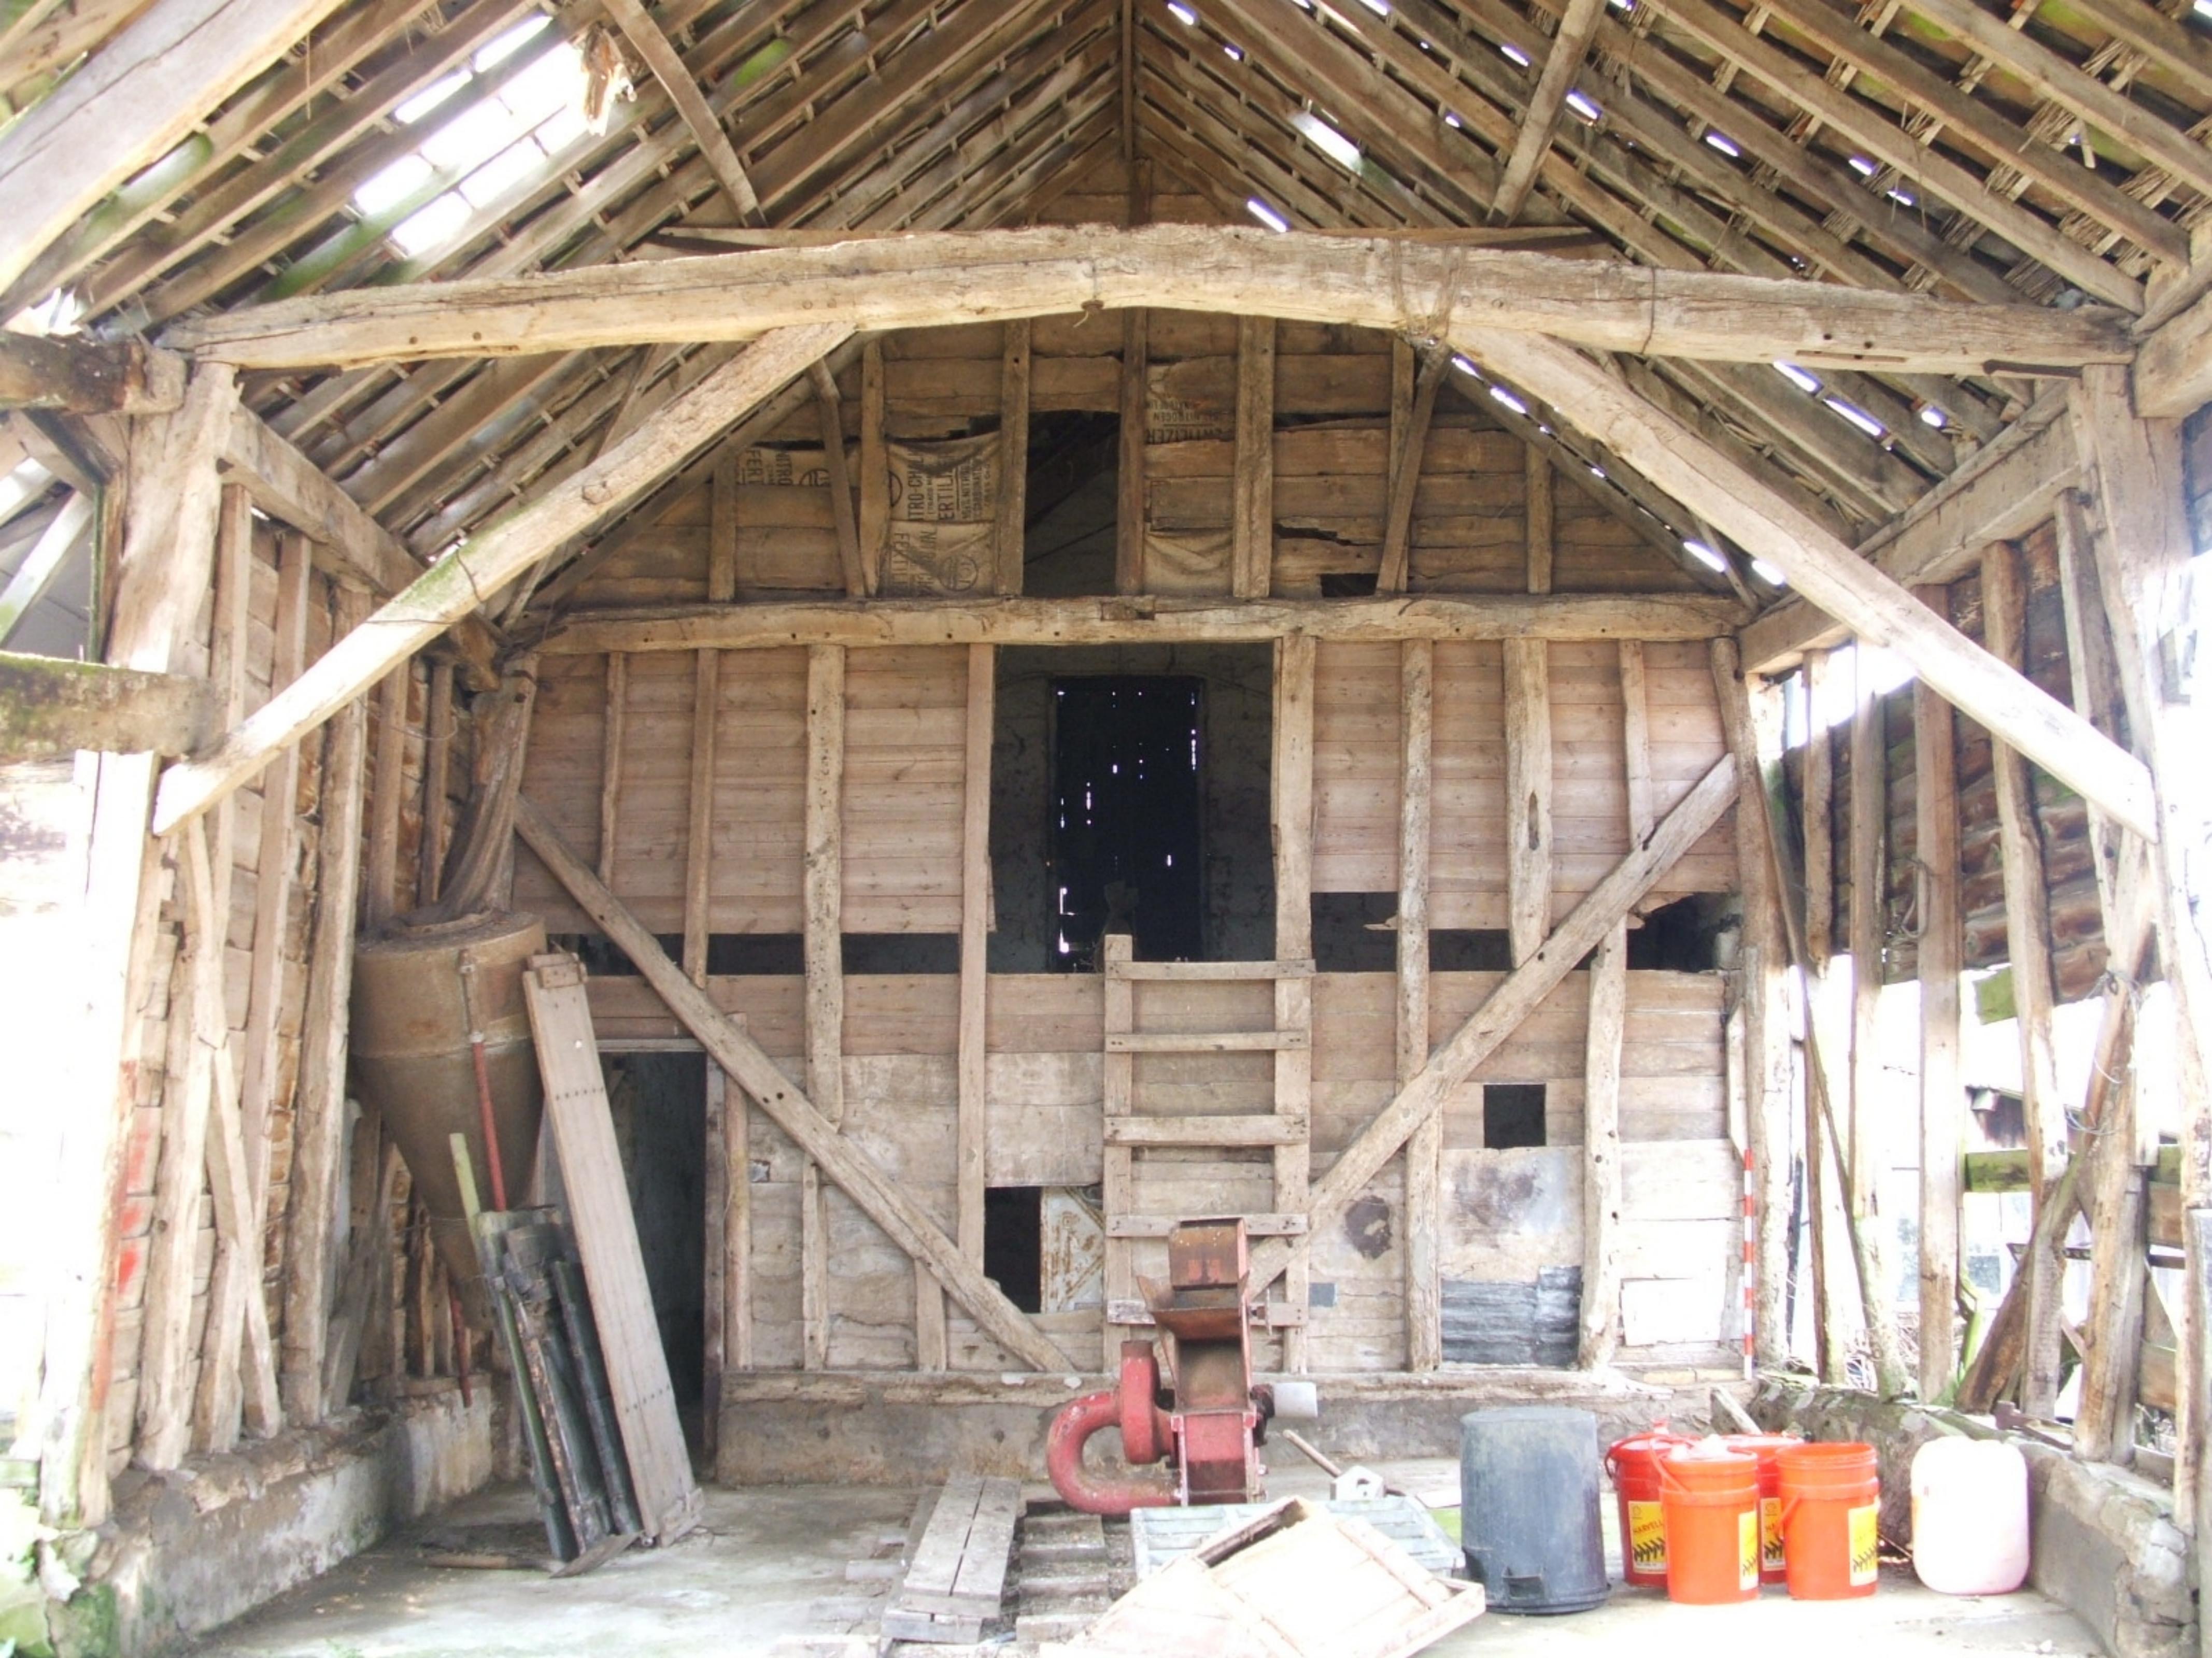
Plate 3. Interior looking west

reused. There is an opening in this wall below the tiebeam (see Plate 3) which gave access to the now missing upper storey of the west extension which was used as a hayloft (pers. comm. Laurence Bartrum).

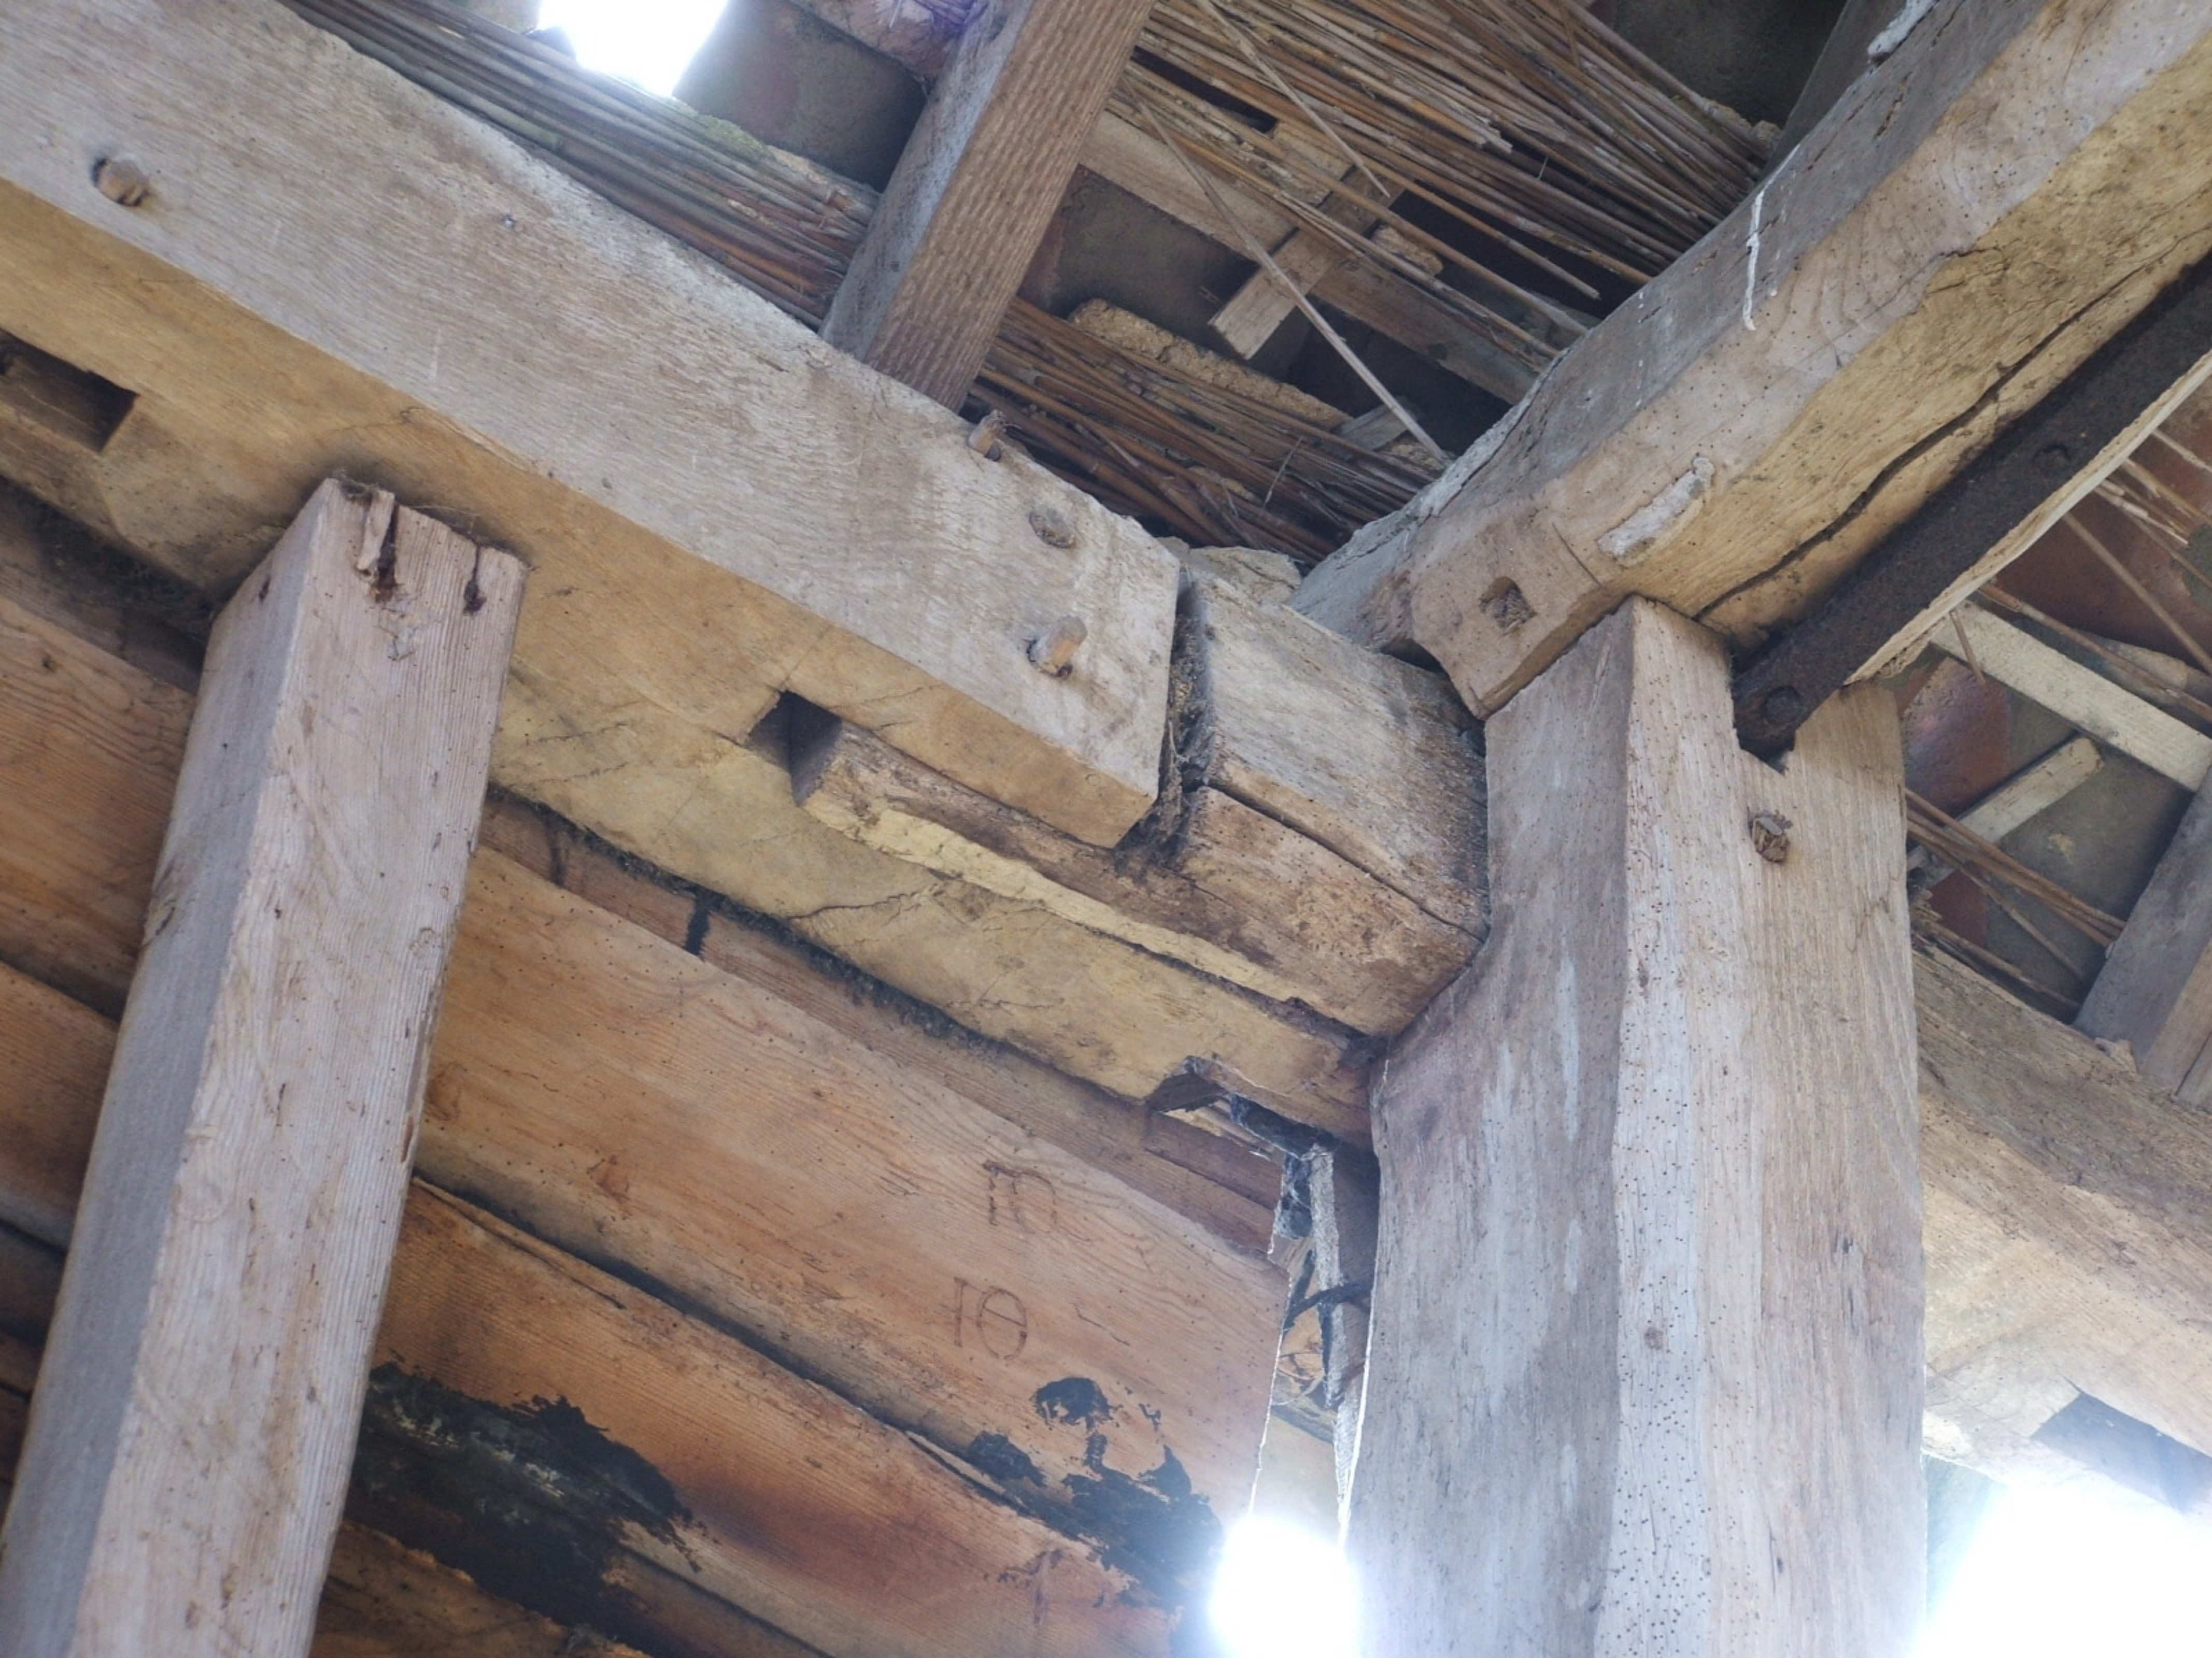
Plate 7. Scarf joint in south-east wallplate

There is a face halved and bridled scarf joint at the west end of the wall plate in the south wall of the east stead (Plate 7). This type of joint was first used in the 16th century, and became the dominant form of scarf in the 17th and 18th centuries. The studs in this section of wall have mostly been replaced, the west end of the wallplate and plinth here are missing and the main post and studs have dropped and been displaced slightly to the north.

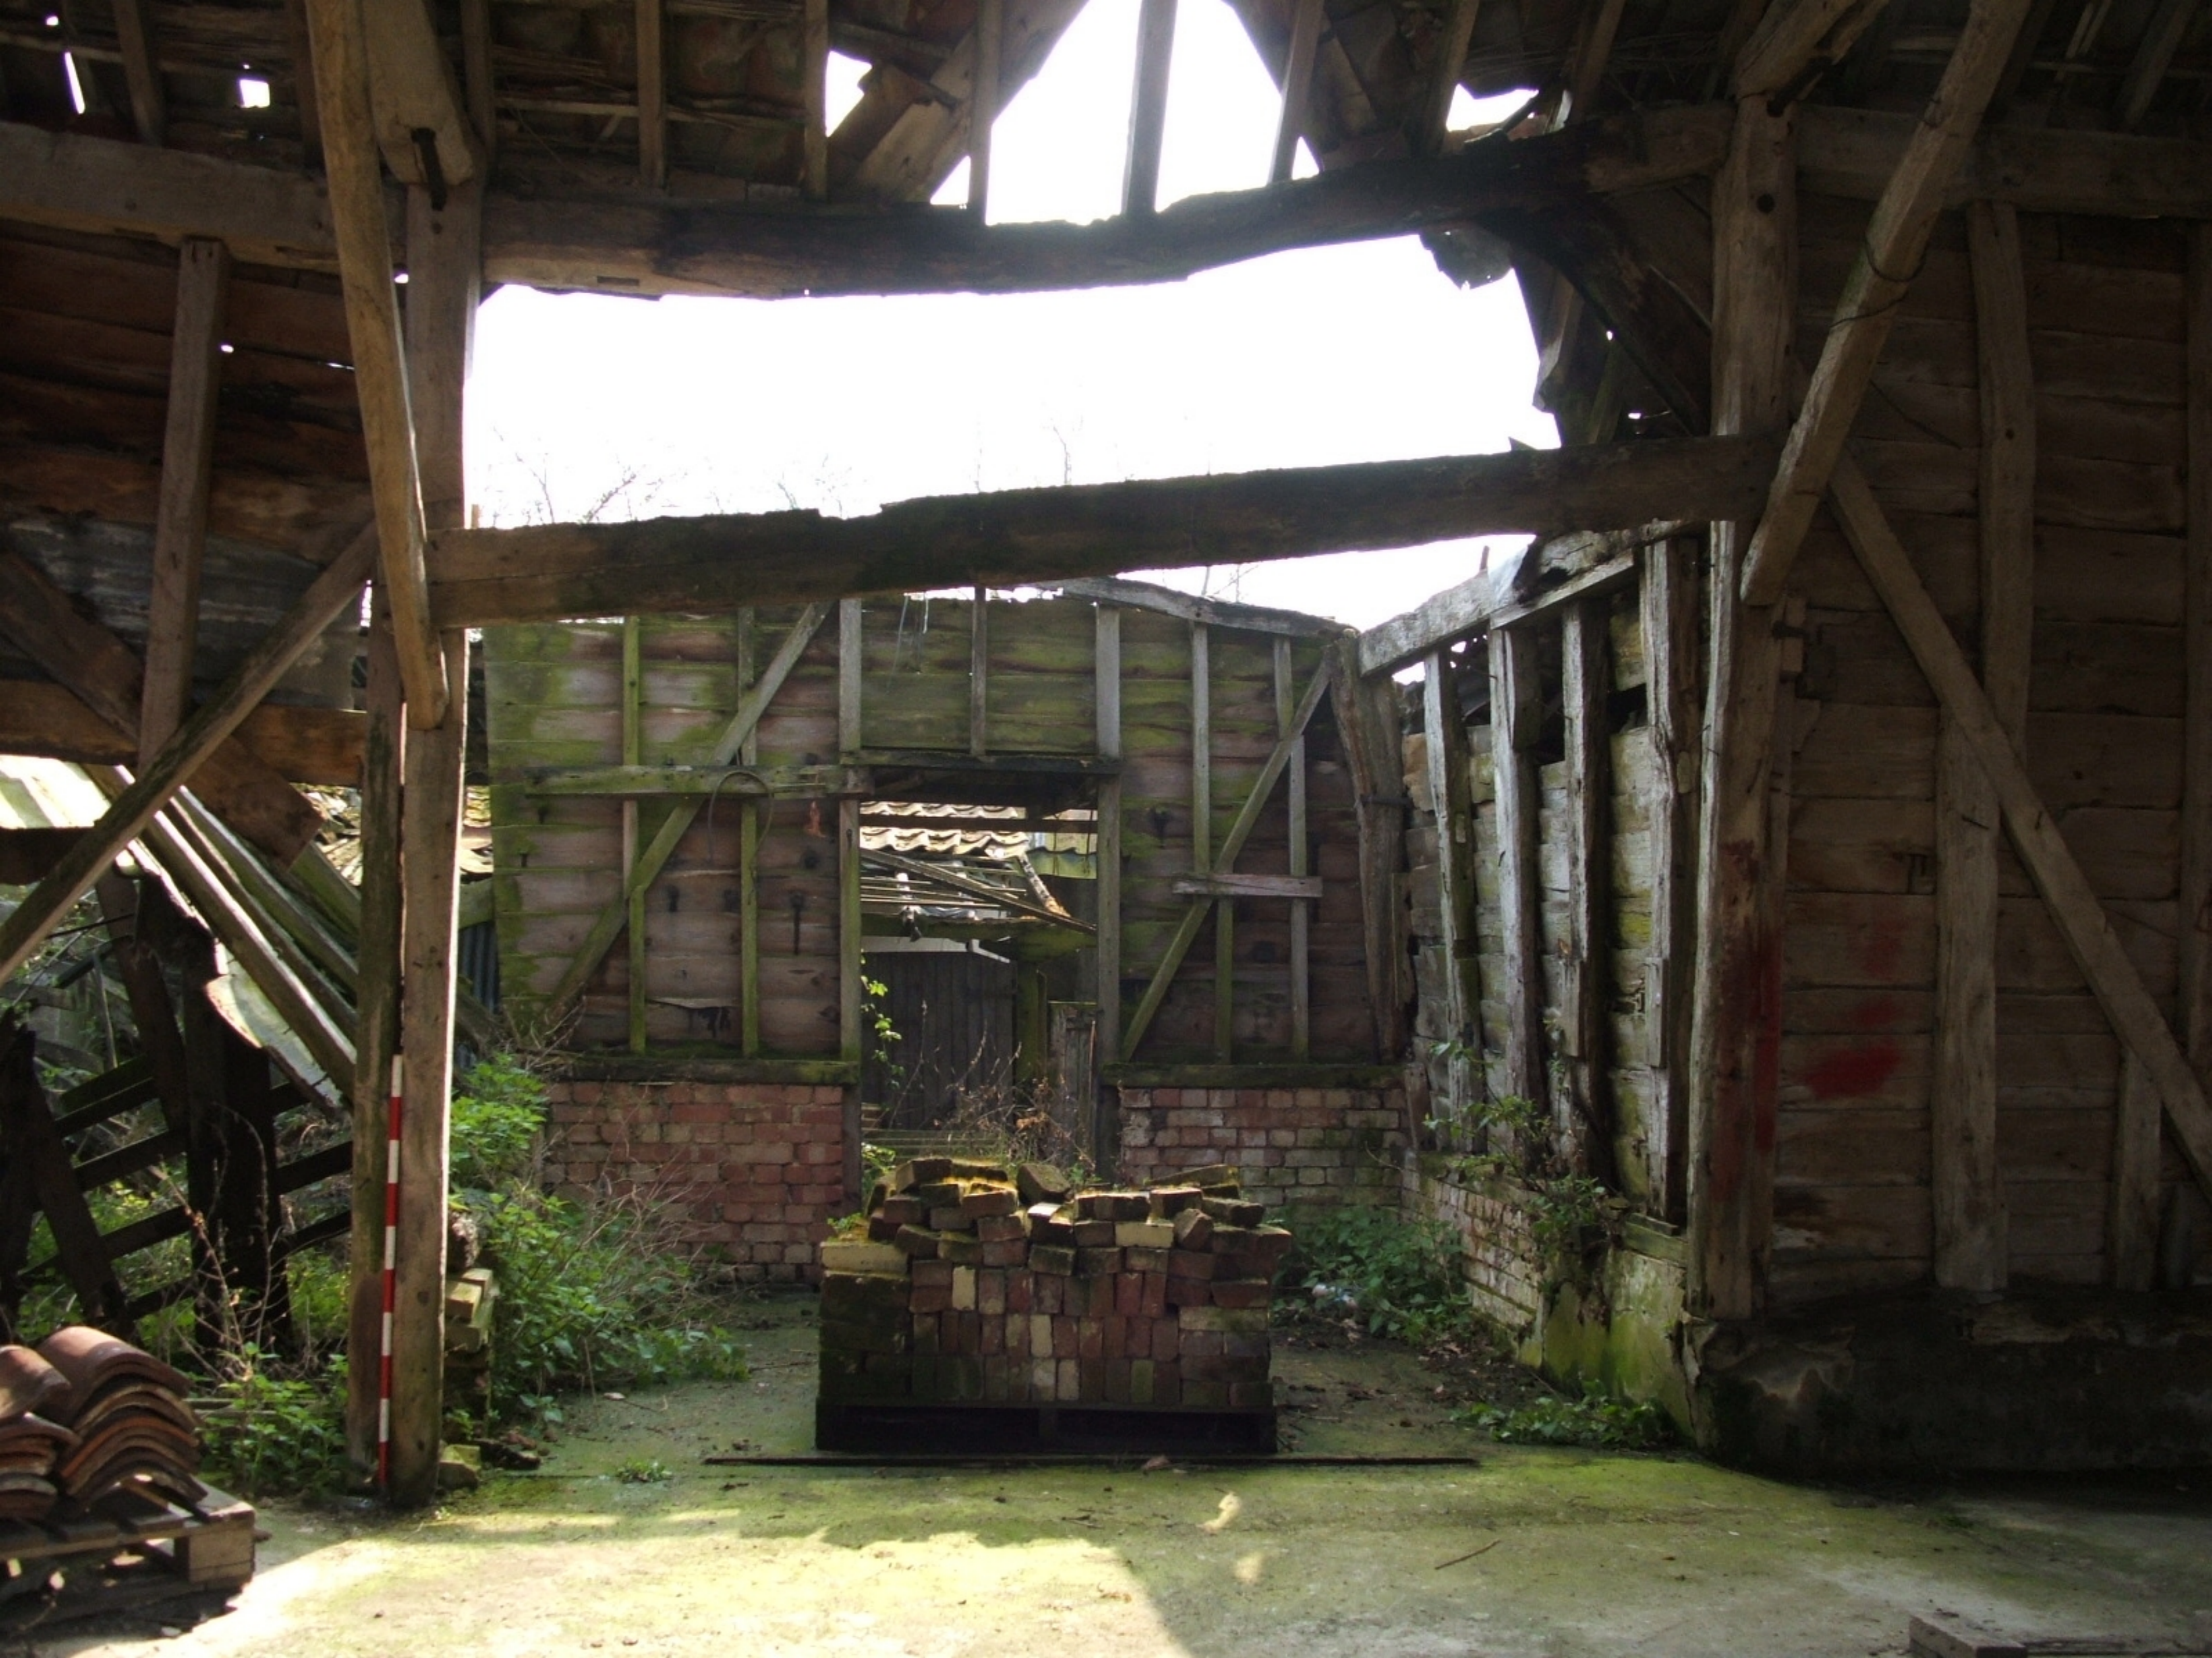
Plate 8. Porch looking south, 1m scale

The porch itself is 3.2m square in plan and extends south from the central bay it is timber framed and weatherboarded in a similar fashion to the barn (Plate 8). The roof is missing and the east wall has collapsed outwards. The porch walls are a metre or so lower than the barn walls. The wallplates of the east and west walls are mortised into the outer faces of the southern main posts of the barn trusses below the barn wallplates and supported by shorter jowled posts at the south corners of the porch. The jowled posts and the wallplates and studs of the east and west walls appear original. The studs are of larger scantling than those of the main barn and there is no bracing. The sillbeams and brick plinth walls, which are now at several levels, have been replaced in the 19th or 20th centuries.

The porch had a pitched roof. The north end of the ridgeplate and the short end rafters are still attached to the barn roof just above wallplate level, and two angled plates indicate the join of the porch and barn roofs (Plate 8).
