**An Historic Building Recording Survey at  
Ivy Farm, Stanhoe, Norfolk**

ENF125176

Prepared for  
**Strata Architectural Ltd.**

December 2010

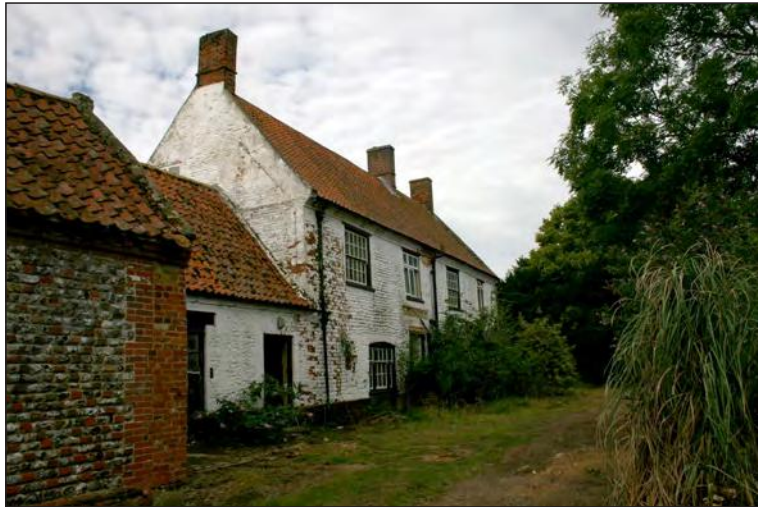
Plate 1. Building A, north elevation facing south-west

Building A was rectangular in design with a length of 17.35m and width of 6.68m (Figs 2 and 3). It had a red pan tile roof gabled to the east and west each surmounted by a red brick chimney (Plate 1). A third brick chimney rose from the ridge line approximately 5m to the east of the western gable end. All four external walls had been coated in white paint with a contrasting shallow plinth approximately 0.4m high and painted black extending around the base of each side. At the eaves to the north and south a moulded brick cornice had been applied in four courses using a much finer brick than that used elsewhere on the building (Plate2).

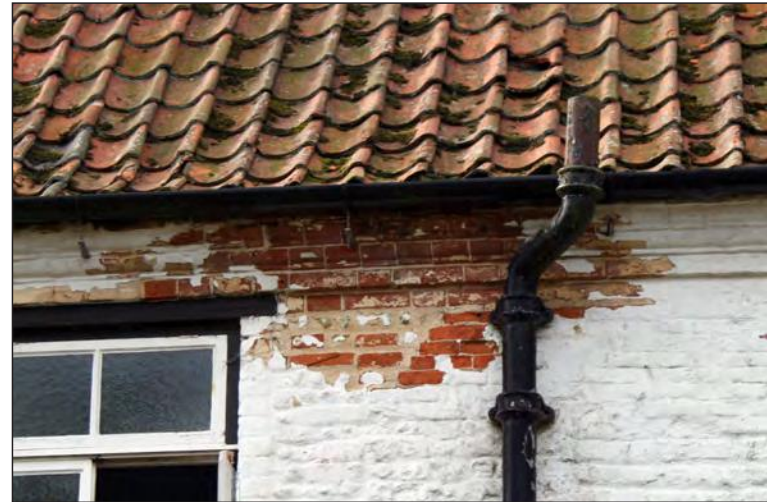
Plate 2. Moulded brick cornice on Building A north elevation

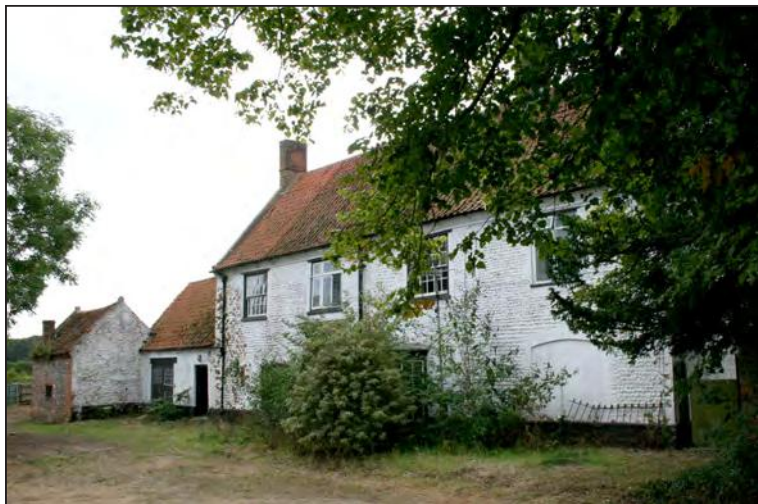
Plate 3. Building A north elevation facing south-east

The northern elevation constructed of coursed flint and brick constituted the main approach to the house and displayed four large rectangular windows evenly spaced across the façade's first floor giving the appearance of four distinct bays (Plate 3). The first and third windows (east to west) showed preserved sash windows of 10 over 10 lights, while the two remaining had been replaced with casements. Each window had brick jambs however those of the westernmost window differed slightly in character, and the opening was narrower than the other three perhaps suggesting an adaptation. On the ground floor a large canted bay window just to the west of centre must have dominated the elevation, although obscured by bushes at the time of the survey. It had a central sash of 8 over 8 lights with subsidiary sashes each side half this size. The front door stood to its east with traces of a removed porch visible upon the surrounding walls (Plate 4).

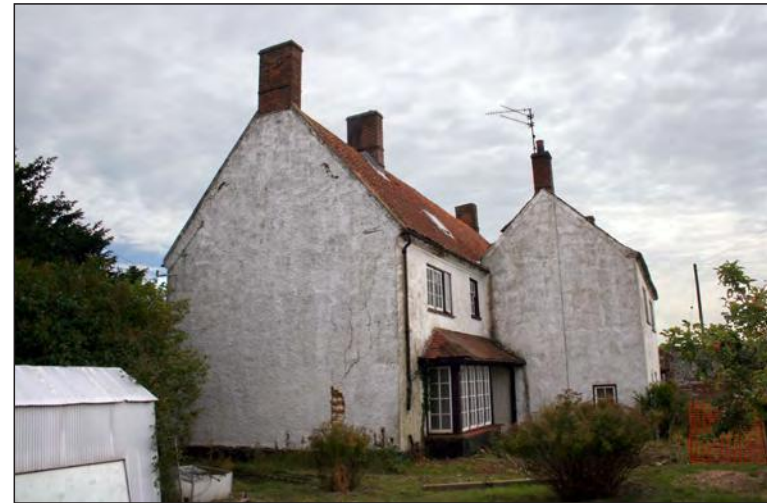
Plate 8. West elevation, Buildings A and B

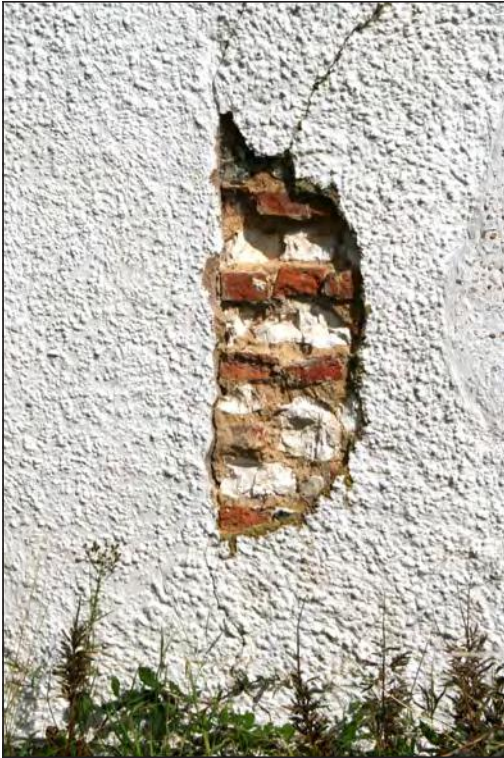
The western gable displayed no openings and a liberal application of pebble dashing prior to its coating in white paint obscured any evidence there might have been for such features. To the south a portion of render had fallen away revealing the wall's construction to be of alternating courses of brick and chalk in a lime mortar (Plates 8 and 9). In the gable above two opposing curved iron clamps evidently tied this wall back into the house.

Plate 9. Exposed walling on west elevation of Building A

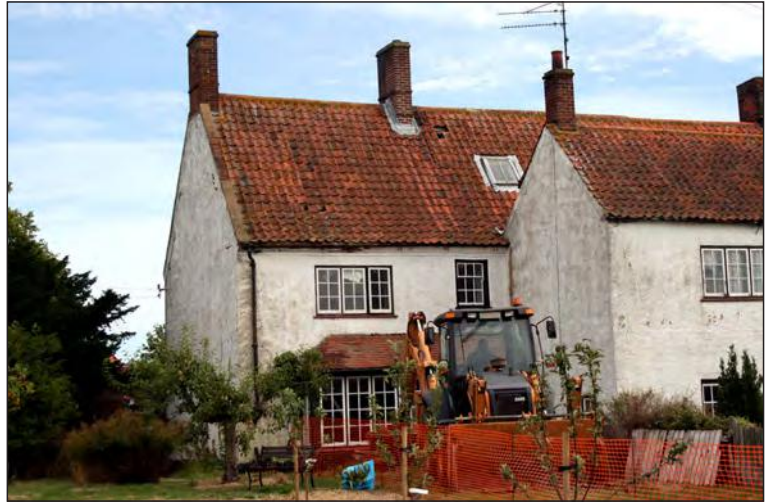
Plate 10. Southern elevation of Building A

design while above the bay window a more modern casement of three panels completed the fenestration (Plate 10). The eastern gable was again obscured by later buildings but externally the visible portions were of brick with a tumble-in pattern in the upper gable (Plate 11). By following the extent of this tumble-in design to the north it was clear that the pitch of the roof had been altered slightly. A clearly defined joint in the brick work indicated that the chimney stack above had evidently been widened. Both the first and second floors had rectangular modern casement windows to the south. Building C projected to the east under a gable roof.

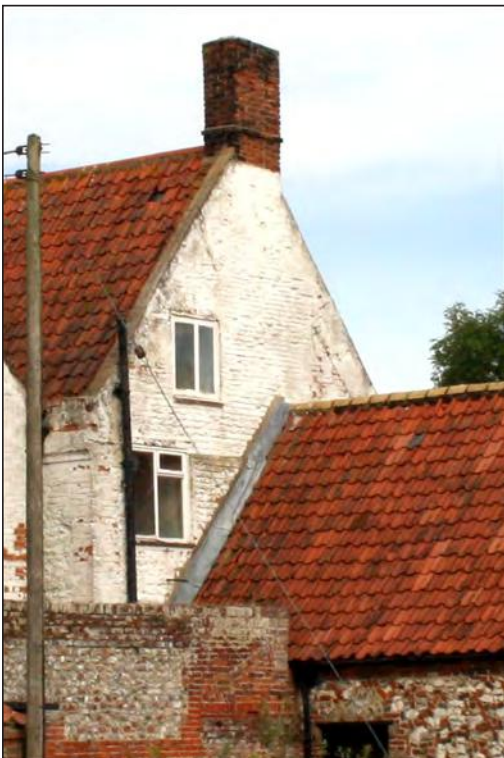
Plate 11. East gable of Building A showing tumble-in detail at eaves

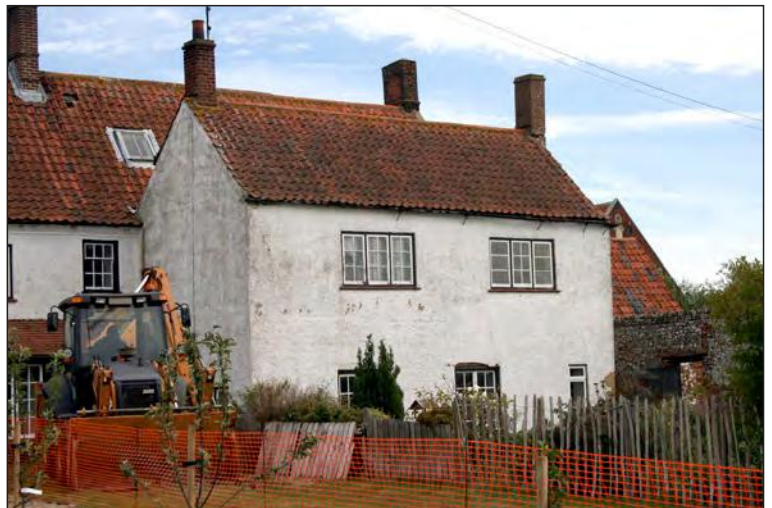
Plate 12. Southern elevation of Building B

Building B was a rectangular two storey extension appended to the eastern end of Building A's southern elevation (which served as its northern wall) (Figs 2 and 3, Plate 12). It measured 10m by 4.7m and to the south and west had received the same coating of white paint over pebble dash as Building A's west end. The elevation to the east was of red brick and flint but was also painted with a thick layer of white paint (Plate 13). The roof covering of red pan-tiles was flanked to the east and west by red brick chimney stacks rising from each gable end while to the north it adjoined the roof of Building A at the eaves to form a valley. The western elevation contained just a single casement window at the southern end of the ground floor which although still glazed had been blocked up internally (Plate 14). The southern elevation displayed two rectangular three-panel casement windows regularly spaced out across the first floor while two French windows on the ground floor below opened out into the garden with a third and smaller casement window at the eastern end (Plate 12). The eastern gable had a single modern casement window on the ground floor just to the north of a central chimney breast projecting away from the walls face and rising to the apex.

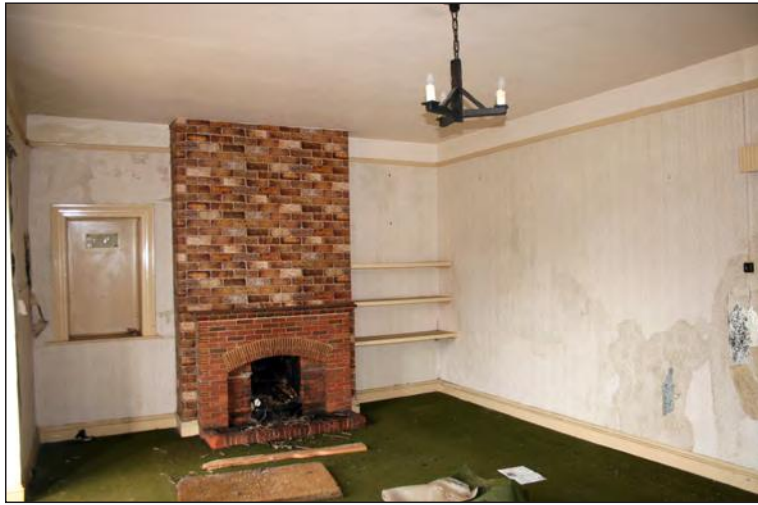
Plate 17. Ground floor, Building B, western room

From the southern end of the hall a doorway opened into a lounge room within Building B with a fireplace at the western end (Plate 17). Along its southern wall two sets of French doors opened out into the garden (Plate 18) while a niche on the western wall just to the south of the fireplace signalled the location of the blocked window visible from the exterior.

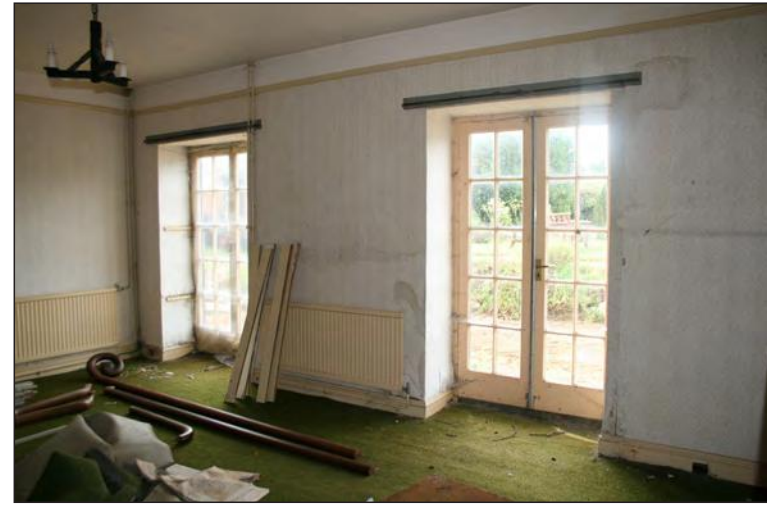
Plate 18. French windows, ground floor, Building B

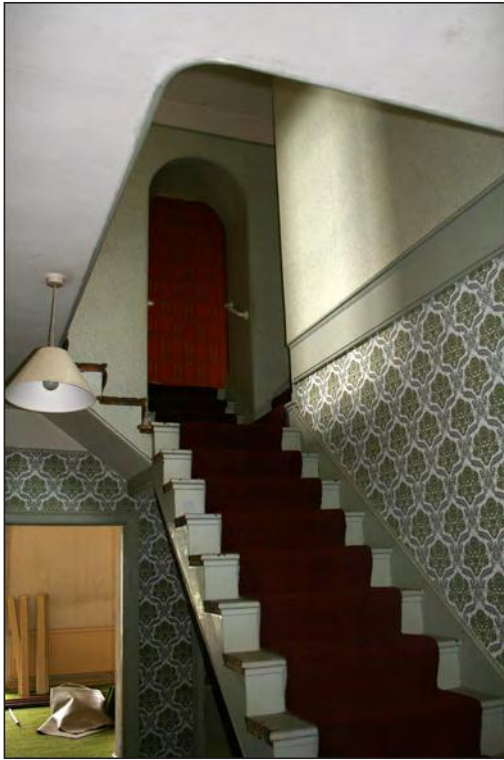
In the eastern half of the building the staircase led up to a small landing from which a further short step up led south into the first floor of Building B (Plate 25). Here two rooms of roughly equal size, one to the east and another to the west, were divided by a north-south partition wall. Each room had its own fireplace at the centre of its respective gable wall while the eastern room displayed a niche along its northern wall that indicated the previous location of a doorway between

Plate 25. Hall stairs leading up to first floor

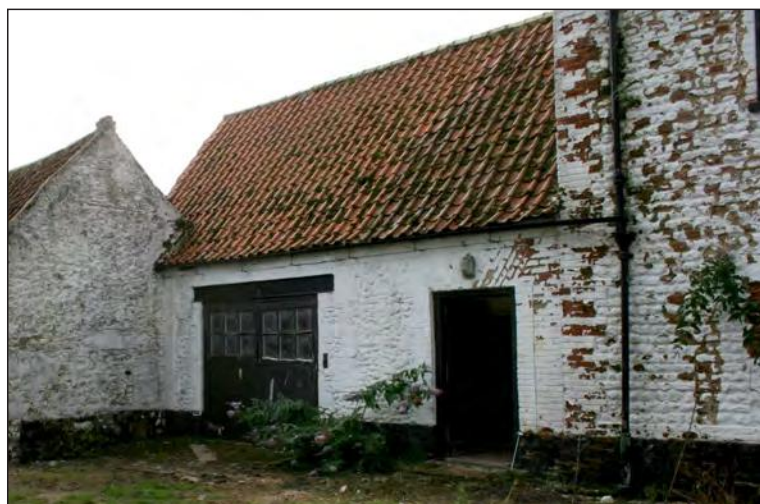
### **Exterior**

Plate 31. Building C north elevation

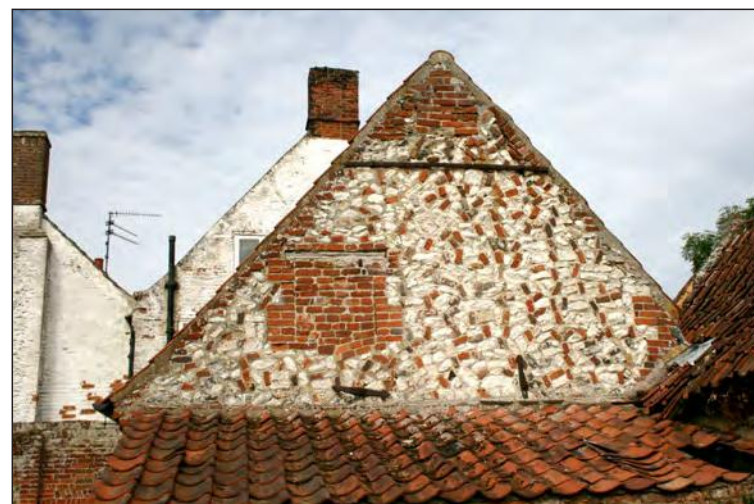
Plate 32. Eastern elevation of Building C

the southern end and below this and hidden from view by building E sat a doorway of similar construction and also blocked (Plate 32). Distinct from the remainder of the walling material the gable's apex was formed in coursed red brick and the presence of a chimney breast on the interior of this wall suggests this was the remains of a removed chimney stack. The southern elevation was similar in construction to the eastern gable with un-coursed brick and chalk however it was noted with interest that it also contained fragments of re-used Barnack stone (Plate 33), presumably quarried from a long demolished building of higher status in the local area. There were two doorways both of similar design located side by side at the western end of the elevation however a north-south garden wall to eaves height and located between the two divided the doors and presumably accounts for the need for both. The changing requirements of the building meant that the one to the west was no longer necessary and had been blocked up. From examination of the eastern face of the garden wall where it adjoined Building C it appeared there may have been a lean-to structure that had previously stood against the southern wall of Building C and was now only suggested by the survival of a possible roof line against the garden wall (Plate 33).

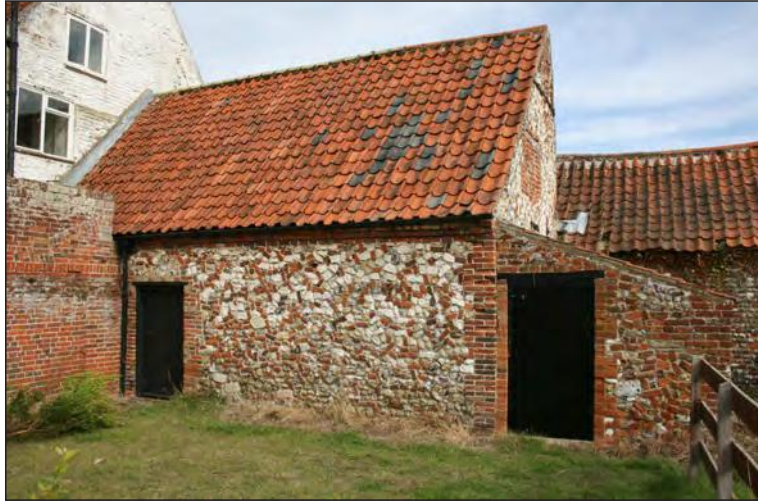
Plate 33. Southern elevation of Building C

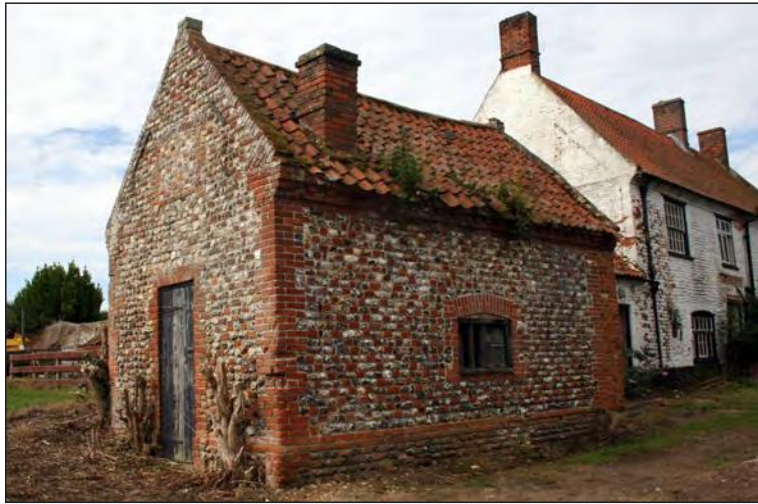
Building D measured 6.4m east-west by 3.9m north-south adjoining Building C to the north-east (Figs 2 and 4). It was constructed of a mixture of coursed flint and red brick headers with brick dressings and a gabled red pan-tile roof (Plate 37). To the north and south a brick dentil cornice sat below the eaves and to the north and east a shallow plinth ran across the base of the walls. At the centre of the northern elevation a low rectangular window with a cambered brick arch and internal

Plate 37. Building D facing south-west

wooden shutters provided the only natural light to the building but the eastern gable preserved the outline of an in-filled window in its upper gable (Plate 37). A doorway positioned directly beneath this latter window was the only remaining external entry to the building but in the opposing wall there were traces of another doorway with its threshold approximately 1.5m from the ground (Plate 38). This had also been in-filled and then heavily obscured by the application of white paint to the wall but nevertheless it was possible to see beneath this opening the truncated jambs of what might perhaps have been an earlier doorway at ground level. By examination of the north-western quoin it was evident there had been some rebuilding work at the western end of the building and it appeared that the structure had been lengthened by approximately 0.4m in this direction. As with Building A tumble-in brickwork had been used at both gables.

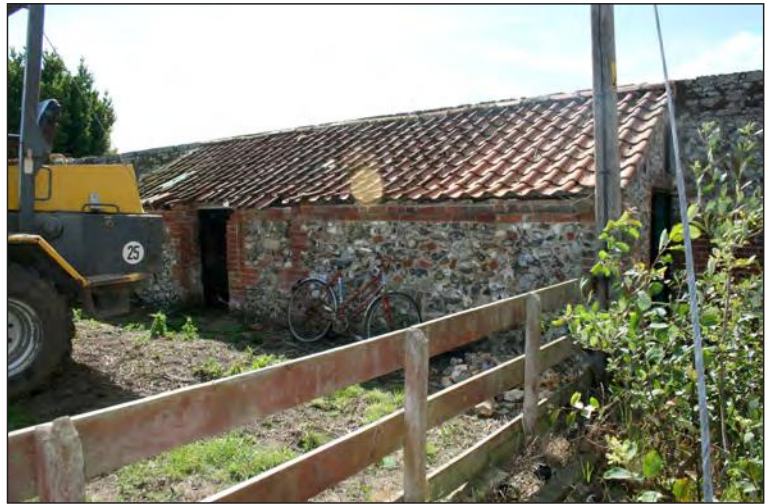
Built alongside the brick garden wall that extended south from the southern wall of Building C, Building F was a low lean-to structure 2.2m wide and 8.2m long with a red pan-tile roof (Figs 2 and 5, Plate 42). Its northern, southern and eastern walls were of flint rubble with brick headers with brick at the quoins and openings. In common with Building C it also contained fragments of re-used shelly limestone probably quarried originally at Barnack. The building was divided into three separate compartments, with a door in the northern wall allowing entry to the northern cell, a second doorway in the western wall giving access to an external central toilet cell and a third opening in the eastern wall leading into a wood store in the southern cell. To the north of the eastern doorway brick jambs may indicate a rectangular blocked window while above the northern doorway a small square opening remained (Plate 43). Traces of soot or coal dust on the walls and brick floor of the northernmost cell may have resulted from the storage of coal.

Plate 42. East elevation of Building F

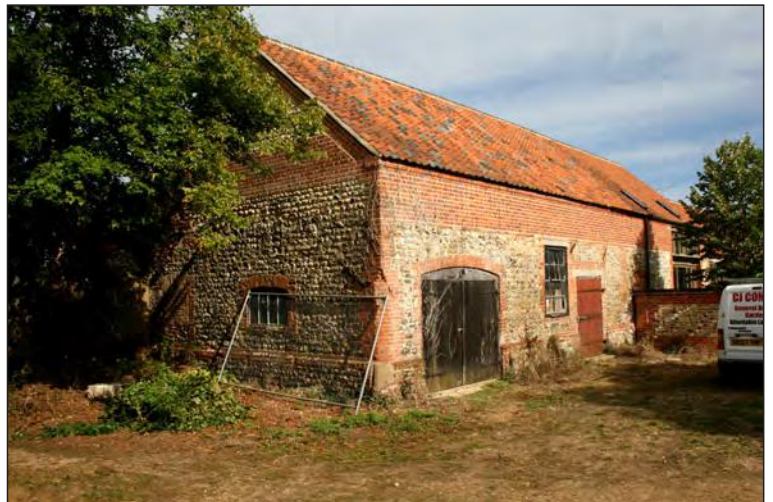
Plate 44. Building G facing north-west

Building G was a rectangular structure aligned against Bircham Road and forming the western boundary of the farm (Plate 44). It sat approximately 12m to the north of Building A (Figs 2 and 5) across a small yard and just to the north of the present day entrance to Ivy Farm House from the road. At least half of the building had already been converted to residential accommodation but the southern half remained in use as a garage and for storage. The total length of the building was over 12m with a width of 7.1m and it was constructed of coursed flint and chalk with brick dressings. The gabled roof was of red pan-tiles however the upper third of the building had been rebuilt in red brick probably in the last decade and most of the roof timbers had been replaced at this time (Plate 44). A shallow brick plinth ran across the base of the building to the east west and south. The western elevation which faced the road was provided with three square brick vents evenly spaced out across the length of the building and sitting directly beneath the wall plate (Plate 45). Their geometric pattern was formed by omitting every other brick header in five rows. Beneath the southernmost vent were the jambs and cambered arch of an in-filled window while further to the north a window of wider dimension but otherwise similar design had also been blocked up (Plate 46). On the southern gable wall another window with a cambered arch was located just to the east of centre no more than a metre from the ground while at the far western end a doorway, again with a cambered arch, had been blocked, initially to leave a window and then later this too has been bricked up. Just above this doorway sat a date stone carved with the initials 'R.G.' and the date '1745' although it looked to have been repositioned, perhaps during the rebuilding of the upper half of the building (Plate 47). At the southern end of the eastern elevation a double door below a cambered arch opened into the southern cell while a second doorway to the north was clearly inserted at a more modern date and had been fitted with a steel door (Plate 44). A large rectangular window with a square lintel had been placed immediately to its south. At the south-eastern corner of the building the lower portion of the brick quoins had been chamfered to reduce the potential for collision with farm machinery.

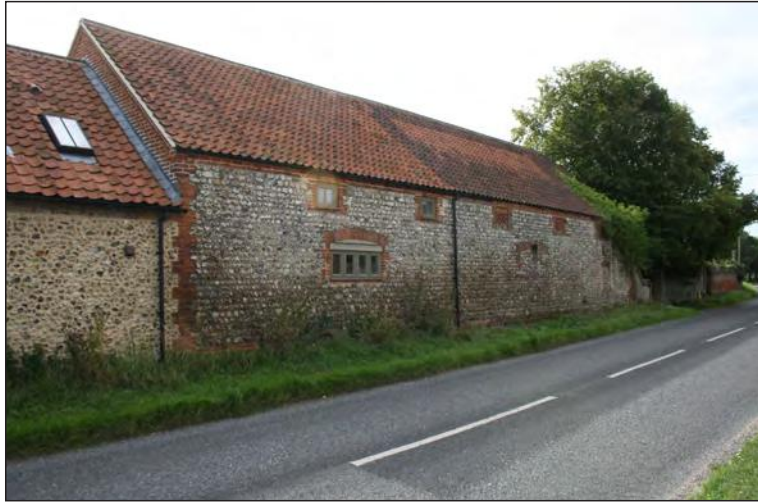
Plate 45. Building G looking south from road

Building G although extensively altered internally was probably a stable with space for crop-storage above. The ventilation windows (Plates 45 and 46) were designed to provide airflow to the stored crops and reduce problems of spoilage while the high ceilings of the lower floor would have given plenty of head space for horses. It is also possible there may have been a window at the apex of one or both gables to allow loading and unloading of crops into the loft but any evidence for this would have been lost during the rebuilding of the upper parts of the structure. More recently the southern cell has obviously been used as a garage while the northern cell has likely seen service as a strong room for chemical storage.

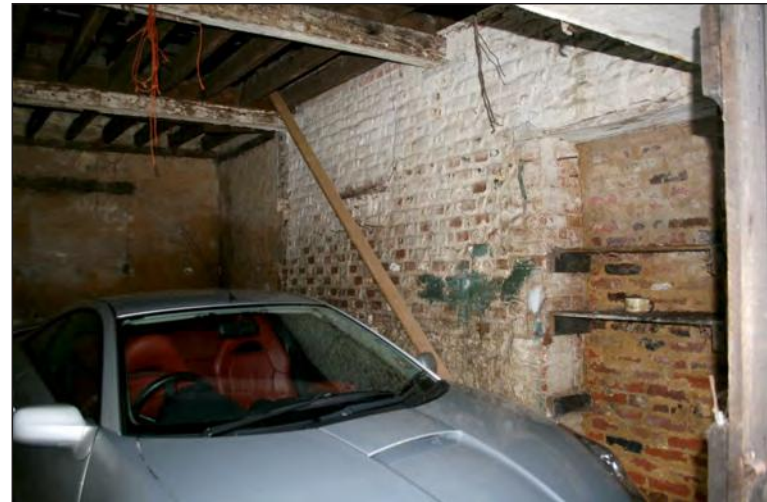
Plate 48. Southern cell of Building G

Building G had been divided internally into a southern cell and a northern cell by a red brick partition wall. The southern cell presently served as a garage (Plate 48) and the northern cell as a general storage (Plate 49) without internal access between the two, however a bricked up doorway at the eastern end of the cross-wall had previously allowed this function. The southern cell had whitewashed walls and a brick floor lain bedding face up while the northern cell had whitewashed walls to the east and west. The southern wall was plastered above 1.5m with black waterproof paint on the lower portion but the northern wall had been left without either. This wall divided off the already-converted remainder of the building but a blocked door at its eastern end indicated this had not always been the case (Plate 50). The floor was of concrete and a steel cell was located in the north-western corner.
