New Tesco Store, Streatham Hub, London Borough of Lambeth: A Historic Building Record and Conservation Assessment

Planning Application Number: 08/03477/FUL & 08/03457/CON

AOC Project No: 30968

Date: July 2011

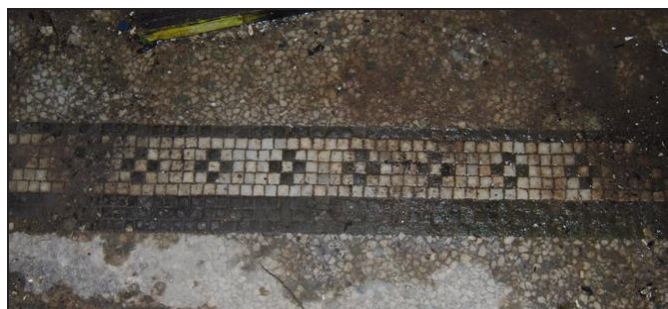
Plate 3: Lobby Floor Detail

- 8.2.7 The northern entrance (**Room 3**) is boarded up and has an unsafe roof following rafter failure. The fixtures and fittings are likely to be the same as are seen in the southern entrance (**Room 2**). Twin doors open into the lobby from the east and retain some original fixtures on the inside. The outside of the doors are boarded over for security. These doors were originally half-glazed with boards in the lower panel. The original door handle is an iron ring, mounted on a circular backplate with four protruding screw fixings. Above the door is an original gas light with a gridded globular lantern. Other fittings include a modern ‘Chubb’ lock and a bolt. The floor of the entrance lobby is terrazzo with a surrounding strip of black and white mosaic tiles. A stone window surround has a single stone

mullion and upper tracery. The windows are small rectangular panes with lead comes, now damaged.

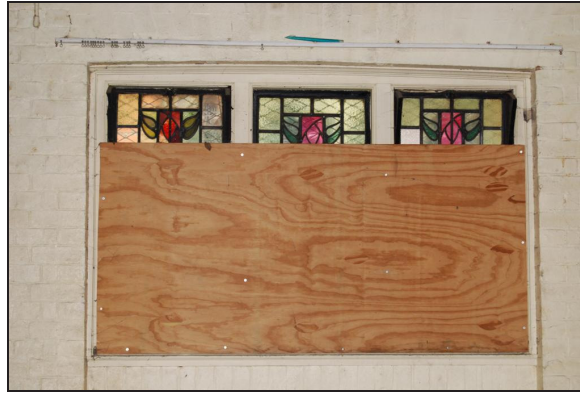
Plate 7: Aisle Window

8.2.9 The main hall (**Room 1**) measures 20m by 8m, but is 13.5m wide if the span of the side aisles are included. The ridge of the pitched roof is 10.73m high. The brick walls of the building are clean and unplastered and the detail of the brickwork clear. The east and west walls both feature large windows. The eastern window has stained or coloured glass, whereas the western window has clear glass. Both windows are formed of small panes with lead comes between stone mullions. The decorative glasswork of the east window is mostly concentrated in the upper geometric tracery and consists of pink roses, foliage and simple comes, which give a gentle quality to the light. The central quatrefoil has a single rose with leaves around. A band of colour towards the bottom of the window consists of narrow red, blue, green and orange lights. Most of the original coloured glass survives, but approximately 15% of the regular pale bluish green glass has been lost. The western window uses opaque colourless glass to enhance its decorative qualities, rather than colour, but has a similar bud and foliate design. The glass is more complete at the rear, a consequence of being more difficult access and vandalised; the windows are currently covered with wire for protection. The side windows of the aisles also have coloured glass panels, repeating the foliage and rose motif of the

front classrooms. This decoration is only present in the upper casements. Each has a central pink rose; the two flanking panels have a red rose each. All aisle windows are securely boarded over. The upper clerestory windows are clear, uncoloured glass.

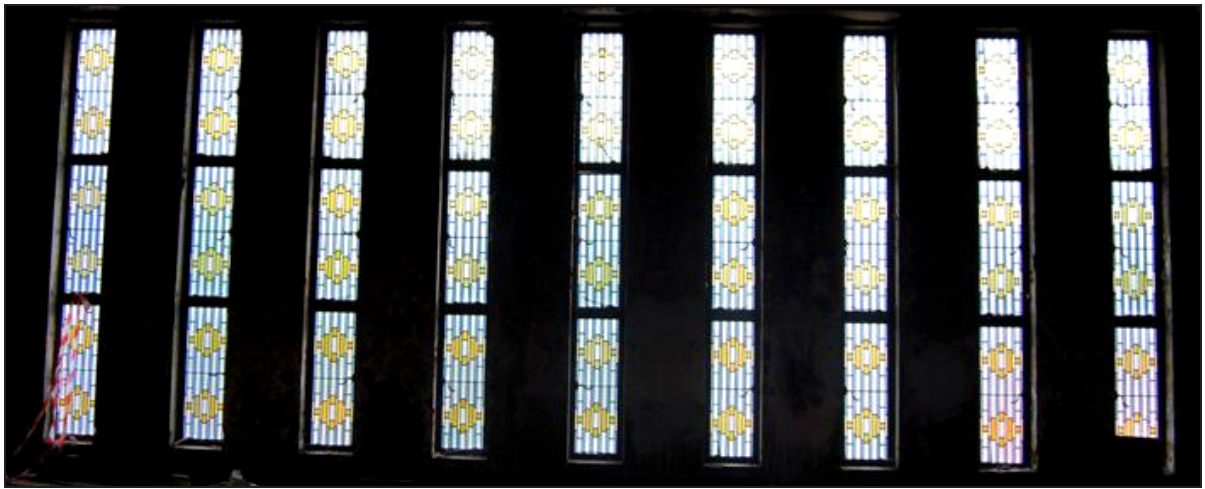
Plate 22: Array of Nine Windows, Ice Rink Function Room

- 8.3.14 The turning stair opens into a short antechamber that leads to a blocked door directly ahead to the south, and a corridor running west. The doorway once led into the main room on this floor; a room with some surviving décor suggesting that it was originally a ballroom or grand function room. In its most recent use this grand room was a club. A twin of the doorway lies on the south side of the main room. The Function Room (**Room 23**) measures 22.5m by 12.5m and is 4.90m high (Figure 10). The internal walls have all been modified from their original form; the original north wall has been

removed between two structural pillars to be later replaced by a boarded partition. The south wall has had a new doorway cut through a decorative pilaster; this doorway has subsequently been re-blocked. The west wall has three blockages: Two of these are doorways that once led down to the balcony level and thence to the Ice; the third is a main doorway to the balcony, which has been part blocked with a smaller lockable door added. These last three blockings all use breezeblocks. The room's grandest feature is the array of nine slender coloured glass windows, each with repeating patterns of yellow sun, blue sky and opaque glass to represent clouds. Each piece of glass is rectangular and affixed with lead comes into metal windows. The windows are in very good condition, although there is some bowing. There are two sets of two other slender windows in the room; these are glazed with clear glass panes and are probably replacements.

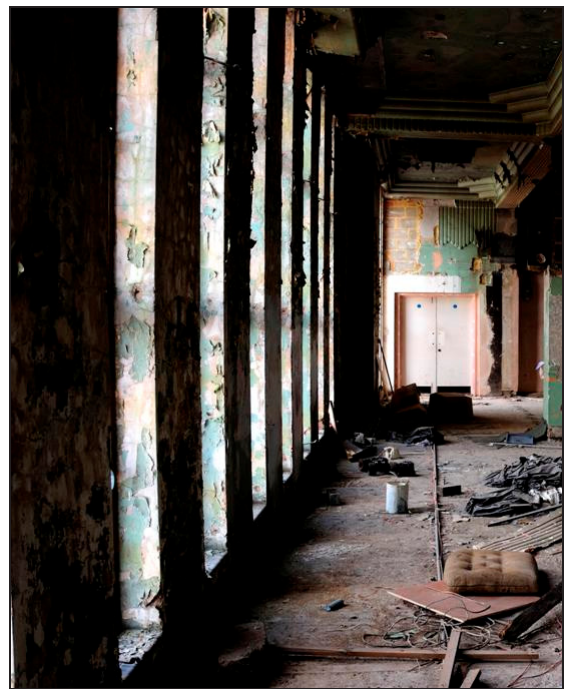
Plate 24: View of Function Room Looking South

8.3.15 The room was in semi-stripped condition at the time of recording with a wooden floor, which had been lifted, revealing a steel and concrete floor. The ceiling is supported by four large I-beams, clad to give a square profile, but with a polygonal capital with floral, foliage and fruit panels and fluting to

the sides. These panels are generally in poor condition. Around the walls are raised strip designs with rounded ends, much of which has fallen away. The steel columns support steel beams that support a flat roof above and these are also decorated with strip designs, formed of plaster over a hessian base. The beams that span the roof form nine compartments; the central row is inset with polygonal panels with ogee curves and straight corners. Two front compartments have panels that are pierced in a regular decorative fashion. These may have held lights, but there were no surviving fittings to prove this. The walls have several decorative elements, including two pairs of pilasters over steel beams hidden within the north and south walls; these pilasters have incised fluting and an incised fluted capital. The condition of the decorative plasterwork is poor and much of it has already fallen from the ceiling. The existence of any original decorative colour scheme for the Function Room is not proven; the walls are currently painted dark green, black and mud brown paint.

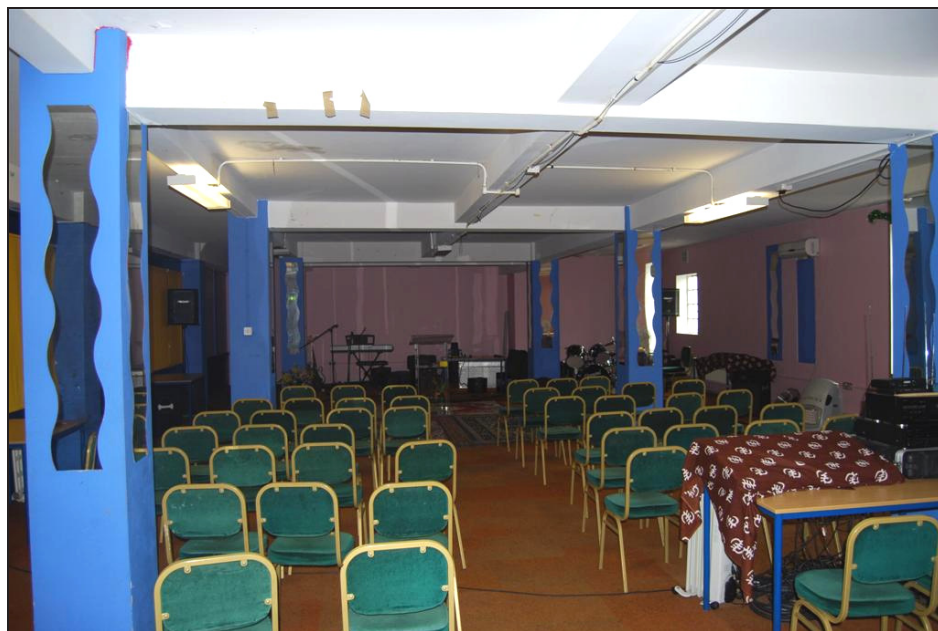
Plate 31: View of Chapel, Looking South

- 8.3.28 The first floor at the west of the building is accessed by either of the two stairs; these rise to landings and each have a doorway inwards to two rooms that occupy the rest of the first floor (Figure 9). The main space is currently used as a chapel (**Room 56**) and measures 18m by 9.5m. The chapel has tall narrow windows along the western wall, most of which are boarded over; large glazed panels on the eastern wall overlook the Ice Rink. This room was formerly the restaurant for the Ice Rink; at the northern end of this room is a small room used as a kitchen (**Room 57**) formed in a space around the chimneystack that rises from the basements. All finishes in these two rooms are modern and plain, with no surface evidence for former use.

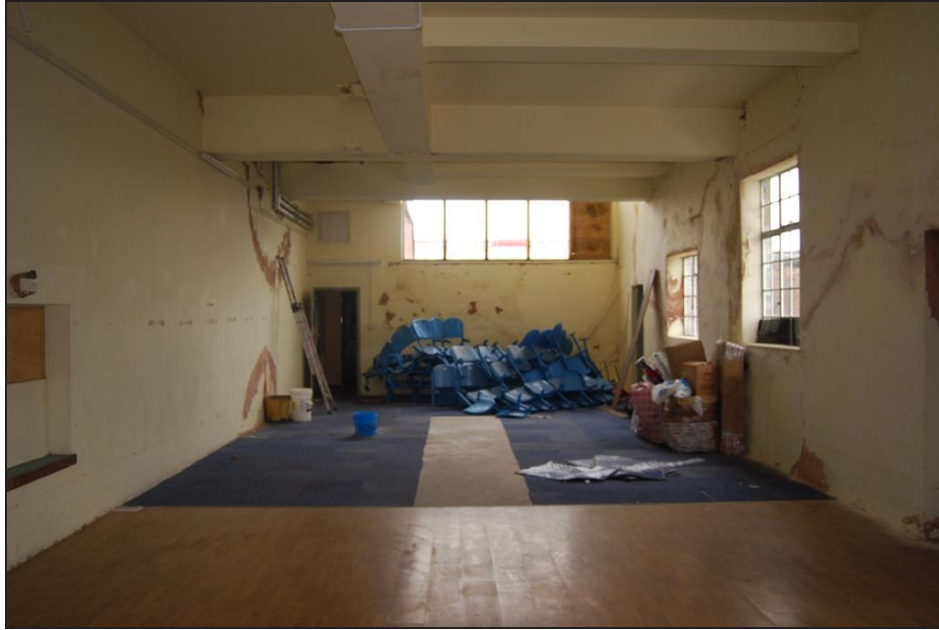
Plate 32: View South of Second Floor of Ice Rink, Rear Block

room is lit by a range of metal framed windows on the west side and by high level plate glass window in the south. The ceiling of the room is relatively high at 3.95m.

- 8.3.31 The roof of this part of the building is flat and is formed of reinforced concrete beams with precast concrete slabs between. There has been some materials failure, as shown by water damage to the floor. Small windows overlook the Ice Rink and there is an external door to an external flat roof, next to the chimney. A low parapet wall surrounds this roof space. There is a low ladder leading to the pitched roof over the Ice Rink. One store room on the flat roof could not be accessed (**Room 64**)

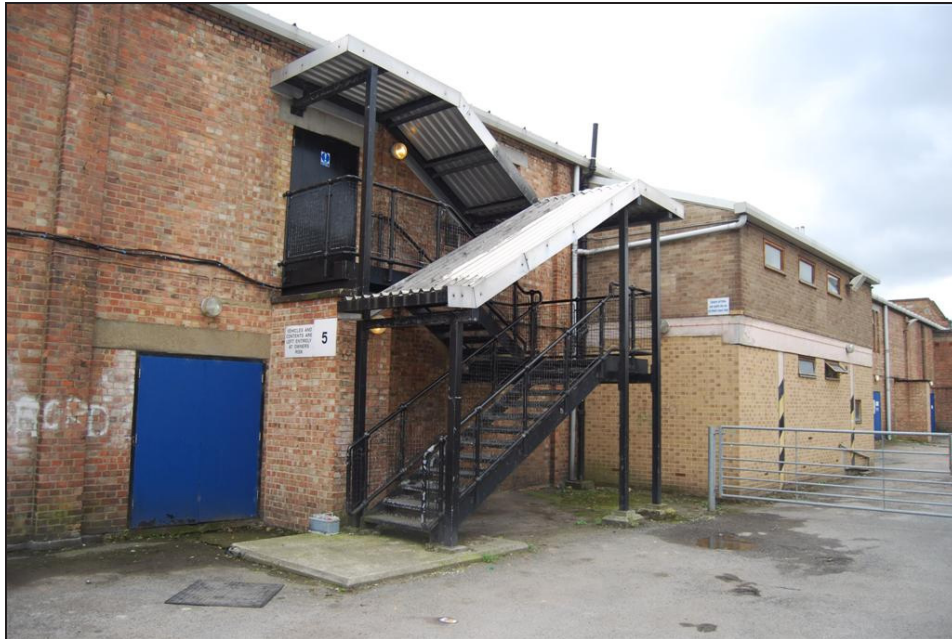
Plate 34: Additional Block on North Side

- 8.3.32 On the northern side of the building is a two storey block, which appears to be additional to the main build. This appears originally to have been a first floor room accessed only off the balcony and supported on brick piers. The ground floor has since been bricked in, forming an additional room on

the ground floor (**Room 68**). The upper block is constructed of dull brown bricks; the lower fill is of yellow brick. Both of these contrast with the pinkish red bricks used in the majority of the rest of the Ice Rink section.

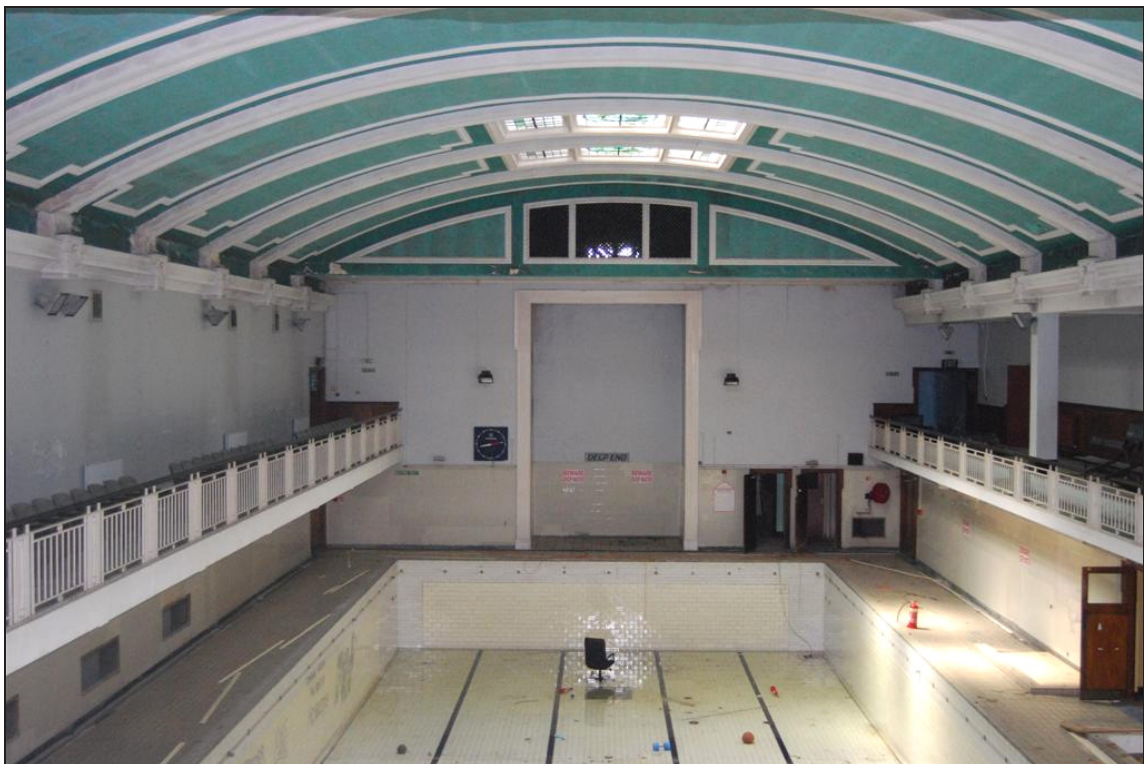
Plate 39: Swimming Pool Looking West

- 8.4.13 The shallow end lies to the east, the deep end to the west, thereby conforming with the natural underlying topography. The pool is tiled with glazed white ceramic tiles on sides and base, with strips of black tiles running lengthways. There are panels of cream-coloured tiles in the sides and end walls. The presence of a former water-level rail is shown by regular fixing points: the rail has been removed.

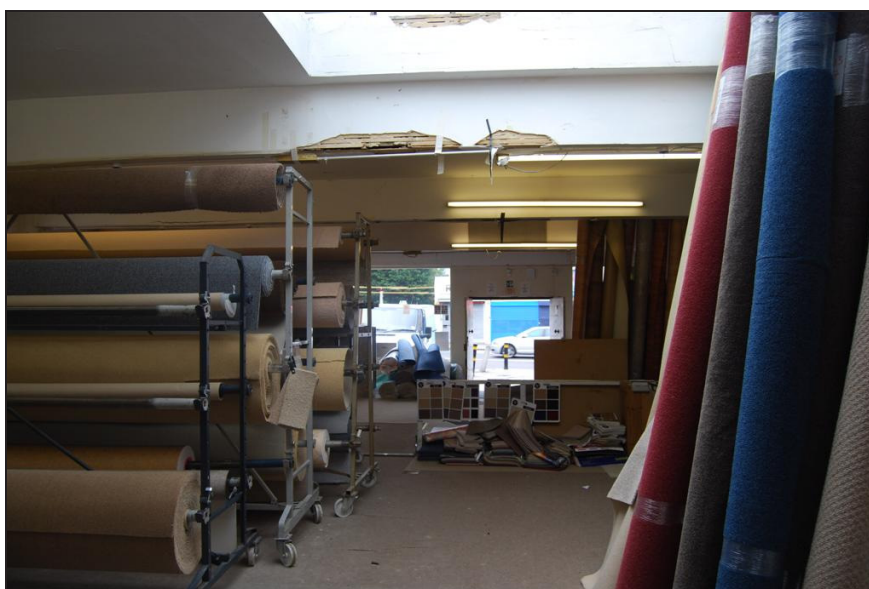
Plate 53: Shop Interior

8.5.3 No phasing of the building is apparent and the modern surfaces are in good condition. The floor is carpeted. Most of the warehouse space is occupied by the store with carpets for sale. To the rear is a sales desk and several partitions. The most permanent partition is a brick wall around the staircase to the basement; this staircase has a curved corner. On the north side of the building are two lavatories and a wash room. The stair to the basement is a straight stair with a landing; at the top of the stair is a railing to prevent falls down the stairwell. The railing has a central decorative panel with
