Hollybrook Limited : Bath House Lofts

Planning Consent : Condition 5

21st September 2012

Archive Document

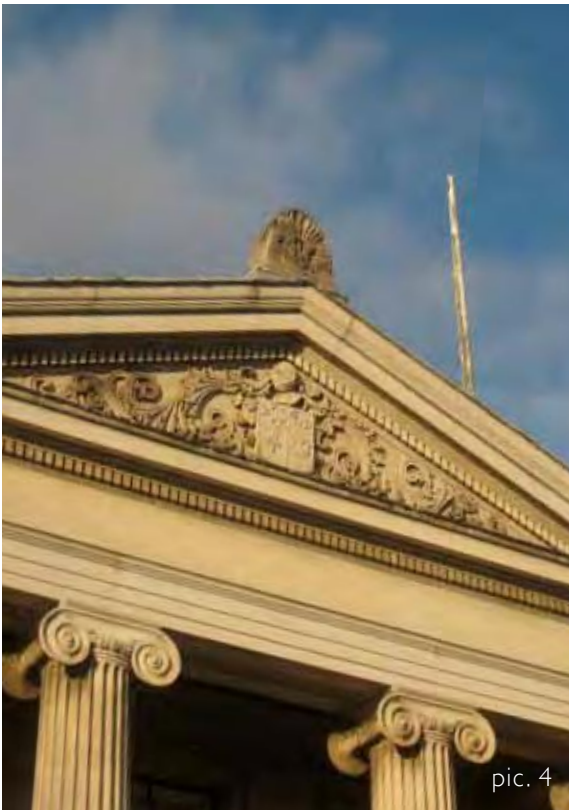
pic. 4

Steps up to the centrally placed entrance sit under the giant tetrastyle Ionic portico (pic. 4) with railings containing decorative infill panels to either side of the entrance and basement area. The tympanum to the pediment includes the Bermondsey Borough arms in low relief and an anthemion to the peak with block attic storey behind. Below the soffit a highly decorative frieze plays out. The Portico entablature with dentil cornice is continuous across the elevation which is articulated by plain, two-storey pilaster strips.

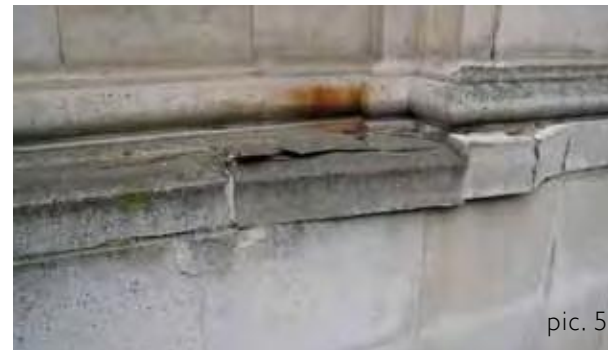
pic. 5

As with the Spa Road elevation the facing material is deteriorating in a number of locations, specifically around fixing points and mouldings (pic. 5). The deterioration here is more pronounced, and the possible reasons for this are discussed on page 25.

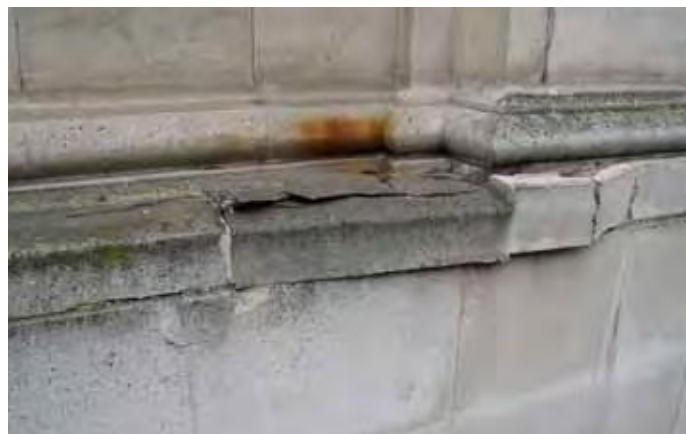
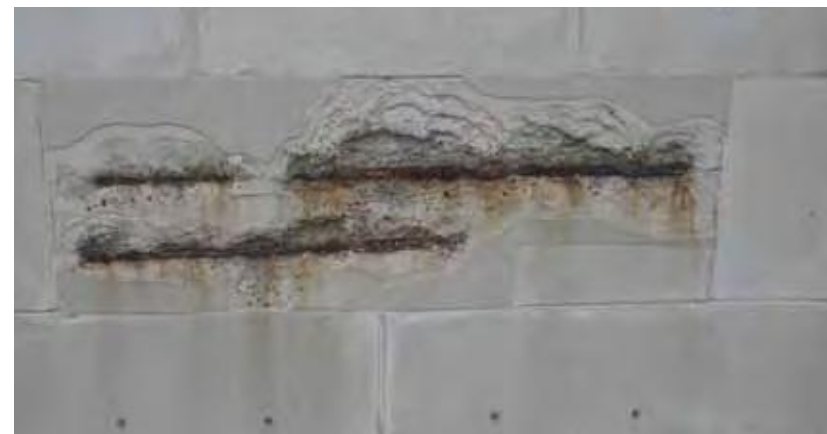
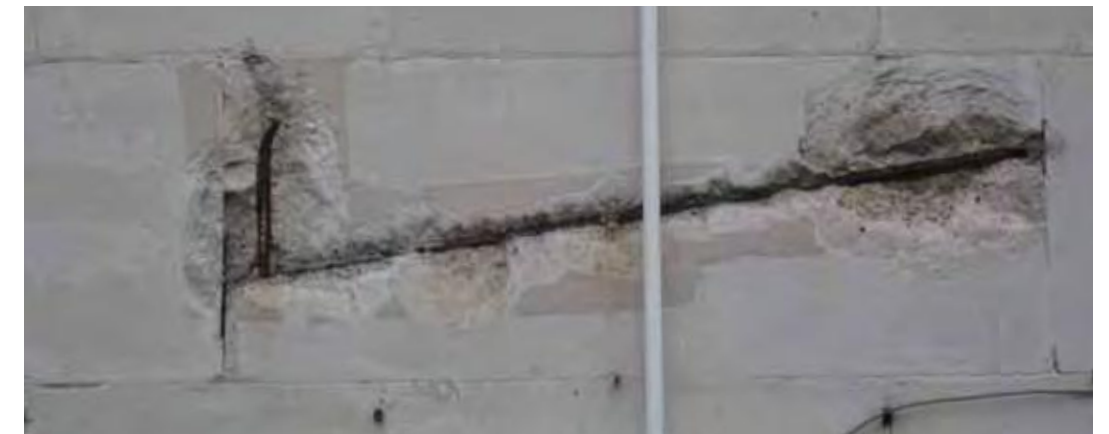
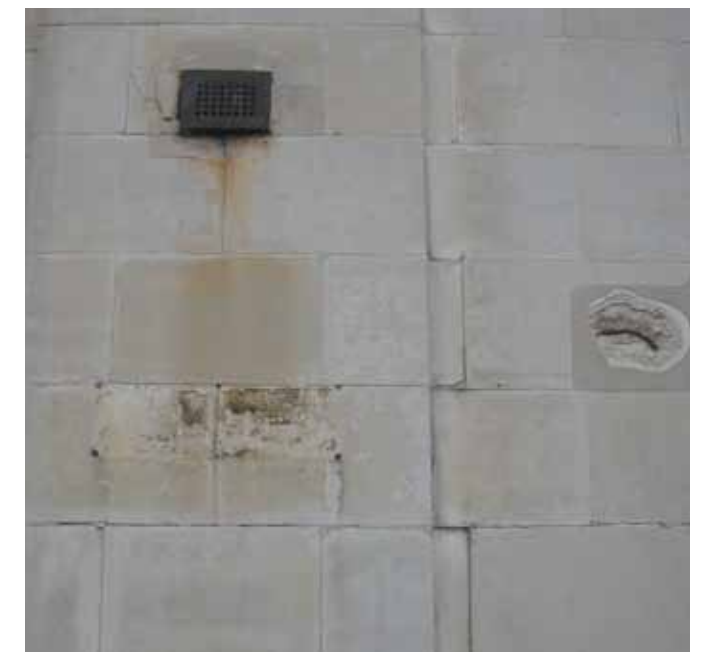
As noted previously the precast concrete facing material to the principal elevations is deteriorating in a number of locations. Within the larger blocks, the steel rebar hoops integral to their design and construction is sitting too close to the front face. As it gets damp the resultant corrosion expands the rebar and forces off the concrete facing.

We suspect that the steel hoops were 'thrown' into the moulds, and that their weight in the larger stones dropped them too near what was to become the external surface. If we were forming such a cast today, spacers and a two part mould would overcome such problems.

The stabilising process to repair the elements is outlined in the LBC Condition 3 document, which is being submitted with this one.

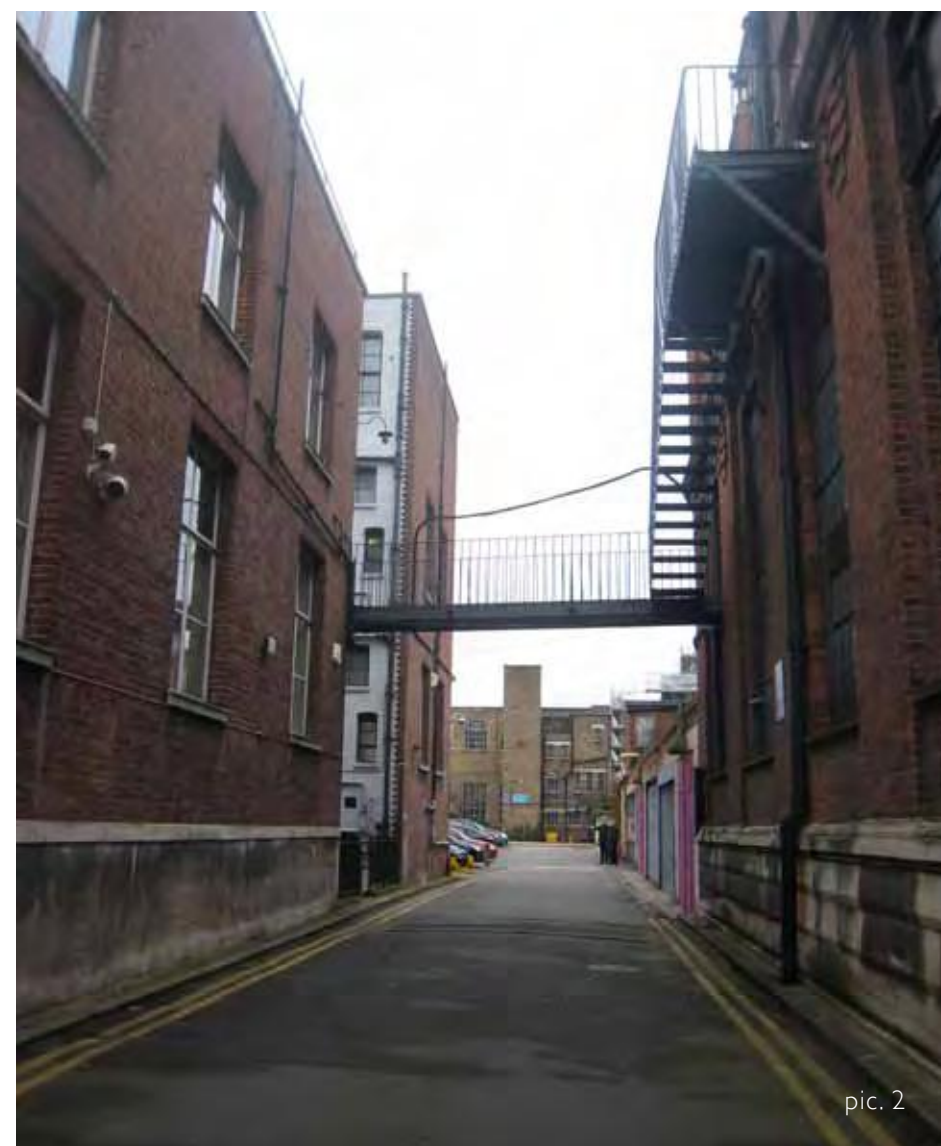
pic. 2

The historic fabric comprising the North elevation is of medium significance. The north elevation (pic. 2) is less impressive than the Spa Road and Neckinger elevations, however, it is still important to the character and setting of the listed building forming the rear elevation.

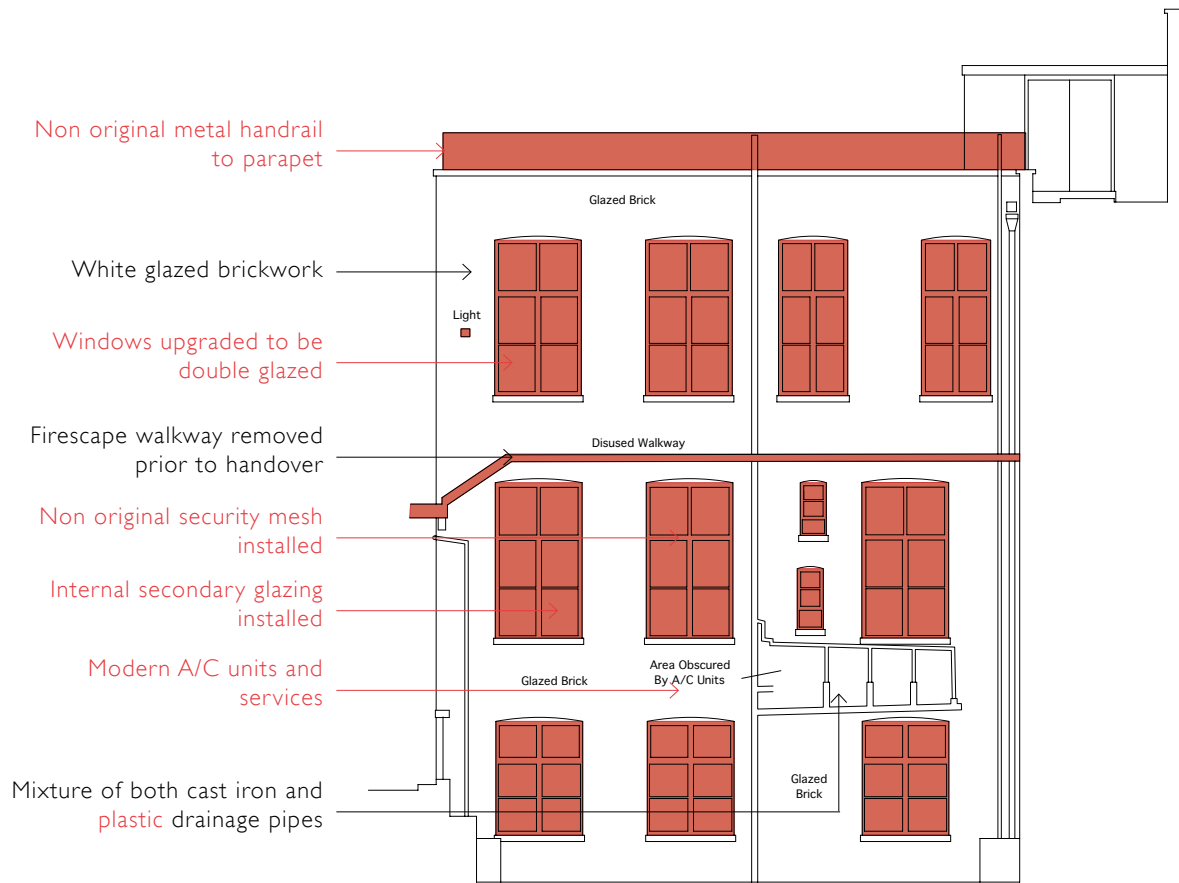
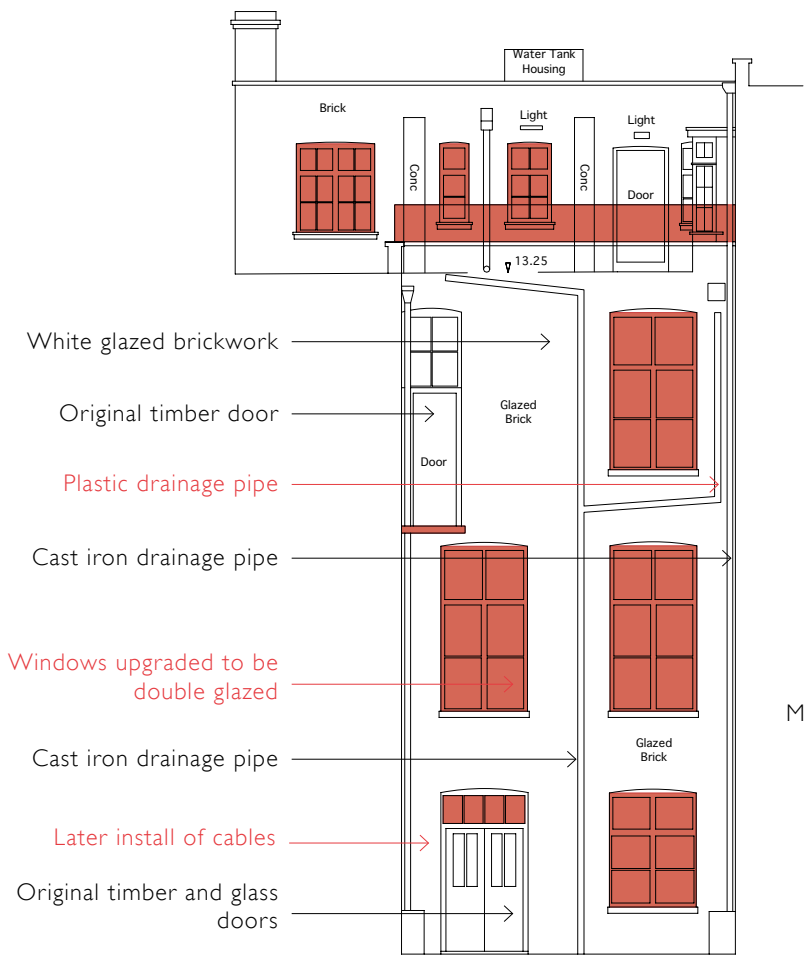
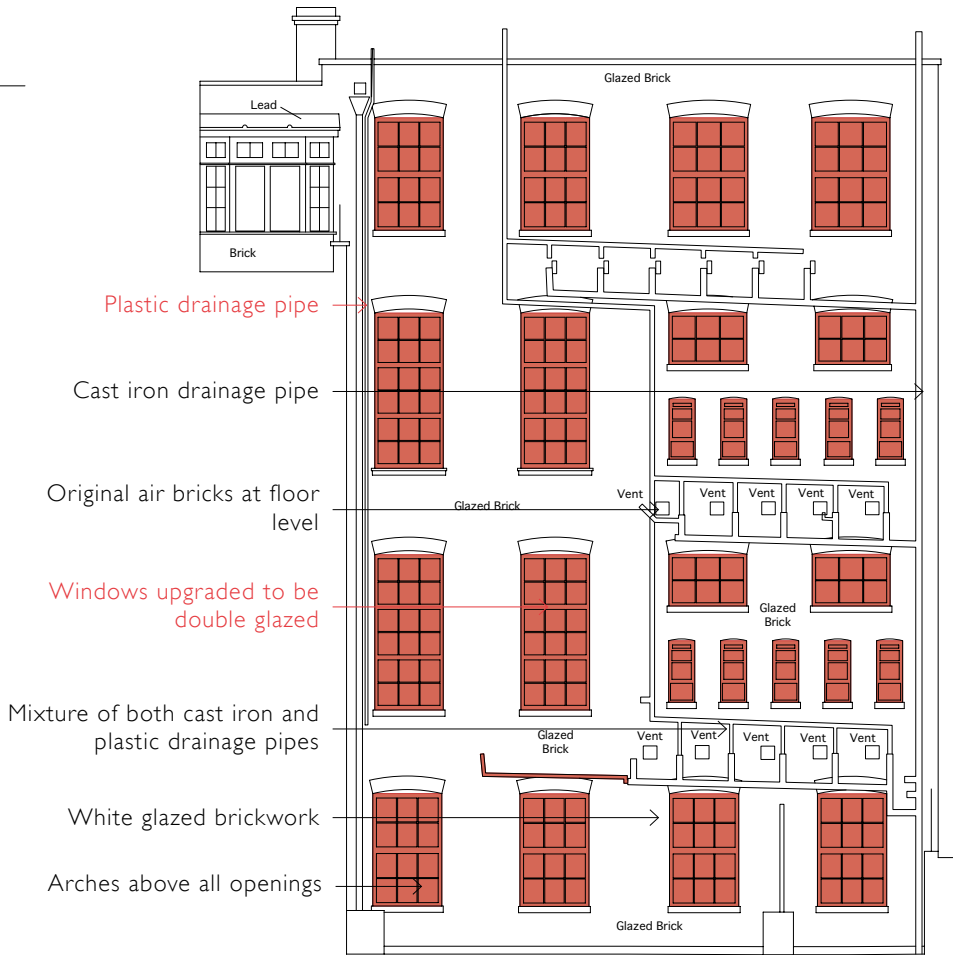
This edge then meets the shallow voussoir arch that is formed over each opening with brick on edge headers, that have not been cut for the purpose.

The cills are formed in bull nose soldier courses. The bed joints and perpend joints are thin bed, as would have been common with this era, and this construction, suggesting a lime based slurry as a construction material. The bricks and joints are in reasonable repair, and appear to have had a recent chemical clean.

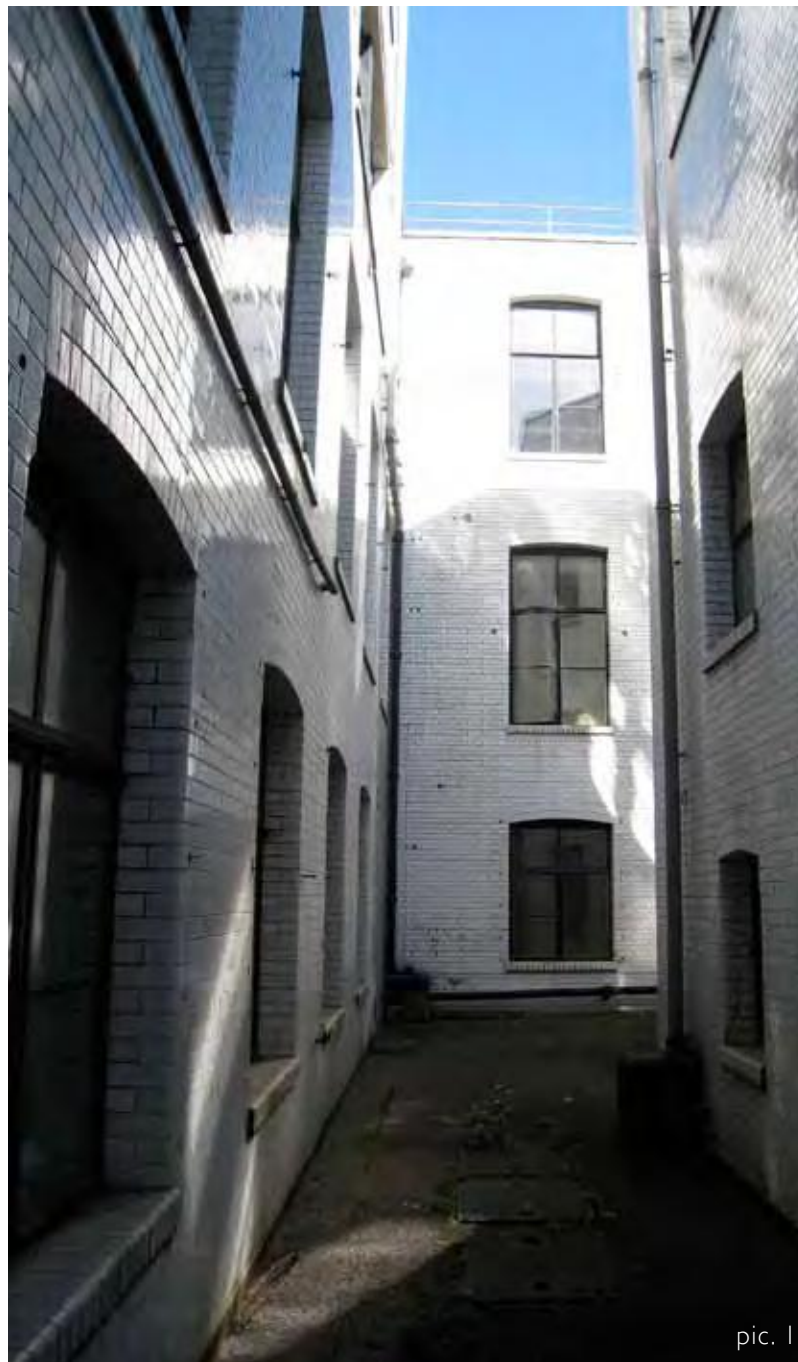
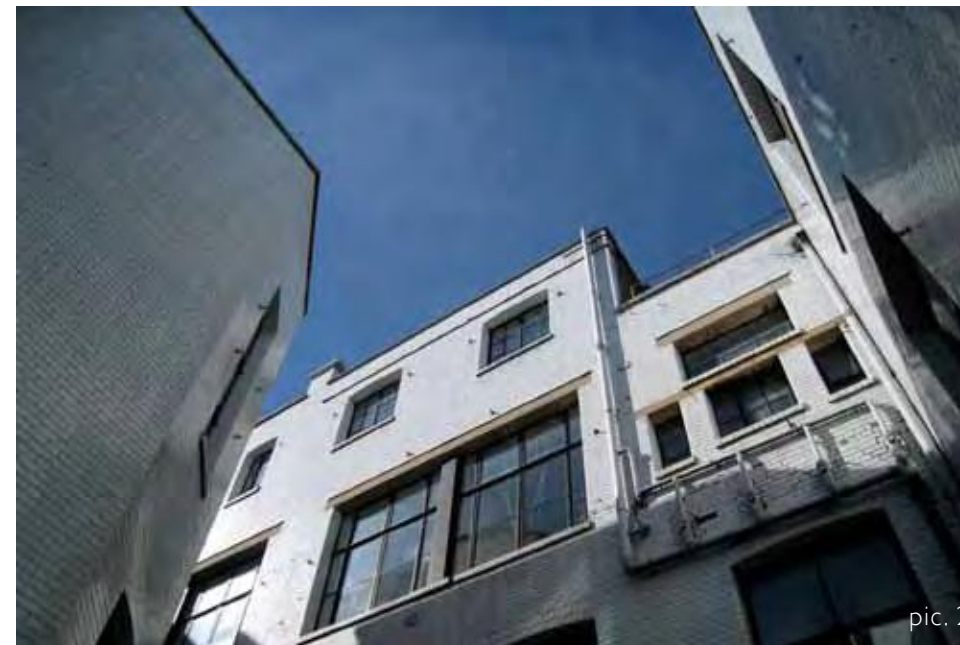
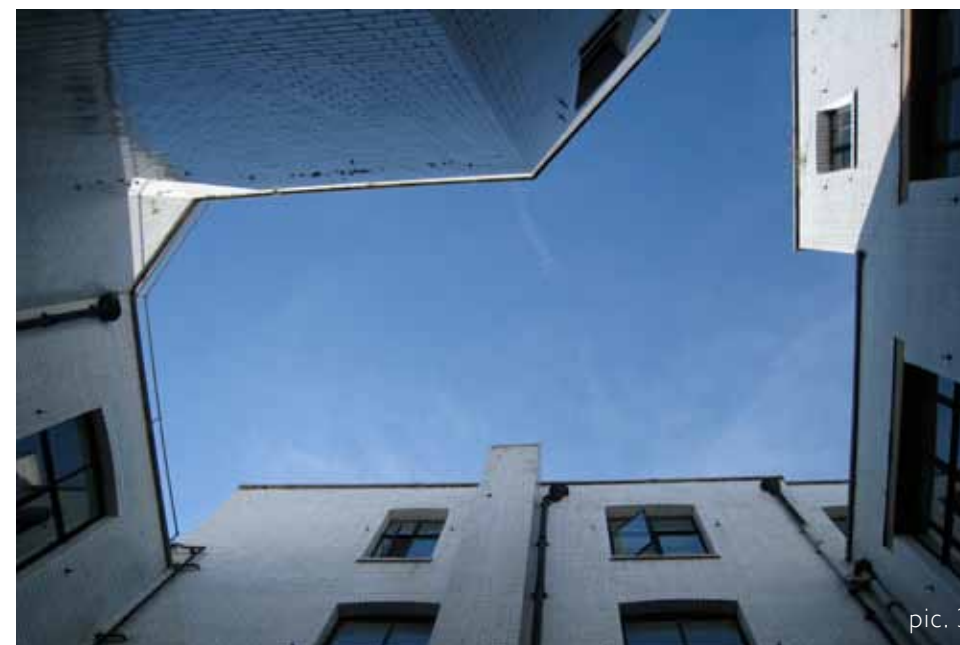
The walls are faced with white glazed brick with shallow brick arches over the majority of the windows - the windows to the first floor of the south elevation have flat concrete lintels (pic. 2.). We believe that these were replacement to the originals, and this was caused by the original rebar corroding and failing. Existing cracking to the brick coursing at high level is located above the new lintols and suggests that when they failed the brickwork failed.

The cills are formed in bull nose soldier courses. The bed joints and perpend joints are thin bed, as would have been common with this era, and this construction, suggesting a lime based slurry as a construction material. The bricks and joints are in reasonable repair, and appear to have had a recent chemical clean. Small amounts of vegetal growth in the bed joints will be easy to treat, and was probably caused by the chemical clean opening the pores of the mortar.

The existing drainage is a mixture of cast and plastic, the former dating from the original construction and the latter from later adaptations. Where it is failing the brickwork is becoming saturated.

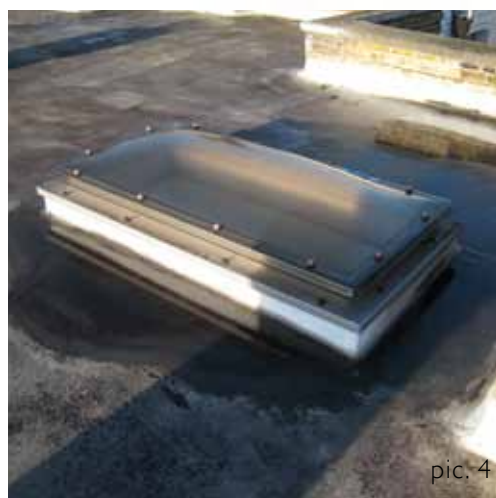
pic. 4

There are several modern roof lights distributed across both roof levels (pic. 4).

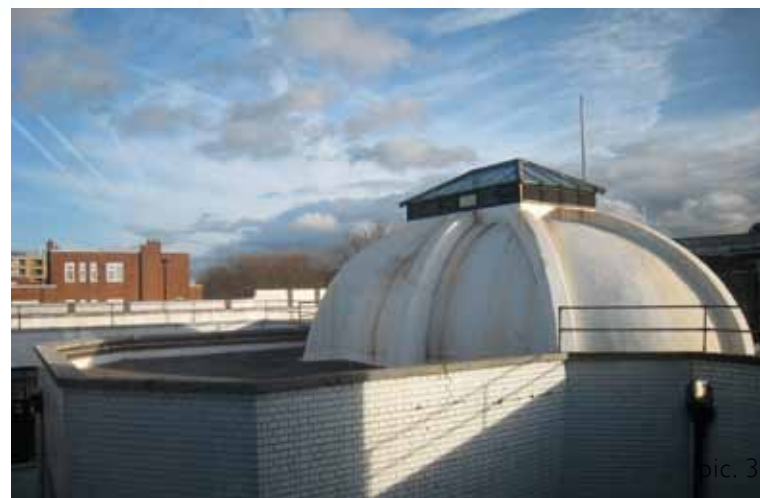
pic. 3

A safety handrail has been fixed into the top of the precast concrete copings around the perimeter of the roof to prevent falls(pic. 3). There is evidence of repairs to both the brick work and the asphalt waterproofing which, we suspect, has been re-laid a number of times.. The asphalt is ventilated through a series of vents that run north along the Neckinger wing.

There is significant ponding of rainwater indicating that a number of roof outlets are currently blocked, and the dpm to parapet junction has failed in numerous locations.

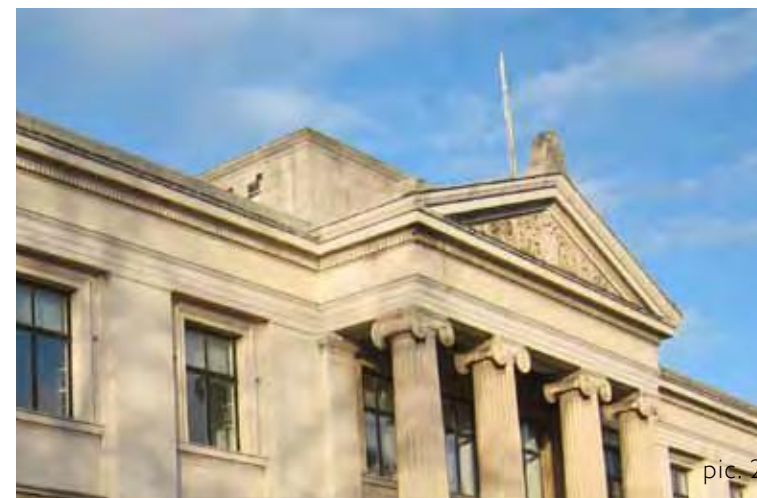
pic. 2

The block attic storey is identified within the historic listing. It is faced in the same material as the Spa road elevation and is capped with by a simple cornice (pic. 2). We suspect the structure behind originally screened plant equipment as there does not seem to be any compositional reason for it. It also appears that the space behind was once covered as the steel spanning between the flank walls are contemporaneous with the rest of the structure (pic.1 ).

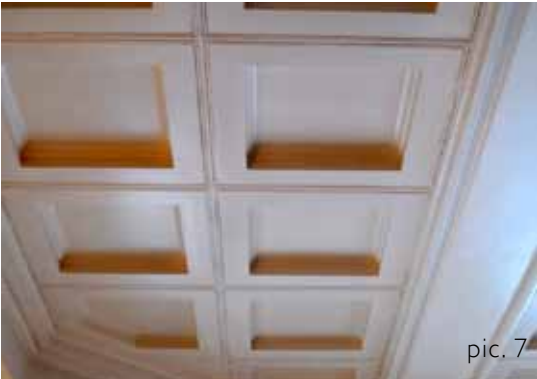
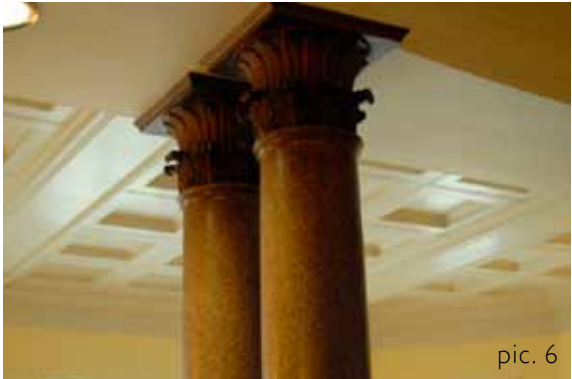
A simple square coffered ceiling with simple cornice sits above the stair enclosure (pic. 6&7).

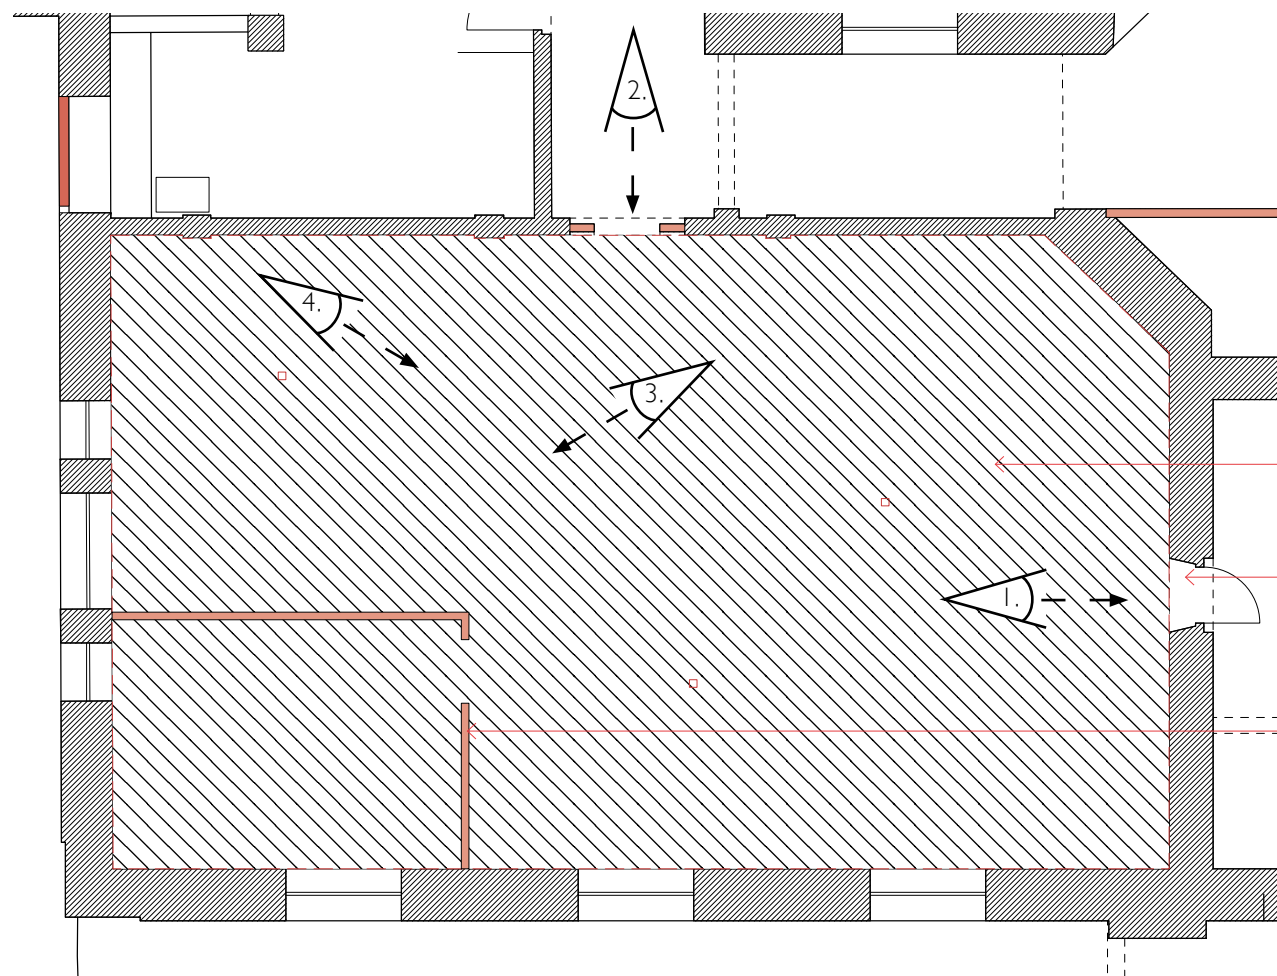
## Internal Fabric Report : Basement South West

Non original suspended ceiling

New door and frame within larger original opening

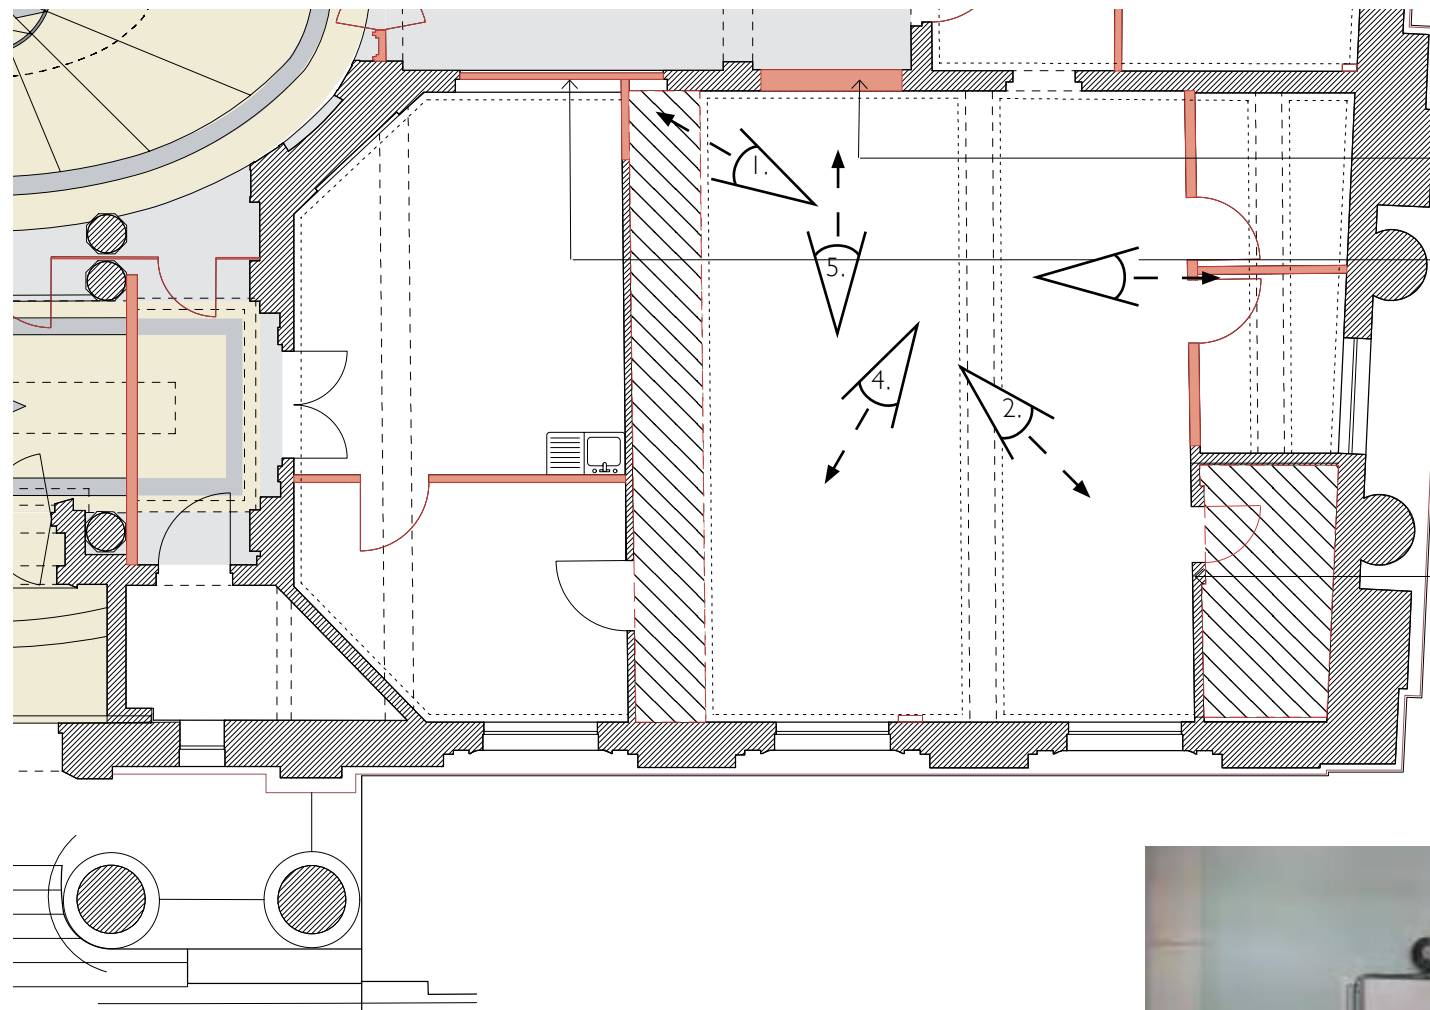
Original doorway blocked up and new entrance point into room located adjacent

Original opening blocked up

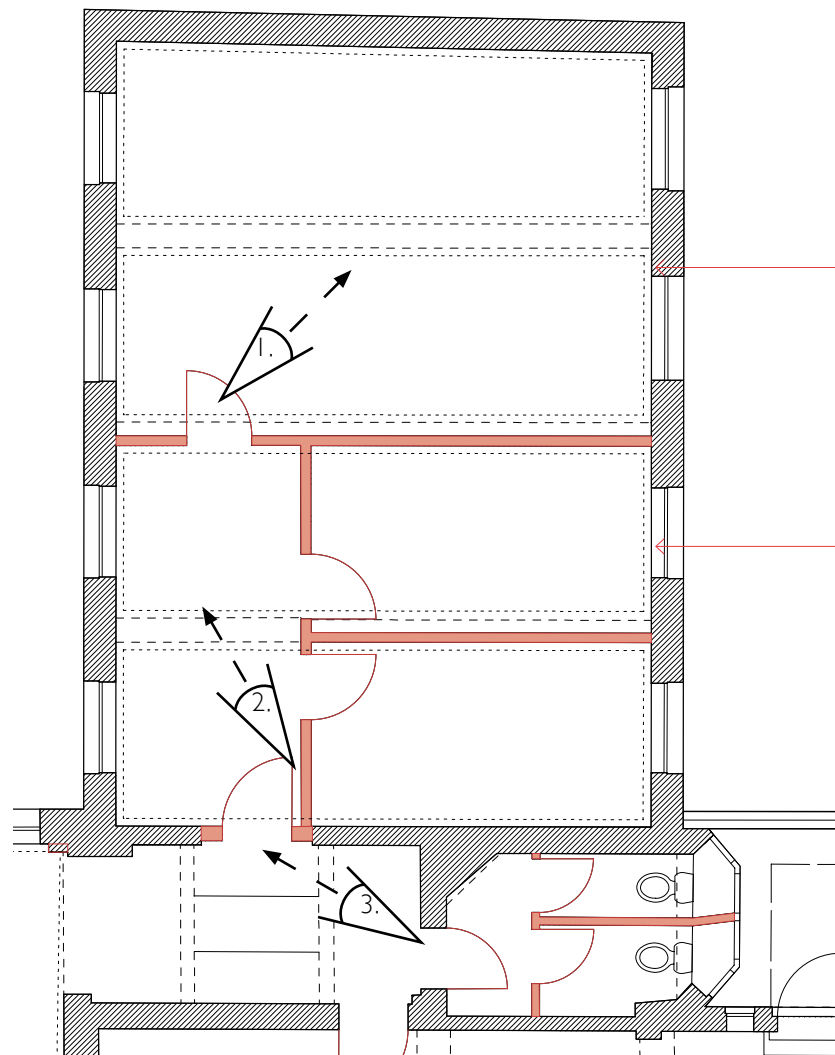
## Internal Fabric Report : Second North West

Power and data services within desk height trunking along walls

Modern radiators beneath windows
