Buccleuch Church, 33 Chapel Street, Edinburgh Historic Building Recording Report

AOC 22983

27th March 2015

Historical Building Recording Report

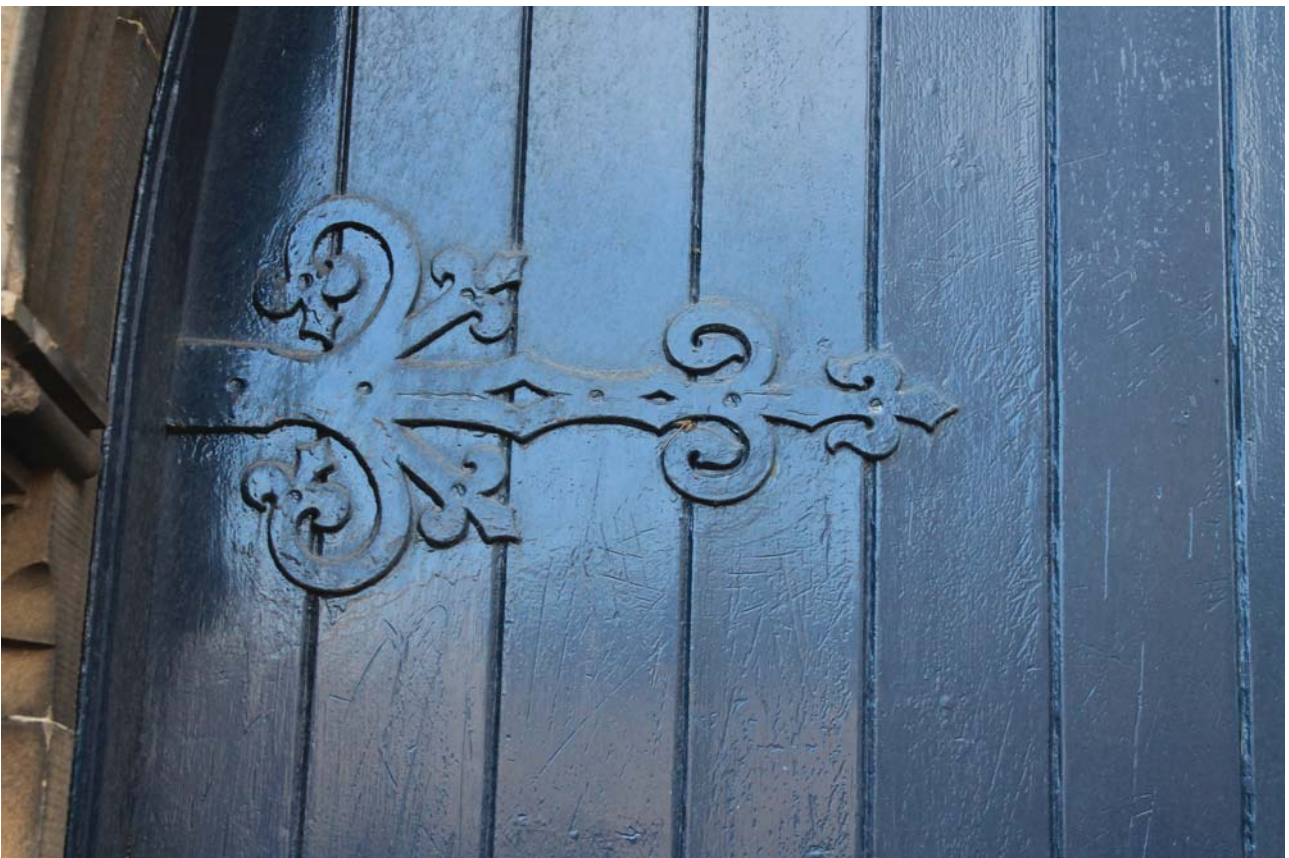
Plate 6: North-east elevation, detail of door hinge from the north-east

- 5.1.1 Buccleuch Church is a 3 x 3 bay stone rubble church with a pitched slate roof, angled north tower and north-west transept. Much of it dates from the original 18th century construction. However, there were some later additions – and blocking of original openings – in the 1860s refurbishment phase. The front of the church to the north-east facing Chapel Street is dominated by a large gable front (Plate 1). At first floor level there is a central three-part pointed arch window with plain rose above, flanked by two smaller windows with quatrefoils all with drip moulds. The gable is topped with a small clock face, also with drip mould. The ground floor windows flanking the porch, which were boarded at the time of survey. However, the interior exposed these to be two-part pointed arched windows with oculus. The porch itself is part of the later 1860s renovations, as depicted on a datestone at the top of its gable (Plates 2 & 3). It is flanked by two engaged columns, each with a different column head (Plates 4 & 5). The door itself may be original to the 1860s, with elaborate strap hinges and some original door fittings, although these have also been replaced by modern ones (Plates 6 & 7).

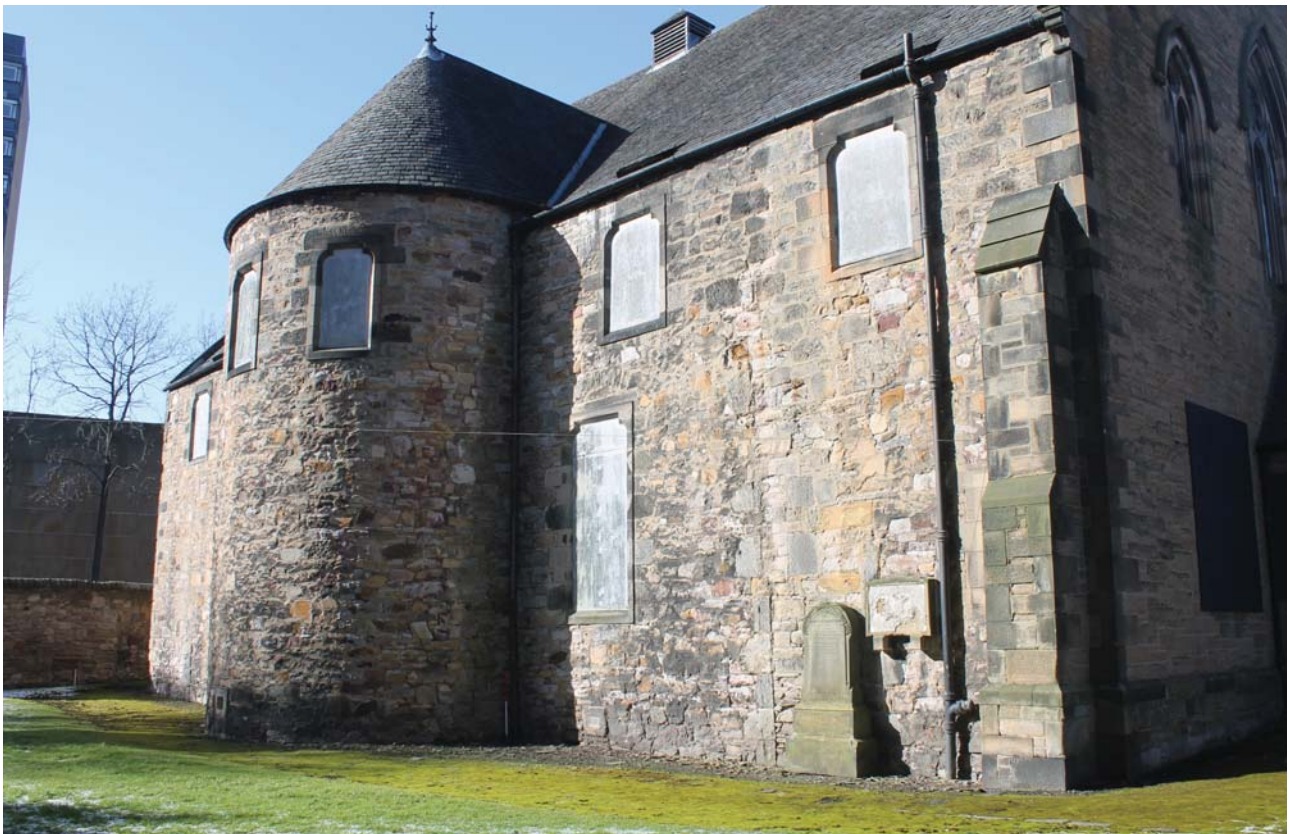
Plate 8: South-east elevation, general view from the east

- 5.1.2 The south-east elevation is set in front of a patch of grassland with a dominant rounded bay (the organ bay) in the centre (Plates 8 & 9). It is constructed of stone rubble which has been heavily re-mortared with cement, which has led to the severe weathering of much of the stonework. The buttress to the north-west side is part of the 1860s refurbishments, constructed in a neater style with chisel-dressed quoins (Plate 10). To the north-east and south-west sides of this elevation are two stone-blocked doorways (Plates 11 & 12). These are clearly the original 18th century openings to this side which were blocked as part of the refurbishments. To either side of the rounded organ bay are two windows, both boarded at the time of survey, although the interior exposes them as simple rectangular windows. To the north-west side against the buttress, is a small tiny window which looks to be inserted (see Plate 10). It does not appear in the 1850s or 1877 map, so must be part of even later refurbishments. The first floor windows are also boarded, the interior exposed as rectangular windows, smaller in height than those to the ground floor.

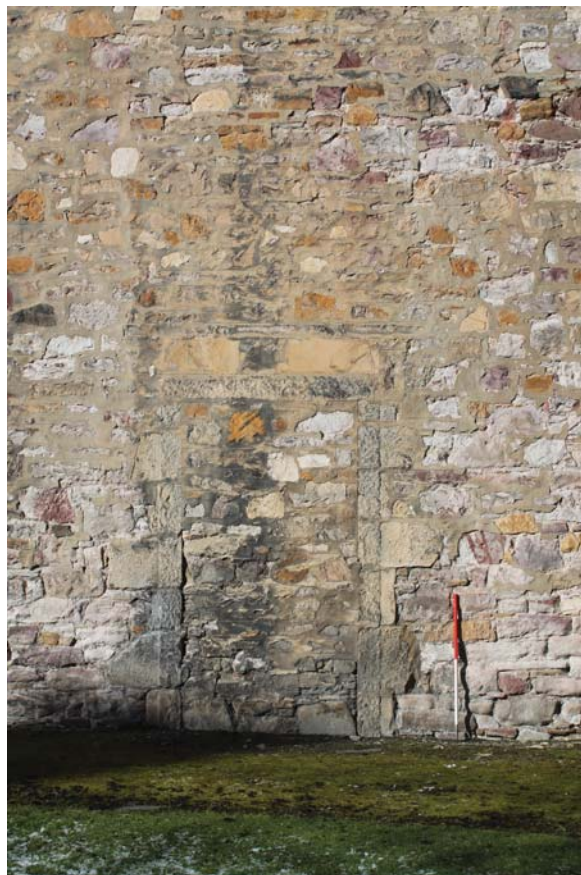
Plate 12: South-east elevation, detail of the blocked opening to the south-west side from the south-east

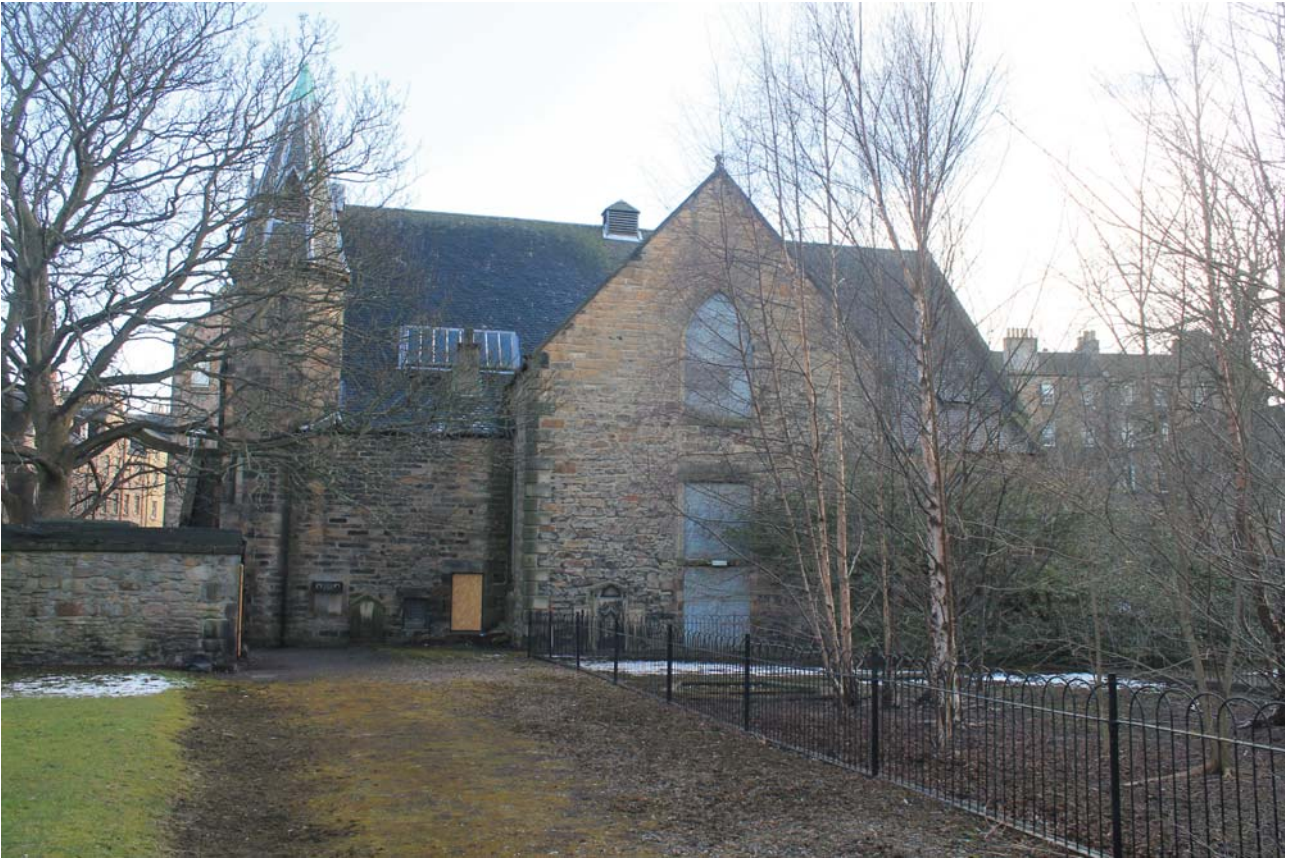
Plate 13: North-west elevation, general view from the NNE

- 5.1.3 The opposite north-west wall has a large north-west transept in the centre, a tall gable-fronted façade with raised skews and finial and chamfered ashlar quoins (Plates 13 & 14). It houses a large boarded-up rectangular doorway, with rectangular boarded-over light above, and a pointed arched window above. Grave slabs have also been embedded to the wall (Plate 15). This part of the building appears on both the 1852 and 1877 maps and therefore was part of the original build. To the north-east facing side of this aspect is another area of blocking (Plate 16). Boarded at the time of survey, there is a tall window which spans the ground and first floor, with an area of stone blocking beneath. There is a similar opening to the south-west.

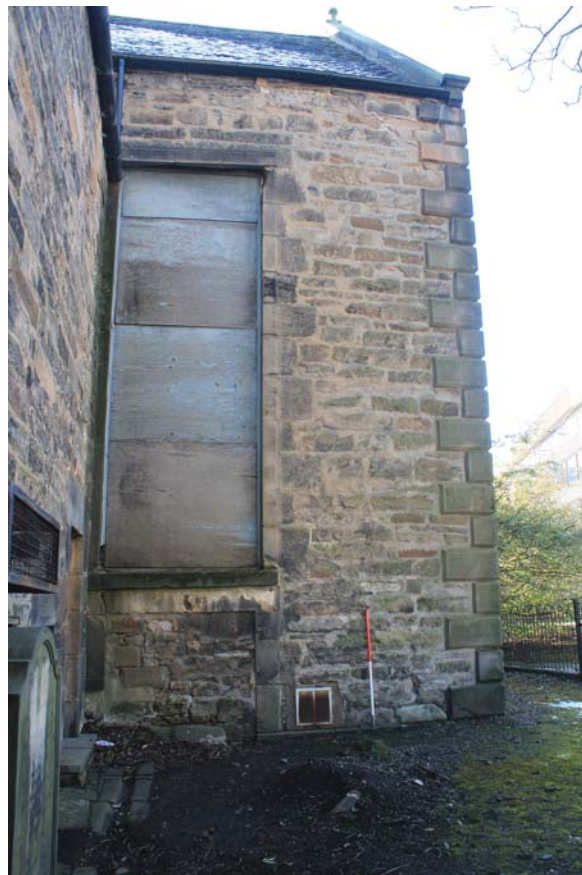
Plate 16: North-west transept, north-east elevation, detail of the large window and blocking beneath, from the north-east

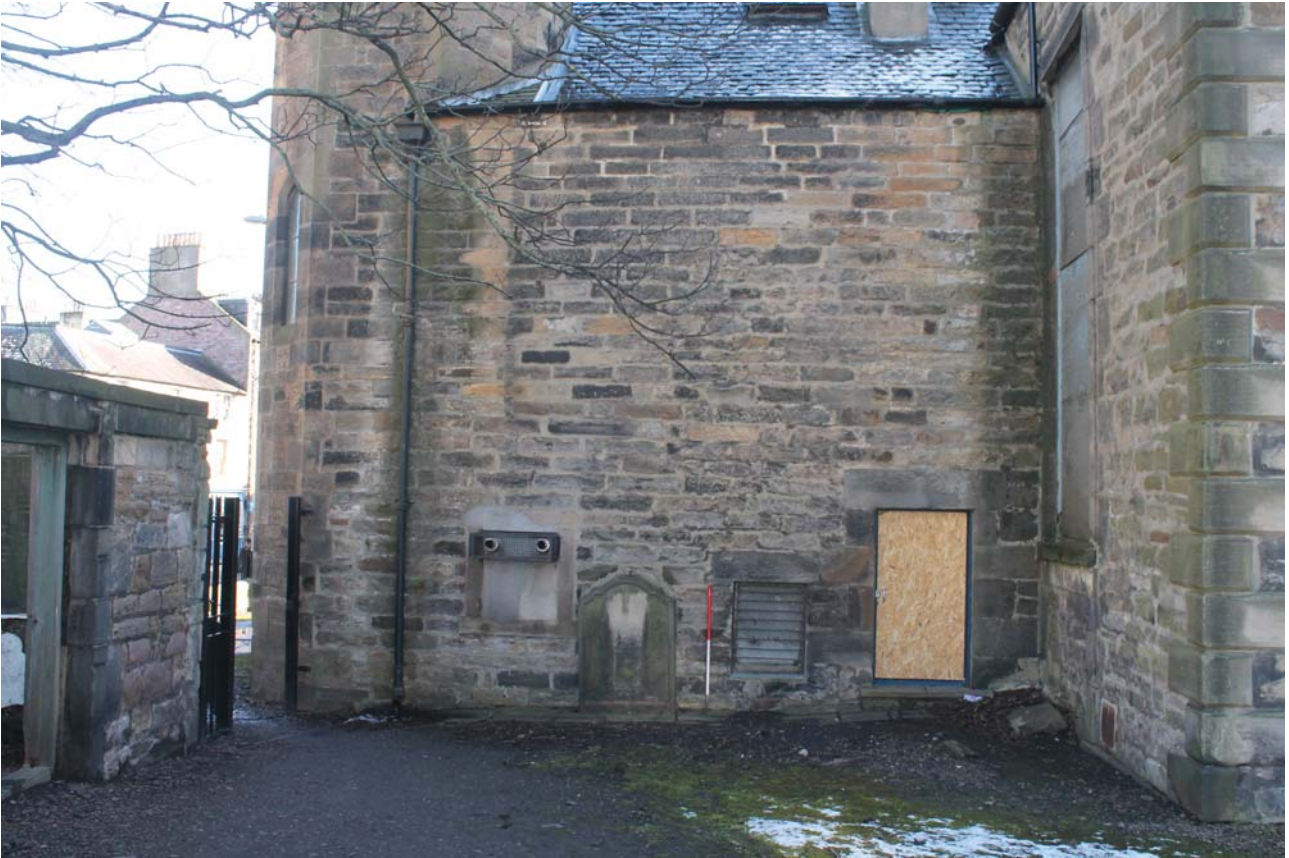
Plate 17: North-west elevation, general view of the openings to the Boiler House on the north-east side, from the north-west

- 5.1.4 Flanking the central gable here are the openings relating to the original church, with a boiler room to the north-east side located beneath the interior stairwell (Plate 17). There is a small boarded-up doorway to the south-west side with a small low-set window adjacent. There is also another blocked window to the north-east side, which has been converted into a vent outlet. In the north corner of the building is a tall bell tower, built as part of the 1860s refurbishments, rising above the height of the pitched slate roof of the main building, with a conical slate roof with lead flashing with small hooded windows (Plate 18).

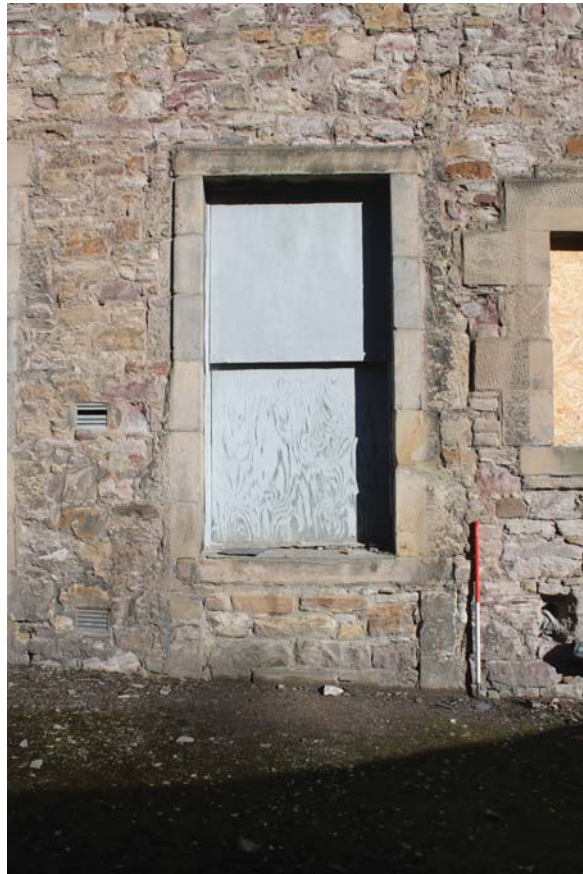
Plate 23: South-west elevation, detail of the central window, showing blocking beneath, from the south-west

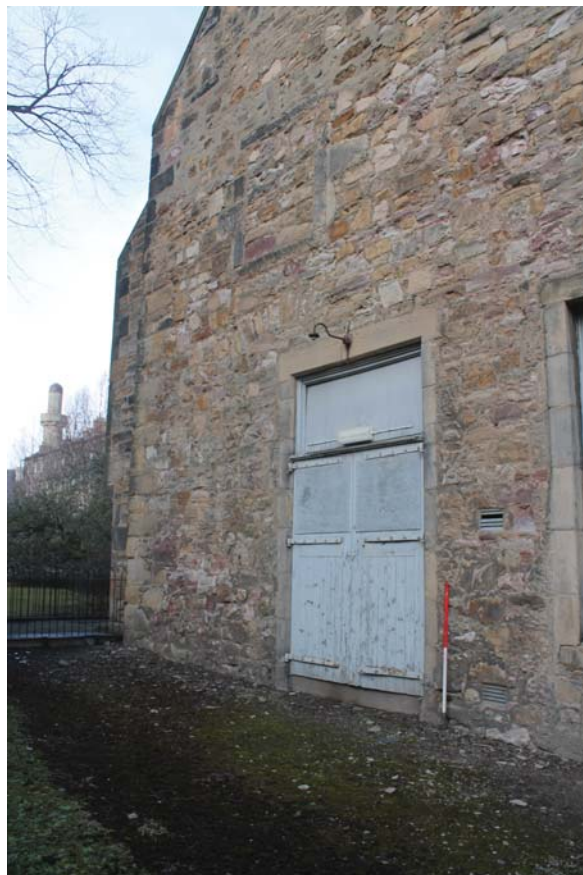
elevation. However, it is clear that there was a previous larger doorway off-set to the south-west of this, much taller, with a relieving arch over (Plate 24). There is also another blocked window above this to the first floor, identical to that on the opposite side of the elevation. There is a tall three-part pointed arch window set high in the centre of the gable (Plate 25).

Plate 24: South-west elevation, detail of the main doorway to the north-west side showing the original blocked entrance from the west

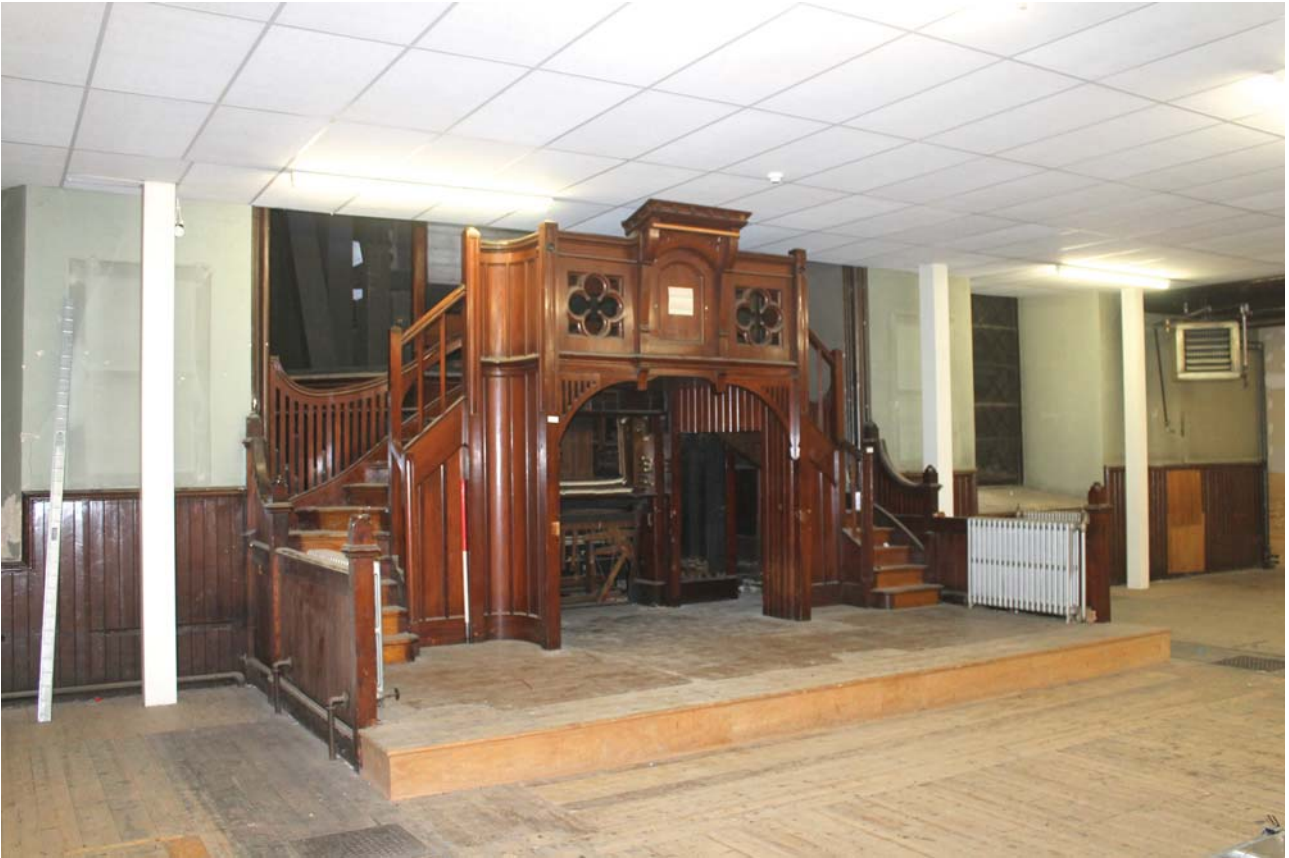
Plate 34: Room 0/1, general view of the organ in the south-east wall from the west

The south-east wall contained the organ to the centre, the structure of which ran up to the first floor level (Plates 34 - 36). Thanks to the building being kept wind and watertight, the actual timber structure of the organ was sound, although the organ itself and its fixtures and fittings were in quite a poor state (Plates 37 - 41). There is a plaque on the organ which identifies that 'Henry Willis & Sons Ltd' care for the organ, although it is not known whether they were the original suppliers (Plate 42). They are one of the oldest organ buildings in the country, with their work dating back to the 19th century, so it is possible that they were the original suppliers, although this would need to be confirmed. To either side of the organ (which is set back into the rounded bay) are two deeply splayed windows (Plates 43 & 44). Both boarded from exterior and cut off by the false ceiling, they contain elaborate stained glasswork. There is no sign of the two blocked 18th century openings to the north-east and south-west of each window respectively, the wall having been rendered over.

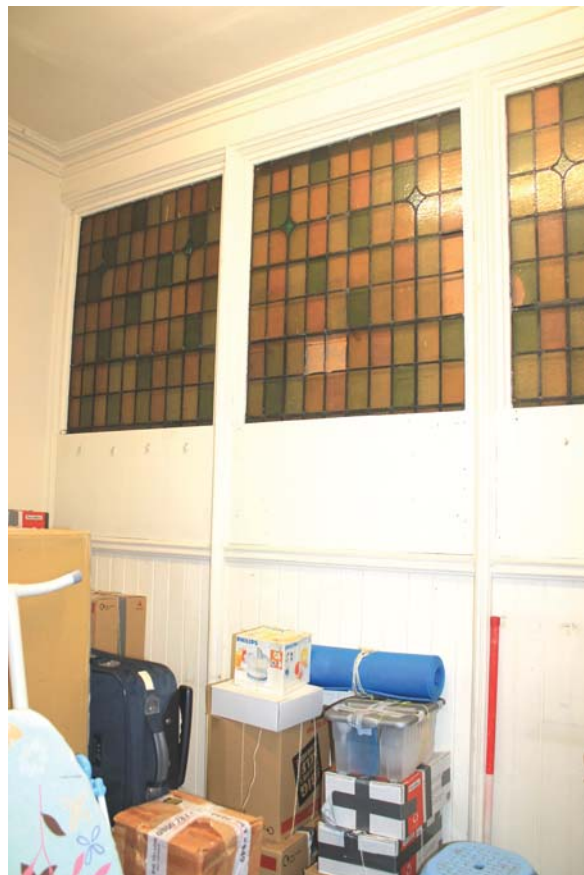
Plate 53: Room 0/2, detail of window in the north-east wall to the north-west side of the porch, from the west

To the immediate north-west side of the main entrance is also a large plain, frosted and fixed glazed two part pointed arch window with oculus above, boarded to the exterior (Plate 53).

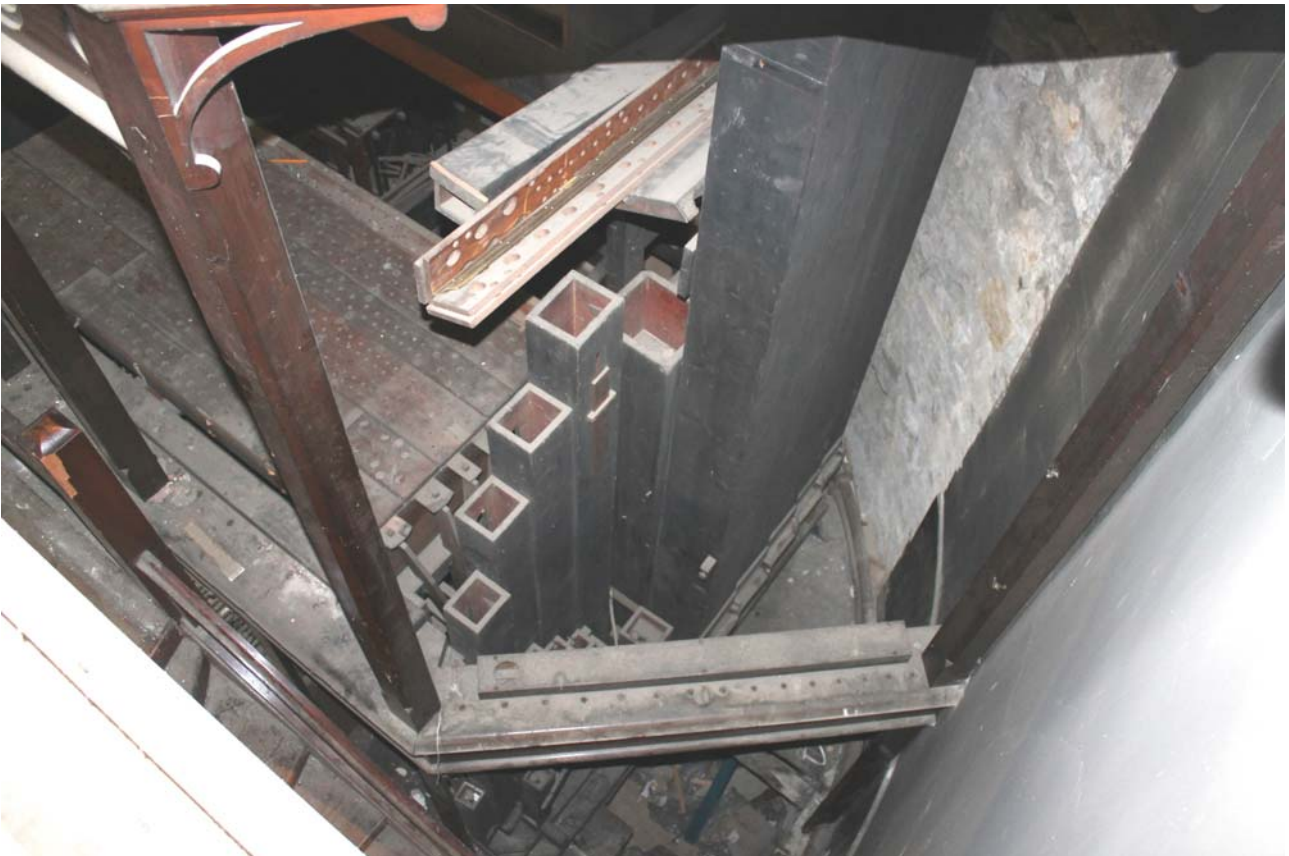
organ have also survived which can be viewed by looking down from the first floor (Plate 70). To either side of the organ, were simple rectangular windows with stained glass windows (Plates 71 & 72).

Plate 70: Room 1/1, detail of the top of the timberwork of the piping of the organ from the north

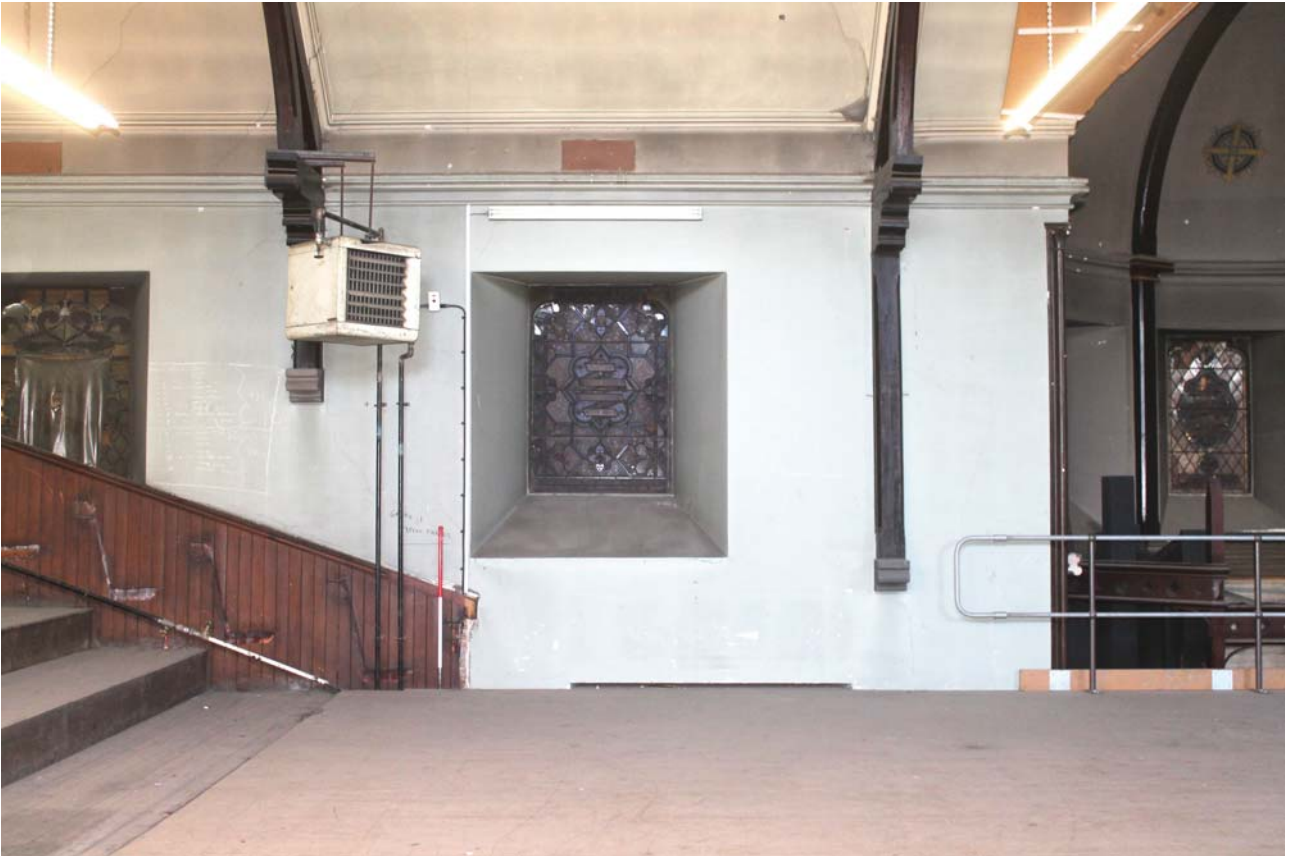
Plate 71: Room 1/1, detail of the window in the south-east wall to the north-east of the organ from the south-west

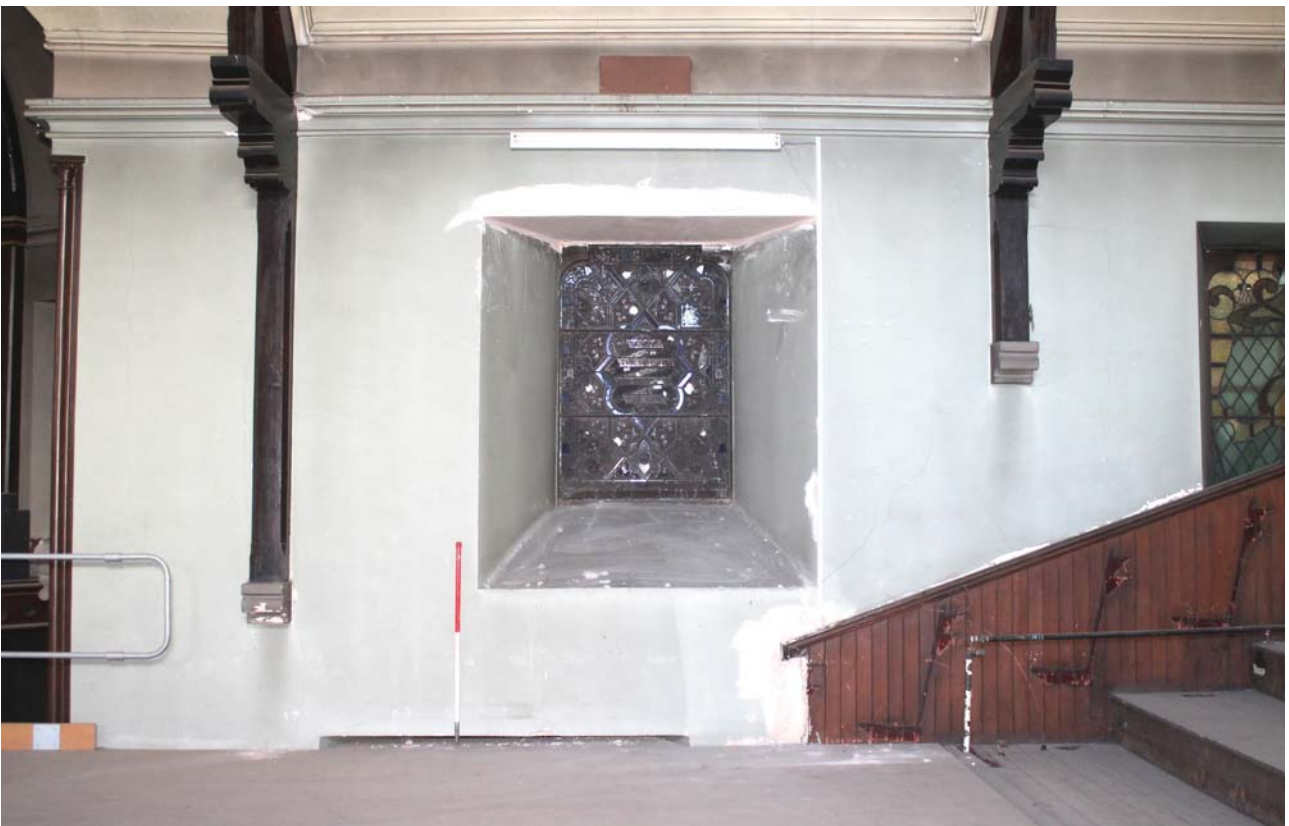
Plate 72: Room 1/1, detail of the window in the south-east wall to the south-west of the organ from the south-west

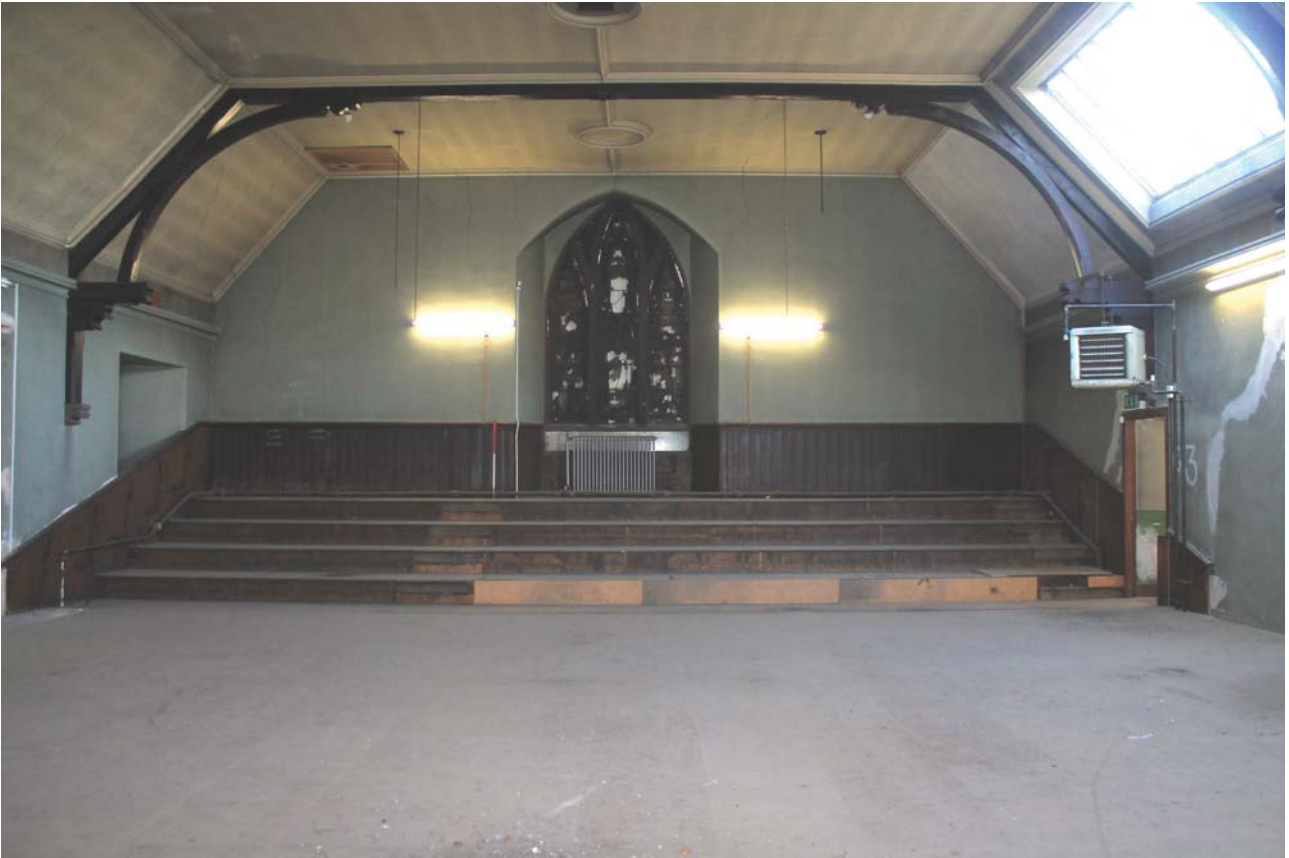
The end south-west wall - as with the opposite wall – had the remains of the timber tiering for the gallery seating, set before a larger pointed arch window (Plates 73 & 74).

Plate 73: Room 1/1, general view from the south-west

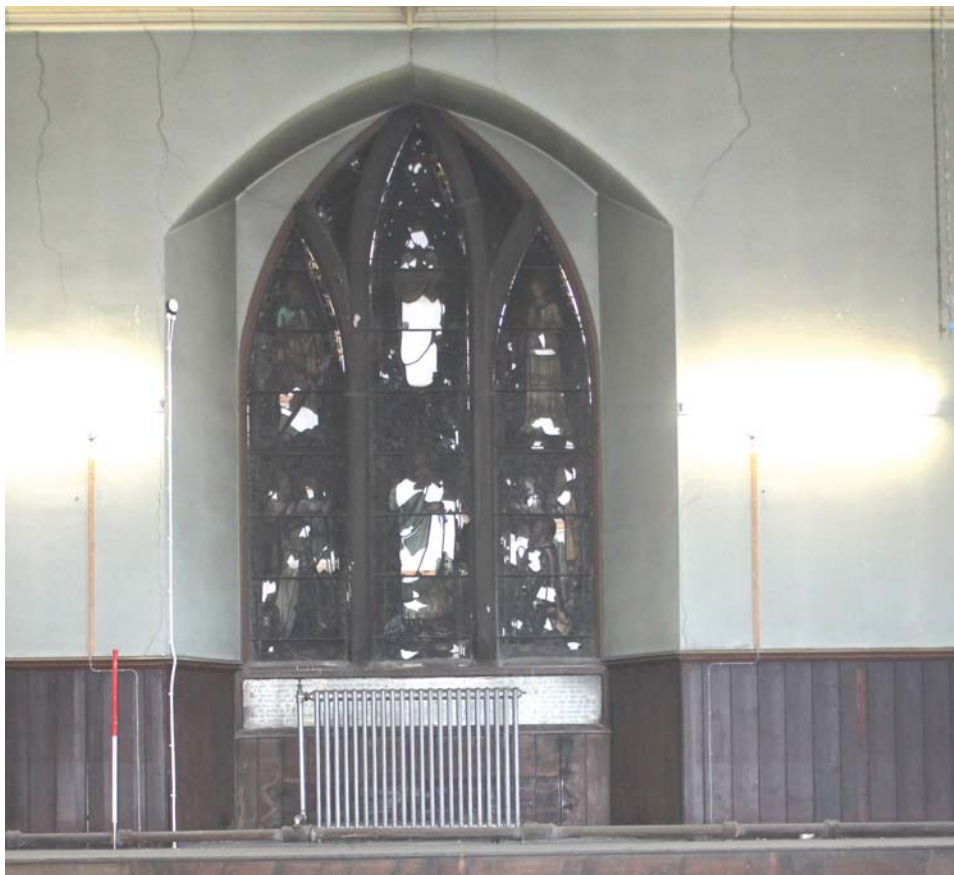
Plate 74: Room 1/1, detail of window in the north-east wall from the north-east

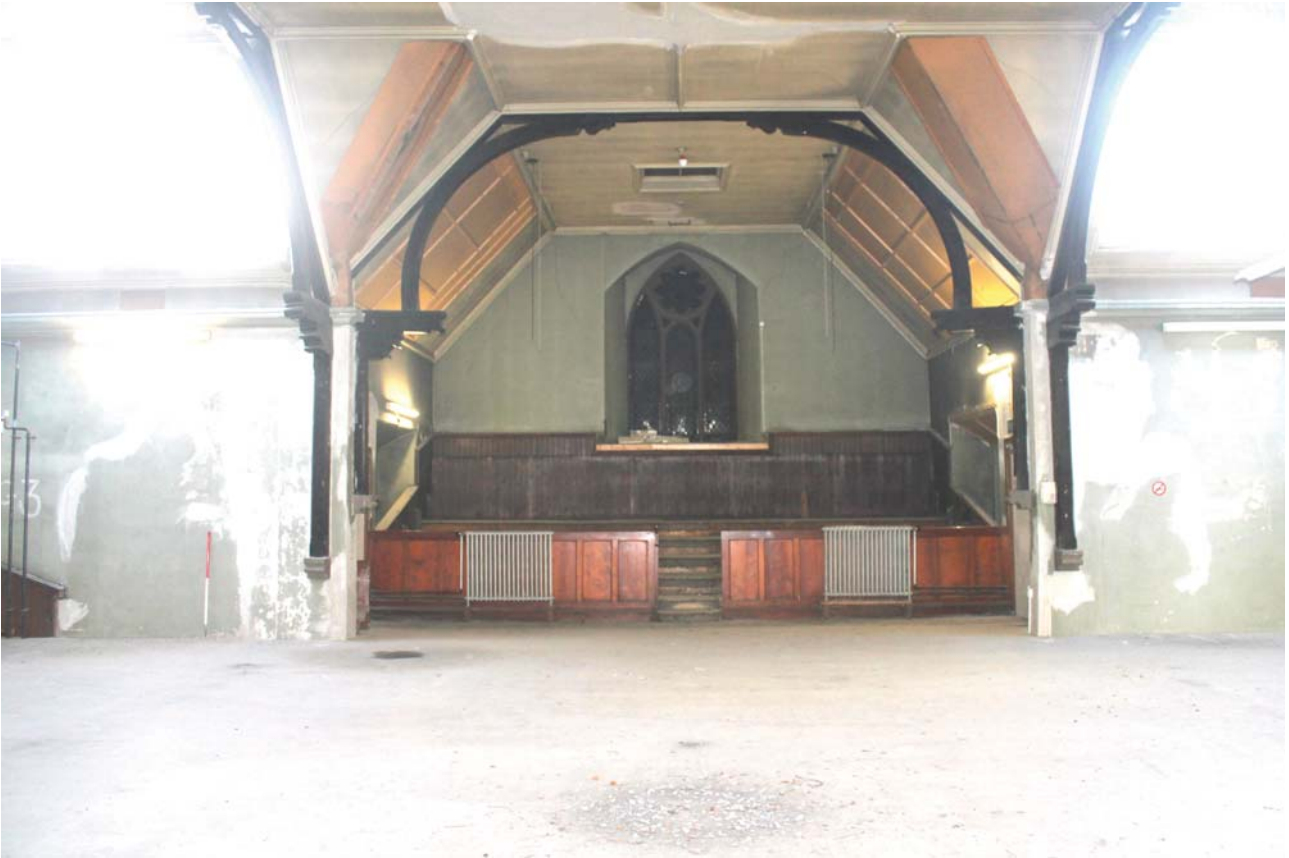
The north-west transept was set back with its own seating, partitioned off from the main gallery by timber panelling (Plate 75). The north-east and south-west sides were identical, with the top of the windows from the ground floor adjacent to another doorway leading from the stairwell (Plates 76 & 77). Above the doorway in the south-west wall was another plaque in memory of an 'Aunt Eliza' (Plate 78).

Plate 75: Room 1/1, general view of the north-west transept from the south-east

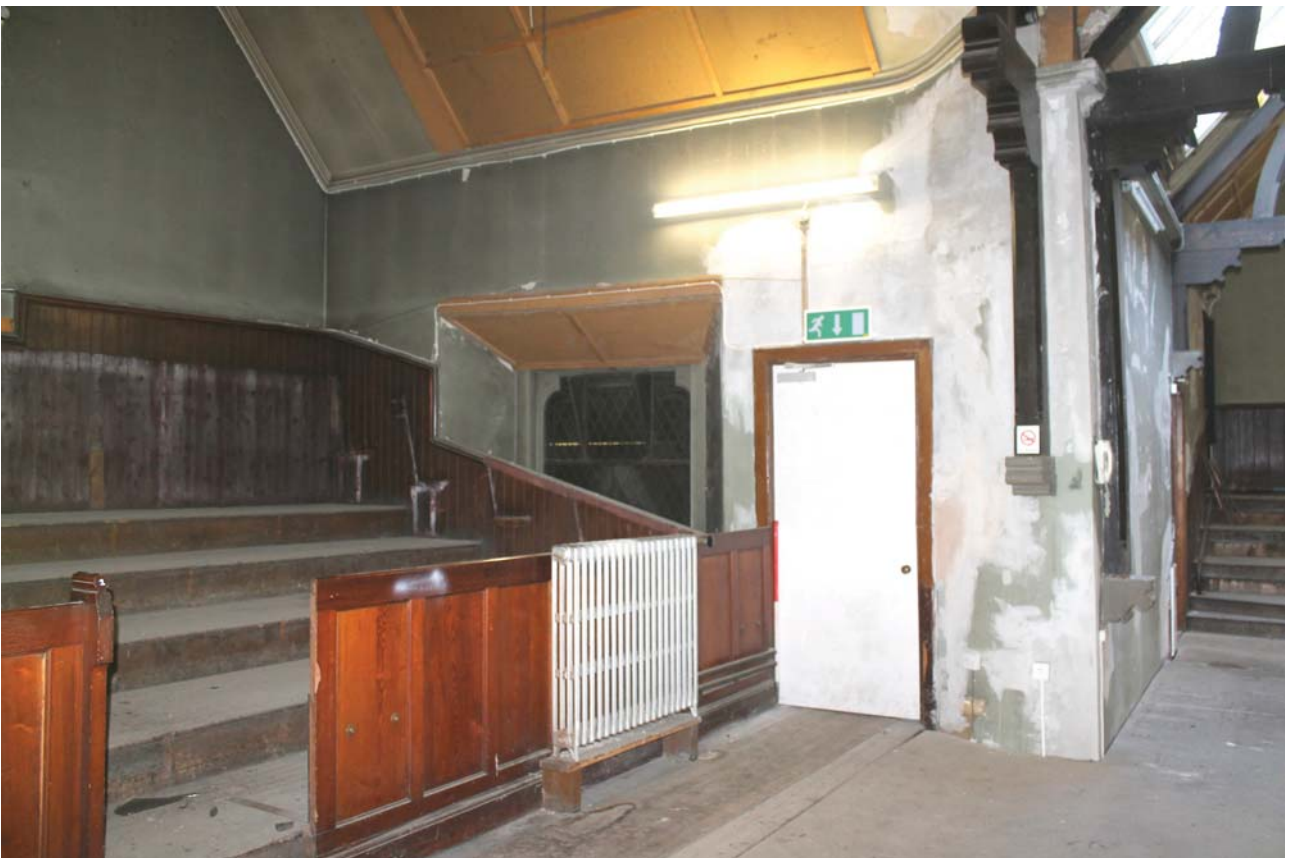
Plate 76: Room 1/1, general view of north-east wall of the north-west transept from the south

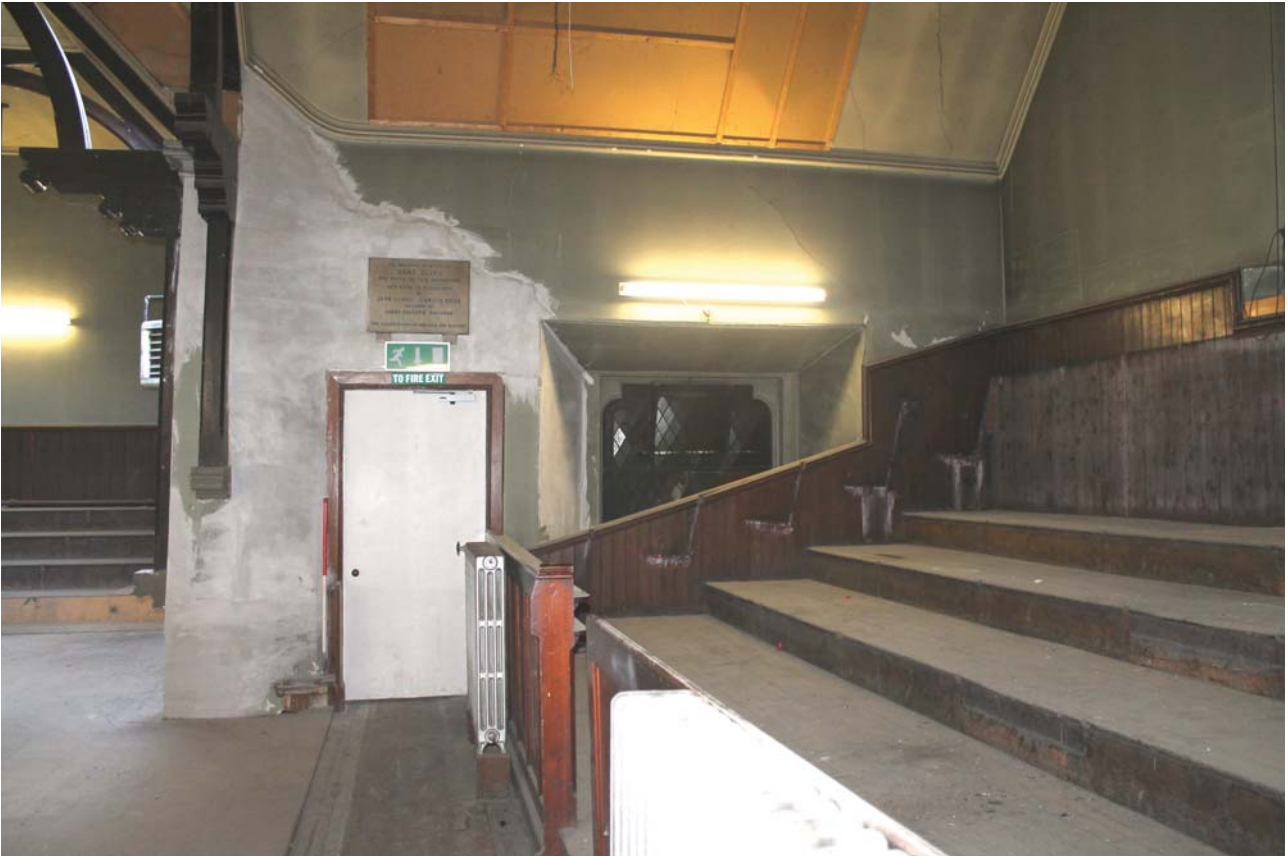
Plate 77: Room 1/1, general view of the south-west wall of the north-west transept from the north-east

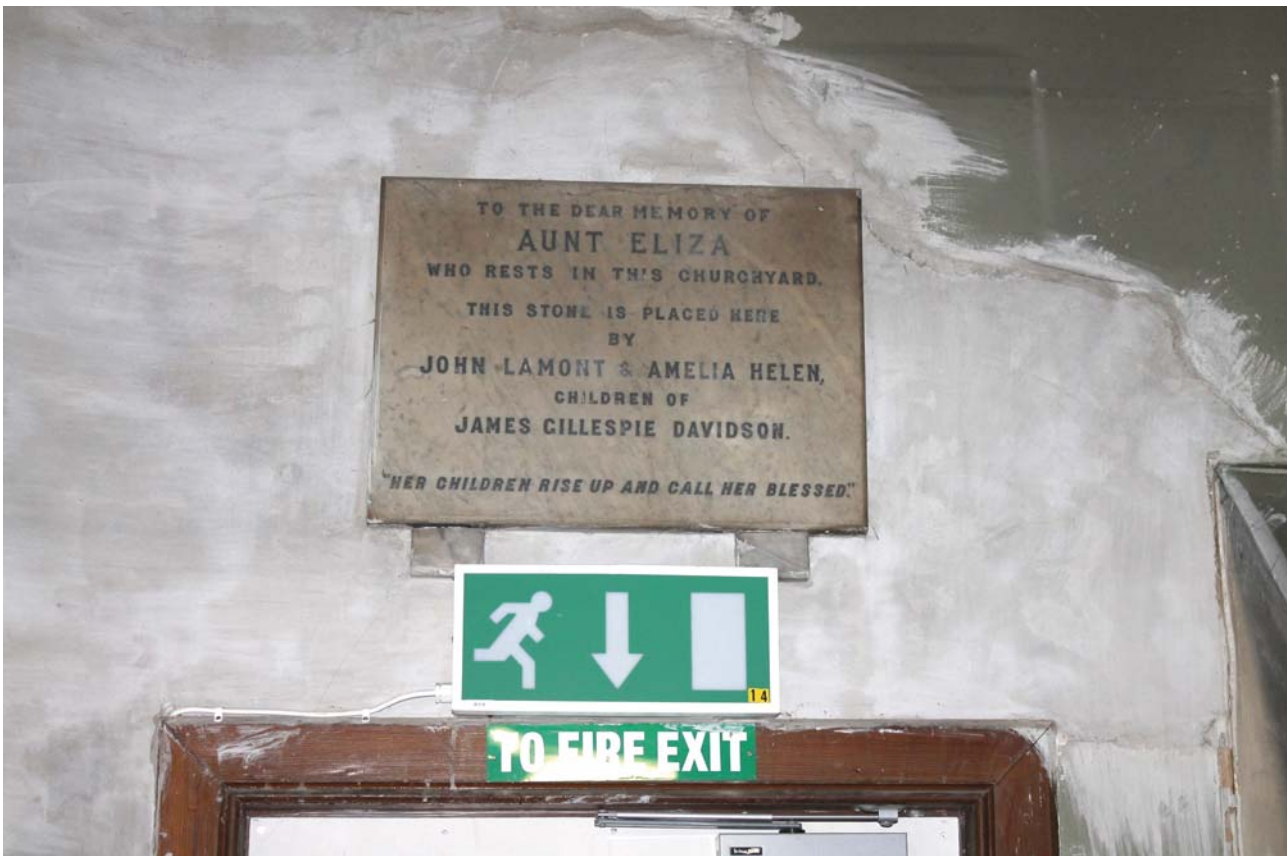
Plate 78: Room 1/1, detail of plaque on the south-west wall of the north-west transept from the north-east

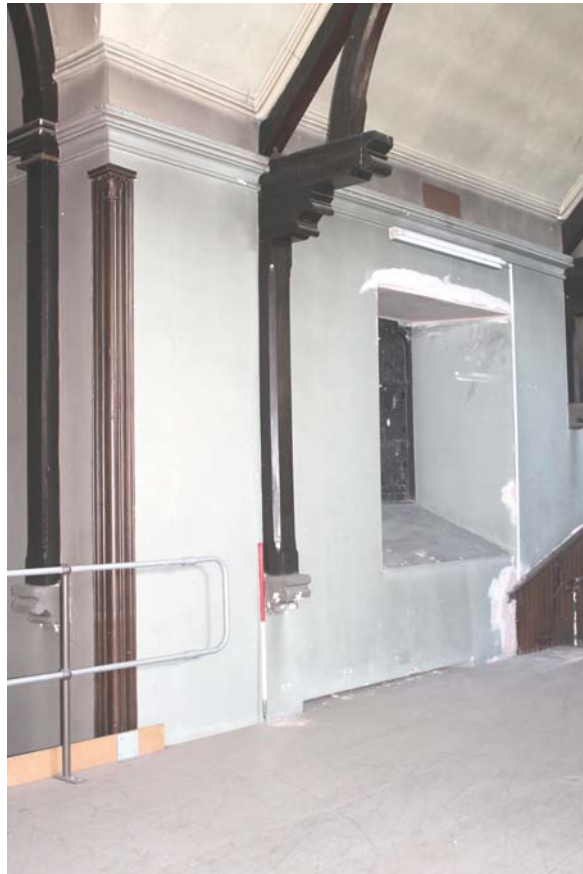
The timber roof was in a highly polished wood, with only the rafters exposed, supported against the walls over stone pedestals and with a carved decorations (Plates 79 – 81). To the centre of the plastered ceiling was a moulded surround with plain circular moulds to the north-east and south-west sides (Plates 82 – 84). The roof over the north transept was less elaborate with a plain rectangular light (Plate 85).

Plate 79: Room 1/1, detail of moulded timber rafter on the south-east wall from the north

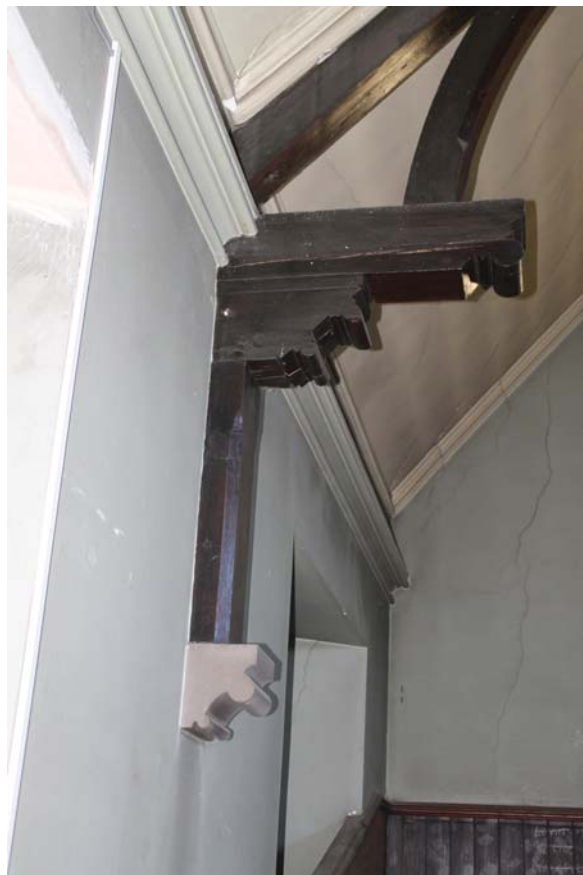
Plate 80: Room 1/1, detail of moulded timber rafter on the south-east wall from the NNE

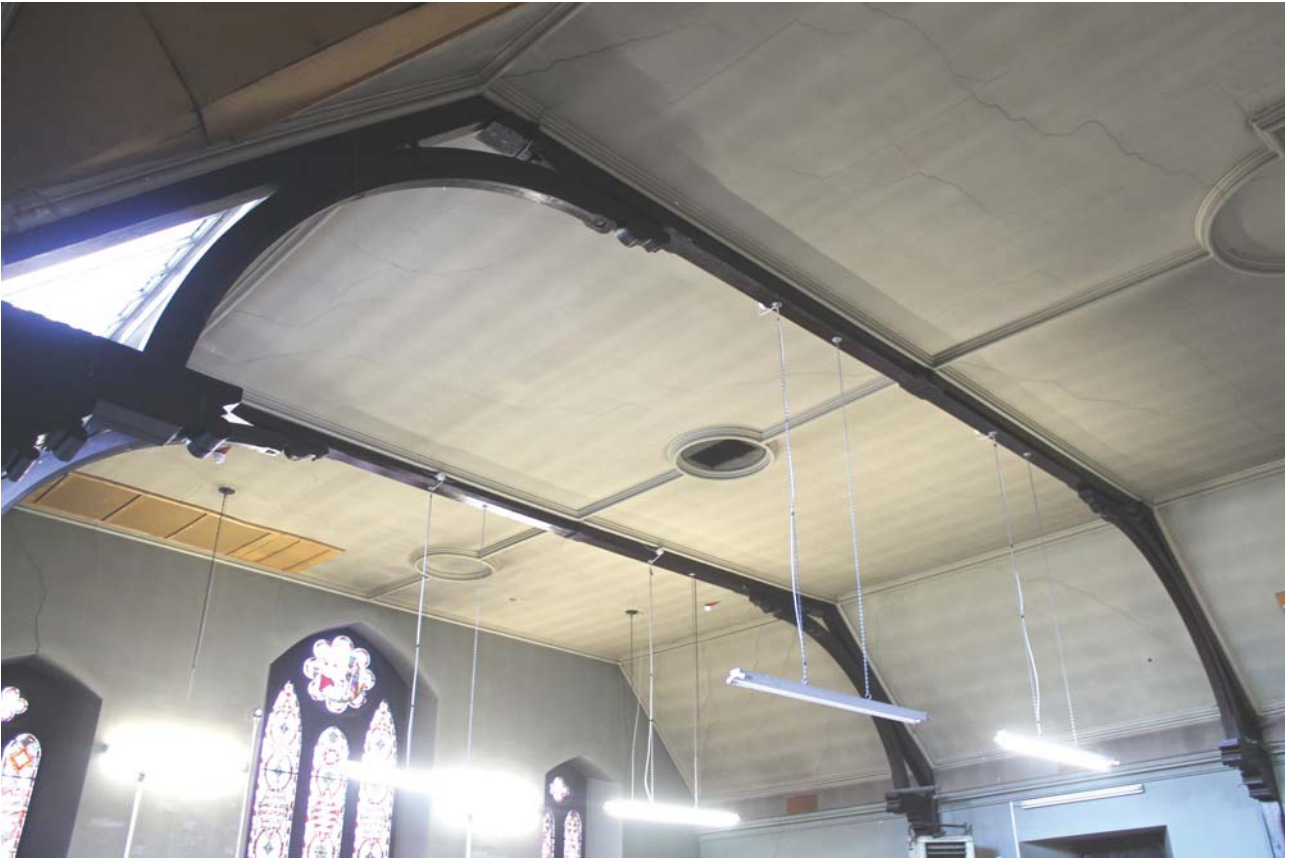
Plate 81: Room 1/1, general view of the ceiling from the west
