Buccleuch Church, 33 Chapel Street, Edinburgh Historic Building Recording Report

AOC 22983

27th March 2015

Historical Building Recording Report

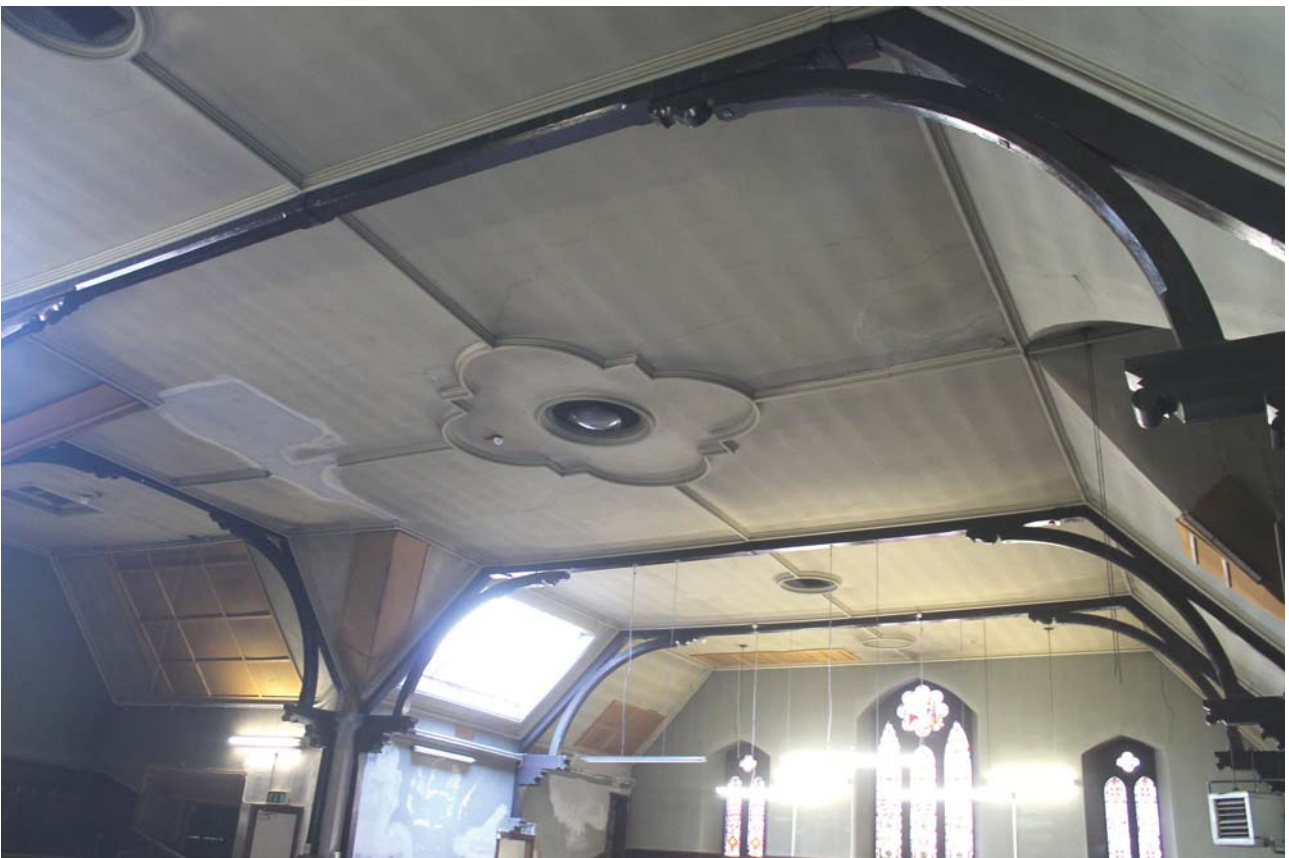
The timber roof was in a highly polished wood, with only the rafters exposed, supported against the walls over stone pedestals and with a carved decorations (Plates 79 – 81). To the centre of the plastered ceiling was a moulded surround with plain circular moulds to the north-east and south-west sides (Plates 82 – 84). The roof over the north transept was less elaborate with a plain rectangular light (Plate 85).

Plate 82: Room 1/1, general view of the ceiling from the south

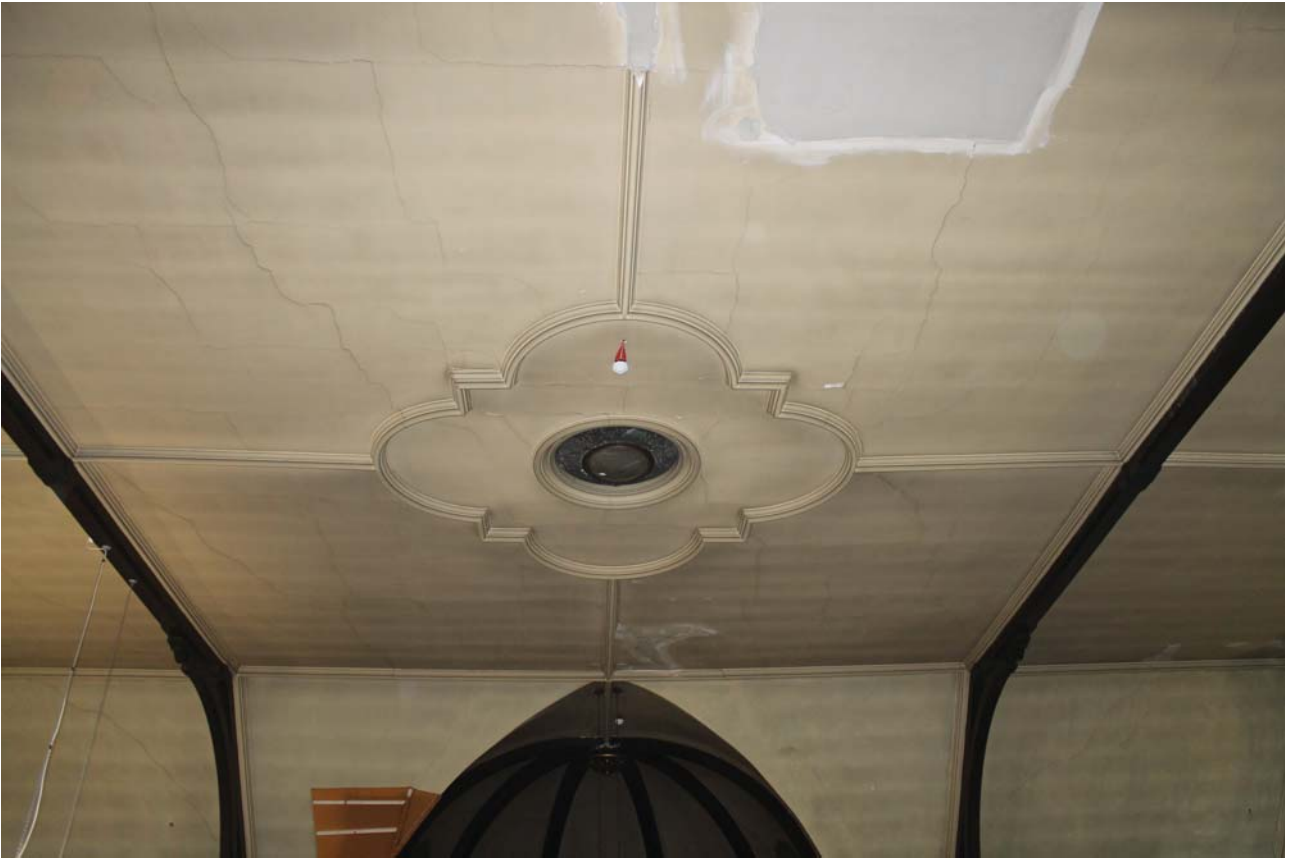
Plate 83: Room 1/1, detail of central the ceiling from the south-west

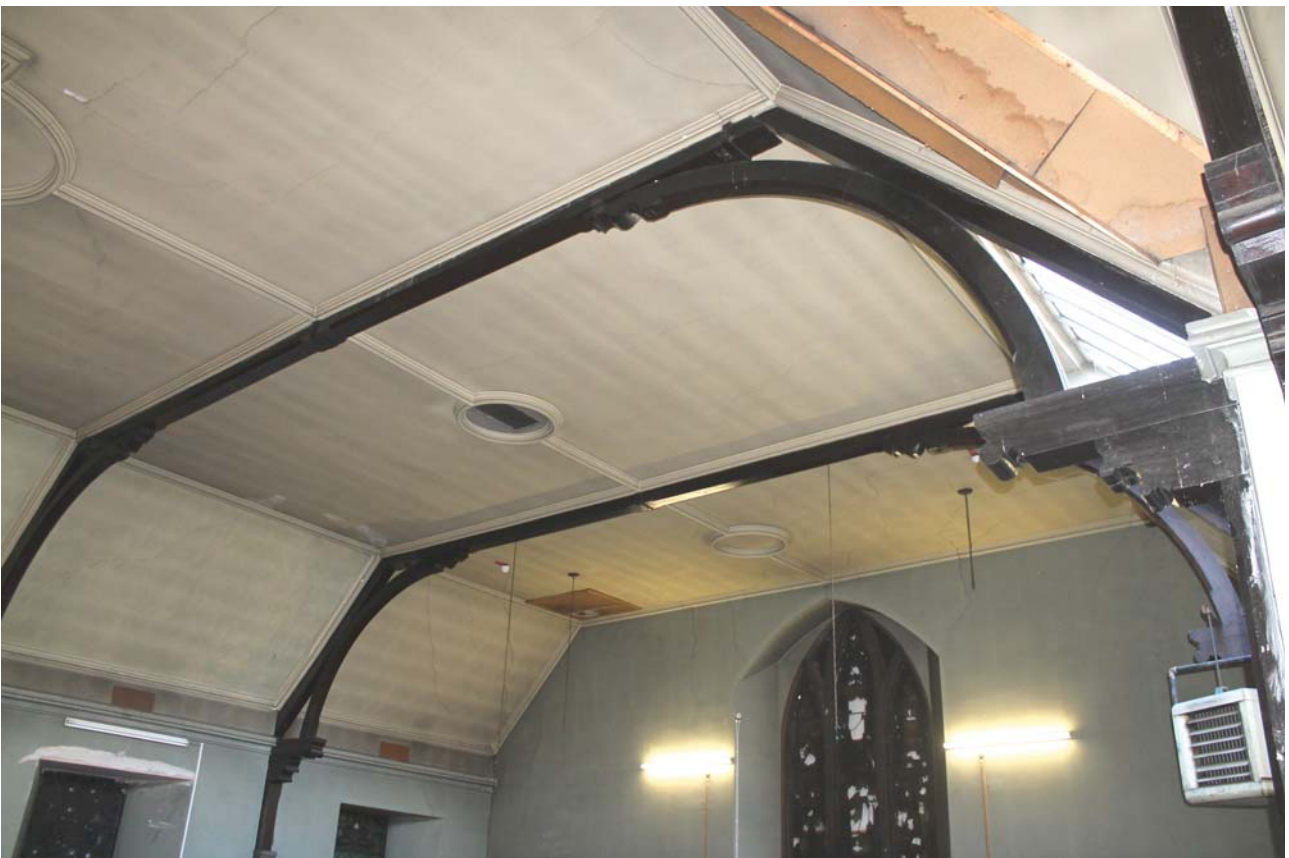
Plate 84: Room 1/1, general view of the ceiling from the east

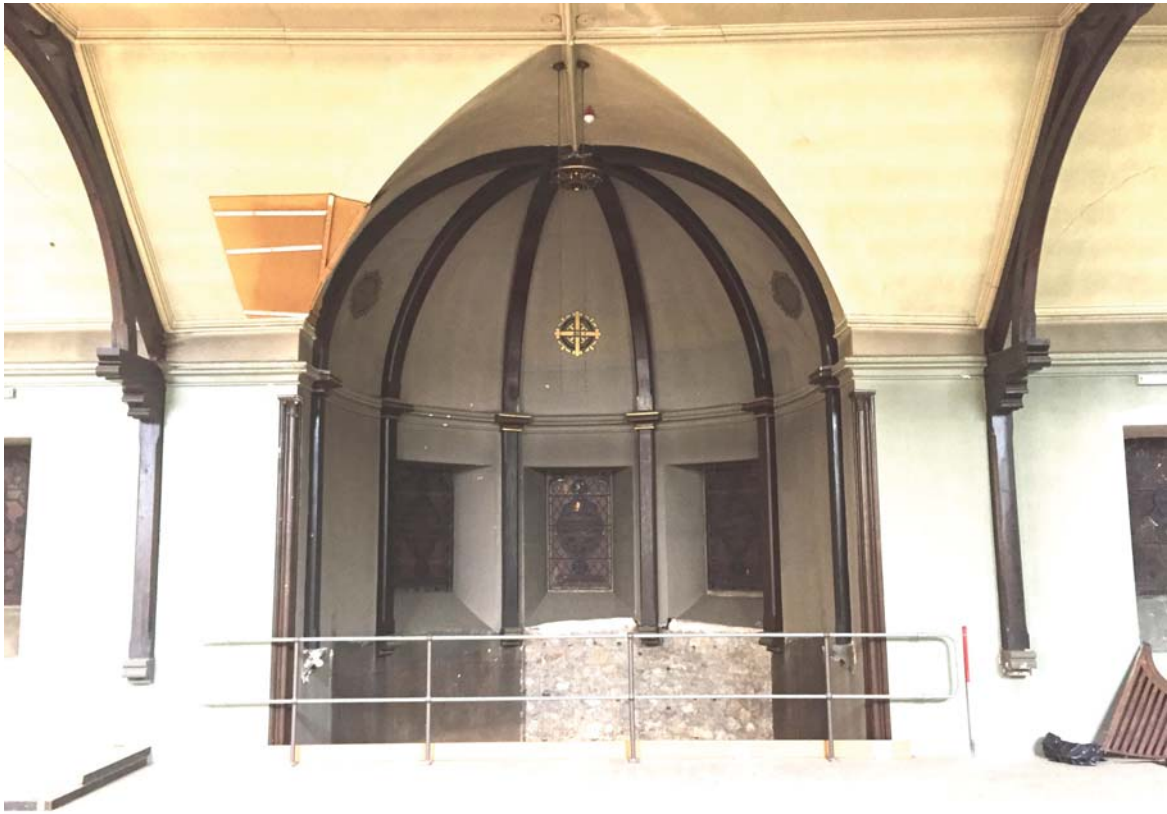
With the exception of the main front screen the organ was removed at both floor levels (Plate 86). Behind it, the stone rubble waling was partially exposed to the rear of the rounded bay and a clear levelling course was visible) (Plates 87 & 88). However, to the east and west sides, some decorative plasterwork was located, a red on brown with some gold (Plates 89 & 90). There was a small cavity below the organ area forming a small knee high crawl space, latterly used as a store, although originally there may have been the mechanisms for the operation of a larger or original organ. No other new features were identified after the organ removal to the first floor, the decorative plasterwork and exposed stone rubble walling ceasing to the level below the first floor windows (Plates 91 & 92).

Plate 91: Room 1/1, general view of the north-west wall after the removal of the organ, from the south-east

carved and still relatively intact; the screen is being retained. The decorative plasterwork looks worn and old and also looks to have been disturbed by the addition of the later organ, with the central area completely devoid of it and exposed to the stonework. Hence these decorative features may date to the Victorian period.

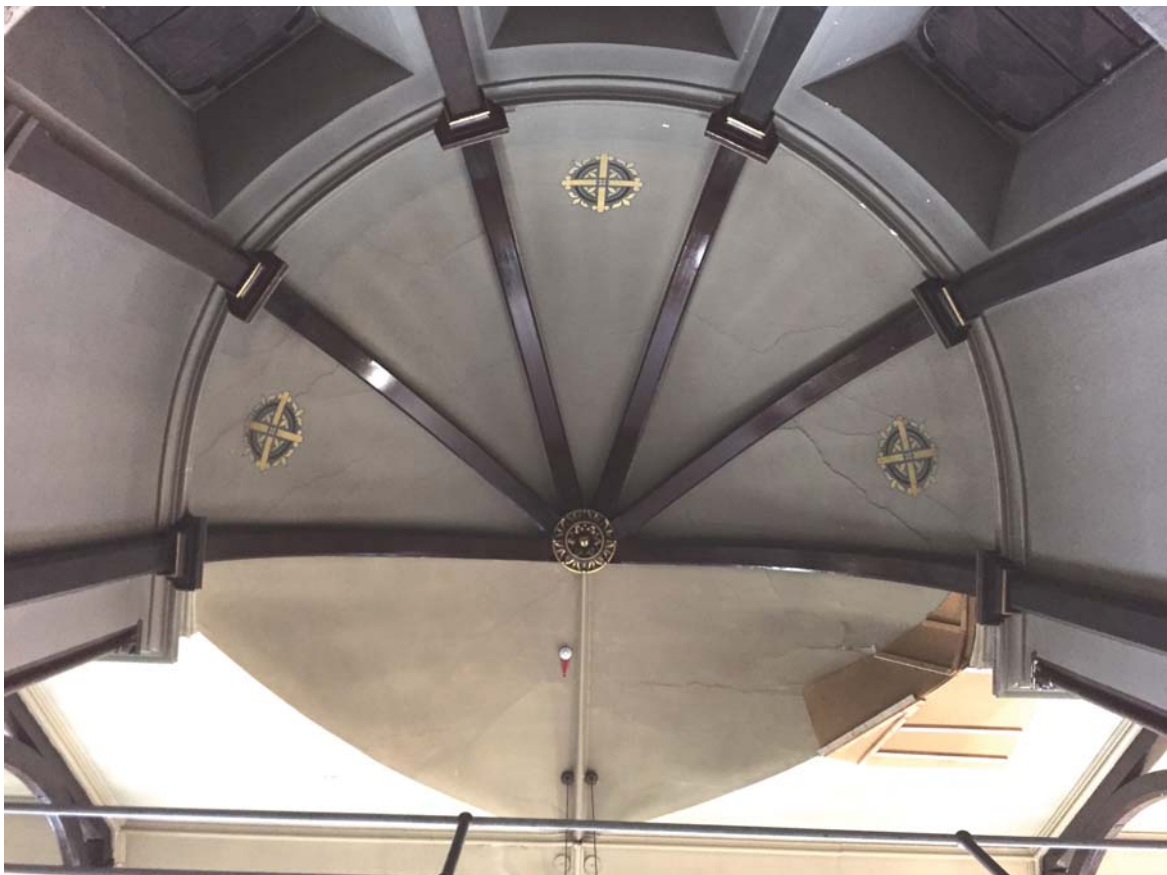
Plate 92: General view of the ceiling of the organ bay to the north-west
