# St Paul's Church, 4 Muirhouse Avenue, Edinburgh: Historic Building Recording Report

AOC Project: 23504

30<sup>th</sup> June 2016

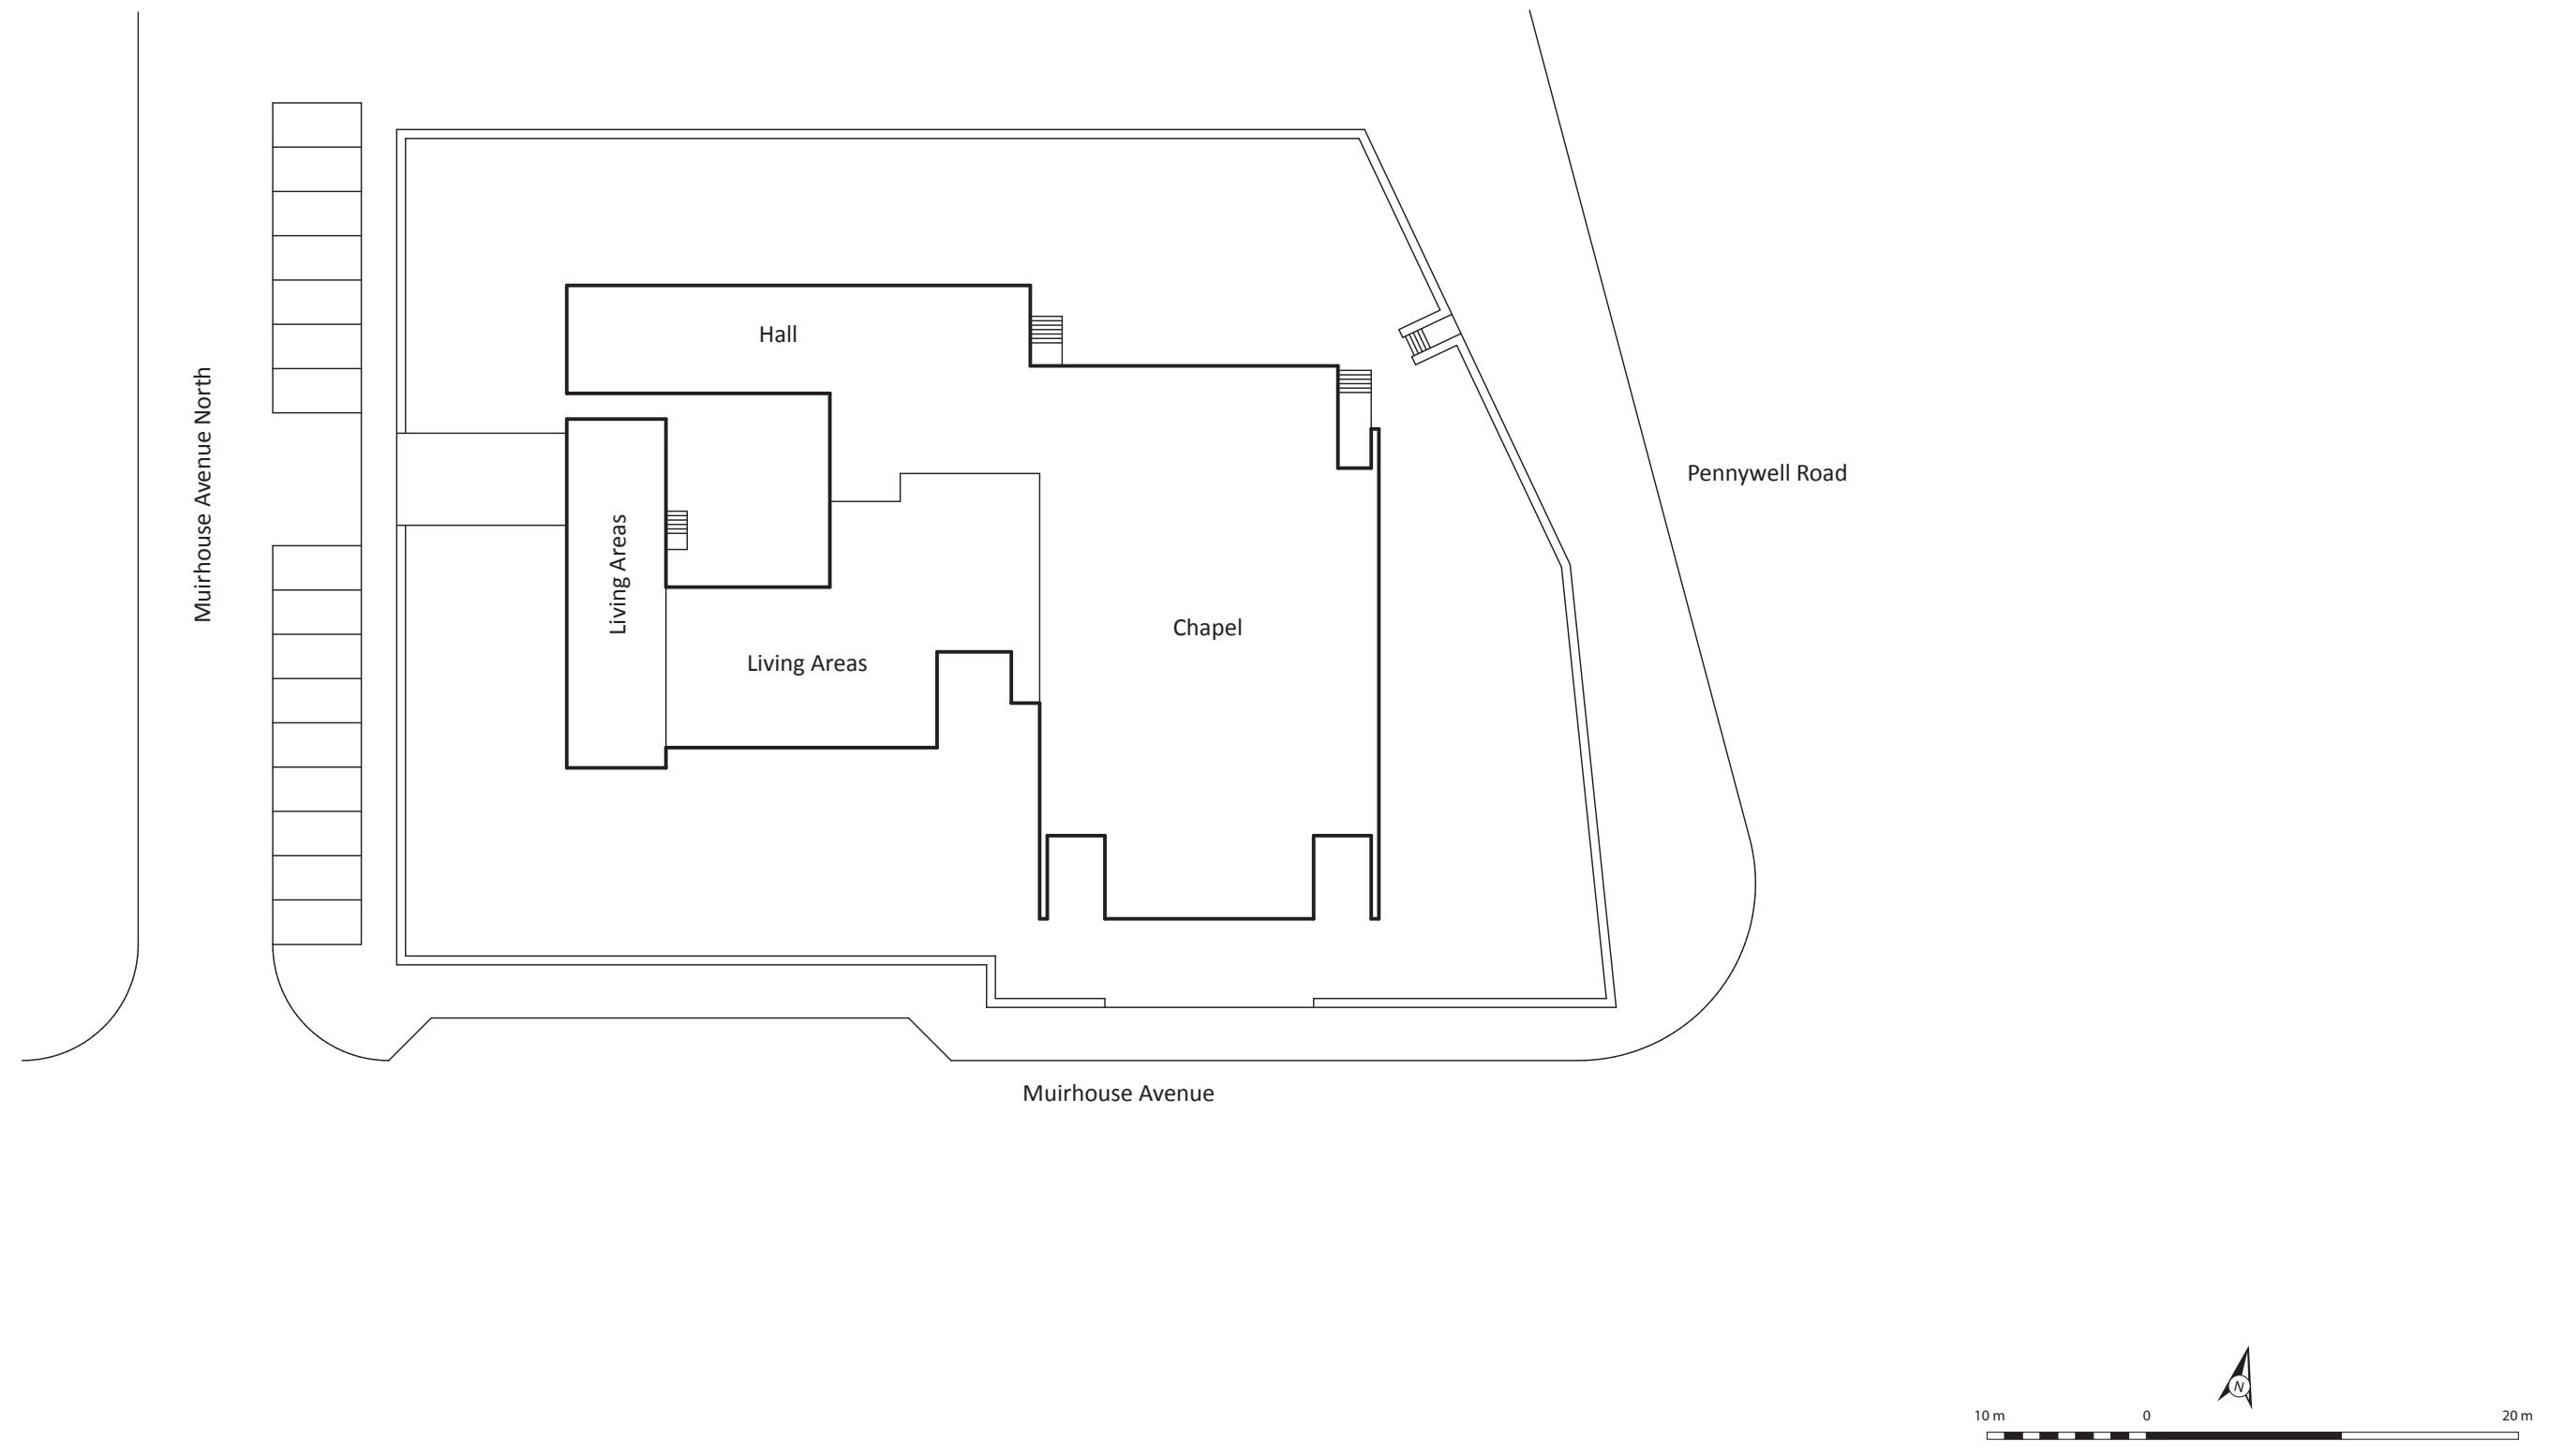
Figure 2: St Paul's Church, site plan (provided by client, Robert Mackenzie)

- 5.1 The church consists of two distinct elements, the Chapel to the east side and living quarters and a hall to the west side, both constructed of brick with white painted roughcast render (Figures 2 & 3; Plates 1 - 7). The main chapel space is double height in size and defined by two roofs, with the northern pitch rising higher than the southern pitch with a range of small windows to the south pitch to add more light to the interior space. The main vestibule to the southern side also has a sharp angle roof set slightly apart from, and sloping down to, the main chapel area, with a main entrance consisting of two double doors with tall lights above (now boarded over) (Plate 8). Additional windows feature throughout the vestibule and chapel to add even more discreet lighting, including a window to the two narthexes (Plate 9). The rear north side of the church consists of a separate activity room, accessed from the chapel. This is also double height in size, the roof sloping upwards to the north, containing six large rectangular windows halfway up the elevation (Plates 10 & 11). The remains of the brick build, sarking boards and steel beam infrastructure can today be seen from a distance due to the removal of the roof after the fire (Plate 12).

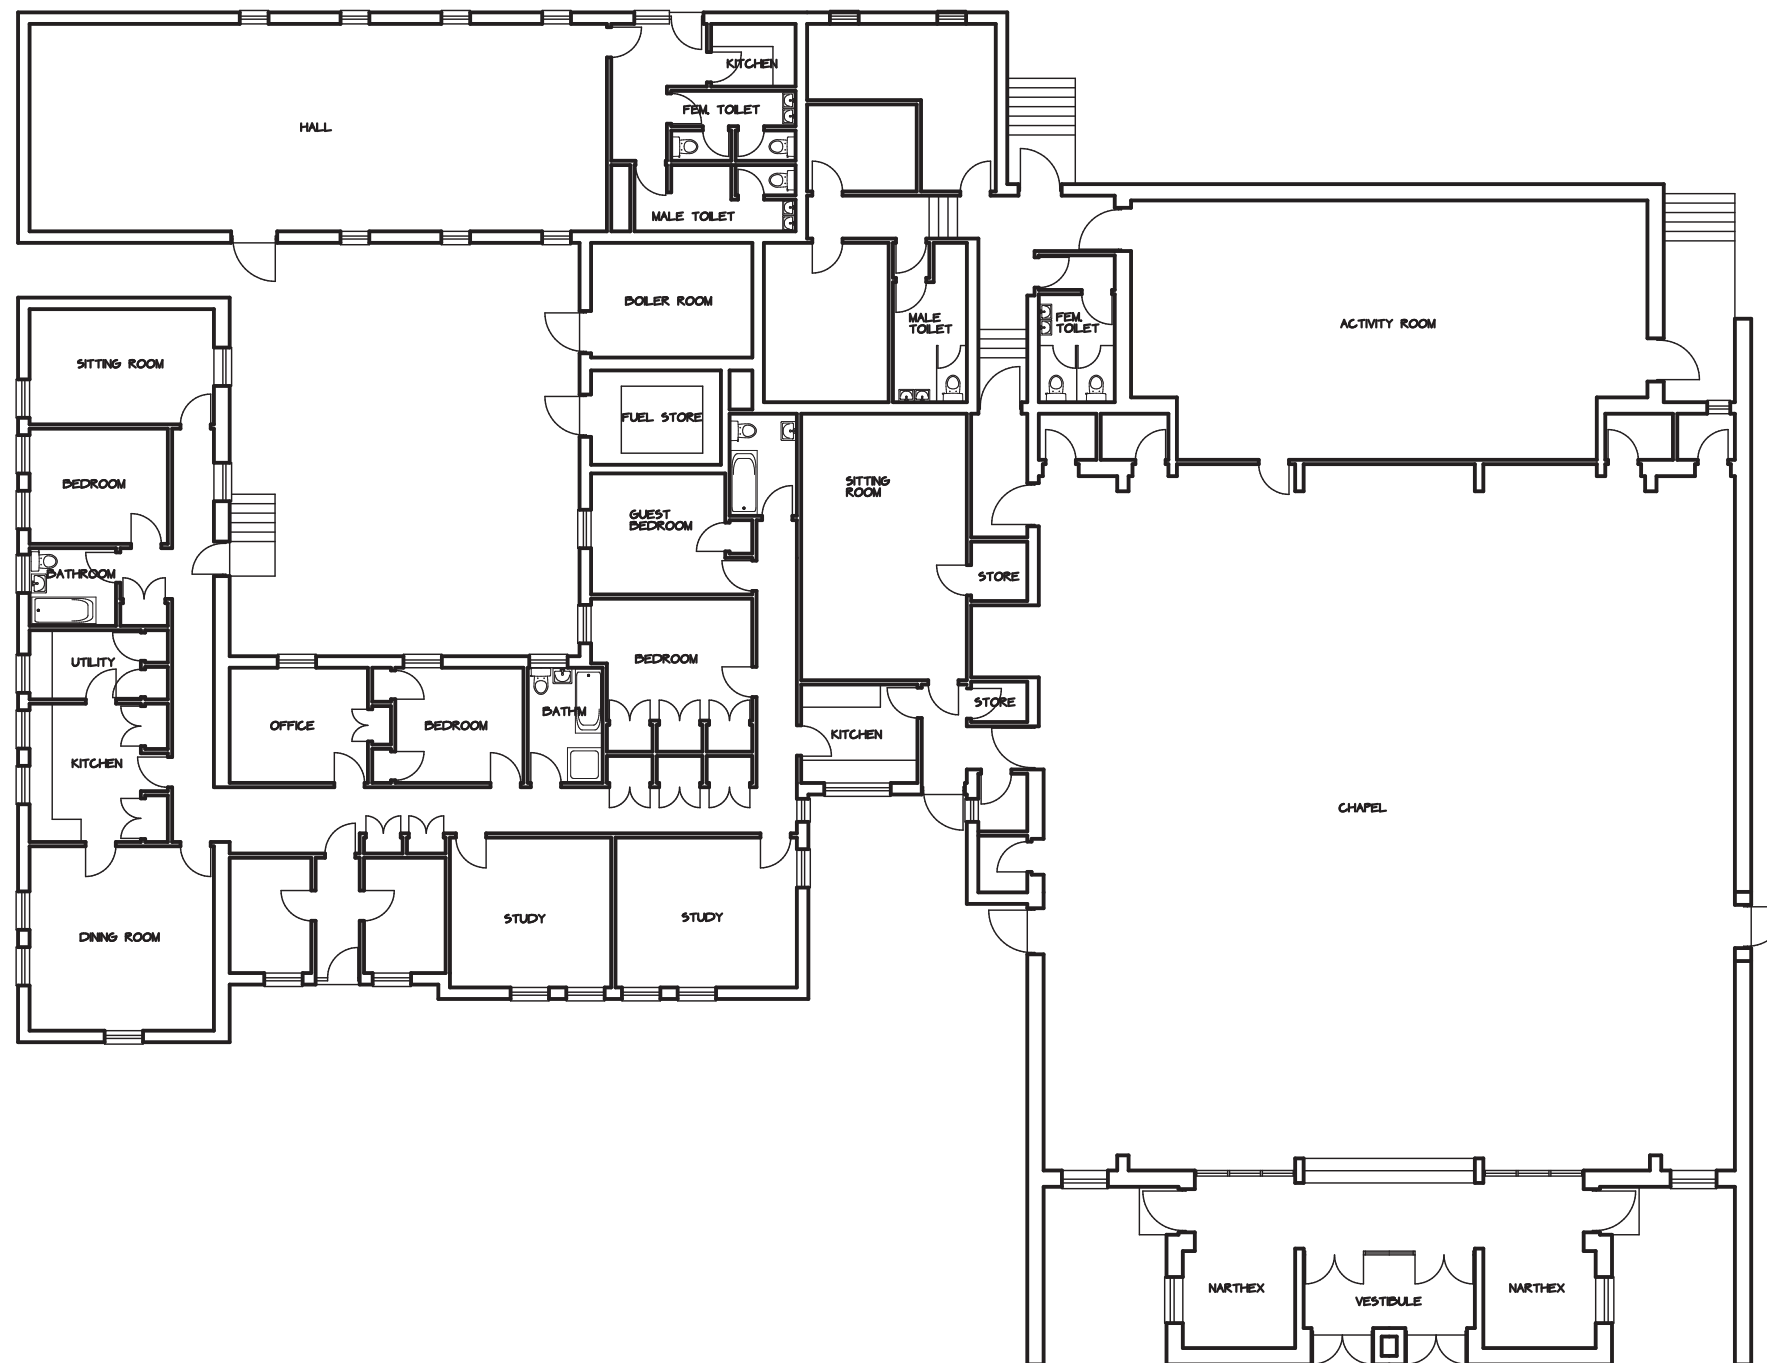
Figure 3: St Paul's Church, ground floor plan (provided by client, Robert Mackenzie) **AOC** Archaeology Group

- 5.2 The west side of the church consists of a number of bedrooms, studies, bathrooms, kitchen, sitting room and hall, all centred around an off-set courtyard (Figure 3). It is largely a flat-roofed single storey block, although the steeply pitched half-roofs were echoed here with a half pitch to the west wing (Plate 13) and a smaller half-pitch over the boiler room with a chimney (Plate 14).
