# 14 Stewart Street, Portgordon, Moray Historic Building Recording Report

AOC Project: 70540

*January 2021*

## Historic Building Recording Report

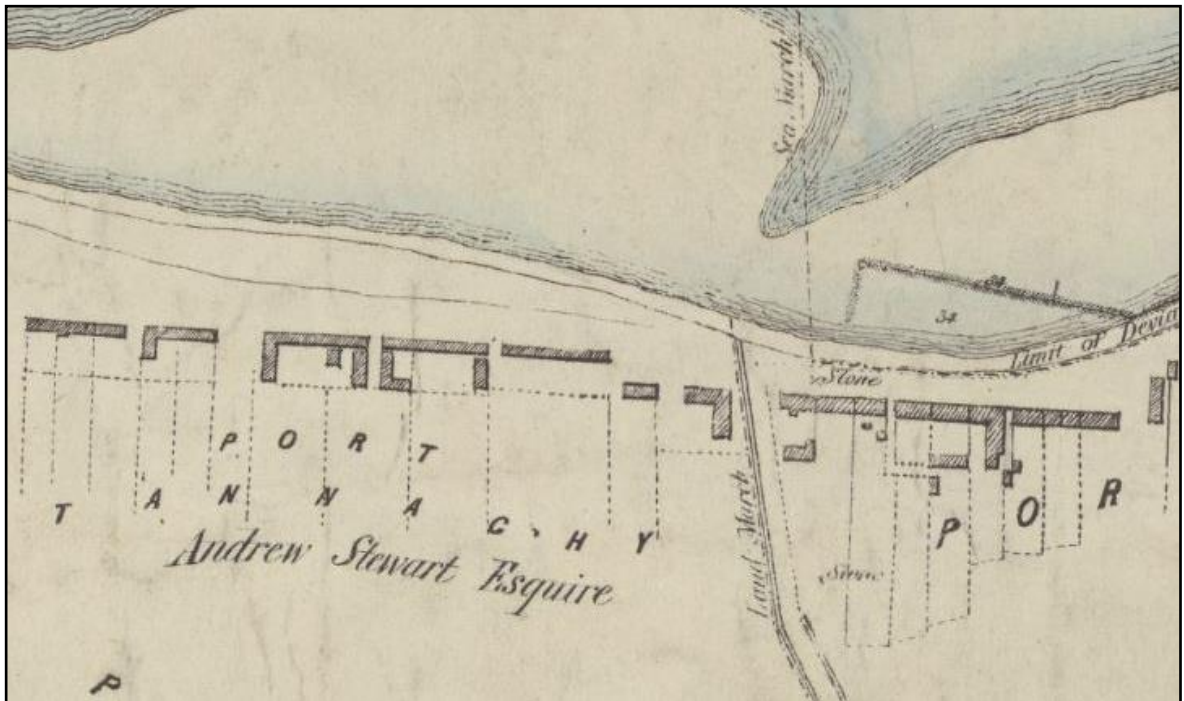
Figure 3: Extract from George McWilliam, *Portgordon plan and sections for improvements and extension of harbour*, 1853

- 4.1 The 1853 George McWilliam, Portgordon plan and sections for improvements and extension of harbour is the first map to show 14 Stewart Street (Figure 3). The map depicts two buildings, a linear building to the North which runs E/W along the sea front, along with an L-shaped building immediately to the south found at the west corner of the linear building. The L-shaped building extends to the east boundary line currently seen on site (Figure 3).

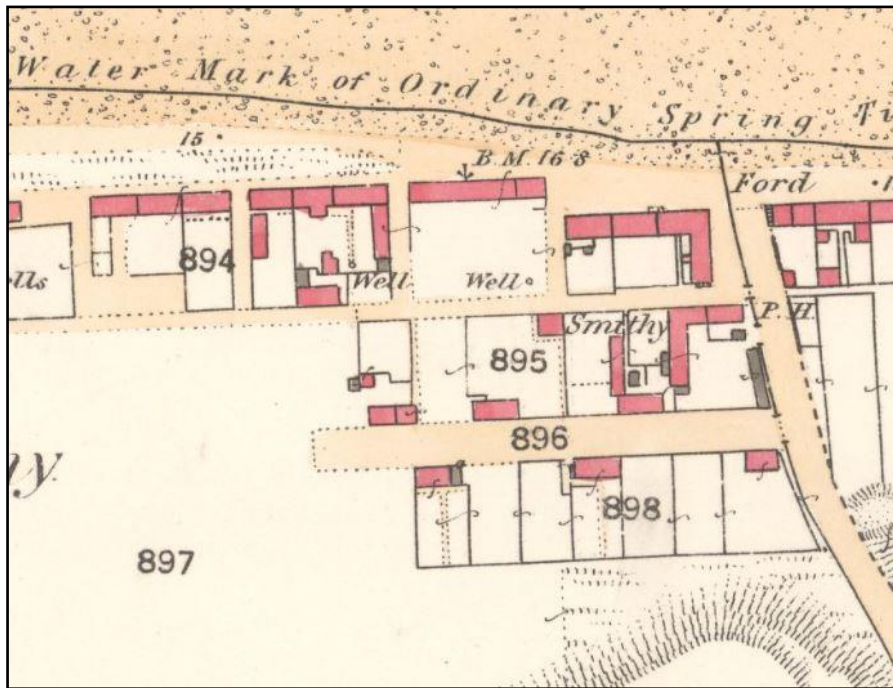
Figure 4: Extract from Ordnance Survey map, 1868  
 Reproduced with the permission of the National Library of Scotland

- 4.2 By the time of the 1868 OS map, there have been alterations to the southern building (Figure 4). This building has changed from an L-shaped layout to a detached single linear rectangular structure running N/S to the south of the west corner of the E/W building.

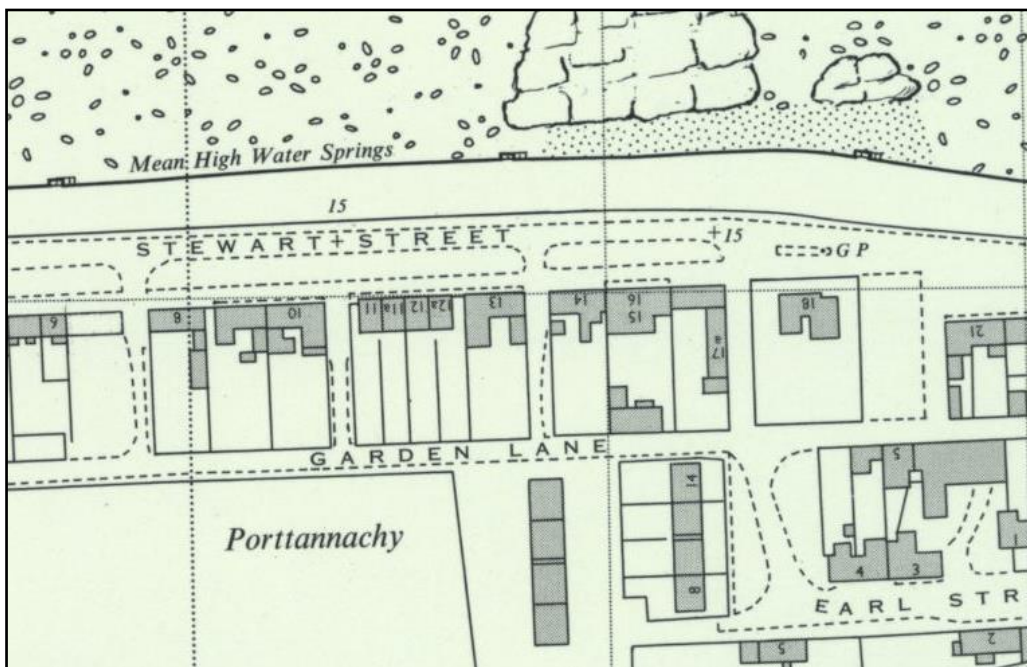
Figure 5: Extract from Ordnance Survey map, 1968  
 Reproduced with the permission of the National Library of Scotland

4.3 The building remains in this layout until the 1968 OS map (Figure 5) which shows the current footprint of the building. The N/S rectangular building has been reduced in size, possibly replaced by a smaller outbuilding. The building is seen on current OS Mastermap drawings but is no longer present on site. The additions that now house the bathroom and kitchen are depicted in the form of a new L-shaped structure that has been added to the east end of the E/W linear building.

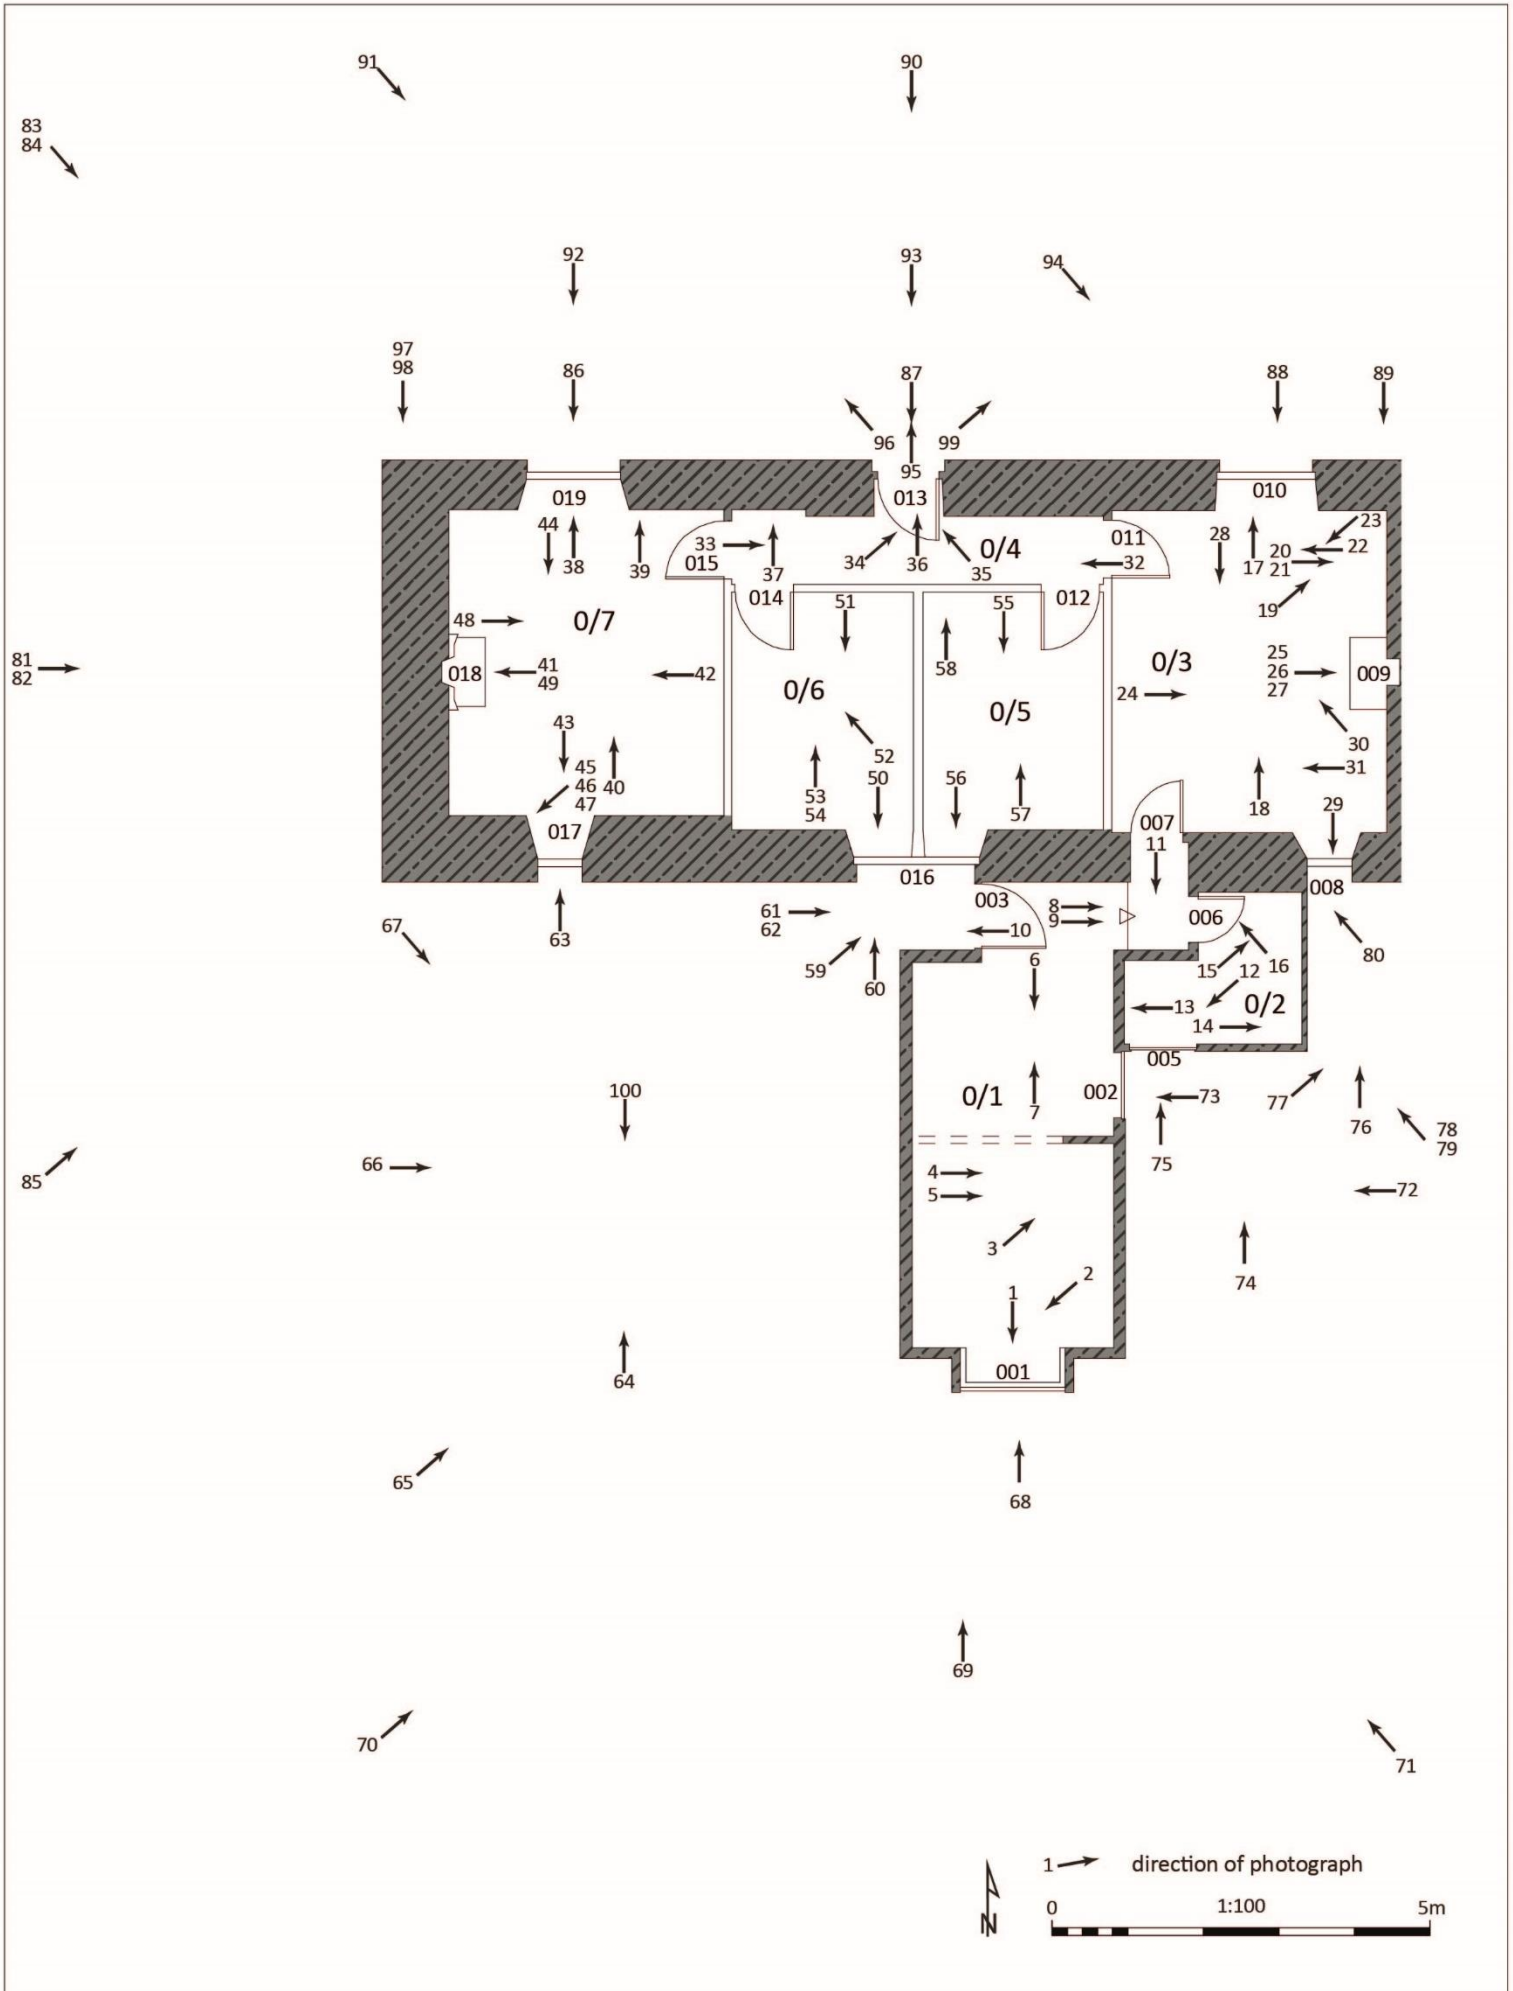
Figure 9: Site plan showing position and direction of photographs

- 6.2 The structural evidence suggests that current building layout can be separated into two phases. The initial stone building running E/W to the north of the site is part of the original stone building as depicted in the early maps whilst the timber extension to the south is a modern addition. It is unclear whether the kitchen area (Room 0/1) is a later addition to the bathroom area (Room 0/2). The changes in floor level, ceiling height and the abutment of windows (002) and (005) suggest that creation of its current state may have occurred over several phases (Figure 9).
