**Outbuilding at  
Moneypot Farm,  
Redgrave, Suffolk  
RGV 048**

**Heritage Asset Assessment**

**April 2011**

## **Heritage Asset Assessment**

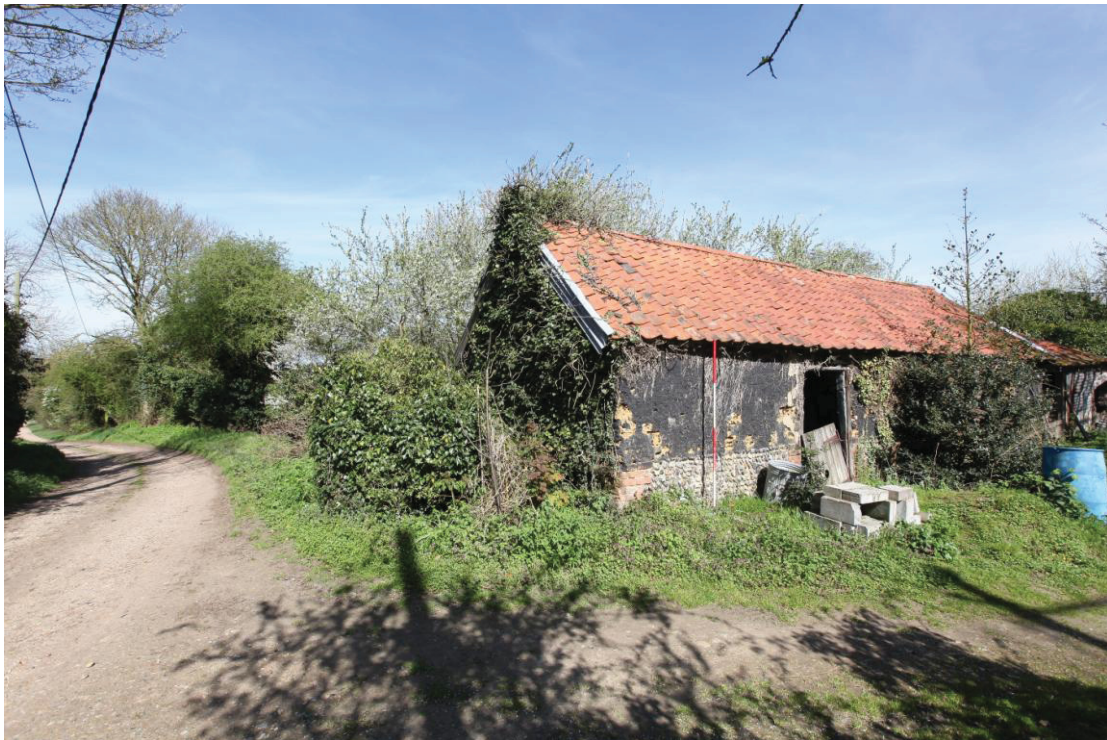
**Illus. 1** General view of the site entrance from the south showing Moneypot Lane to the left and the outbuilding to the right.

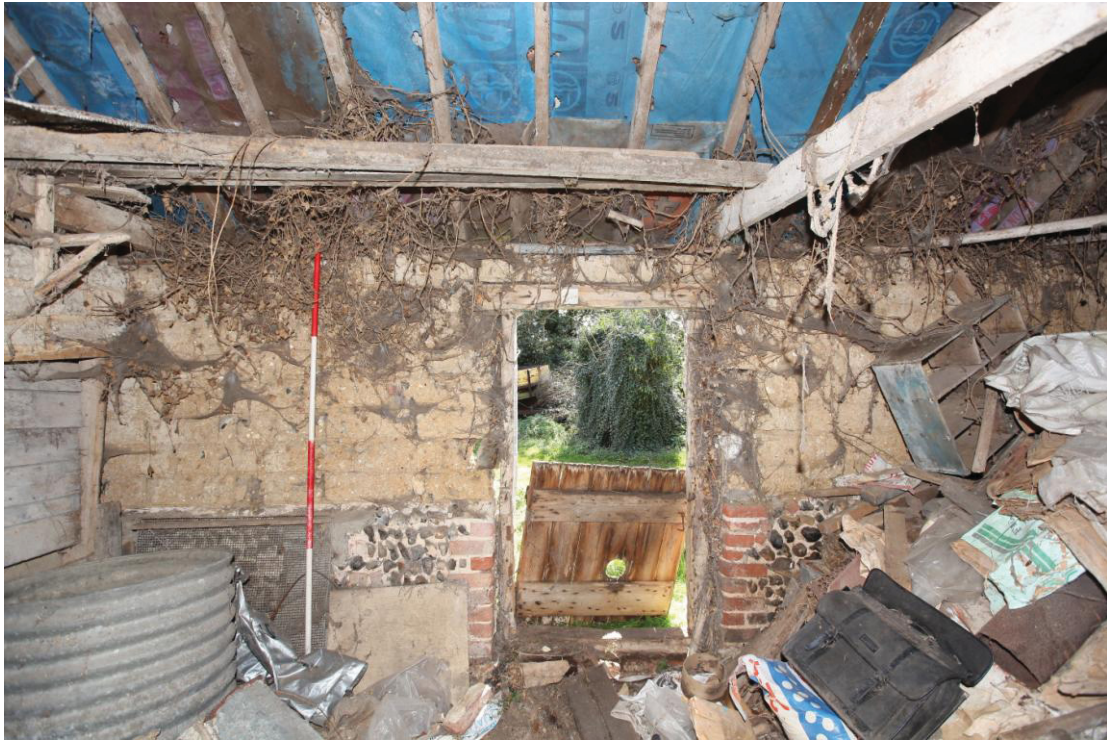
**Illus. 5** The southern interior of the western clay-lump shed (1a) showing its original entrance with red-brick dressing to the flint plinth & two bentwood hooks attached to the clay-lump internal partition to the left.

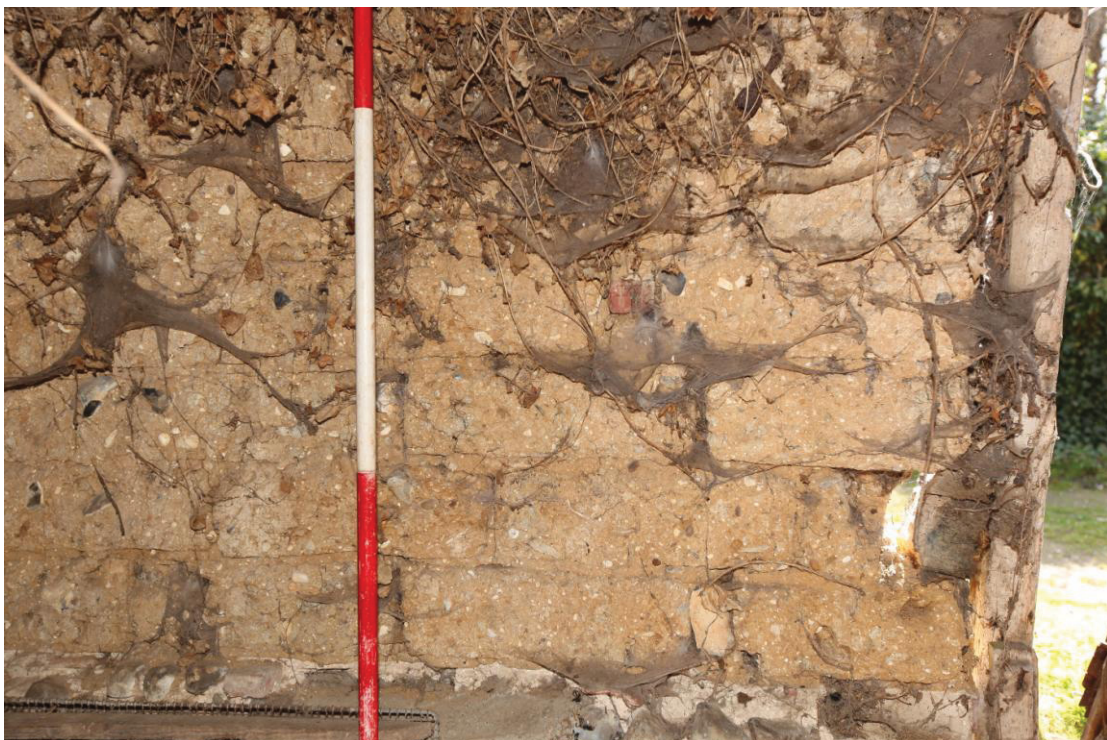
**Illus. 6** Detail of the southern interior of the western shed (1a) showing the individual clay-lump blocks laid in clay mortar.
