**Barn at Pond Farm,
Thrandeston,
Suffolk
TDE 022**

Heritage Asset Assessment

June 2011

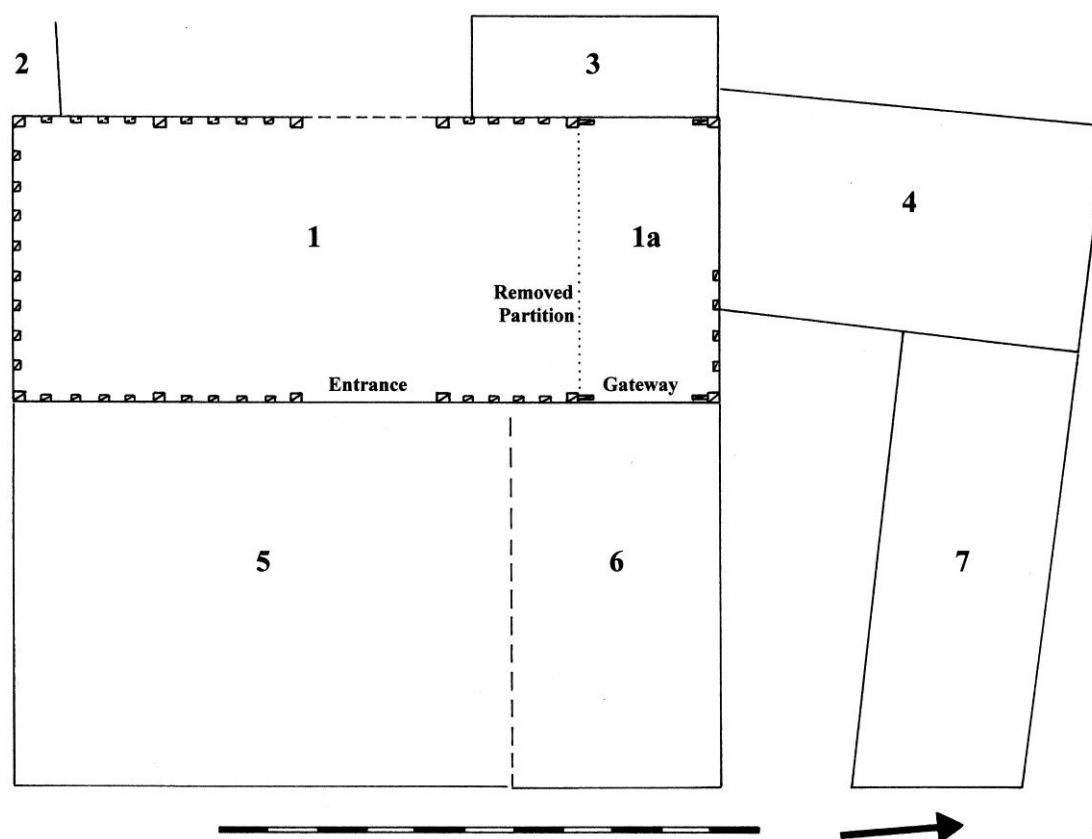
Figure 7

Schematic block plan of the farm buildings, numbering the key elements for ease of reference in the text and photographs. Scale in metres. Not fully surveyed.

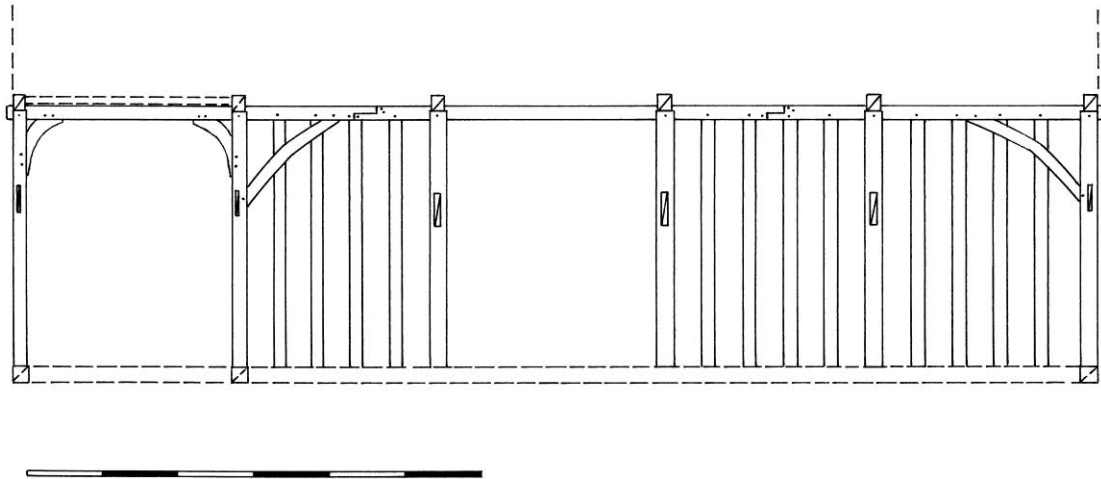
Figure 8

The front (eastern) internal elevation of the barn showing its intact wall framing with the original entrance to the four-bay threshing barn in the centre and the gateway to the left. The missing joists of the ceiling or loft above the gateway are indicated by broken lines. The secondary studs which now block the gateway are not shown. Scale in metres.

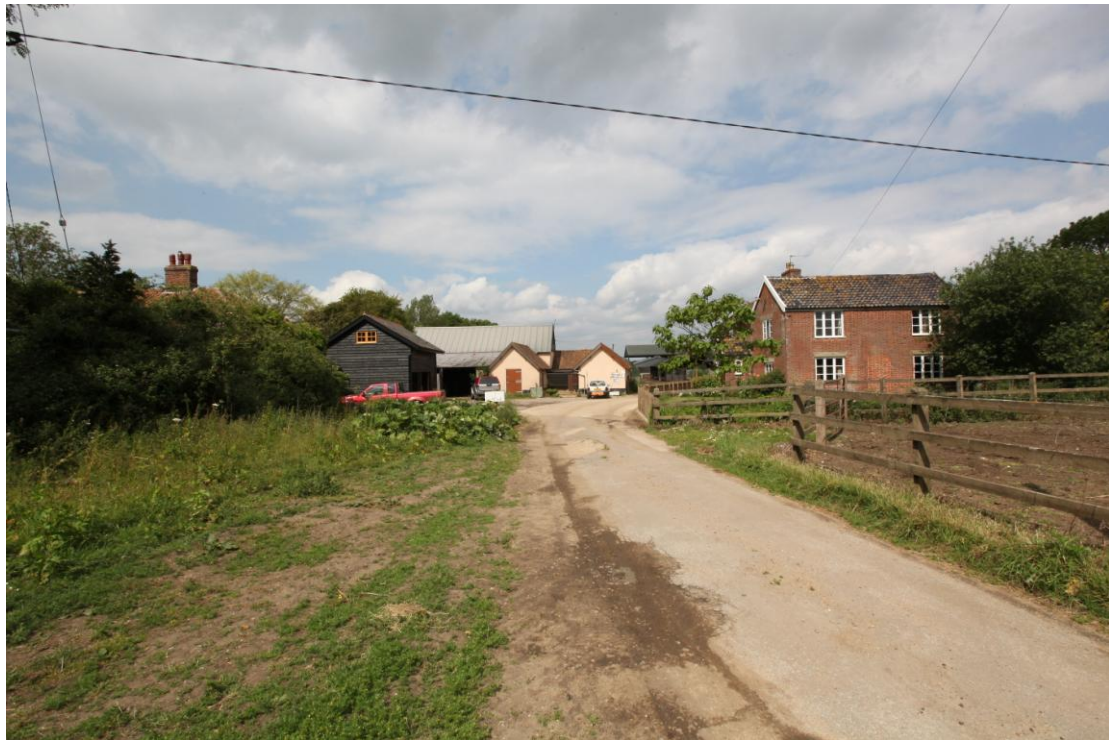
Illus. 1 General view of entrance to farm from site of Great Green to east. The green, now fully enclosed, originally extended to the bridge over the broad, water-filled ditch adjoining the farmhouse garden in the centre of this image.
