**Outbuilding at  
Valley Farm,  
Coddtenham, Suffolk  
CDD 076**

**Historic Building Record**

# **Outbuilding at Valley Farm, Blacksmith's Lane, Coddendam, Suffolk**

## **Historic Building Record**

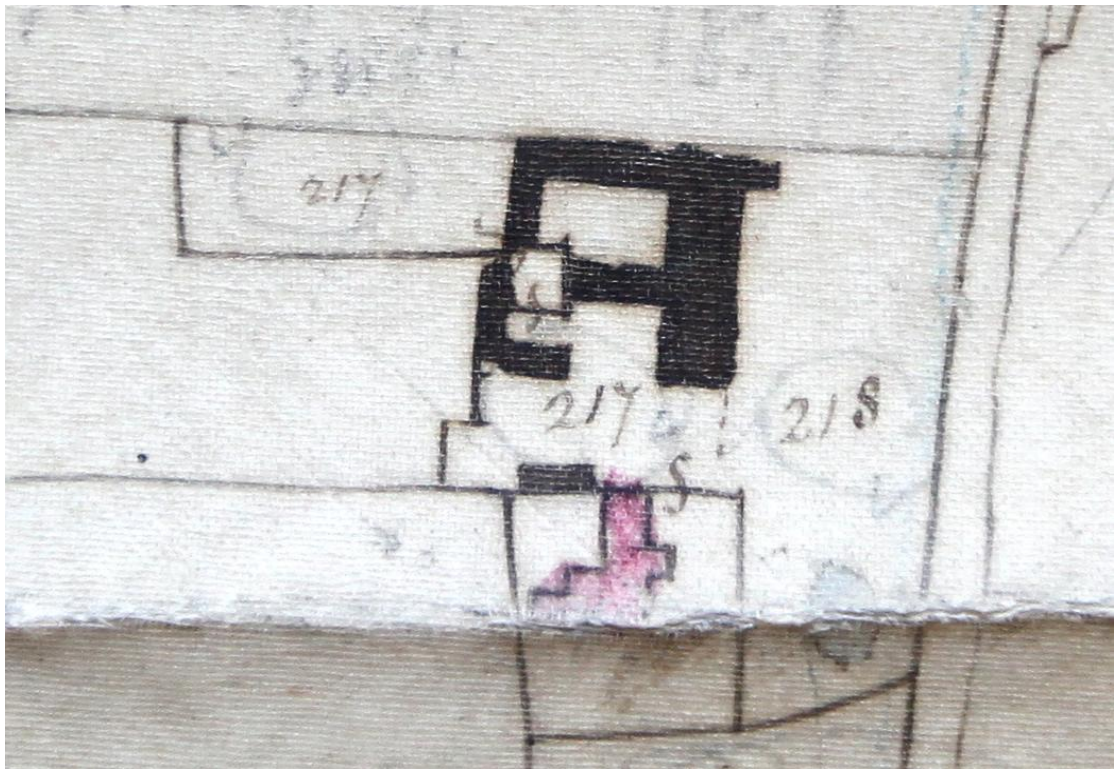
**Figure 2a**  
Detail of the 1839 tithe map showing the outbuilding in black ink with a simple rectangular outline adjoining the corner of the farmhouse (the latter shown in red).

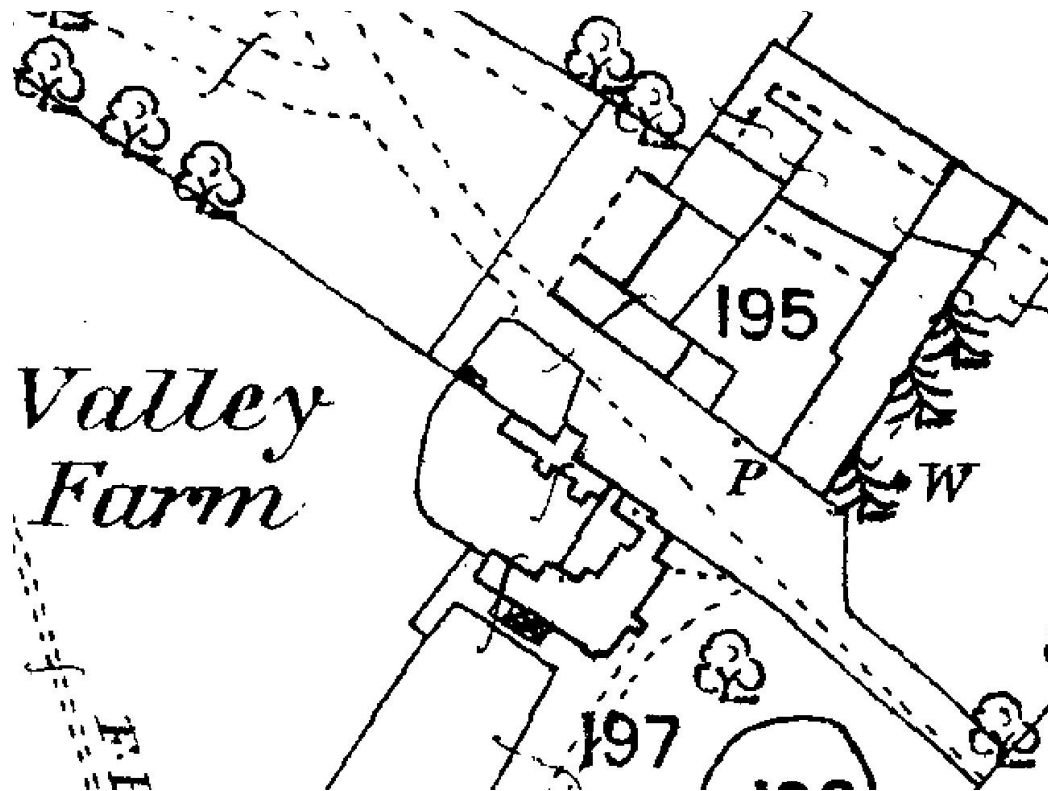
Figure 3

The First Edition 25 inch Ordnance Survey of 1884. The outbuilding had been extended to the west and had acquired a central projection to the north (the brew-house, no. 3 in figure 6) and two small projections to the south.

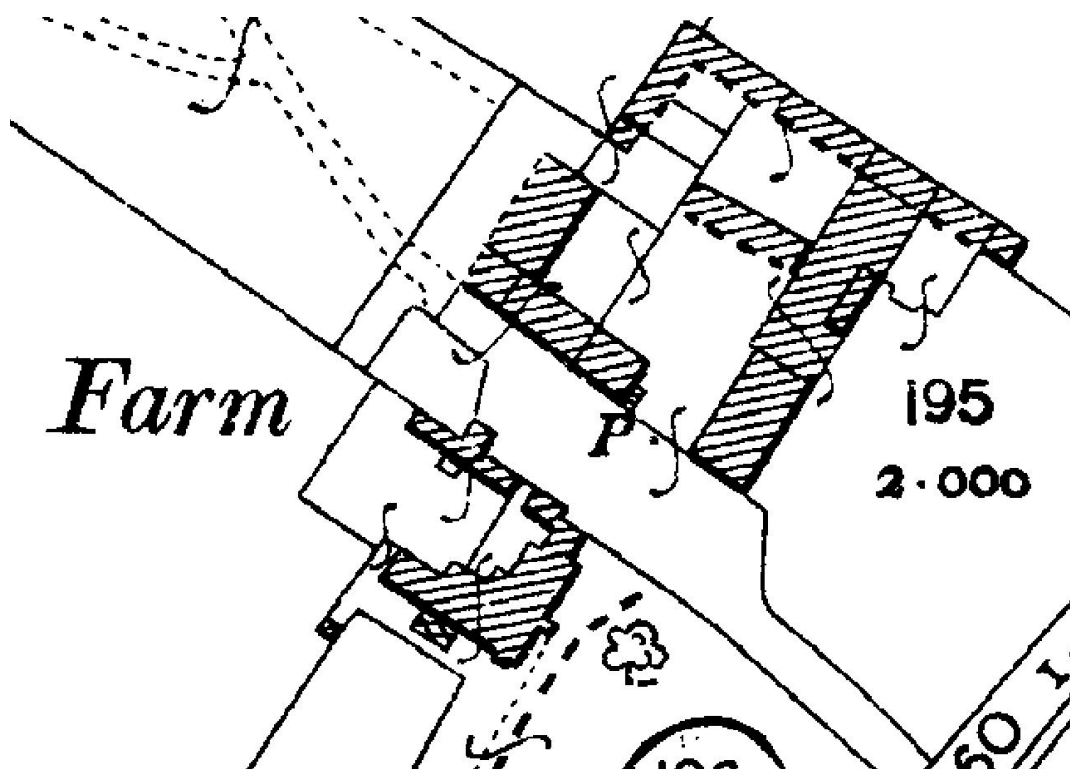
Figure 4

The Second Edition 25 inch Ordnance Survey of 1904. One of the two southern projections of 1884 had been lost, leaving only the surviving yard (1d in figure 6).

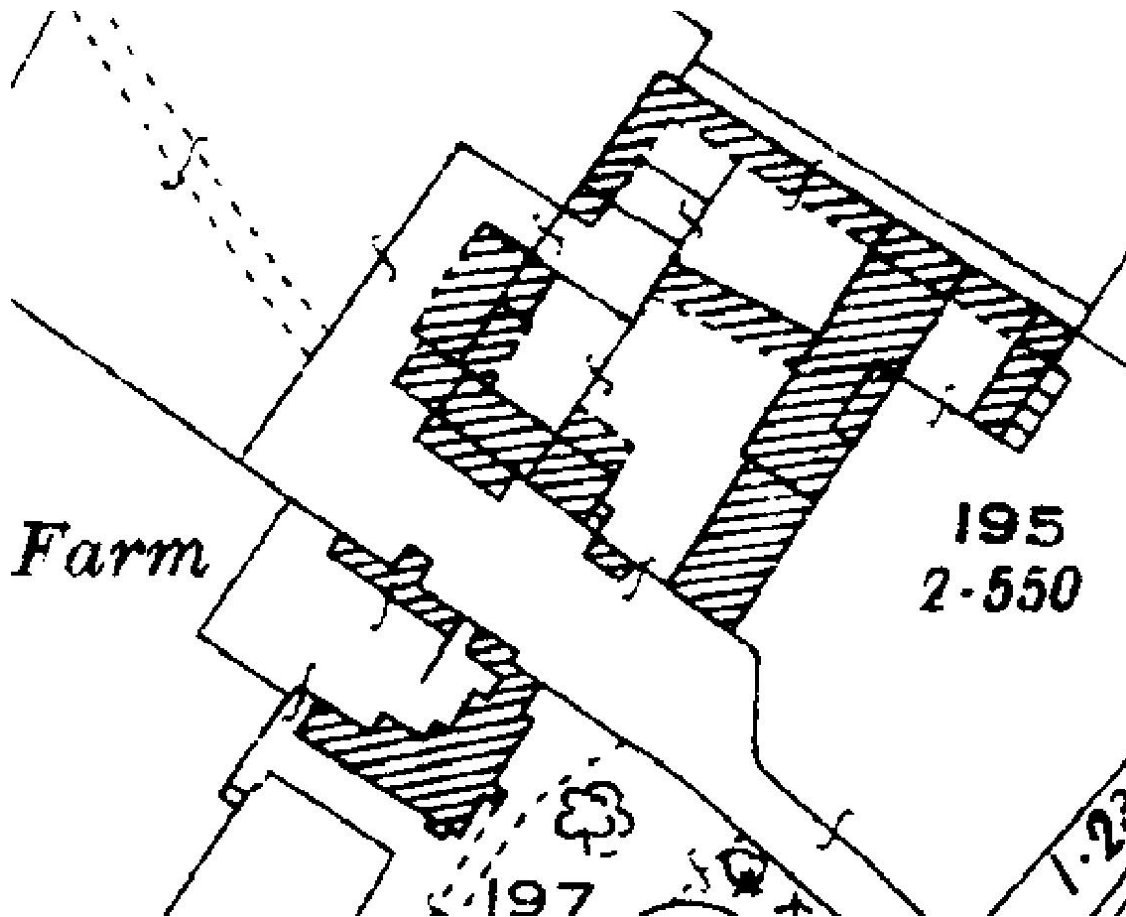
**Figure 5**  
**Third Edition 25 inch Ordnance Survey of 1926. The southern yard (1d) had disappeared since 1904, but its original wall has been omitted in error.**
