**Barn at  
Willow House,  
Fressingfield, Suffolk  
FSF 068**

**Heritage Asset Assessment**

# **Barn at Willow House, Harleston Hill, Fressingfield, Suffolk**

## **Heritage Asset Assessment**

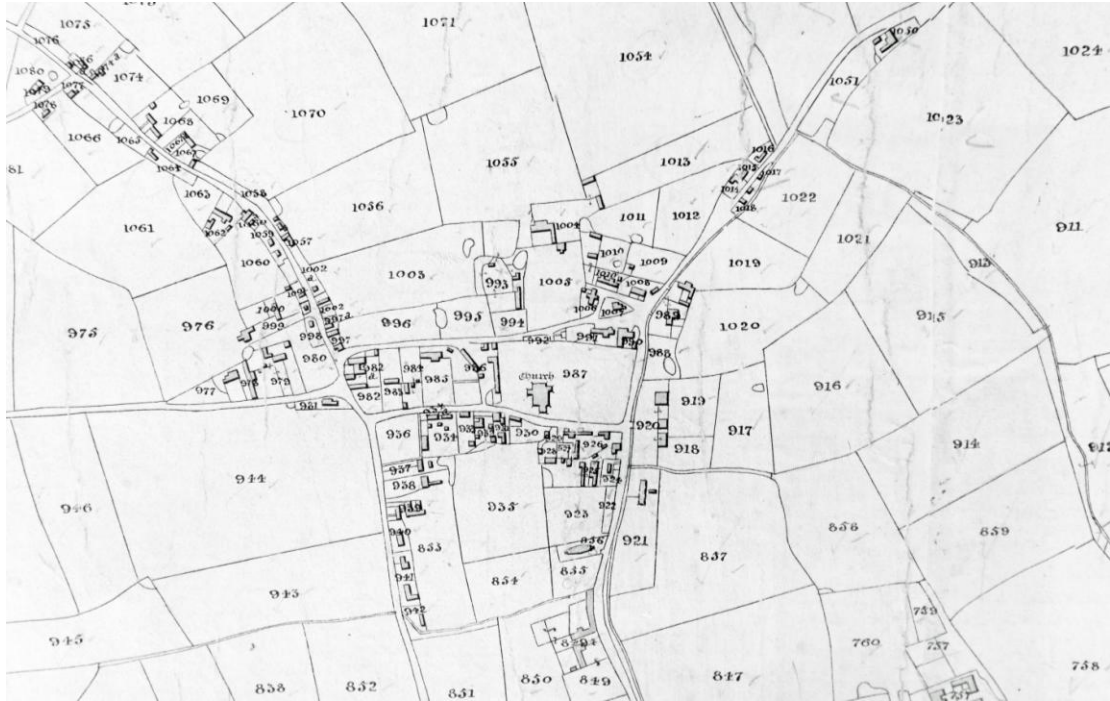
**Figure 2.**

**The Fressingfield tithe map of 1838 (showing north towards the top right-hand corner). The small block of land belonging to Willow House lies immediately opposite the north-eastern corner of the churchyard and extends along Harleston Hill.**

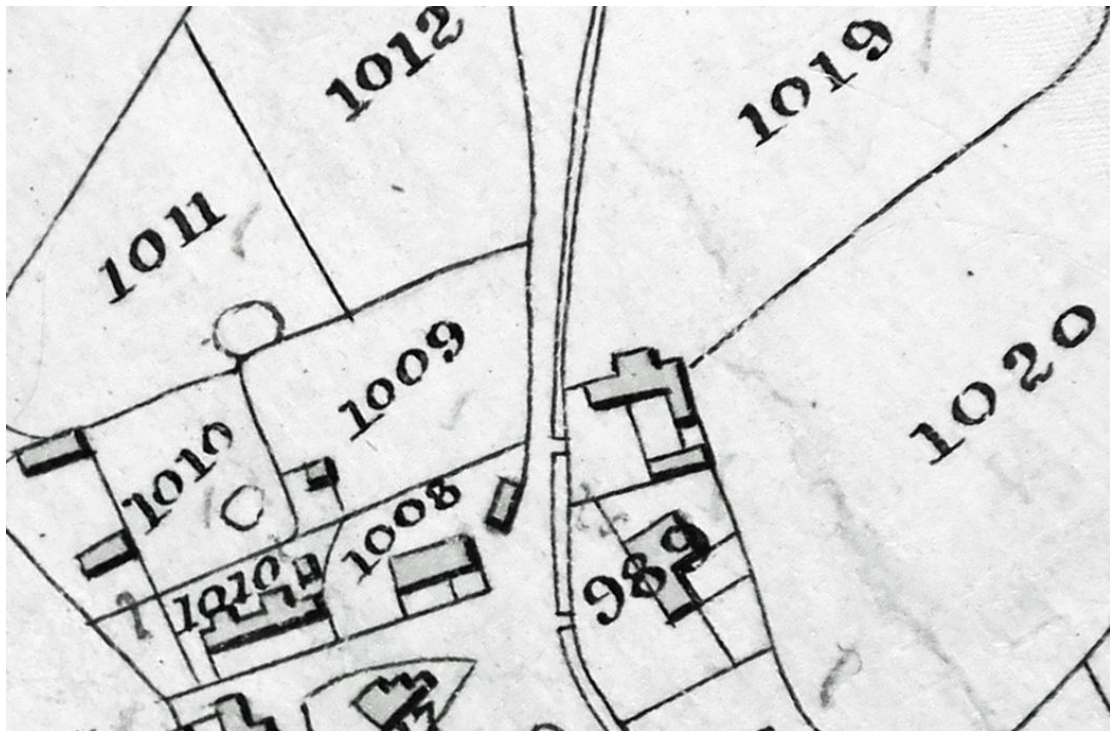
**Figure 2a**

**Detail of the 1838 tithe map, re-oriented to show north in the usual direction. The barn lies to the north of the house (no. 989) adjoining the pastureland known as Barn Meadow (1019) and Home Meadow (1020). Its present L-shaped outline remains unchanged but the projection to the north no longer survives. This projection adjoins the entrance bay (C in figure 5) and probably represents a gabled or lean-to porch.**

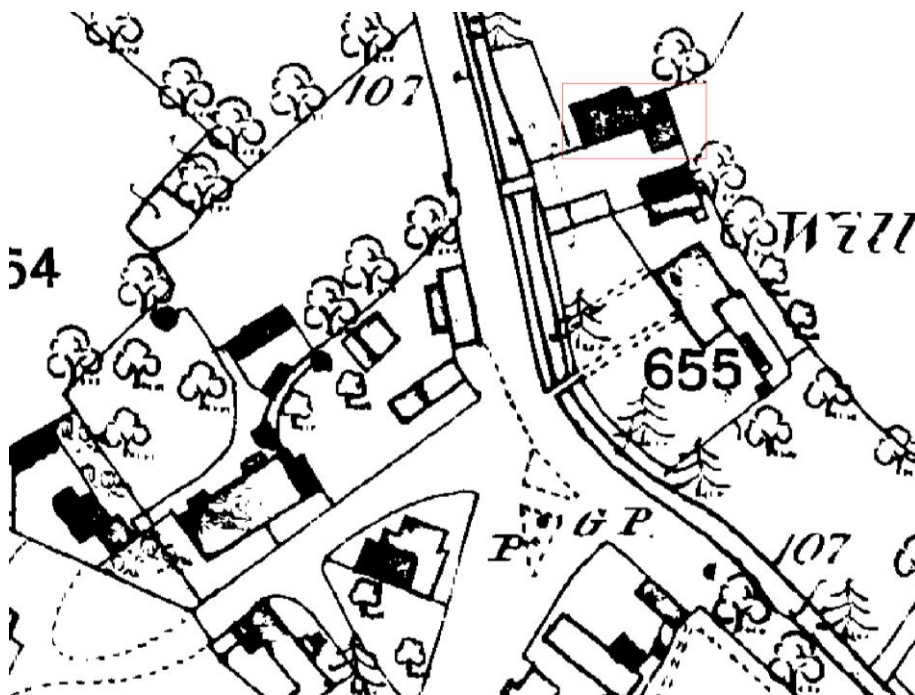
**Figure 3. The First Edition 25 inch Ordnance Survey of 1885.**

**The northern projection had been extended to the western gable since 1838 and the recently converted ‘granary’ built to the south, but the layout of the yard had otherwise remained unaltered since 1838.**

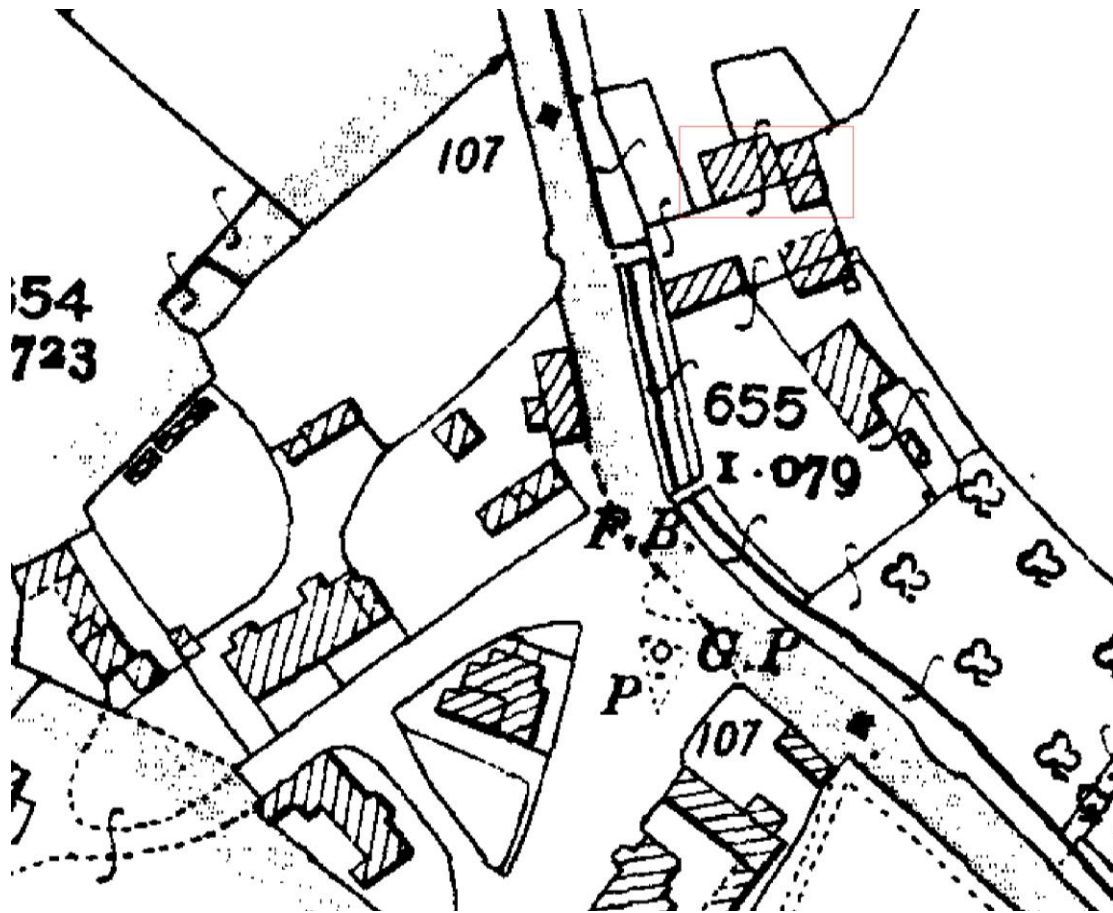
Figure 4  
Second Edition 25 inch Ordnance Survey of 1904, showing little change since 1885. The barn's internal partition appears to be on the wrong side of the entrance bay (i.e. to the east rather than west) but internal features were often surveyed inaccurately. The corner of the churchyard is shown here to bottom right.

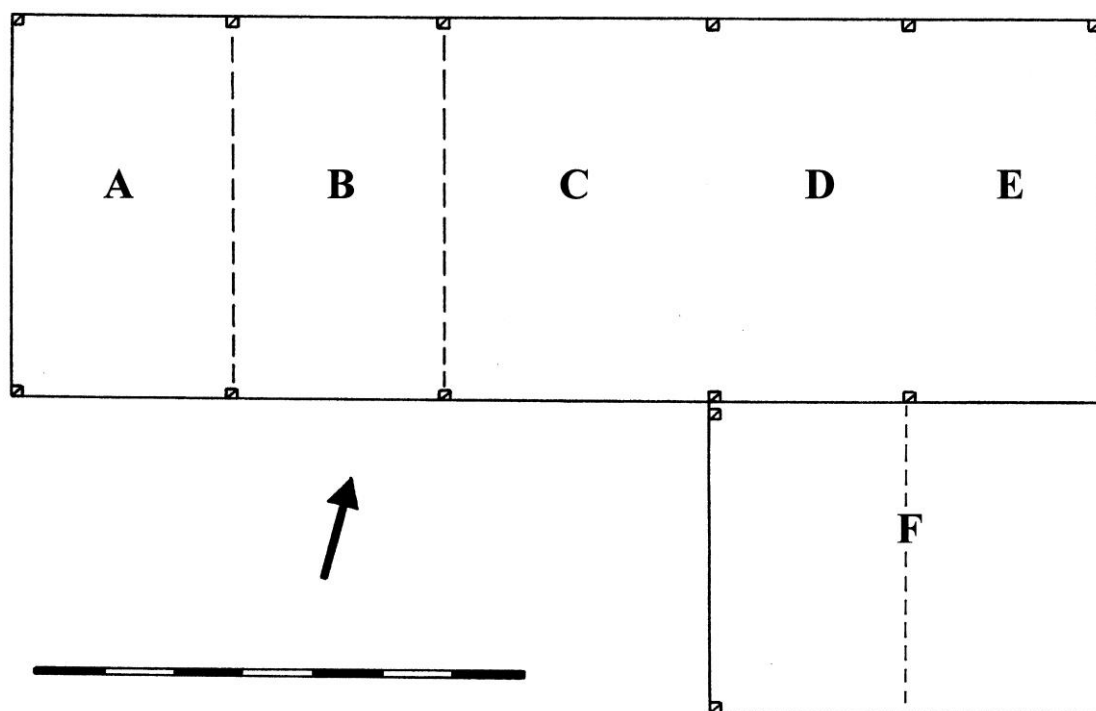
Figure 5

Ground plan of the barn, identifying the bays and principal compartments for ease of reference in the text and photographs. Scale in metres.

**D-E** Open barn, apparently without tie-beam braces of any kind. Roof replaced.
