**Barn at Charity Farm,
Hemingstone,
Suffolk
HMG 028**

Historic Building Record

Barn at Charity Farm, Main Road, Hemingstone, Suffolk

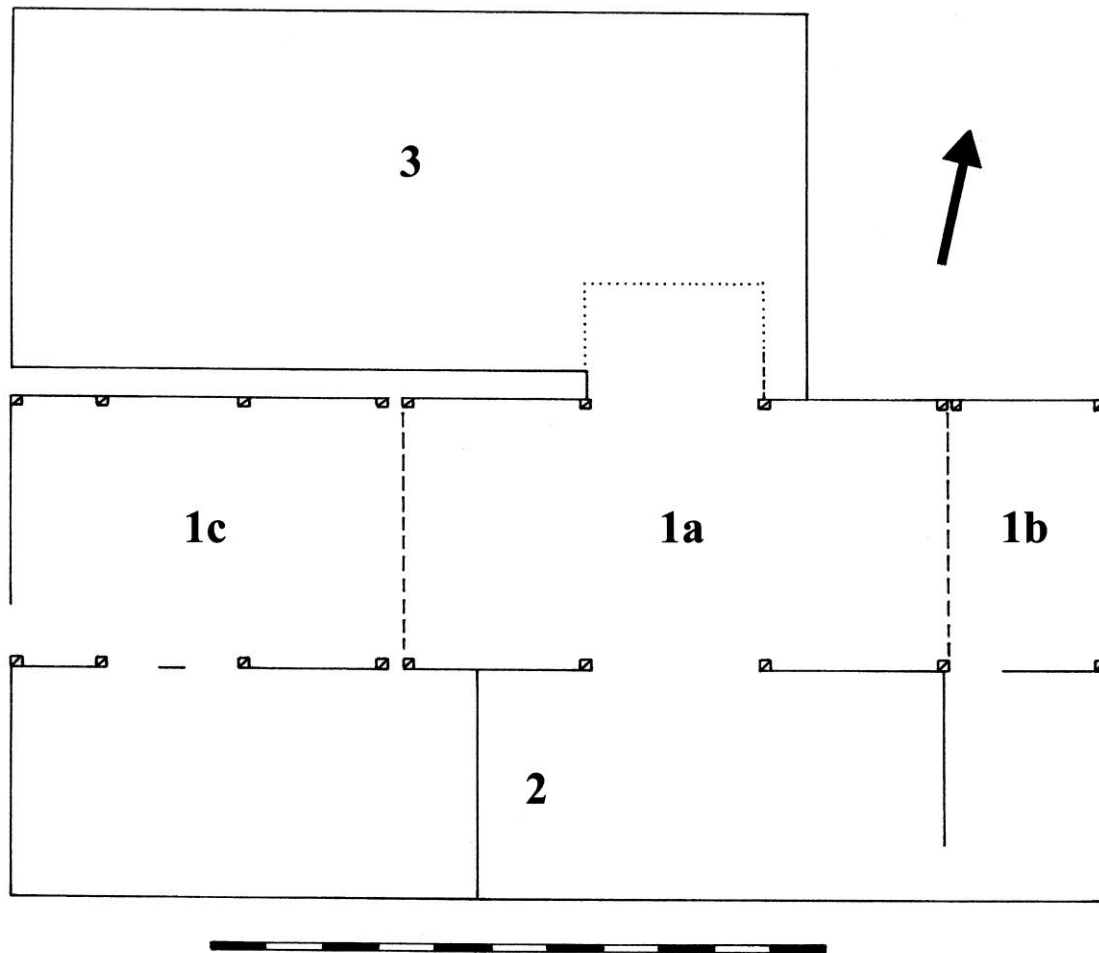
Figure 6

Schematic block plan of the barn and attached sheds, numbering its principal historic elements for ease of reference in the text and photographs. Scale in metres.

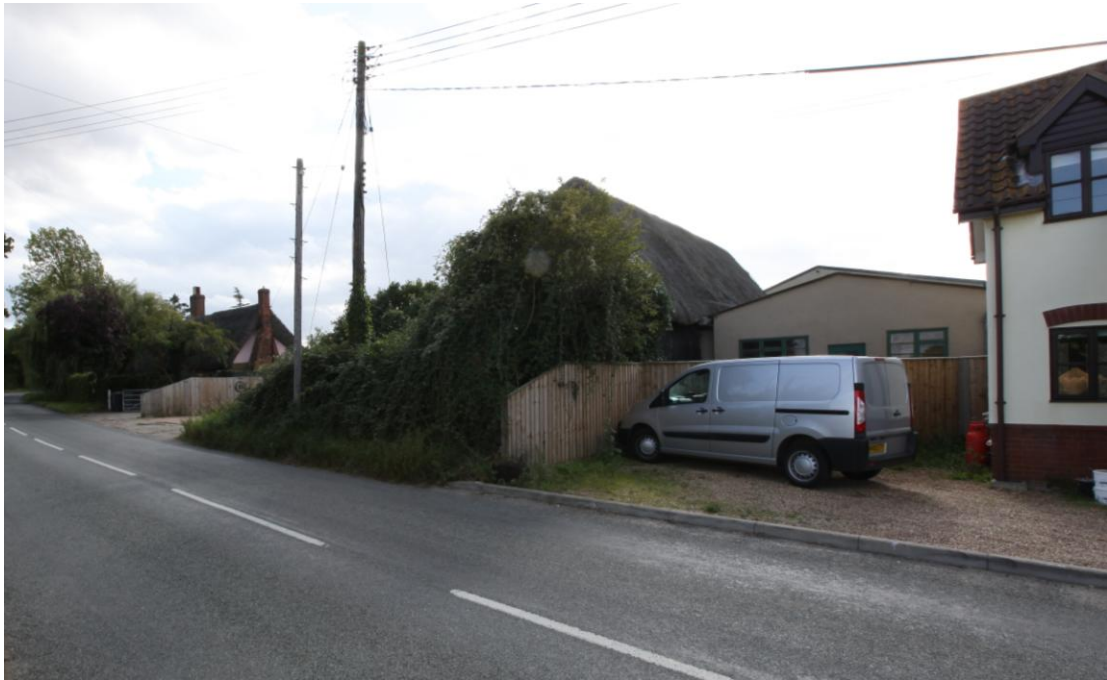
Illus. 1. General view of the site from Main Road to the north-east showing the eastern gable of the thatched barn (1) in the centre with the late-20th century garage shed (3) adjoining its northern elevation to the right. The grade II-listed thatched farmhouse is visible in the rear to the left.

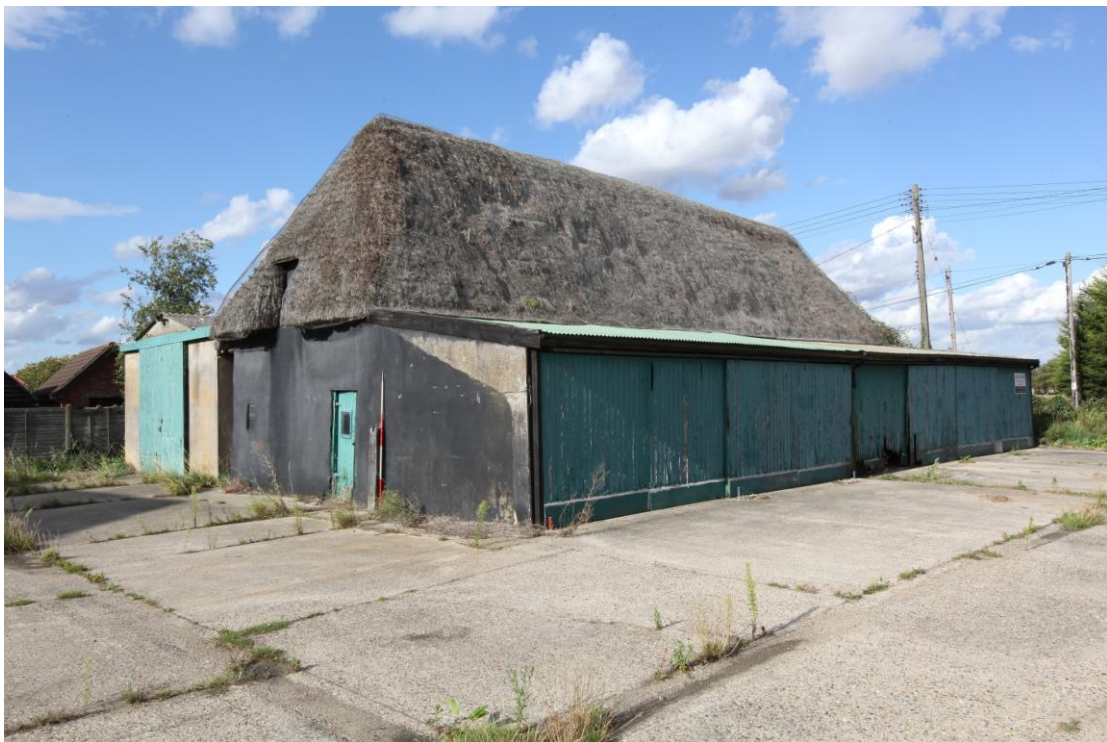
Illus. 2. The exterior from the south-west showing the fully hipped and thatched roof of the barn (1) in the centre with the late-20th century lean-to with sliding doors (2) to the right and the garage shed (3) to the left.

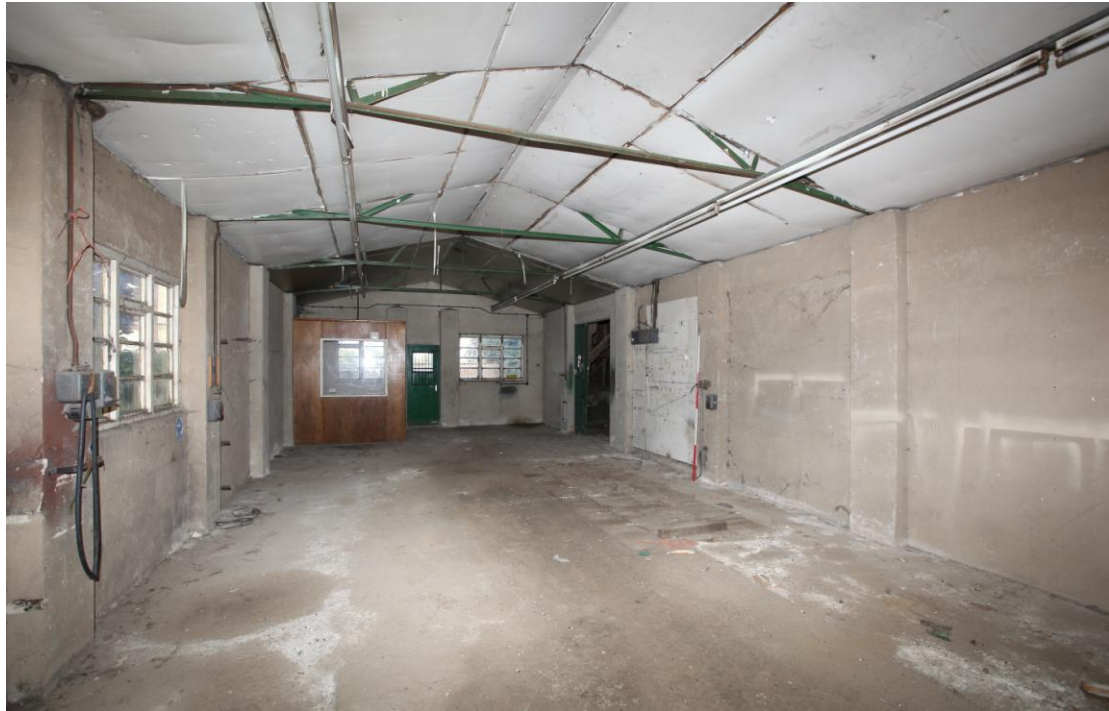
Illus. 5. The interior from the west of the late-20th century garage shed (3) showing a boarded office in its north-eastern corner to the left and the entrance to the central bay of the barn (1a) to the right.
