**Sancroft Barn,
Laxfield, Suffolk
LXD 065**

Heritage Asset Assessment

September 2011

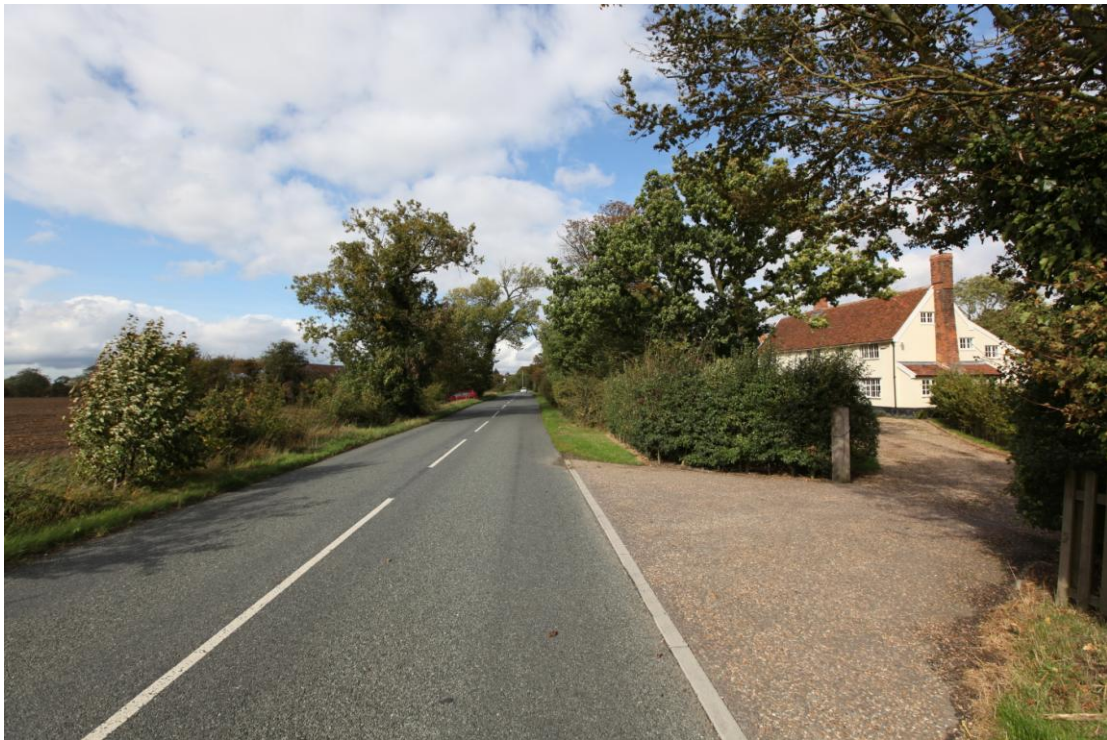
Illus. 1 A general view of the site from Stirrup Street to the south, showing the proximity of the barn (partly hidden by trees in the rear to the left) to the grade II-listed late-16th century Sancroft Manor Farmhouse to the right.
