**Barn at Shelland Hall,
Rattlesden, Suffolk
RAT 038**

Historic Building Record

OASIS ID: Suffolkc1-113357

October 2011

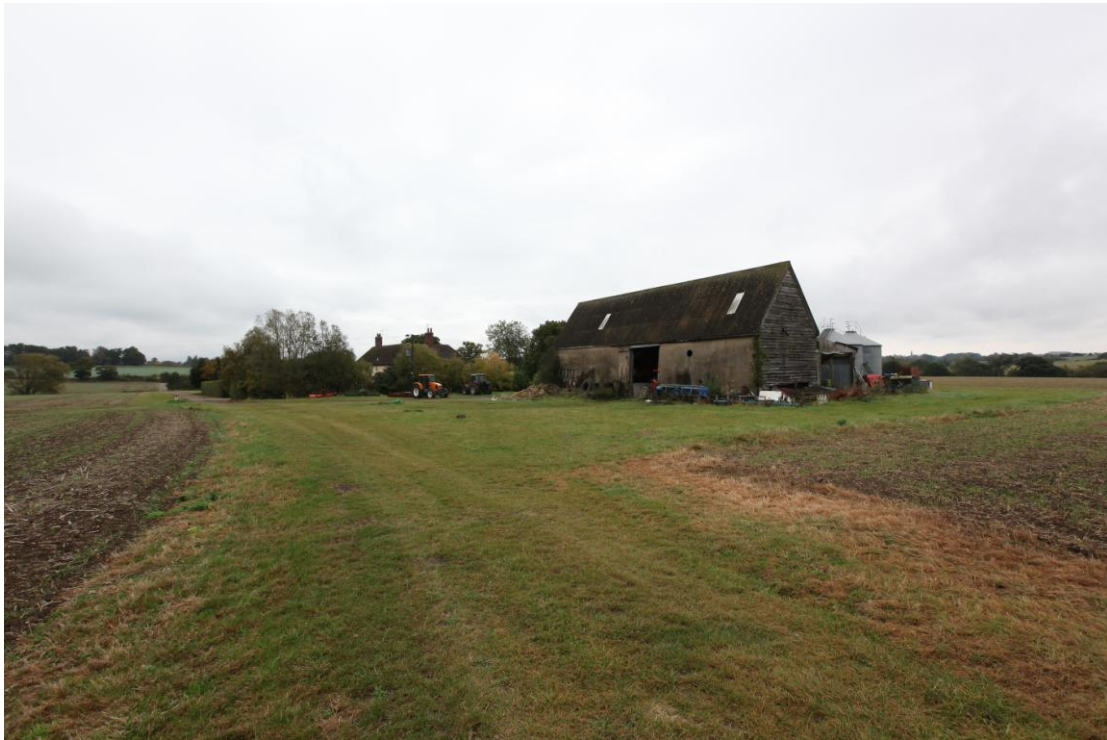
Illus. 1. General view of site from west showing barn to right, entrance track from public road to left and Shelland Hall in centre

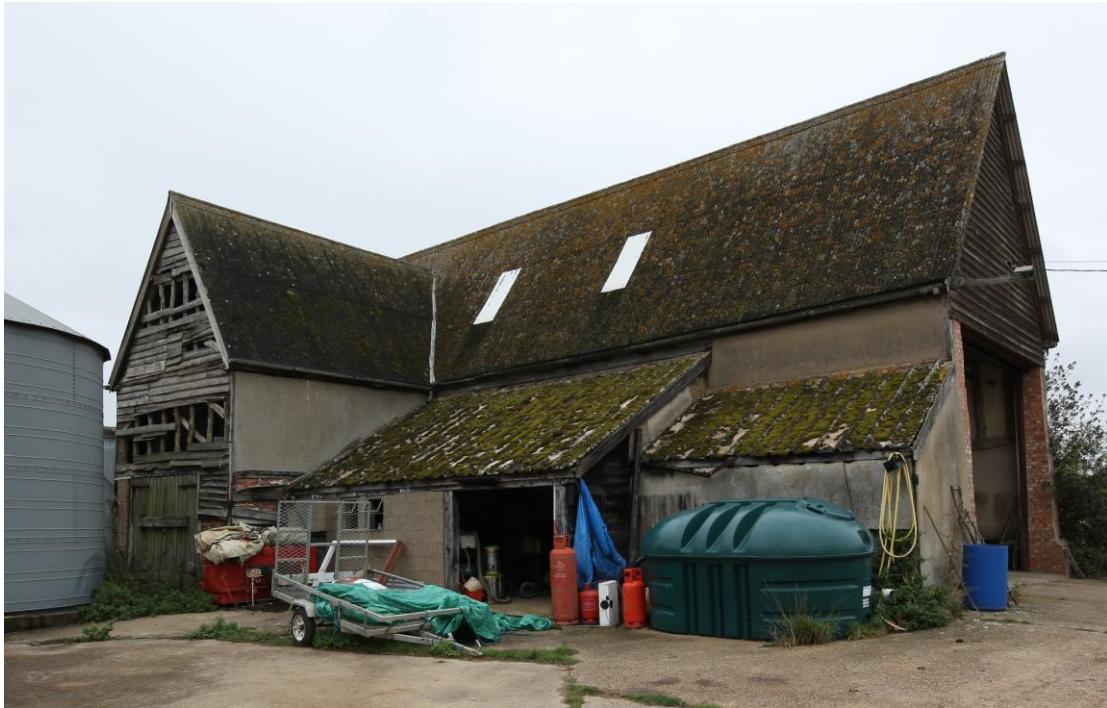
2. An 18th or early-19th century lean-to shed that appears to have been built as a tack room with bentwood harness hooks when the eastern bay of the barn (F) was partitioned from the rest and converted into a stable. Original brick floor.

3. A mid-19th century lean-to shed with 20th century concrete cattle manger, now largely rebuilt in 20th century cement blocks but preserving a section of original external clay daub to the barn.

Illus. 3. Southern exterior showing original porch (1a) to left, lean-to tack room (2) to right and lean-to shed (3) in centre.

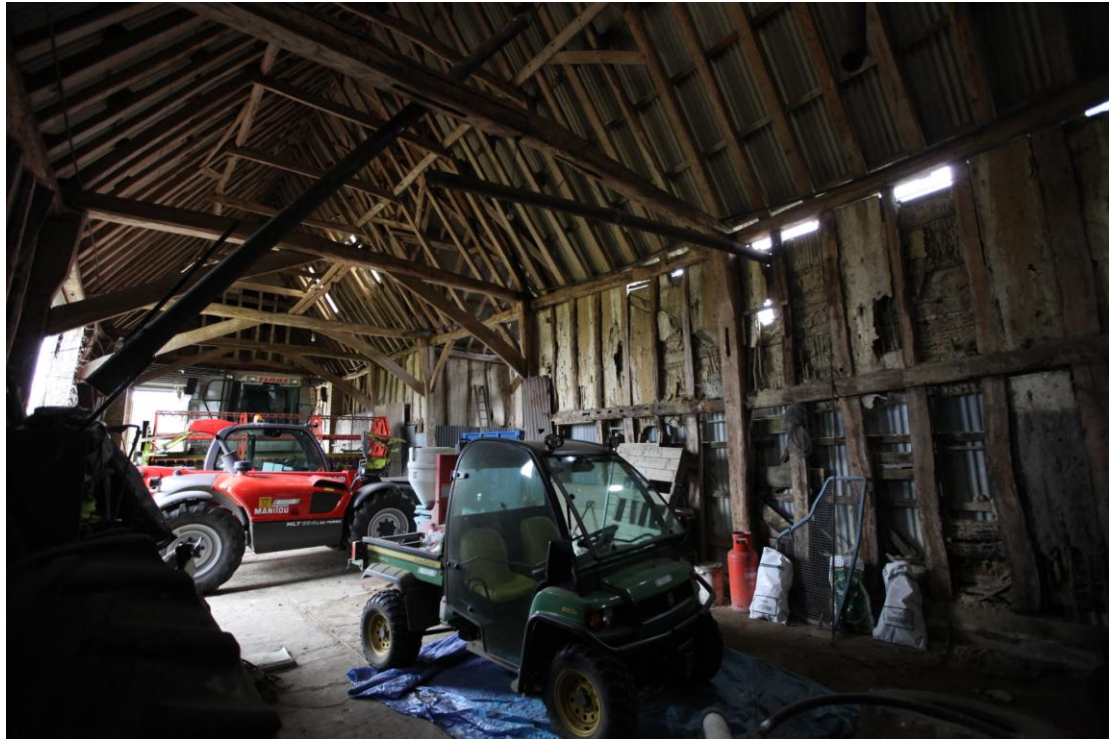
Illus. 5. General internal view of barn from north-western corner (bay A) showing its largely intact timber frame and current use as a garage for farm vehicles.
