**Agricultural Buildings at
Street Farm,
Redgrave, Suffolk
RGV 049**

Heritage Asset Assessment

December 2011

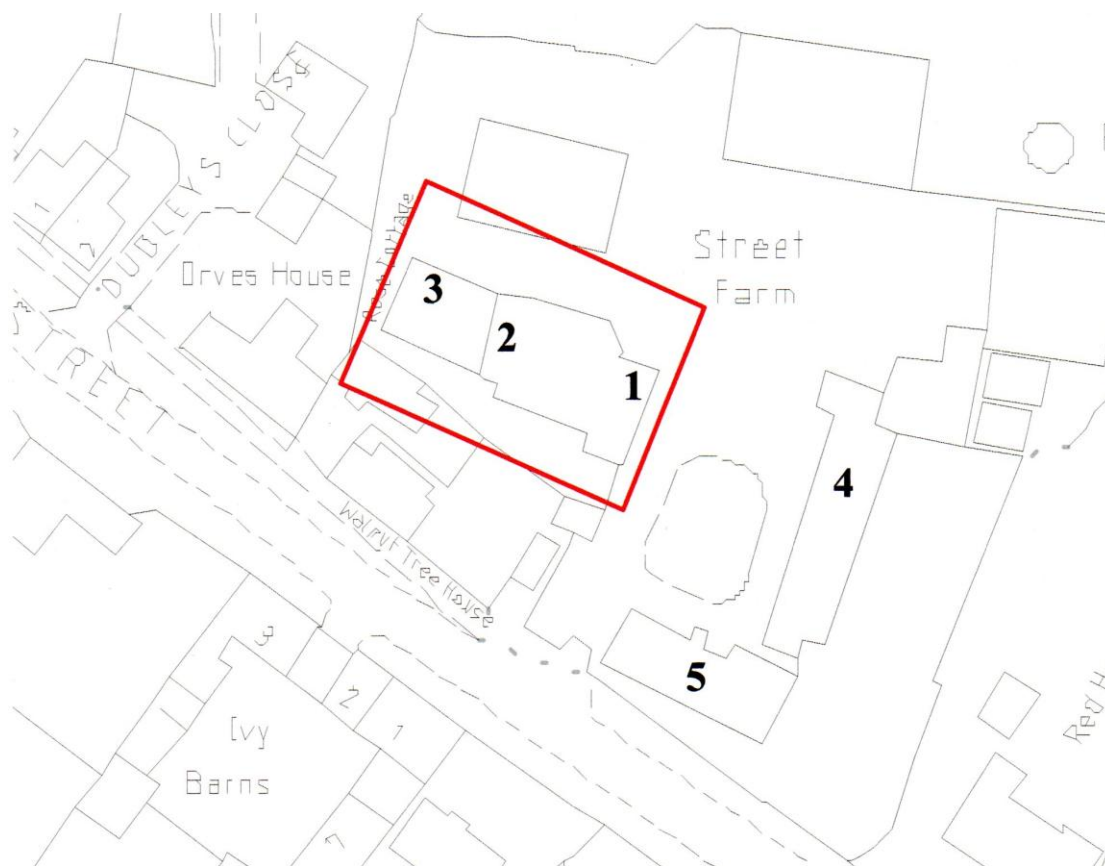
Figure 5

Block plan of the site (based on Ordnance Survey) numbering the principal buildings as follows: Stable (1), shelter-shed (2), 20th century corrugated iron vehicle shed of no historic significance (3), derelict 19th century brick maltings (4) and grade II-listed timber-framed 17th century farmhouse (5).

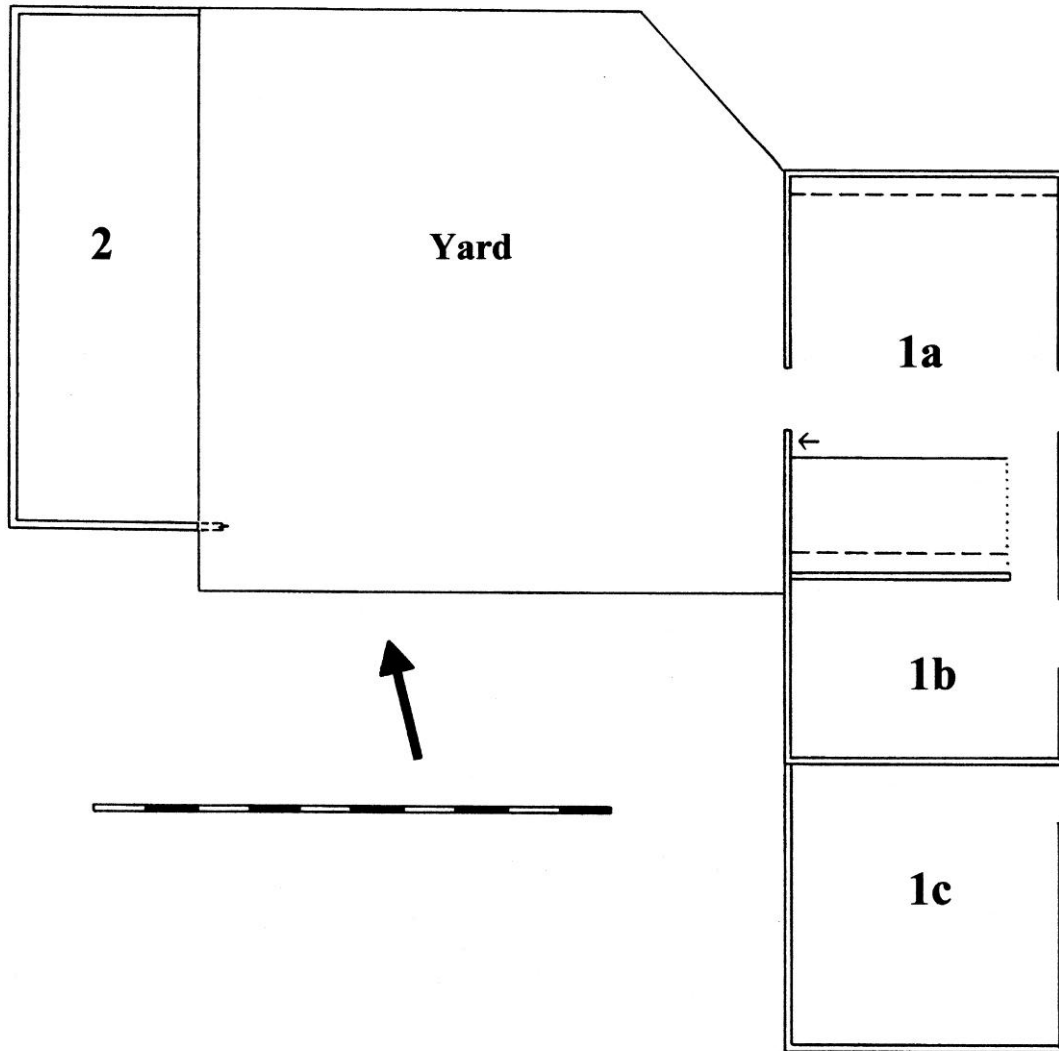
Figure 6

Ground plan of the stable (1) and shelter-shed (2) identifying the former's three compartments for ease of reference in the text and photographs. Scale in metres.

1. A timber-framed and weatherboarded stable range with pantiled butt-purlin roof. *Circa* 1820. Divided into the following compartments:

1a. Stable with central cross-entrance and hay racks and mangers beneath hay drops indicated by broken lines at both gables (the racks and mangers removed). Sections of the original wattle-and-daub floor of the hay loft still extant. A later boarded stall to the south, preserving a cobbled floor, with an original eastern passage to the adjoining tack room. Internal loft ladder beside western entrance (indicated by arrow). Converted for cattle during 1960s by removing fittings and inserting an automatic drinker.

1b. Tack room with original rendered ceiling and internal walls. A rail of wooden harness hooks to the north still retaining some leather tack at the time of inspection. This compartment appears to have been designed as a stable for riding or trap horses since an oak stall partition with a carved finial adjoins the western end of the northern elevation (the larger northern stable intended for working animals).

1c. Loose-box used in the mid-20th century for mares and foals. Lacking its roof and the walls partly collapsed. The southern half of this compartment is of brick rather than timber and its present proportions appear to have been formed by extending the

original stable range and removing its southern gable in *circa* 1870, but precise analysis is hampered by its fragmentary condition.

2. A red-brick and pantiled open-sided shelter-shed serving the yard adjoining the stable. *Circa* 1870 but on the site of an earlier building shown on the tithe map of 1846. Softwood clasped-purlin roof structure with nailed collars. The timber arcade posts to the eastern elevation are 20th century replacements.

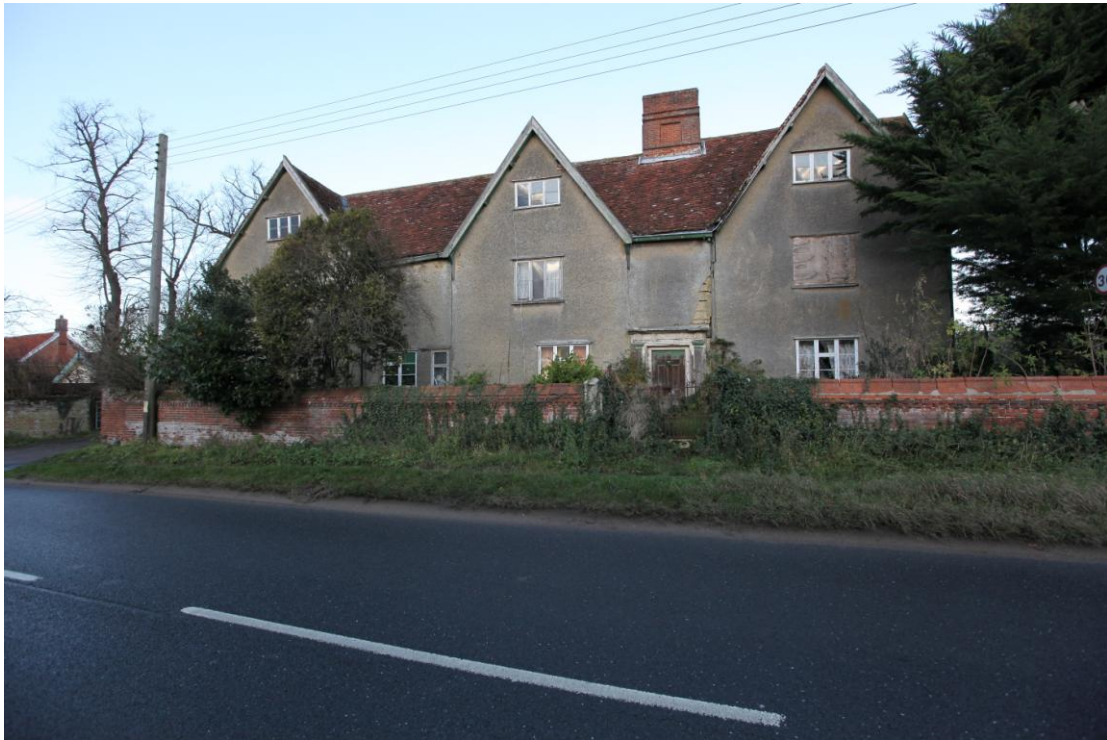
Illus. 1. The cement-rendered facade of the 17th century grade II-listed farmhouse (5) seen from The Street to the south, with the farm entrance to the left. Included for site context.

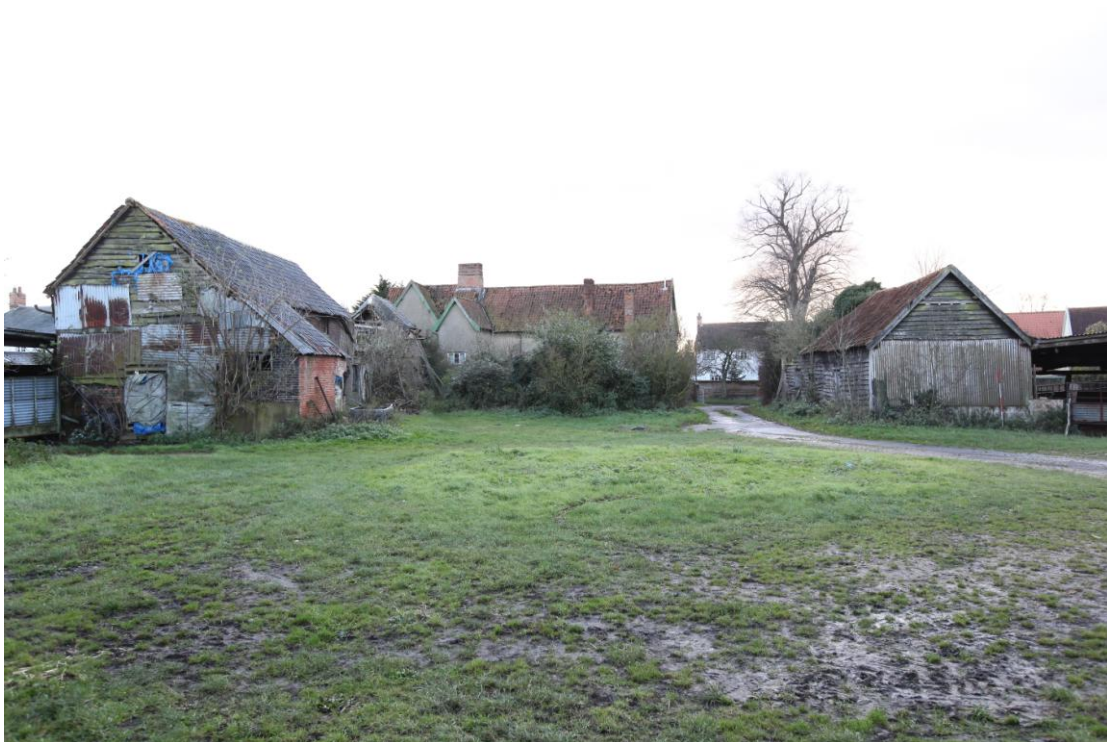
Illus. 2. A general view of the site from the north showing the derelict 19th century brick maltings (4) to the left, the grade II-listed farmhouse (5) in the centre and the timber-framed and weatherboarded stable (1) to the right.

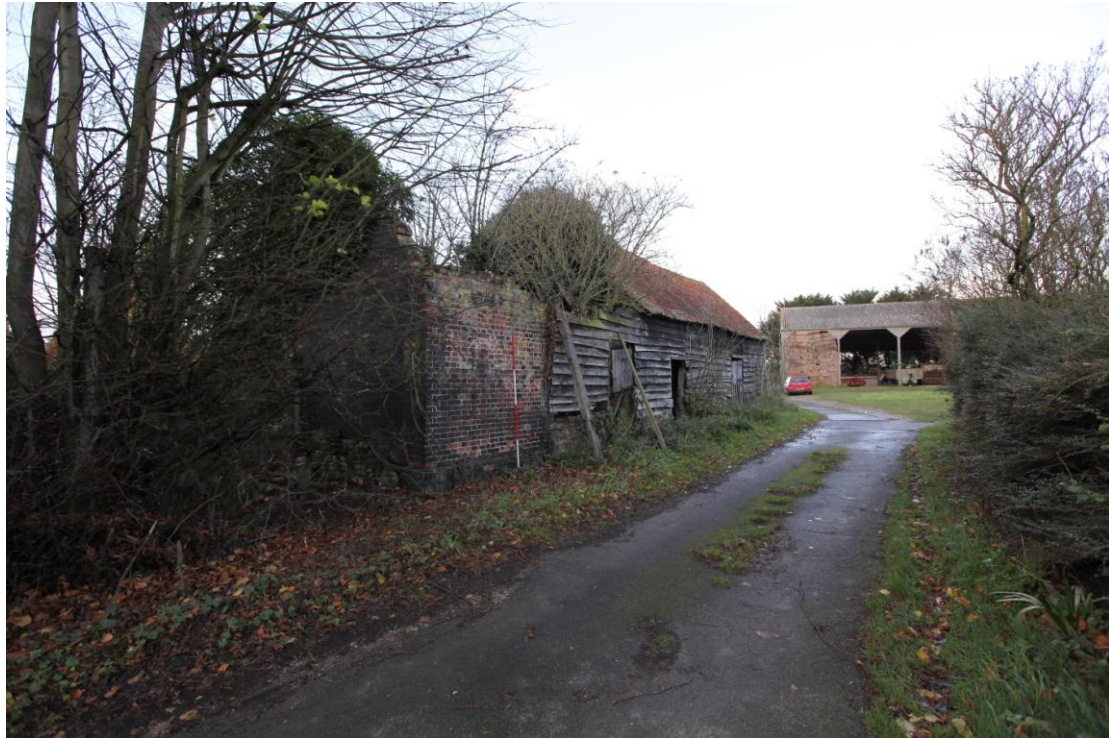
Illus. 3. The farm entrance track from the south-west showing the stable (1) to the left and a 20th century Dutch barn in the rear.
