**The Old Dairy,
Valley View Cottage,
Middleton, Suffolk
MDD 018**

Historic Building Record

The Old Dairy, Valley View Cottage (Valley Farm) Leiston Road, Middleton, Suffolk

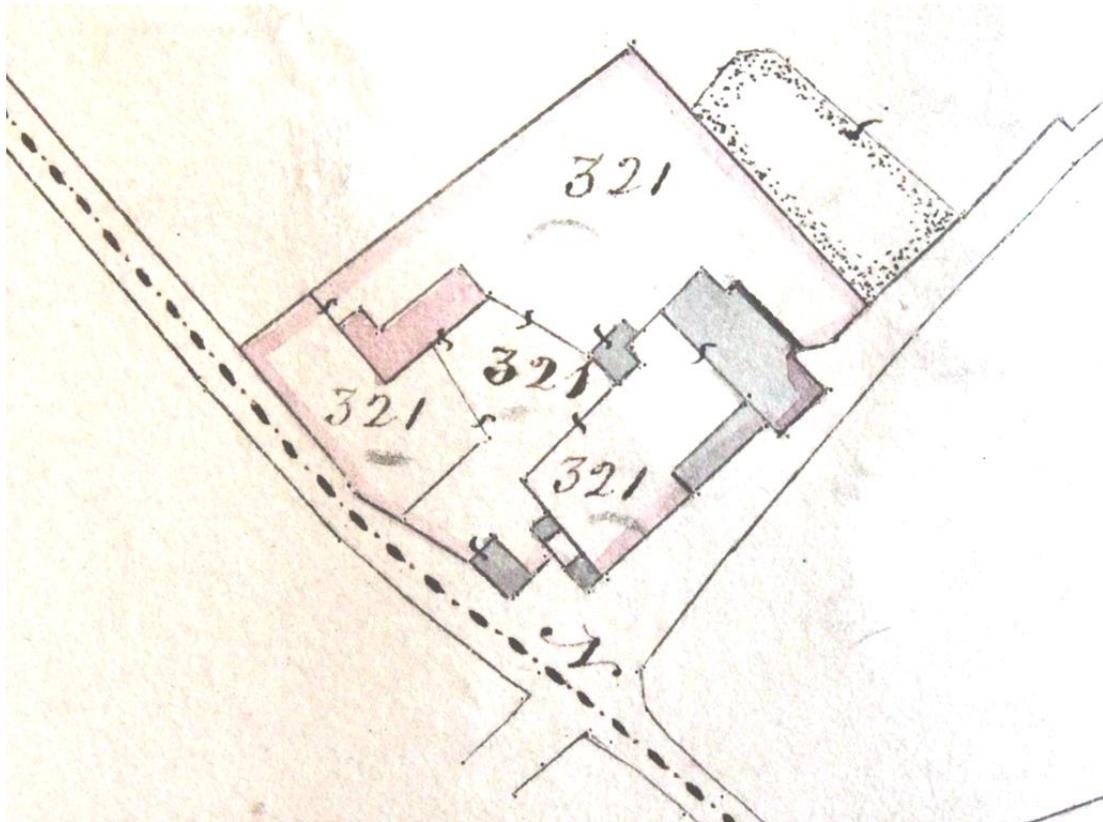
Figure 2
The Middleton parish tithe map of 1839 (Suffolk Record Office)
Showing the L-shaped farmhouse in red and the thatched barn adjoining the track to the east (prior to the addition of the stable to its northern gable). The dairy is conspicuous by its absence. The dotted line on the Leiston Road indicates the boundary with Fordley parish

The dairy is not shown on the 1839 tithe map of the parish, at which time the Leiston Road formed the boundary with the separate medieval parish of Fordley to the south-west (figure 2 above). The two parishes are now united as Middleton-cum-Fordley. Fordley church stood in the same churchyard as Middleton but, according to White's Suffolk Directory of 1844, 'was suffered to go to decay many years ago'. Both churches were standing in 1620 when a complaint was made to the bishop of Norwich that as the services in each church began at different times 'the bells and steeple of one disturbed the congregation of the other'. The tithe map shows the house and thatched barn (without its thatched stable) but not the dairy or the northern range of farm buildings. The accompanying apportionment describes the farm as a modest tenanted arable holding of 64 acres (of which just 5.5 were pasture), although more land may have been in Fordley parish which has a separate tithe survey. It was owned by Timothy Fellowes and occupied by Edward Reynolds Annison.

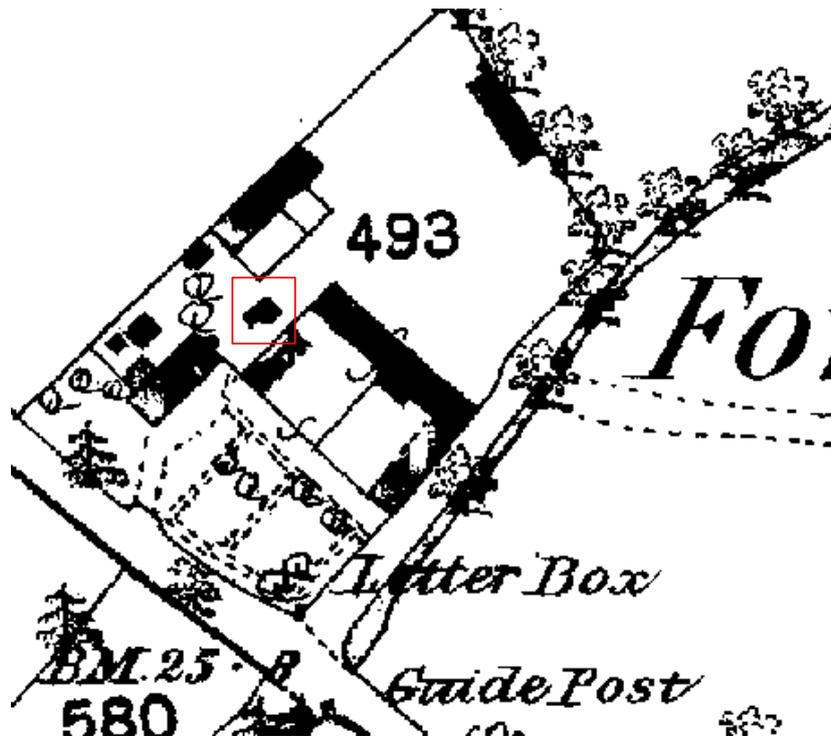
Figure 3

The first edition 25 inch Ordnance Survey of 1884.

The thatched stable had been added to the north-western gable of the barn since 1839 and a new group of sheds and yards built to the north. A detached shed is shown for the first time on the approximate site of the present dairy (in the red square) but this is significantly smaller than its successor and lies further from the farmhouse. The site is labelled 'Fordley' and 'Hogs Corner', as in 1904.

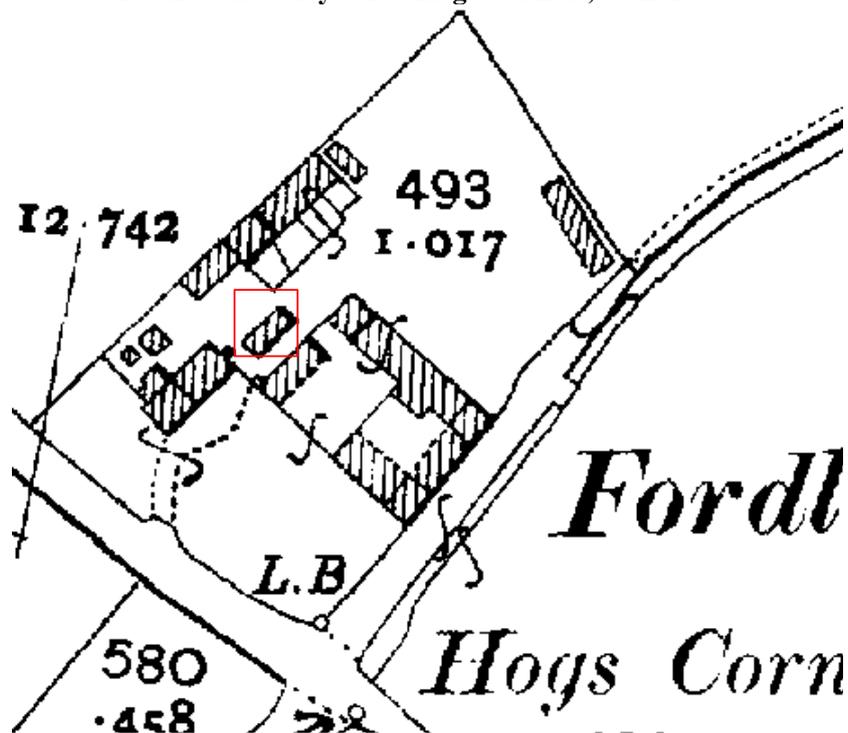
Figure 4

Second Edition 25 inch Ordnance Survey of 1904.

The dairy building is shown with its present outline for the first time and had evidently replaced the smaller shed shown in 1884.

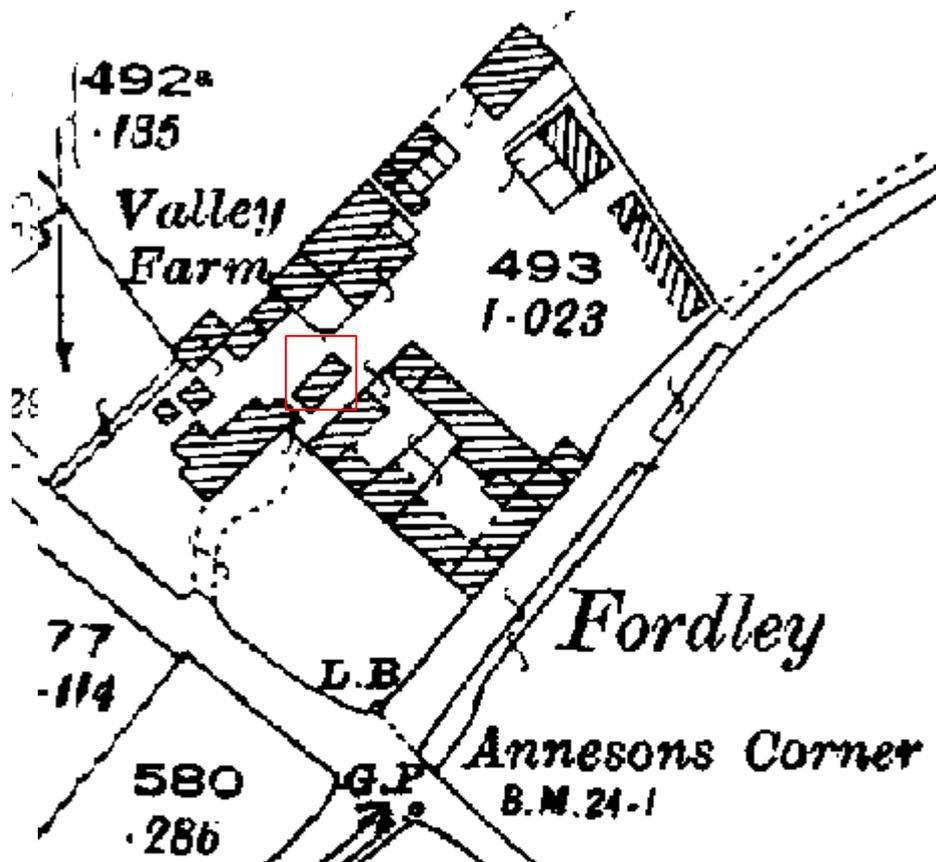
Figure 5
Third Edition 25 inch Ordnance Survey of 1927, showing additional farm buildings to the north but the dairy had remained unaltered since 1904. The corner had been renamed Annesons Corner after the farm's tenant of 1839.
