**Bribery Cottage,  
Walsham le Willows,  
Suffolk  
WLW 102**

**Heritage Asset Assessment**

**March 2012**

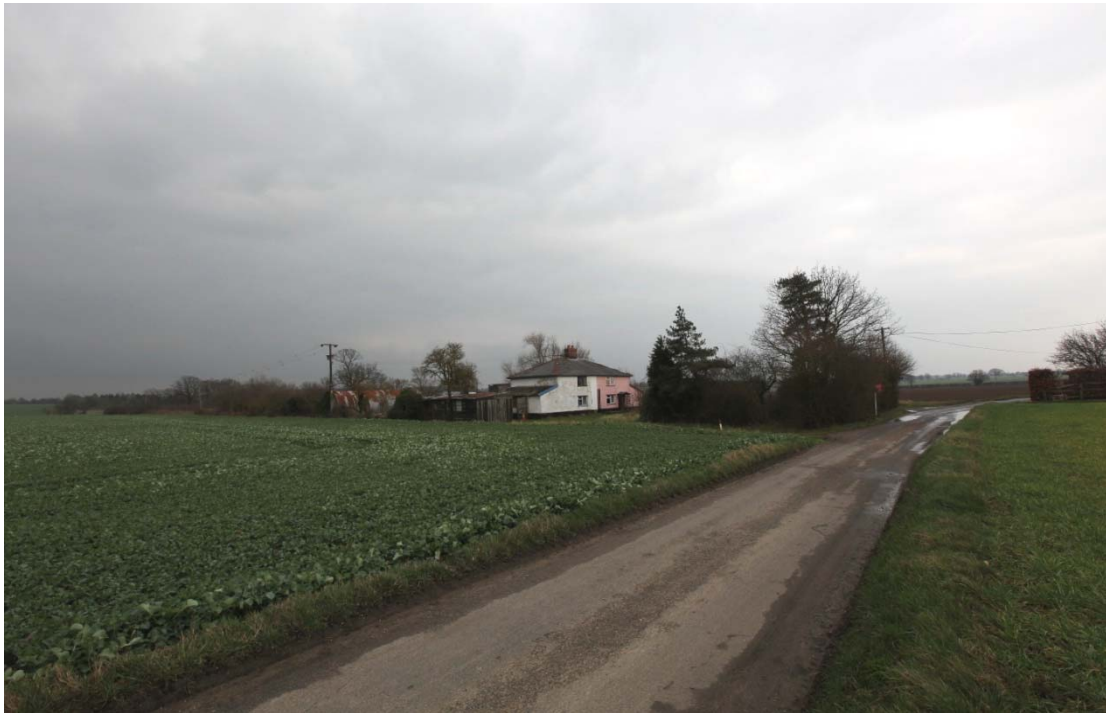
**Illus. 1.** A general view of the site from Bribery Lane to the north showing the cottage's isolated location on high ground in open countryside.
