**Outbuilding at
Lane Farmhouse,
Wilby, Suffolk**

Enhanced Historic Building Record

April 2012

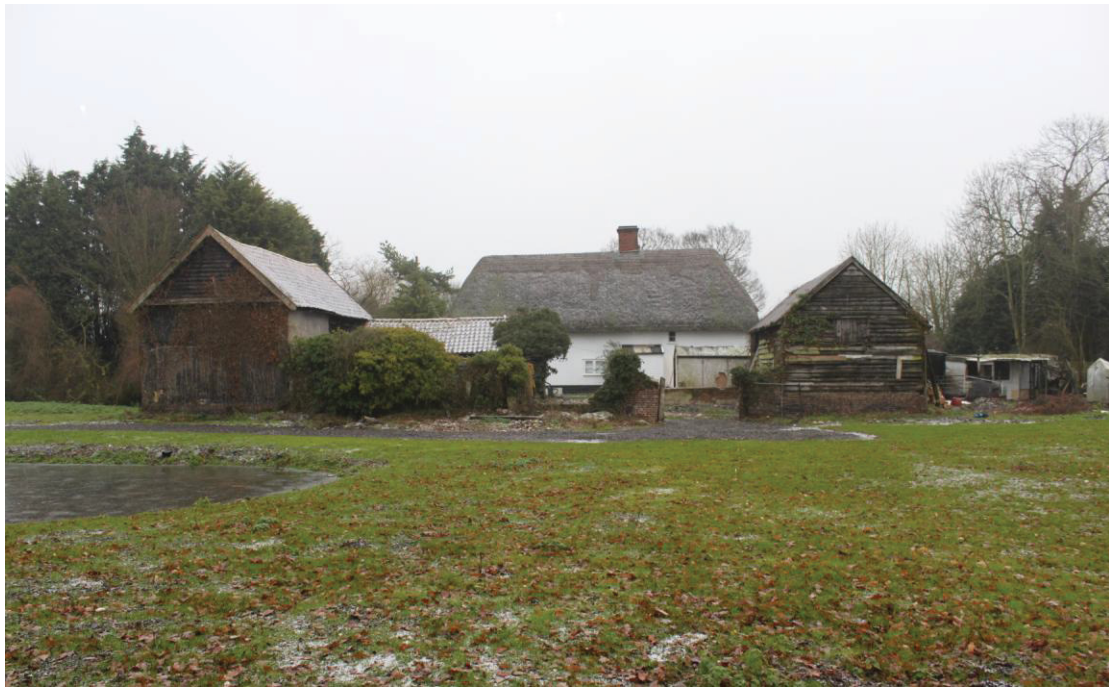
Illus. 1. General view of site from west showing the outbuilding (1) to the right, the thatched 15th century farmhouse (2) in the centre & the 17th century threshing barn (3) to the left.

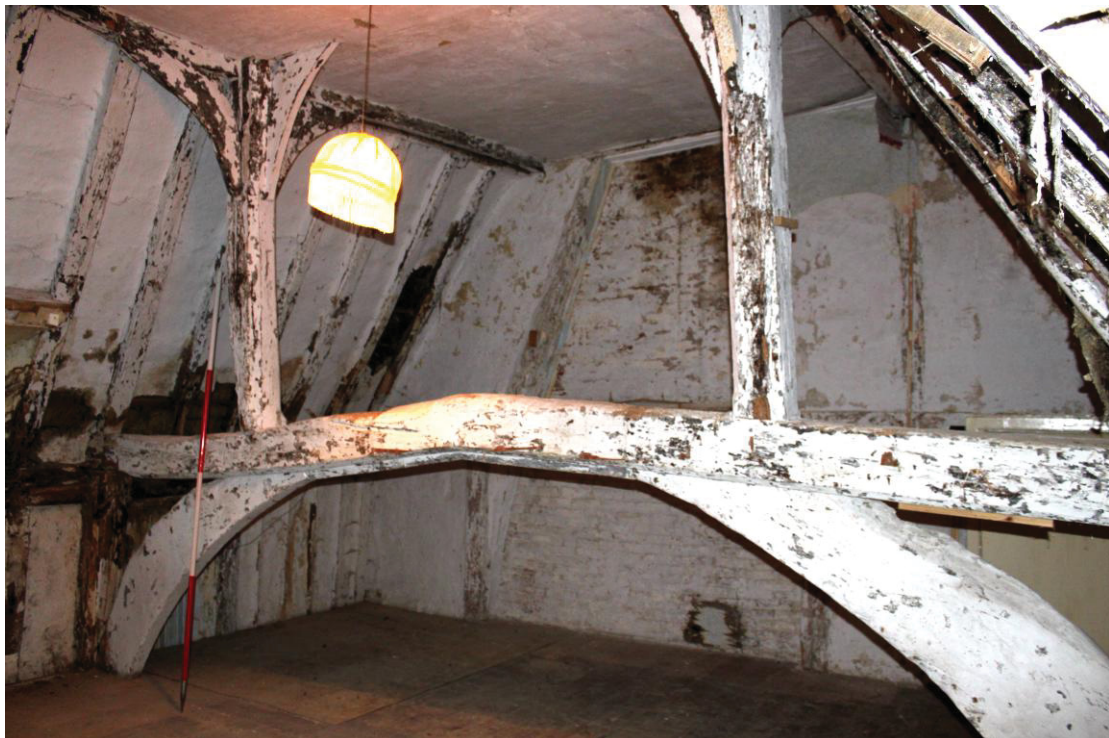
Illus. 2. The impressive queen-post open-truss of the 15th century open hall in the farmhouse (2) seen from the low-end to the north-west. The whitewash conceals heavy sooting. Included for site context.
