**The Barn,  
Heath Farm,  
Coney Weston, Suffolk  
CNW 019**

**Heritage Asset Assessment**

# **Barn at Heath Farm, Coney Weston, Suffolk**

## **Heritage Asset Assessment**

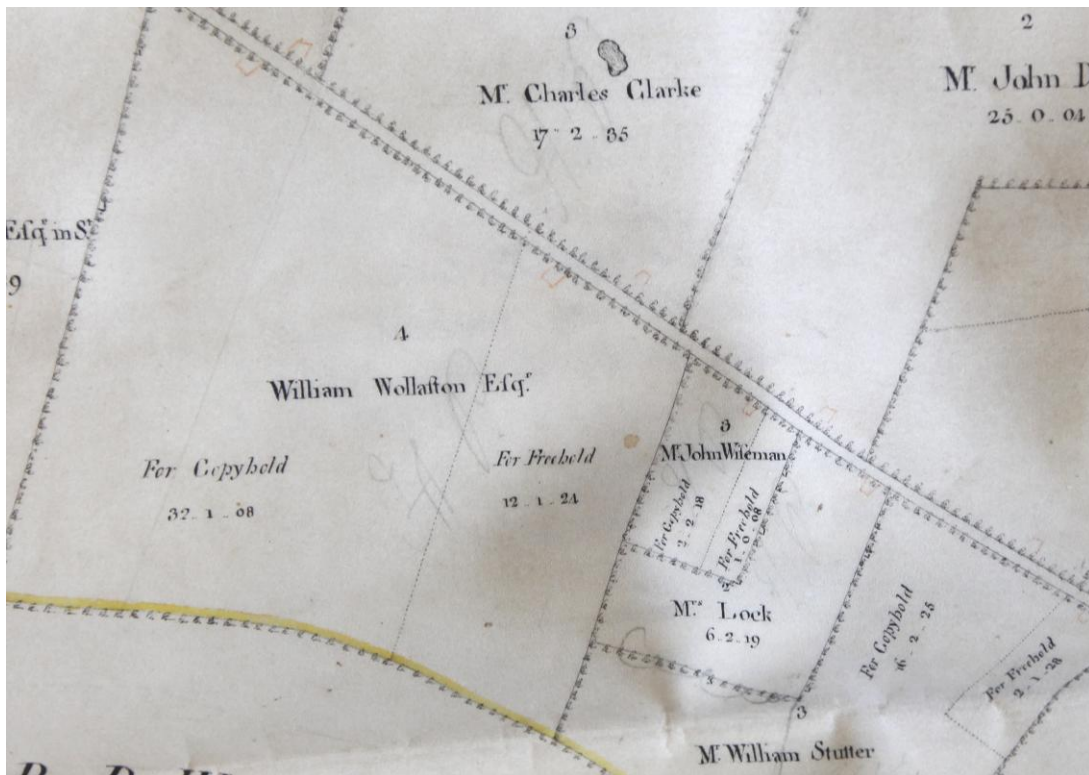
**Figure 2a.** Detail of the 1777 enclosure map showing the future site of Heath Farm (centre) in the north-eastern corner of a large empty field of William Wollaston Esquire.

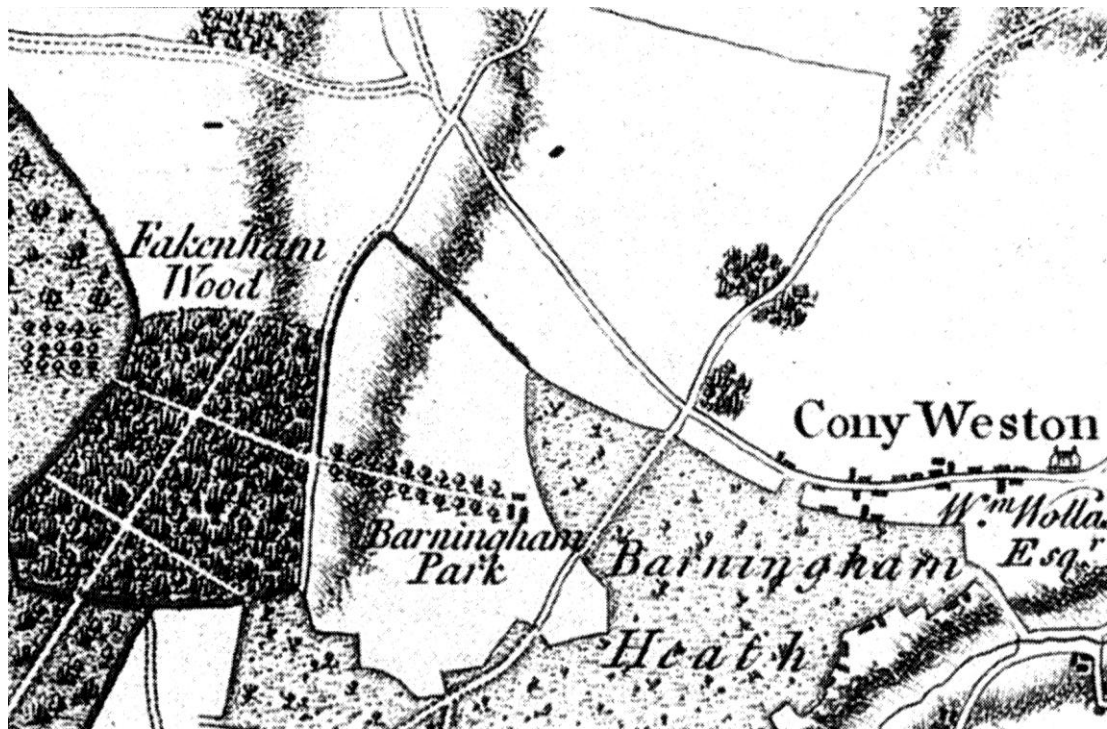
Figure 3. Hodkinson's Map of Suffolk in 1783.

Six years after enclosure Heath Farm is still conspicuous by its absence in the approximate centre of this image, but a building on the approximate site of Heath House is indicated to the north of the same road.

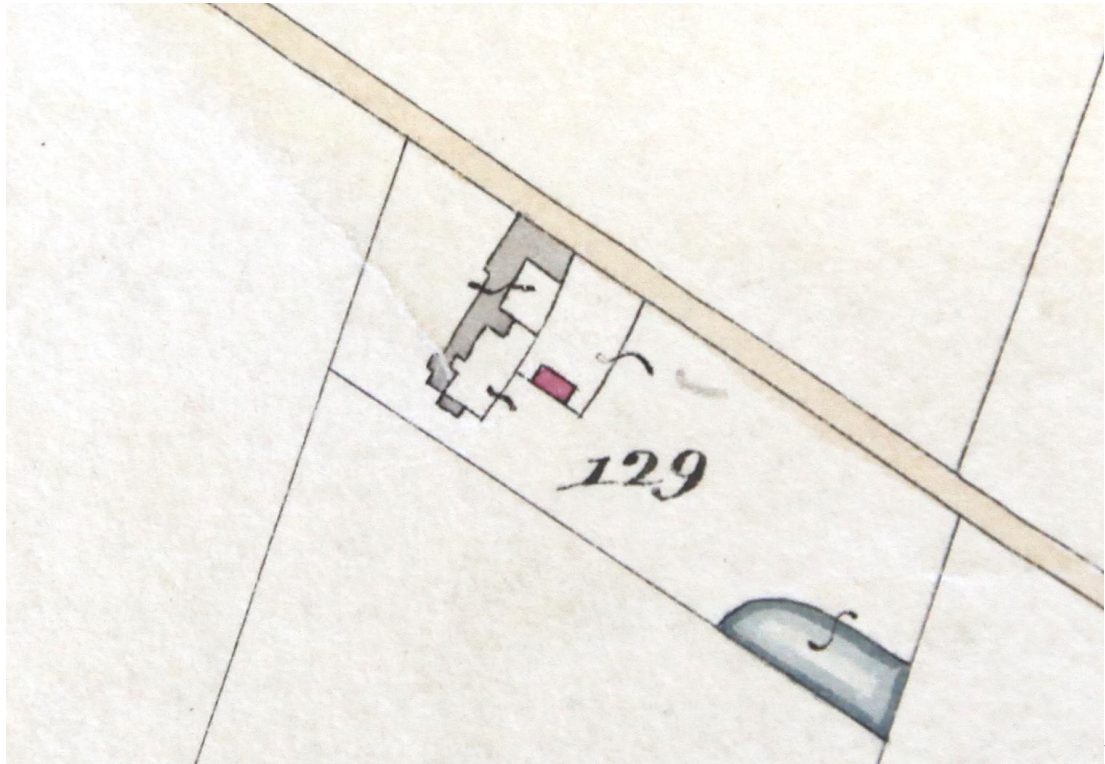
Figure 4a. A detail of Heath Farm on the 1843 tithe map. The house shown in red may represent the low, rear range of 'Greystones'. The clay-lump stable (2) had not yet been added to the barn's south-eastern corner and the broad structure adjoining the road may have performed the same function.

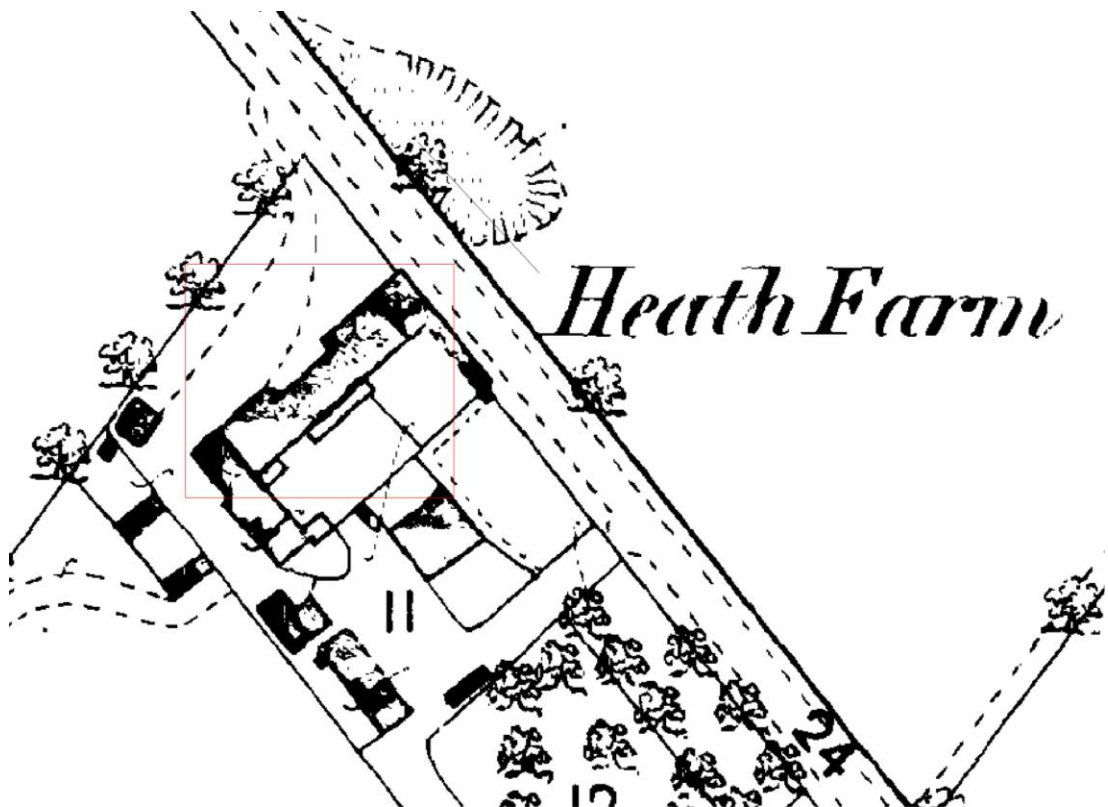
Figure 5. First Edition 25 inch Ordnance Survey of 1883. The clay-lump stable (2) is now present and the house had been either rebuilt or provided with a new front range.

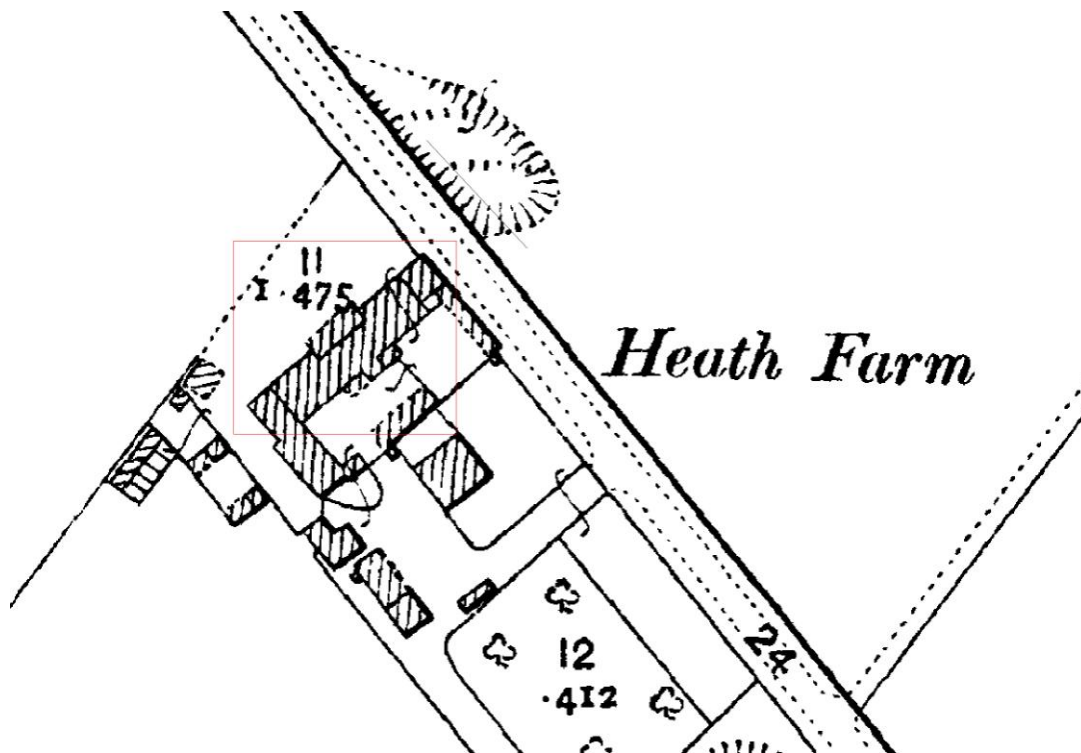
**Figure 6. The Second Edition 25 inch Ordnance Survey of 1902. A new open-sided shelter-shed had been added to the south-eastern side of the horse yard since 1883 but the existing L-shaped range (3) had not yet been completed.**
