**Barn at
White House Farm,
Southolt, Suffolk
SLT 008**

Heritage Asset Assessment

OASIS ID: Suffolkc1-133994

September 2012

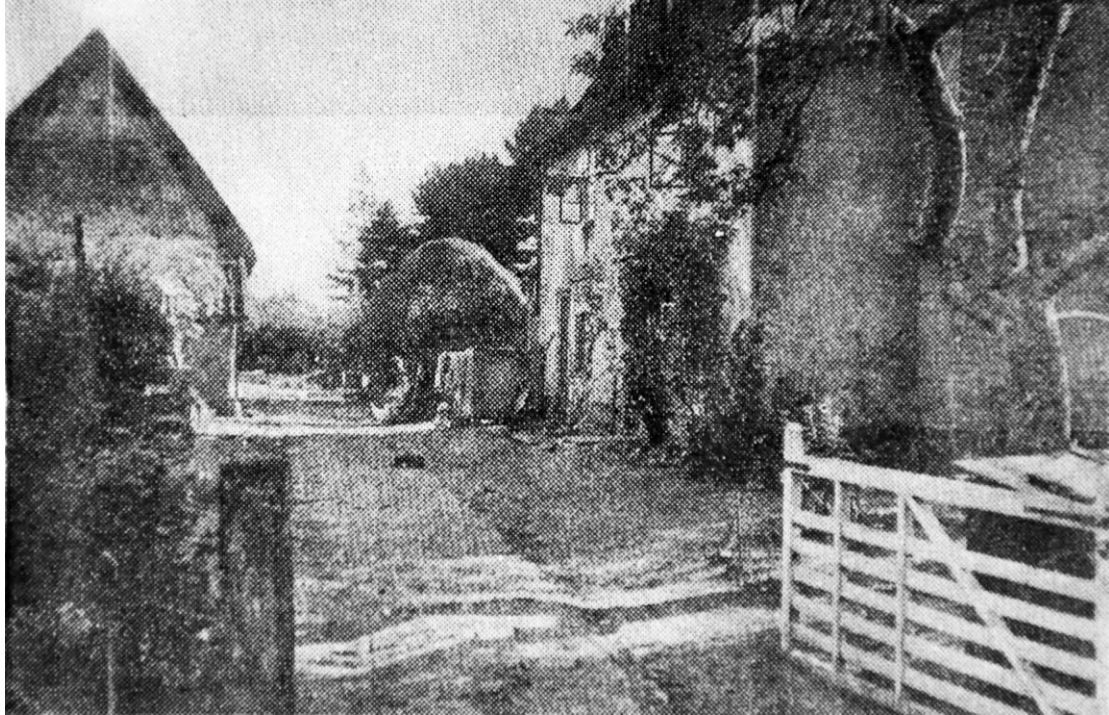
Figure 5

Photograph of the farm yard from its northern entrance published in the Southolt entry of the 'Pocket Histories of Suffolk Parishes' series (Suffolk Chronicle, 1936). The view is clearly of White House Farm but was labelled only 'Beautiful Sunlight Effect on a Farmyard'. Note the thatched roof and the pantiled lean-to shed adjoining the barn's northern gable to the left. If the barn was designed with windows in this gable they had been blocked prior to this date.

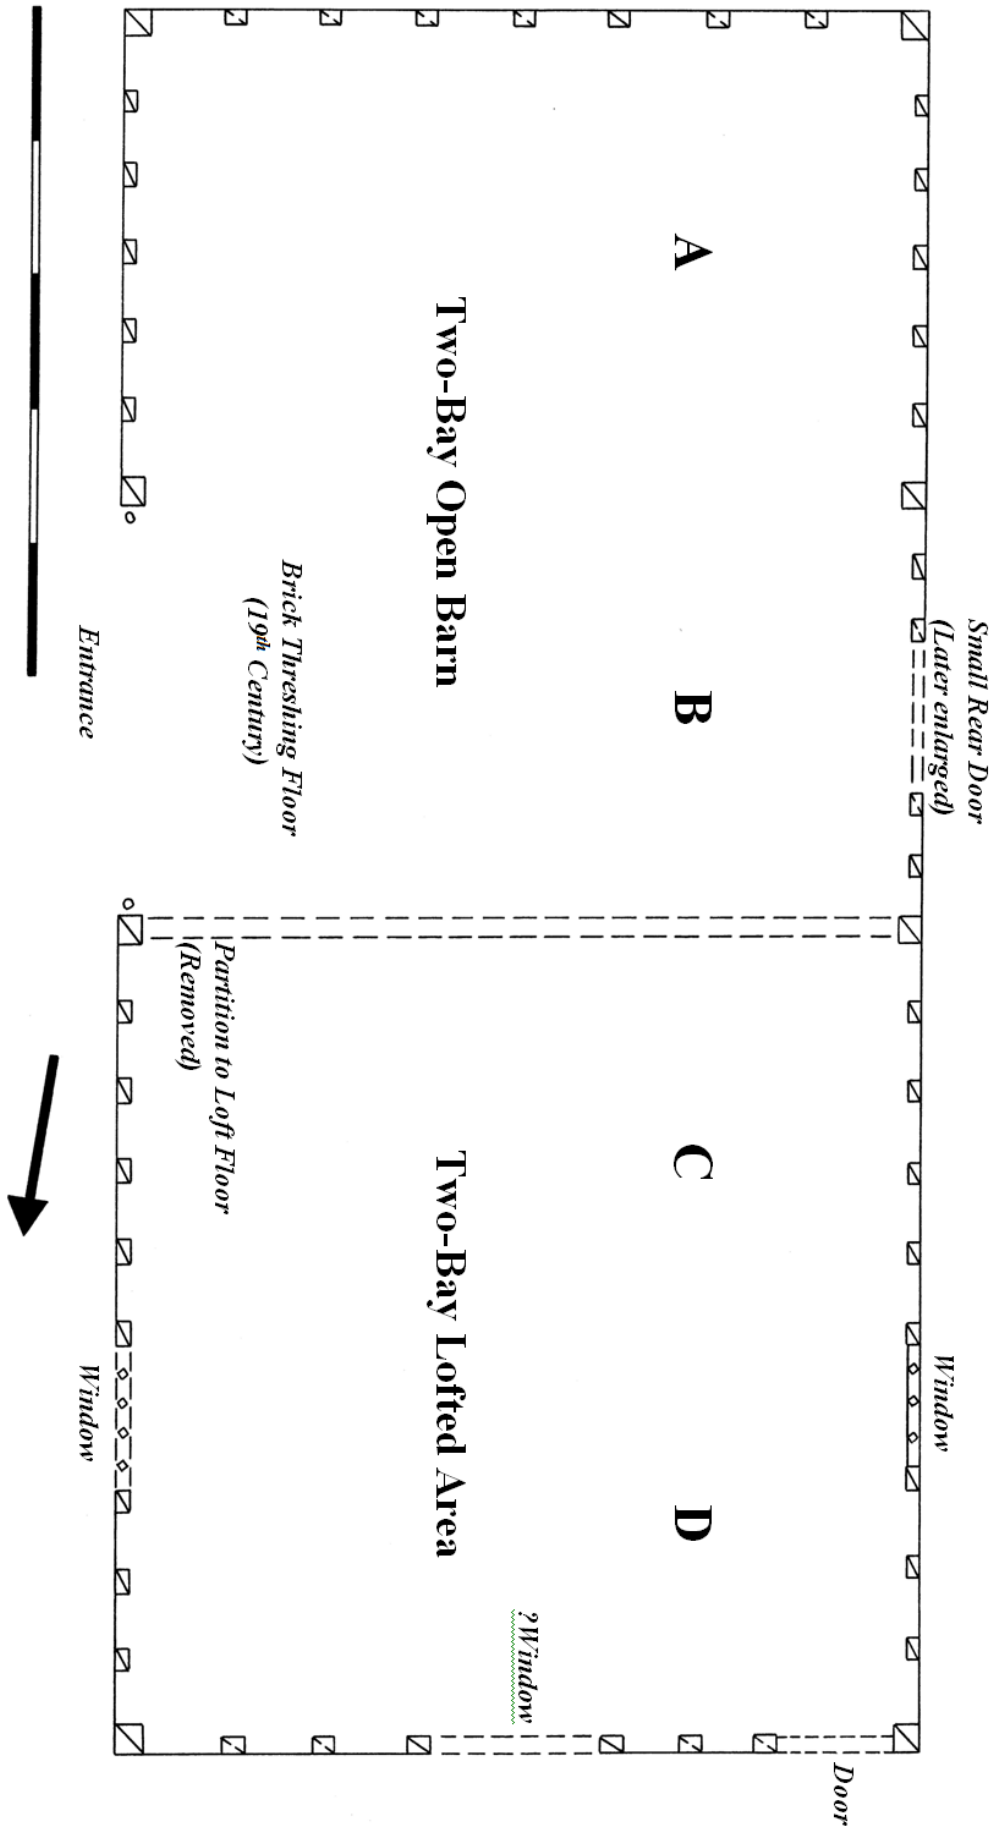
Figure 7. Original Ground Plan (missing timbers indicated by broken lines)

between bays B and C held the rail of an internal half-height partition that divided an open threshing barn of two bays to the south from a floored-over area of similar scale to the north. The threshing barn was entered by full-height doors in the eastern elevation of bay B, as shown by the lack of stud mortises in its roof-plate and by the presence of circular holes which held the original pin hinges. A central, un-pegged mortise in the same section of roof-plate held the vertical bar to which the doors were secured. The rear, western elevation of the same bay contained a small, low door with studs above and beside its lintel, as reconstructed in figure 11. The width of this door is indicated by the wider infill panels flanking the remaining central stud, but its precise height is unclear as it was raised and widened in the 18th or 19th centuries. Small rear doors of this kind were intended to create a through-draught for threshing and winnowing but not to admit carts, and were standard features of English barns until the 19th century when vehicle thoroughfares were introduced to accommodate threshing machines. By the mid-20th century very few local barns had escaped the insertion of full-height rear doors, and the survival of so much original studwork here is unusual and of considerable historic interest. The threshing floor of the entrance bay is a replacement of the 19th century in both red and gault (white) brick, but this too represents an increasingly rare survival and may hide an earlier floor beneath.

The internal partition between the two halves of the barn has been removed along with the northern loft, but its position is revealed by two double-pegged mortises in the storey posts between bays B and C (1.8 m or 6 ft above the modern floor). These secured a rail with studs or boarding beneath and arch-braces to the tie-beam above, as reconstructed to the right of figure 10. The arch-braces are approximately 35 cms (14 ins) higher than those of the truss to the south of the threshing floor in order to accommodate the rail, and it was possible to load the loft from the threshing floor. The joists of the loft would have been lodged upon or possibly tenoned to this rail, and there is evidence of a similar rail at the same height in the northern gable; this was tenoned and pegged to the corner posts but lapped and pegged over the inner faces of the studs as shown by trenches in the extant timbers adjoining the reconstructed window. The loft was 6.25 m in length (20.5 ft), as opposed to the open barn of 6.75 m (22 ft), and its joists cannot have spanned this distance without additional support. The central tie-beam between bays C and D is not arch-braced (in order to avoid restricting access on the loft) and lies above a common stud rather than a storey post as would normally be expected. In the absence of any mortises in this stud for a lateral binding joist it must be presumed that the ends of any lateral joist penetrated the walls where they were secured by external wedges, or were supported by internal Sampson posts.

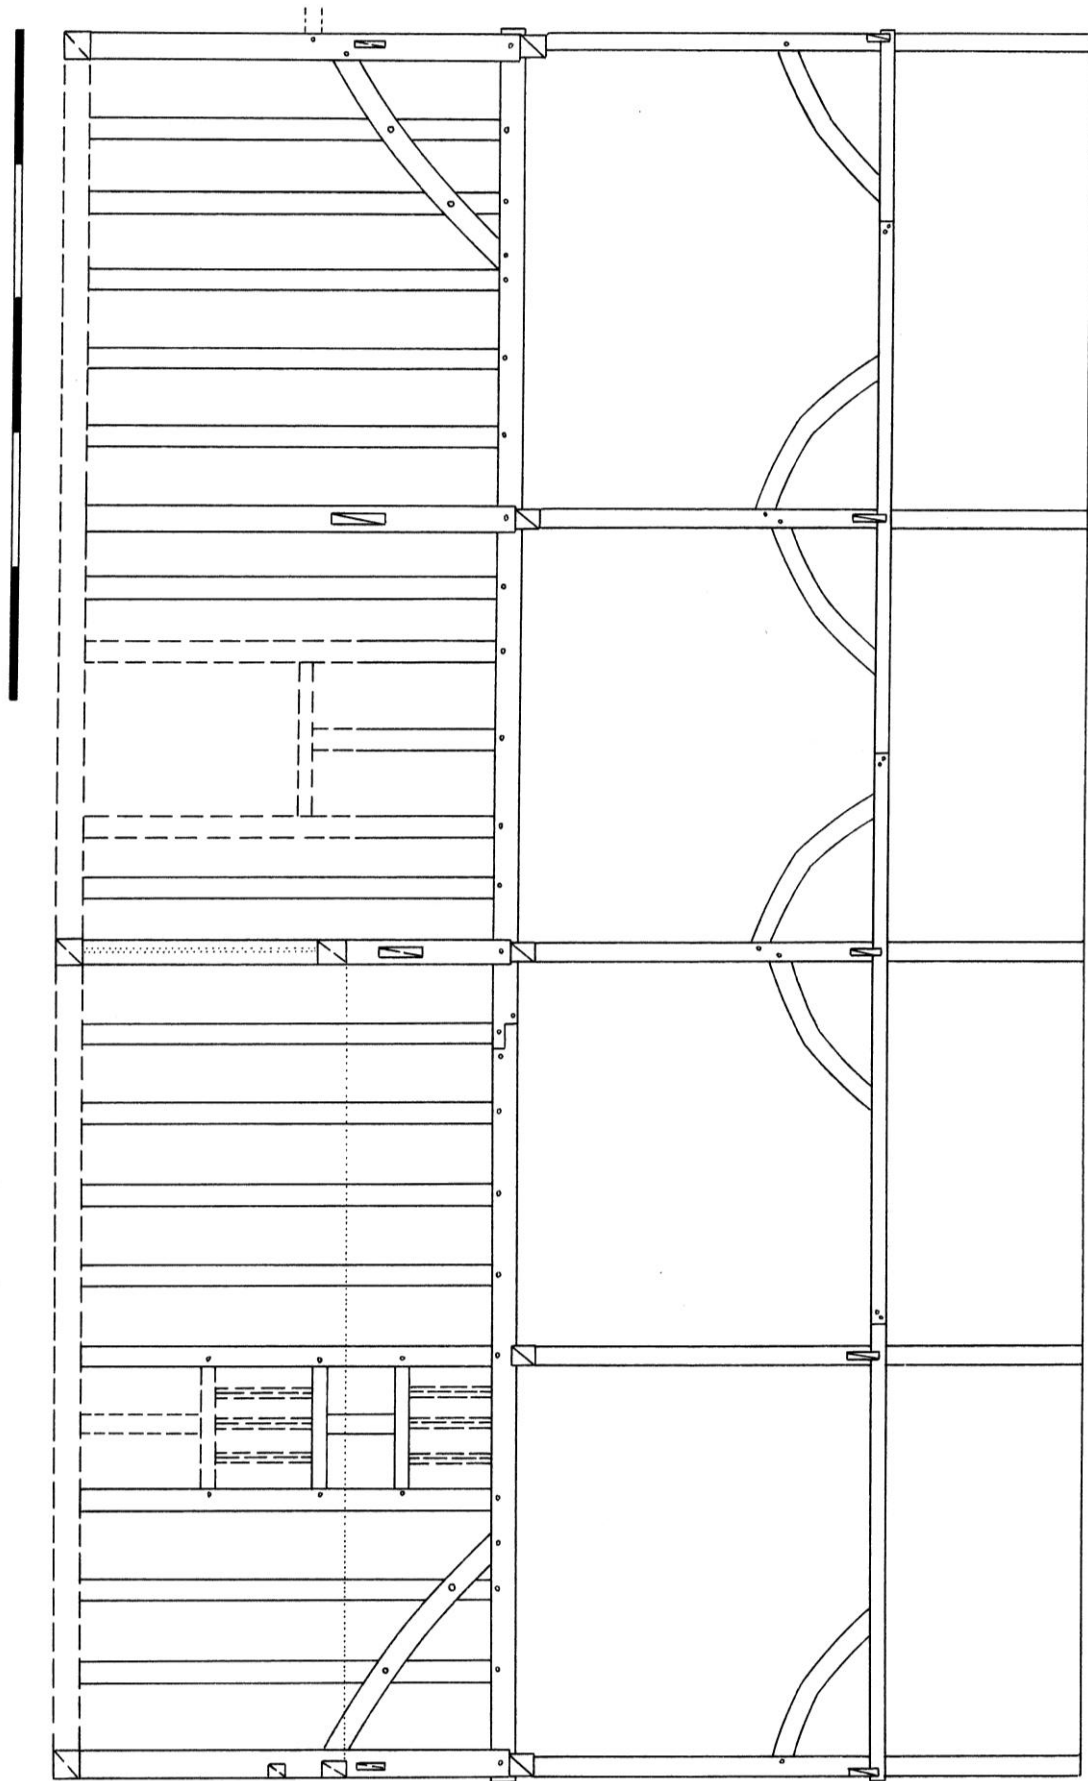
Figure 8. Internal Rear (Western) Elevation (omitting common rafters)

Although now open to its roof along its entire length, the barn was very different when first built. The northern bay (D) contains evidence of original first and ground floor windows to both front and rear, as shown in figures 8 and 9, and empty mortises in the storey posts

The lofted bays were lit by ground and first-floor windows containing diamond mullions (square bars set diagonally) as shown in the drawings. Those of the eastern facade were slightly wider at 1.1 m as opposed to 0.9 m to the rear (43 ins and 35 ins respectively). This anomaly must explain the curious 'double' mullion mortises in the underside of the western roof-plate where the carpenter appears to have attempted to accommodate four mullions as he had to the east before realising he had room for only three. The original mullions have been removed, but the original first-floor window sill and ground-floor lintel survive to the west. The latter was at some time converted into the lintel of a secondary door, as outlined in the external weatherboarding, the insertion of which required the removal of the corresponding sill. The two windows of the northern gable are modern reconstructions using pegged joints which have unfortunately damaged the evidence of the original arrangement. The window jambs contain pegged sill mortises that may be original, and appear to pre-date the modern sills that now lie within (the present sill obstructs the peg hole of the upper western jamb), but a central stud mortise in the tie-beam suggests the windows are insertions. However, this mortise may not be original and it is possible that the barn contained gable windows of similar scale from the outset. The other studs of the same gable are modern replacements, but a pegged mortise in the western corner post corresponds with a gap in the original stud mortises and reveals the position of an original external door as shown to the left in figure 10. The southern gable preserves only a single original stud below its tie beam.

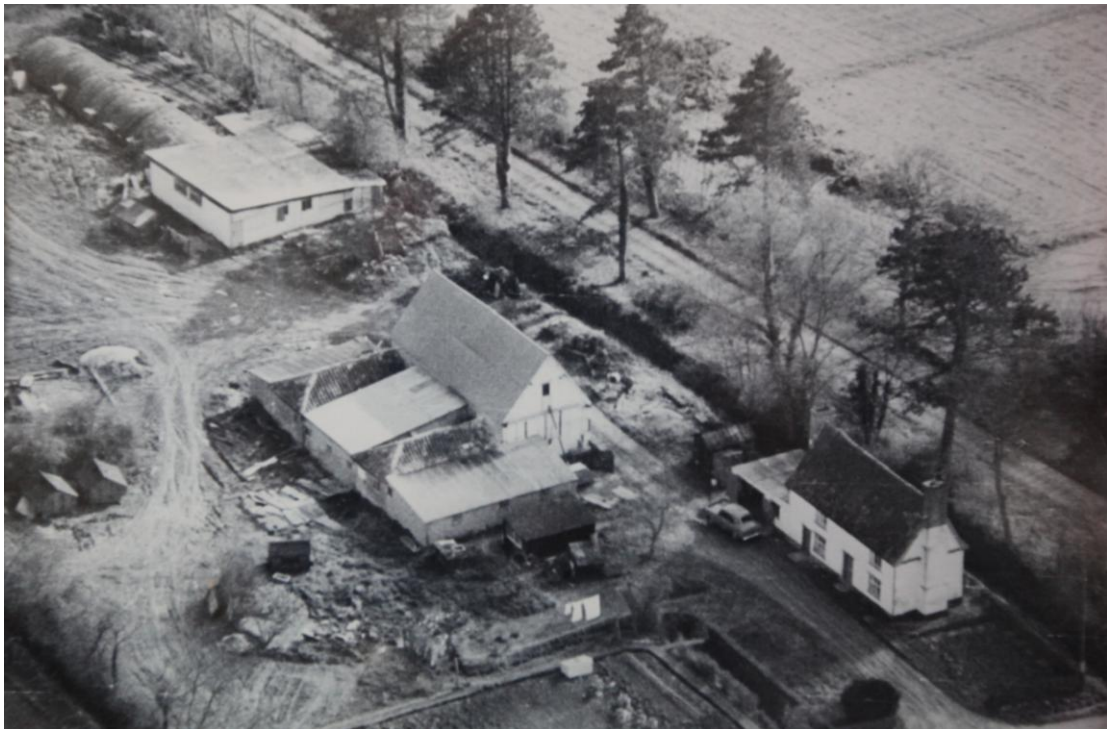
Illus. 1. An Aerial photograph of 1964 taken from the north-east and showing the close proximity of the grade II-listed farmhouse (5, right) and the grade II-listed barn (1, centre). The yard adjoining the barn's eastern elevation is walled and roofed as a lean-to, with a separate lean-to against the northern yard shed (4) – both since demolished. The house has two doors and appears to form a pair of cottages.

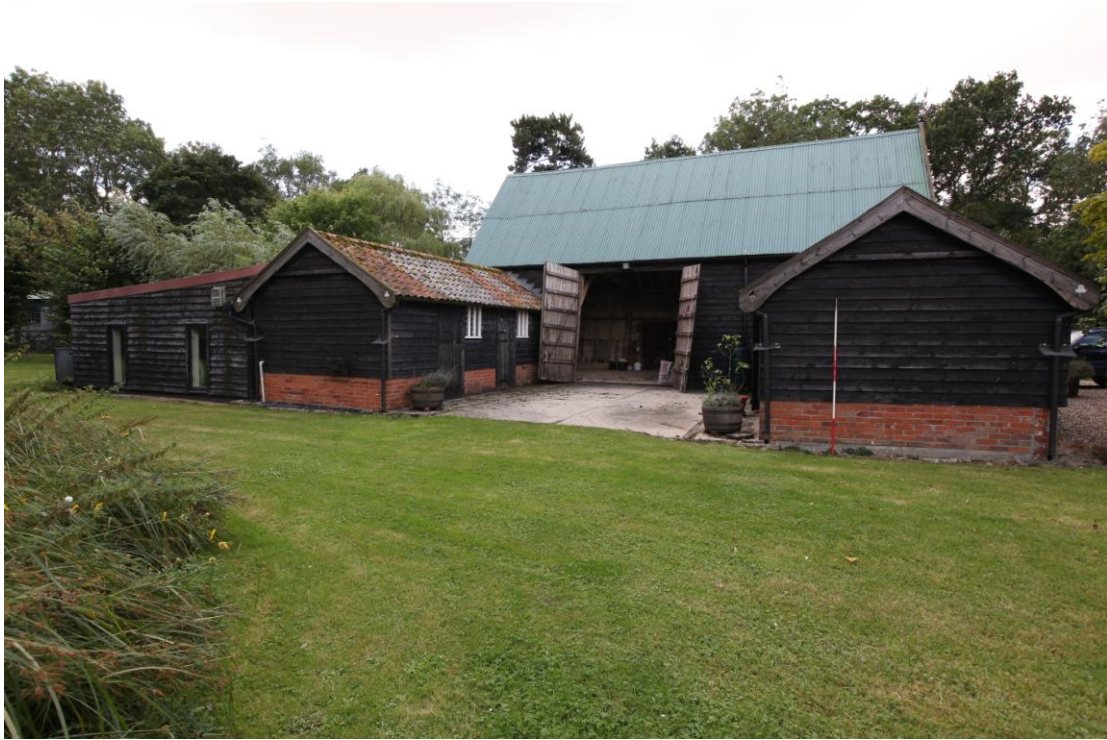
Illus. 3. The barn complex from the east showing the timber-framed threshing barn (1) with its corrugated iron roof in the rear and the 19th century yard sheds (3 & 4) to left and right. The 20th century lean-to to the extreme left (4) houses a swimming pool and the adjoining yard shed has been converted into boiler and wet rooms.

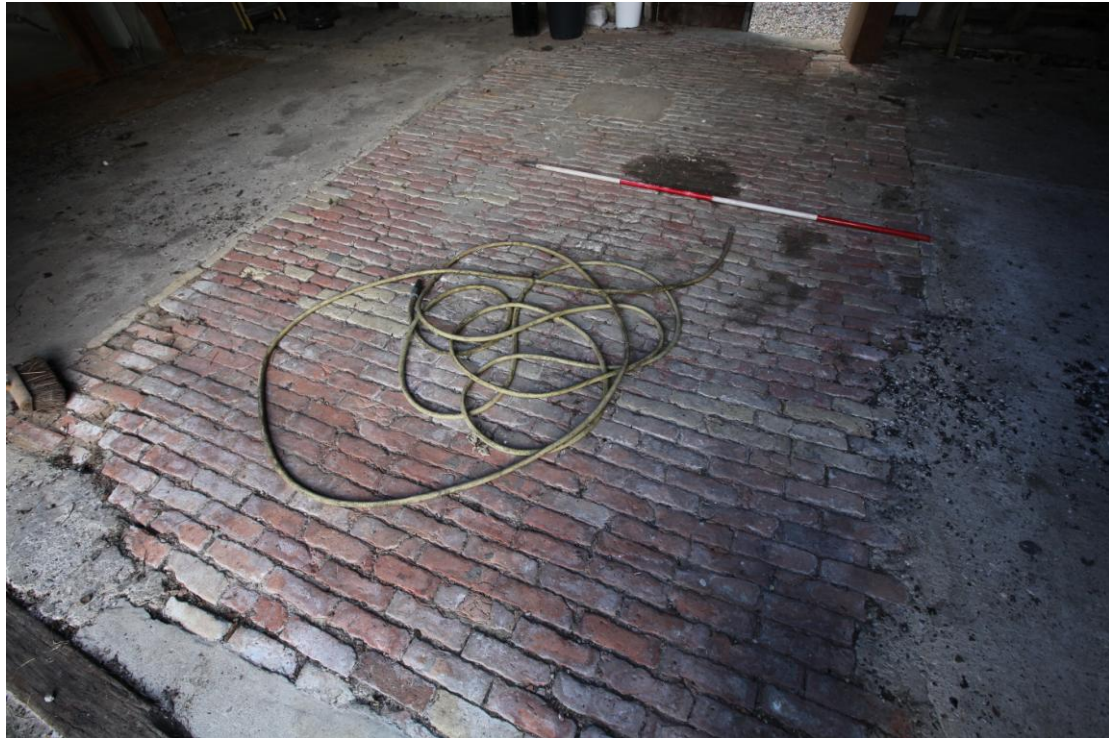
Illus. 7. The well preserved 19th century threshing floor of mixed red and gault brick in bay B of the barn (1), seen from its eastern entrance. The floor is of modern concrete elsewhere.

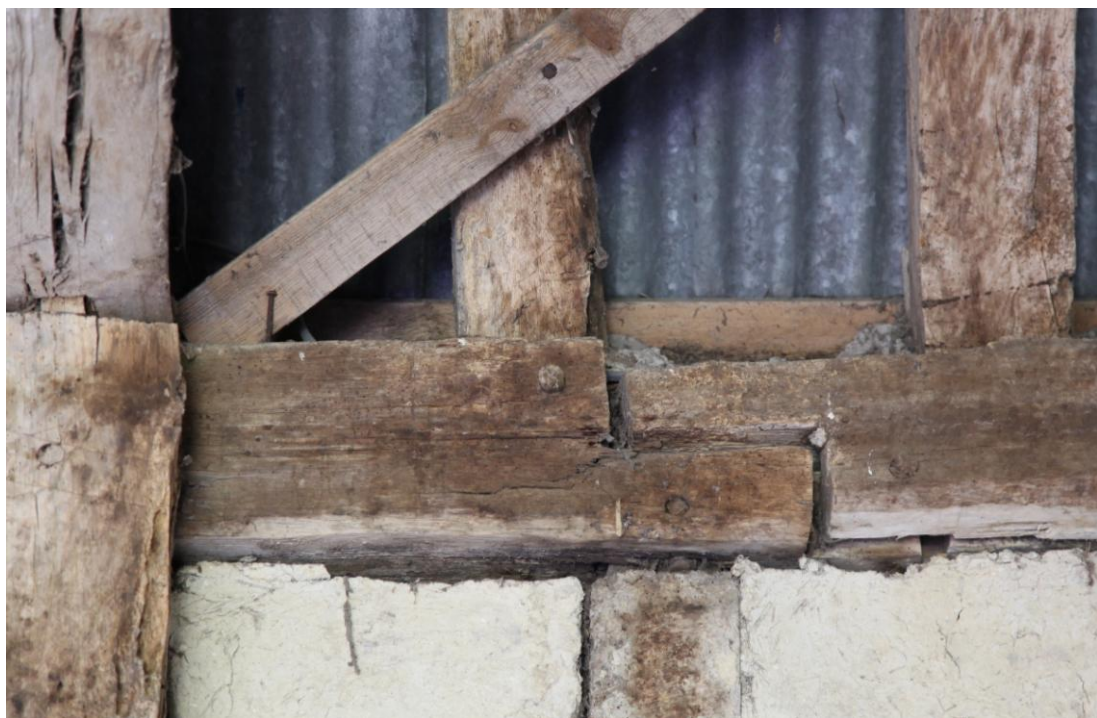
49. Detail of damaged eastern roof-plate of bay C showing remains of 16th century type edge-halved & bridled scarf joint to right.
50. Eastern roof structure of northern bays (C & D) showing intact reverse-cranked wind braces & un-braced tie-beam.

Illus. 10. A detail of the 16th century-type edge-halved and bridled scarf joint in the western roof-plate of bay C. Joints of this kind were quickly superseded during the first quarter of the 17th century.

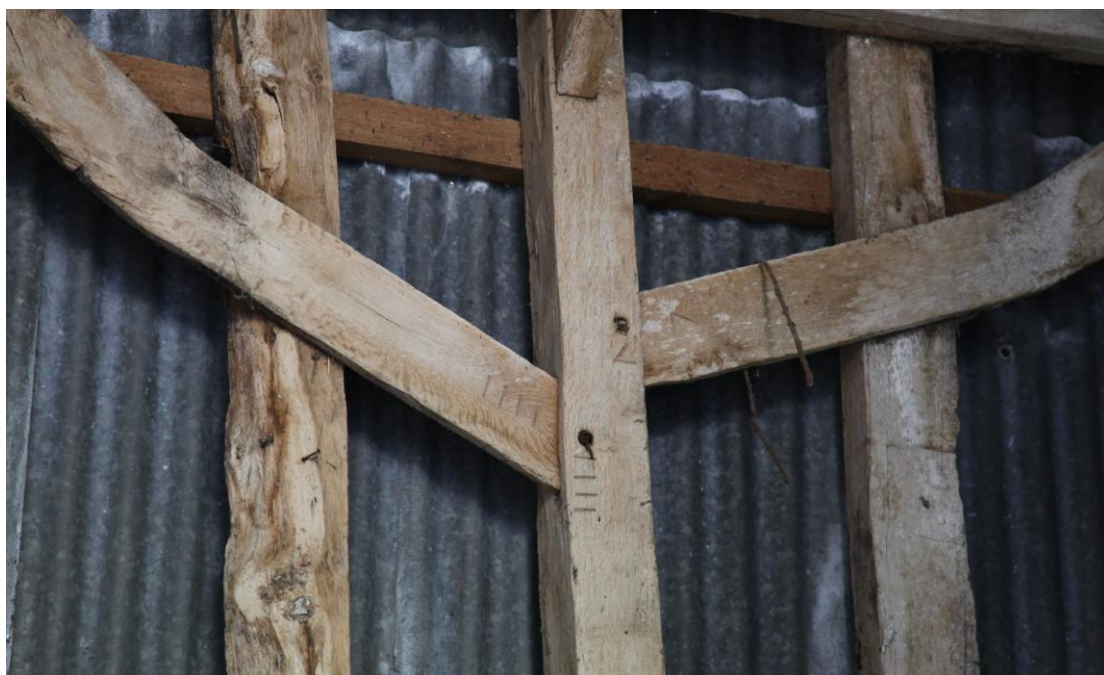
Illus. 12. Detail of the chiselled Roman carpenter's numerals III and V to the western reverse-cranked wind-braces between bays B and C. Chiselled marks of this type (as opposed to scored marks) are typical of the 17th century and later, and are rarely found in conjunction with edge-halved scarf joints.
