**Barn at  
Potash Farm,  
Kenton, Suffolk  
KNN 019**

**Heritage Asset Assessment**

# **Barn at Potash Farm, Eye Road, Kenton, Suffolk**

## **Heritage Asset Assessment**

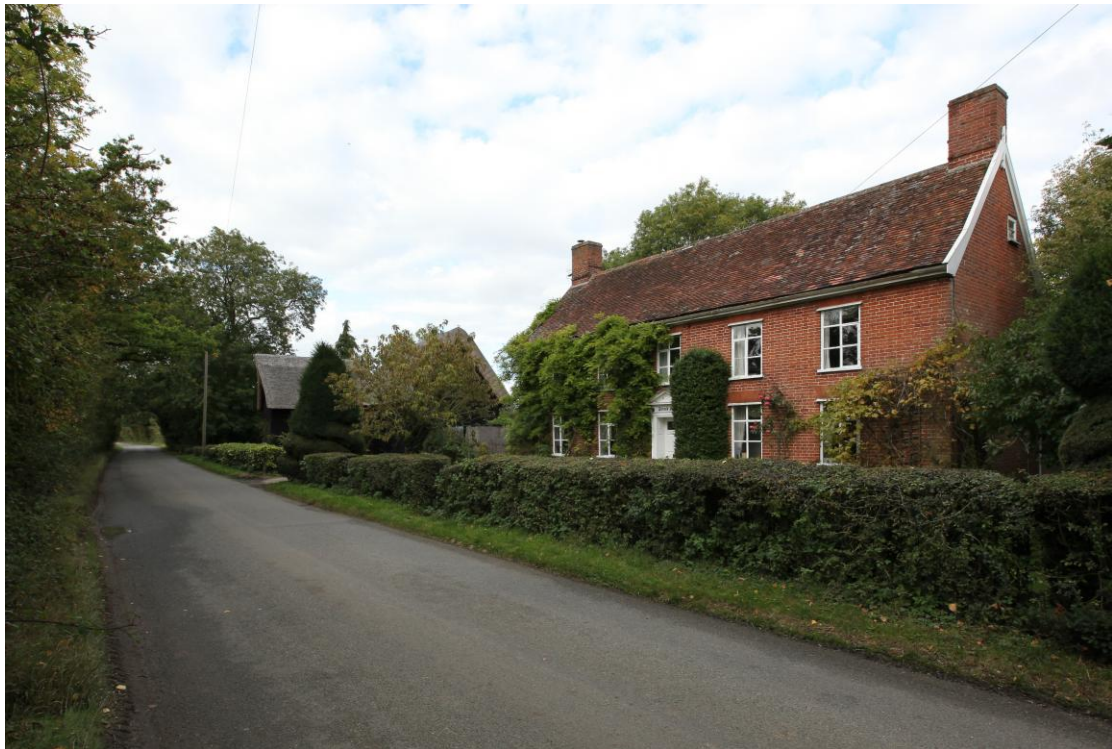
**Illus. 1. A general view of the site from the Eye Road to the south showing the imposing Georgian brick facade of the grade II-listed farmhouse to the right with the barn in the rear to the left.**
