Eye Castle masonry repairs EYE 116

Archaeological Monitoring Report

SCCAS Report No. 2012/184

Client: Mid Suffolk District Council

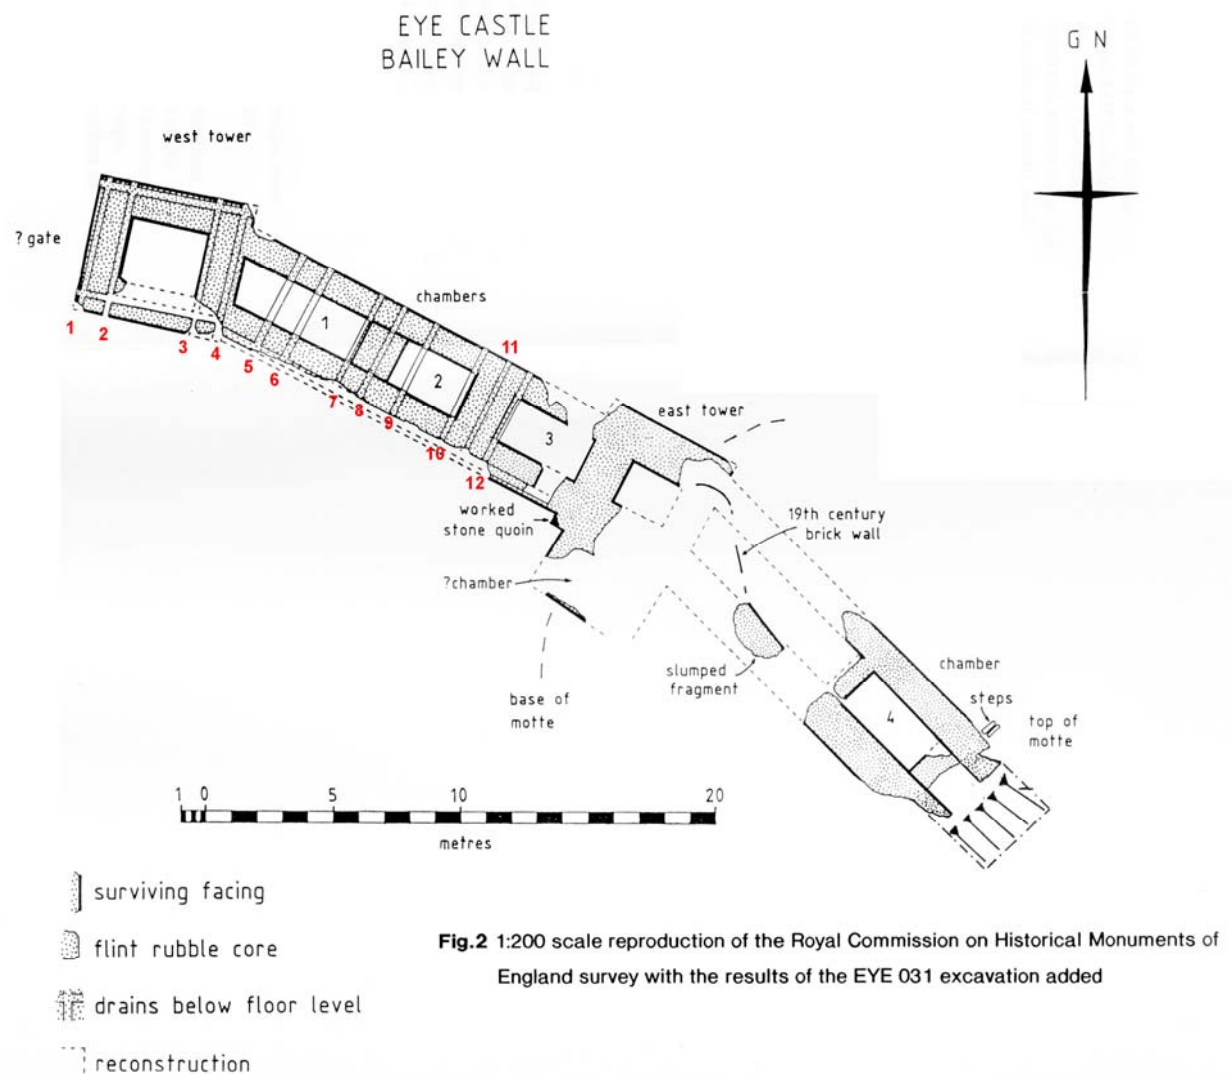
Figure 2. Plan of the bailey wall reproduced from the Royal Commission on Historical Monuments survey of 1994. The designations used on the drawing have been maintained for ease of reference in the current text. Numbers added in red were issued in 2012 to identify the channel entrances numbered in the photo archive

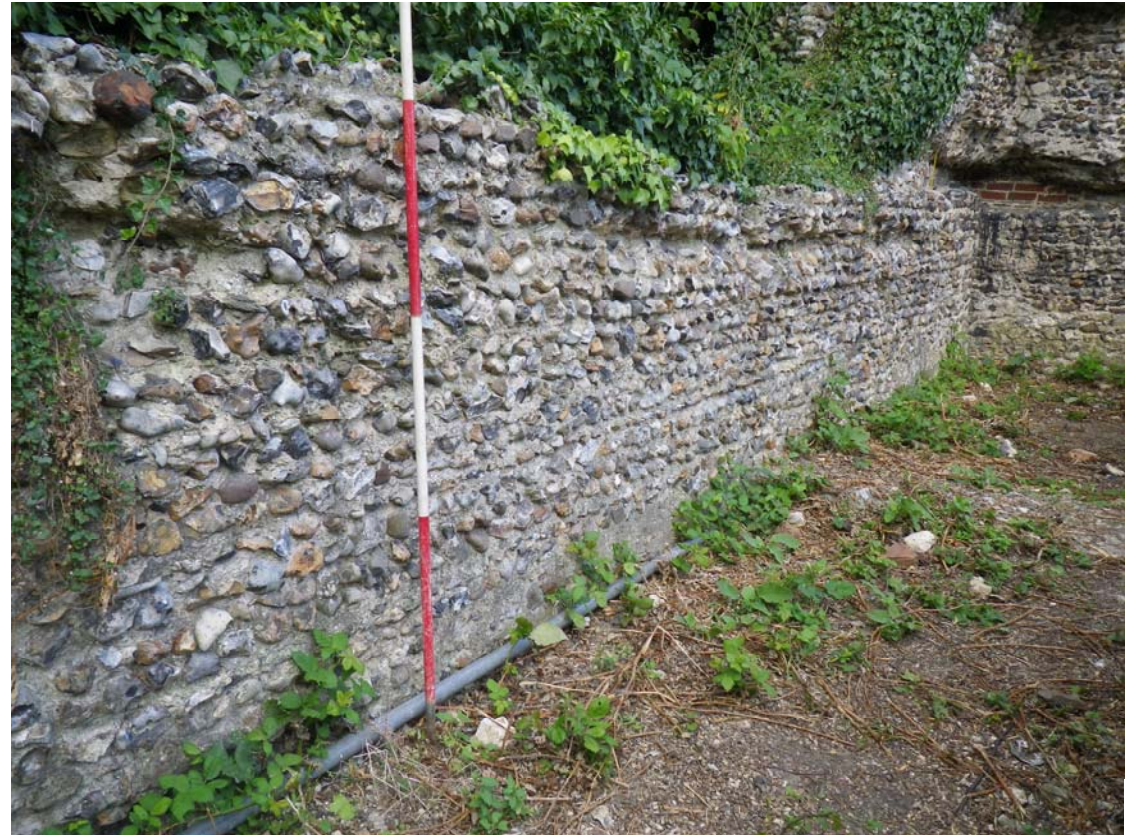
Plate 8. Interior (south) face of the north wall of chambers 1 and 2 showing the flints laid in neat horizontal courses typical of the work of Norman masons.

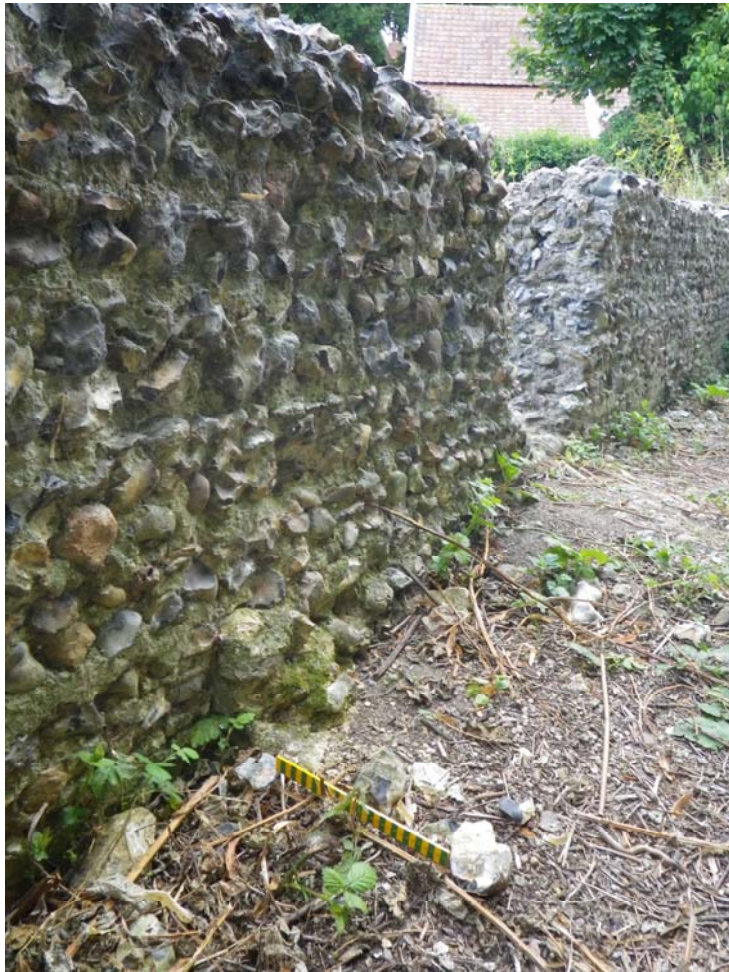
Plate 9. Interior of the south wall of chambers 1 and 2. The two chambers are separated by a central stub wall, which is buried below existing ground level there is no scarring on the vertical wall faces to indicate that the stub wall extended above its extant height which suggests that was not a partition but a support for a suspended floor and chambers 1 and 2 were not divided above floor level.

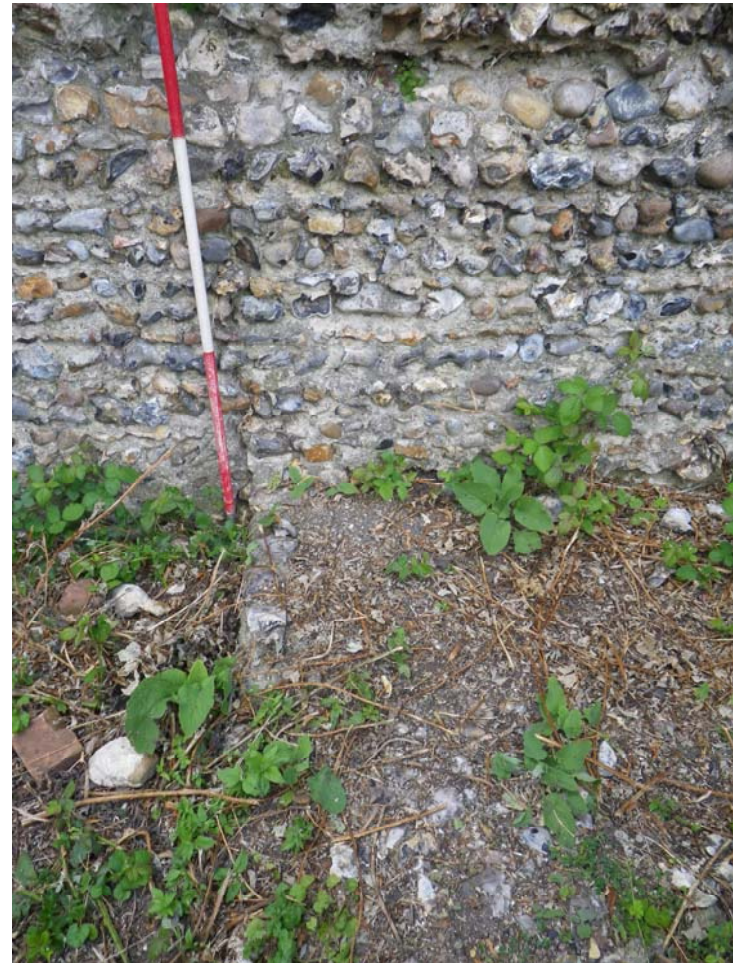
Plate 10. Interior of the north wall of chambers 1 and 2. The scale is positioned against the west face of the central sub wall. The unbroken flint work to the right of the scale demonstrates that the stub wall did not rise above floor level.

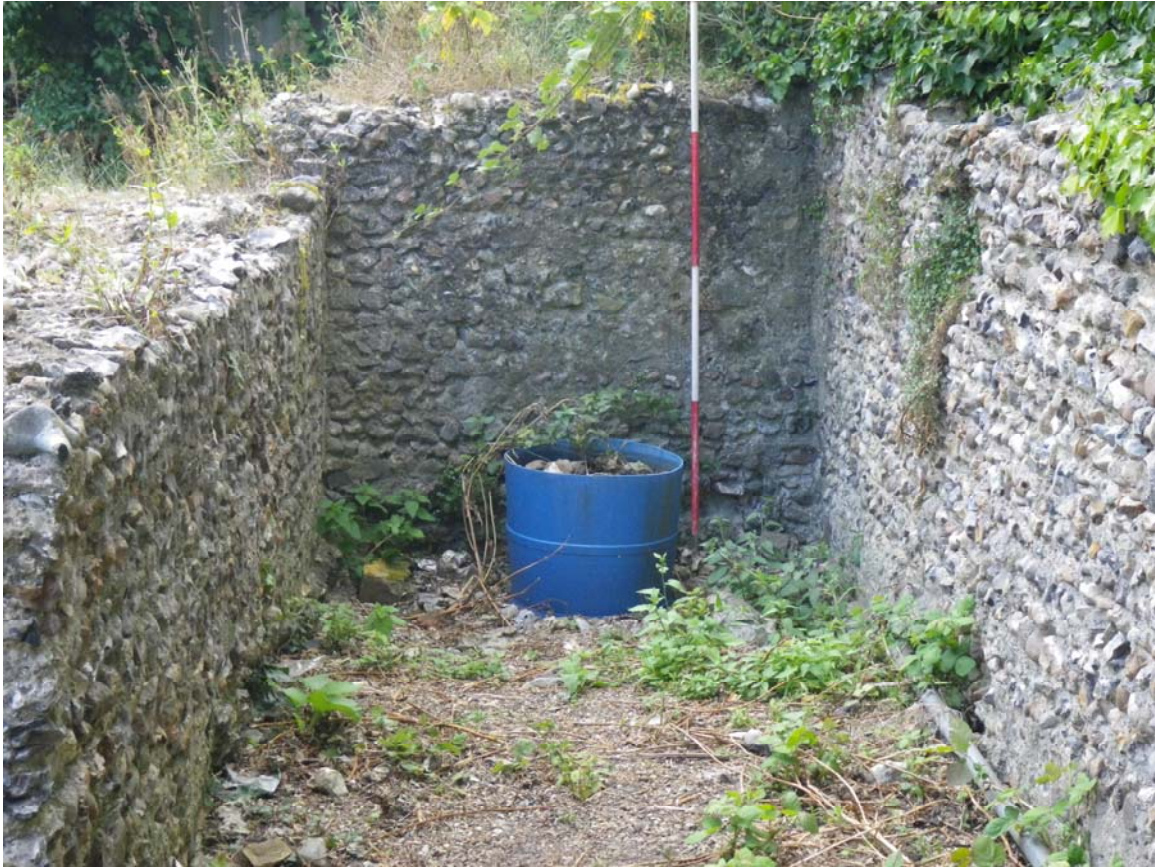
Plate 11. Interior of the west wall of the chamber 1. The internal corners of chamber 1 and 2 are constructed entirely of flint and differ from the construction method of the corners in the west tower.

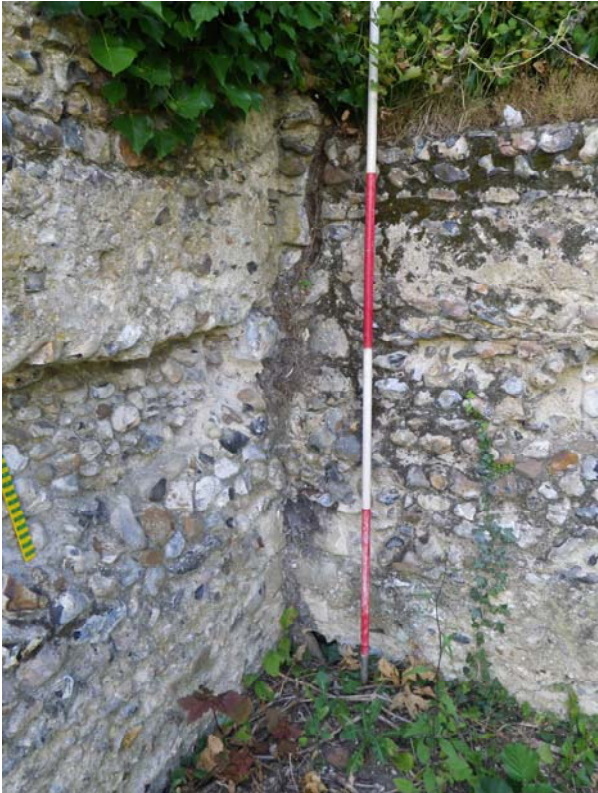
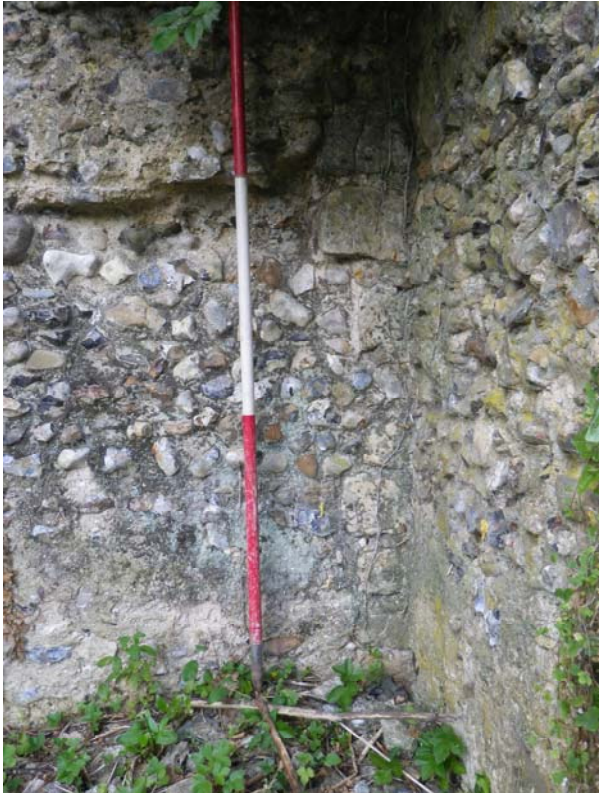
Plate 12. The internal north corners of the west tower are constructed with stone quins that stitch the corners together. The walls of the NW corner (left) has been refaced obscuring the quins but a full set are visible on the NE one (right).

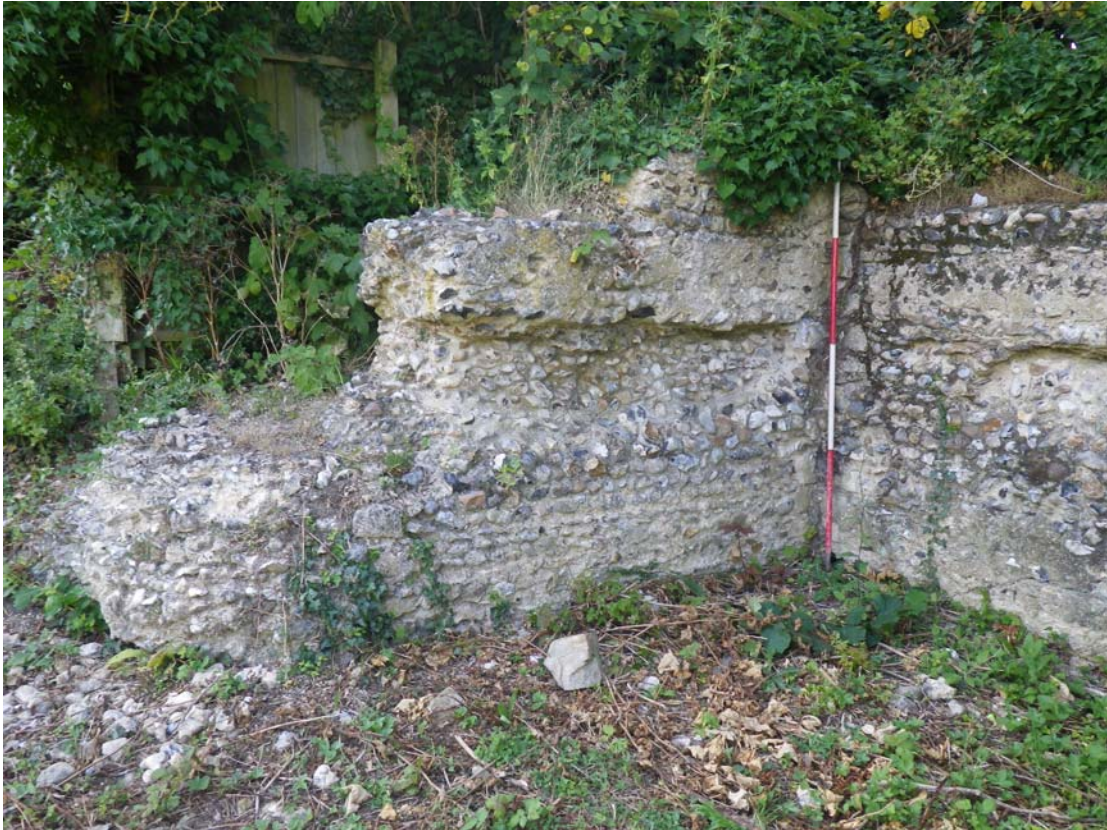
Plate 13. The west wall of the west tower showing horizontal coursing on the lower part of the wall and a horizontal gouges at mid-height similar to ones seen cut into the wall faces in other part of the bailey wall. The south wall of the tower has been truncated at ground level but the stone quoins (partly obscured by ivy) in the wall face show the position of the internal corner.

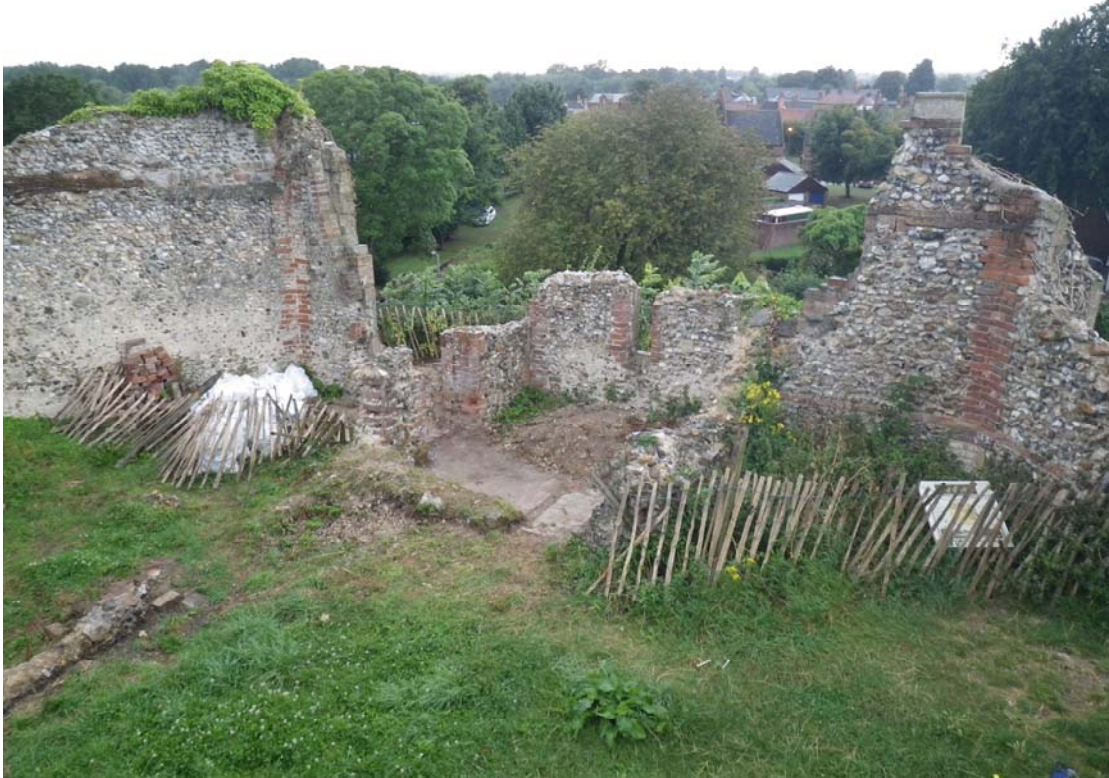
Plate 16. General view of the remains of the dwelling constructed during 1844 in the south half of Kerrison's Folly.
