## ARCHAEOLOGICAL MONITORING REPORT

SCCAS REPORT No. 2012/182	Parish: Nayland with Wissington
<b>Loretto, 6 Church Lane</b>  <b>NYW 053</b>	Planning Application No.: B/12/00053/FHA/JD
	HER Event No.: NYW 053
Address: Loretto 6 Church Lane Nayland with Wissington	Grid Reference: TL 9761 3429
	Number of Site visits: 1
	Date of visit: 19th November 2012

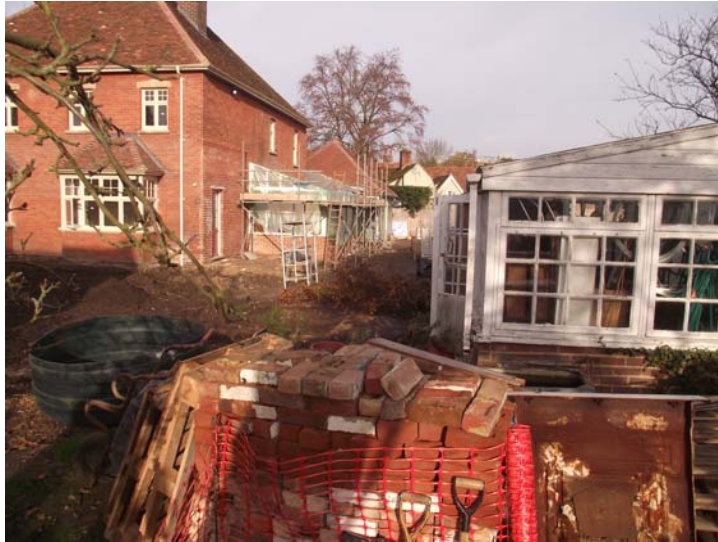
Unfortunately the Archaeological Service was not contacted during the digging of footings or service runs (PIs 1 & 2). A short segment of service trench associated with an adjacent property (but within the garden of Loretto) could be viewed however and this was recorded (Fig. 2).

Plate 1. View looking north showing extension under construction (with scaffolding) with new build behind
