**Barn and Outbuildings at
Mulletts Farm,
Barking, Suffolk
BRK 128**

Historic Building Record

Barn and Outbuildings at Mulletts Farm, Willisham Road, Barking Tye, Suffolk

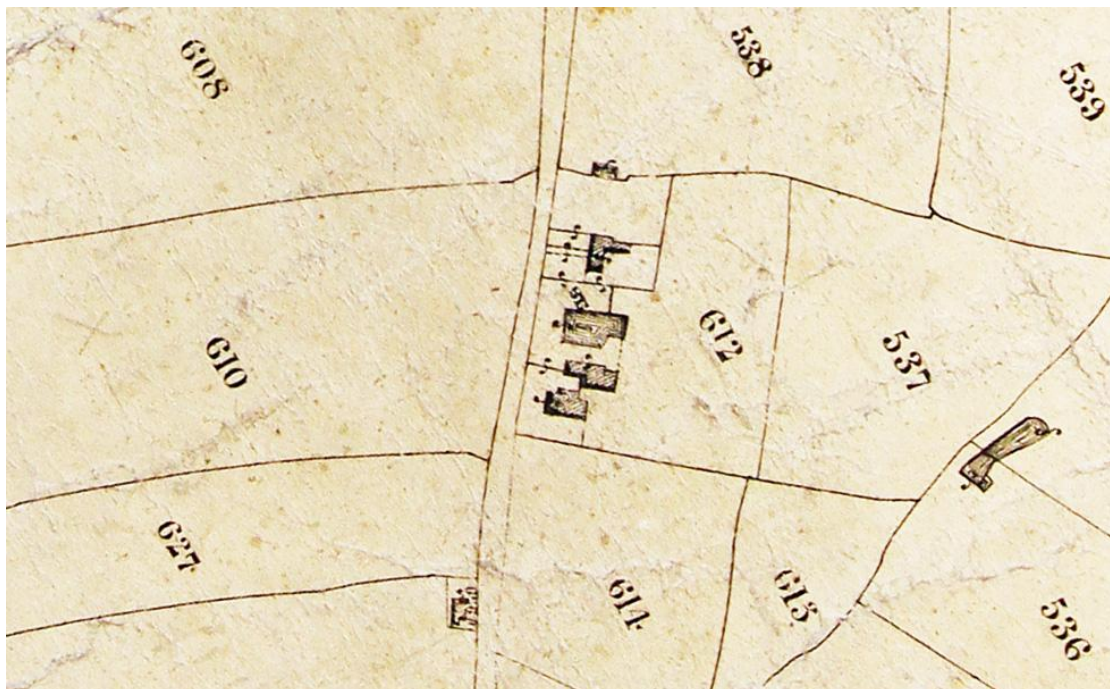
Figure 2a. Detail of the 1842 tithe map, reoriented to show north in the usual direction. The barn is shown to the south of the site with its rear lean-to and (probably) an additional small shed adjoining its western gable. The farm was occupied by Samuel Mullet and the site is described in the apportionment as ‘buildings and yards’ (611) with ‘Home Meadow’ (612) on the east.

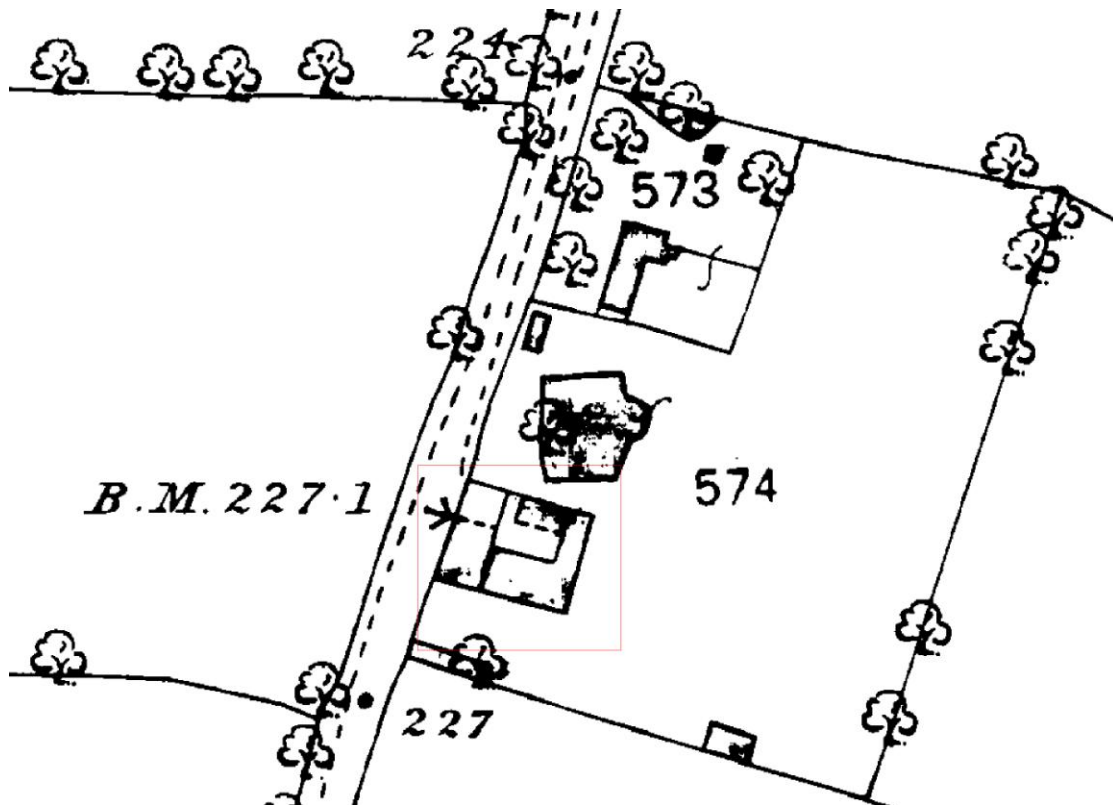
Figure 3. The First edition 25 inch Ordnance Survey of 1886. The recently demolished clay-walled sheds to the west the barn had appeared since 1842, with an open-sided shelter-shed to the north (indicated by the broken line of its southern elevation).

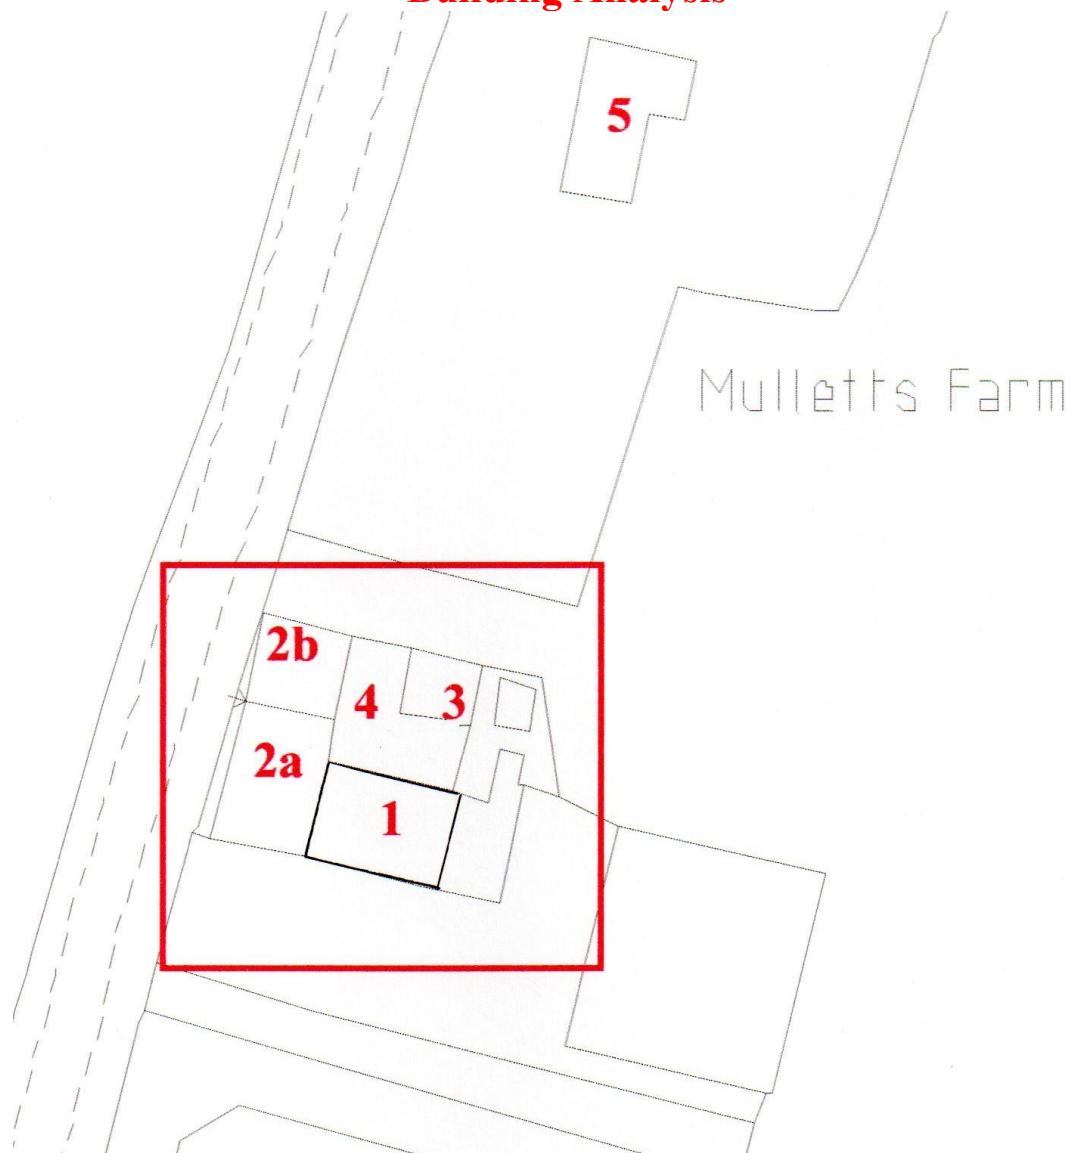
Figure 5

Ground plan of the farm buildings identifying each area with a number for ease of reference in the text and photographic record.

1. An early- to mid- 16th century timber-framed and weatherboarded threshing barn in three bays with a 20th century shallow-pitched roof of corrugated iron. Entered from the south with evidence of a small rear door facing the farmhouse. A rear (northern) lean-to was probably added before the end of the 16th century but was widened and largely rebuilt in the 19th century. Both gables were also rebuilt in the 19th century but the open trusses and the rest of the wall framing survives largely intact with all but one stud at least partly intact. The barn was originally infilled with wattle-and-daub and rendered externally with clay.

2. A mid-19th century roadside shed consisting partly of shuttered clay with brick dressing. The northern section (2b) was rebuilt in cement block-work during the mid-20th century and the rest had been largely demolished prior to inspection leaving only fragments of the outer walls intact.

3. **An open-sided cattle shelter-shed shown on the Ordnance Survey of 1886 but rebuilt in cement block-work, corrugated iron and re-used telegraph poles during the mid-20th century to leave only a section of 19th century brickwork in the western gable.**
4. **A cattle yard enclosed by cement block walls of the mid-20th century.**
5. **A grade II-listed timber-framed and rendered farmhouse consisting of a late-15th century open hall with a heavily sooted crown-post roof (the rectangular crown-post with chamfered edges and (missing) braces to the collar purlin only) flanked by a parlour bay on the north and a service bay on the south. A later chimney has been inserted into the cross-passage and the service bay converted into a parlour.**
