**Farm Buildings at
Goldings Farm,
Sotterley, Suffolk
SOT 014**

Historic Building Record

Farm Buildings at Goldings Farm, Smiths Road, Sotterley, Suffolk

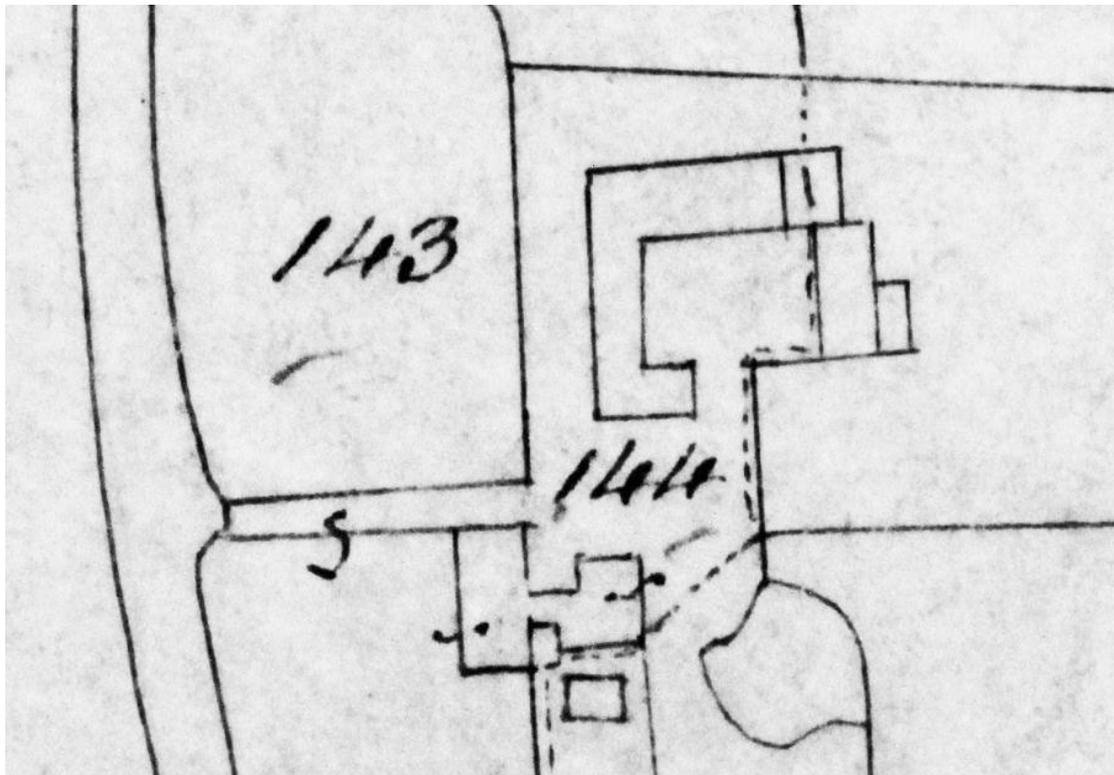
Figure 2a. Detail of the 1843 title map. The farm buildings form a U-shaped yard to the south of the barn much as today, but the eastern range differs significantly from the current building on the site and the eastern range probably represents the predecessor of the existing shelter-shed and granary. The broken line marks the parish boundary.

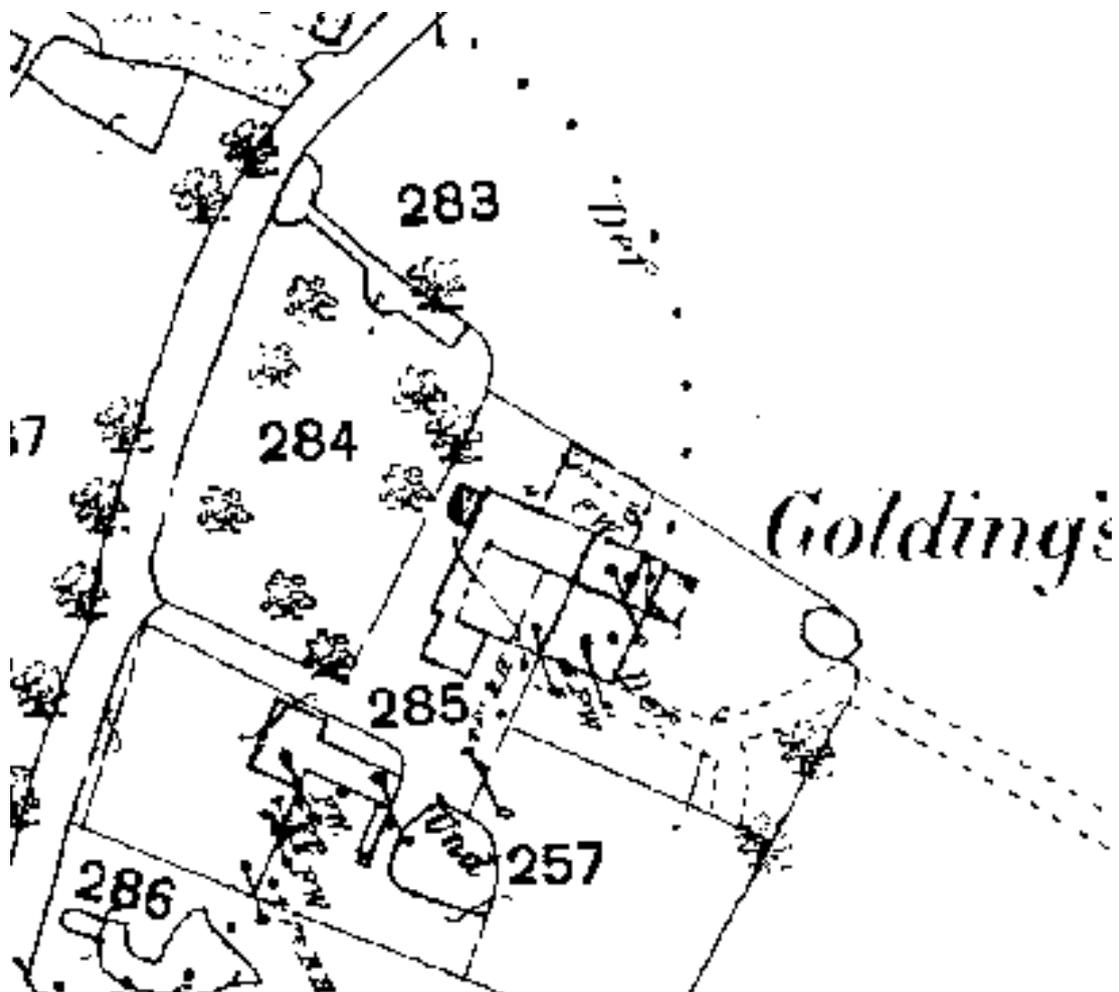
Figure 3. First edition Ordnance Survey of 1884, showing the farm buildings much as they remain today. An additional animal yard and shelter-shed lay to the north of the barn, and an open shed adjoined its eastern gable.

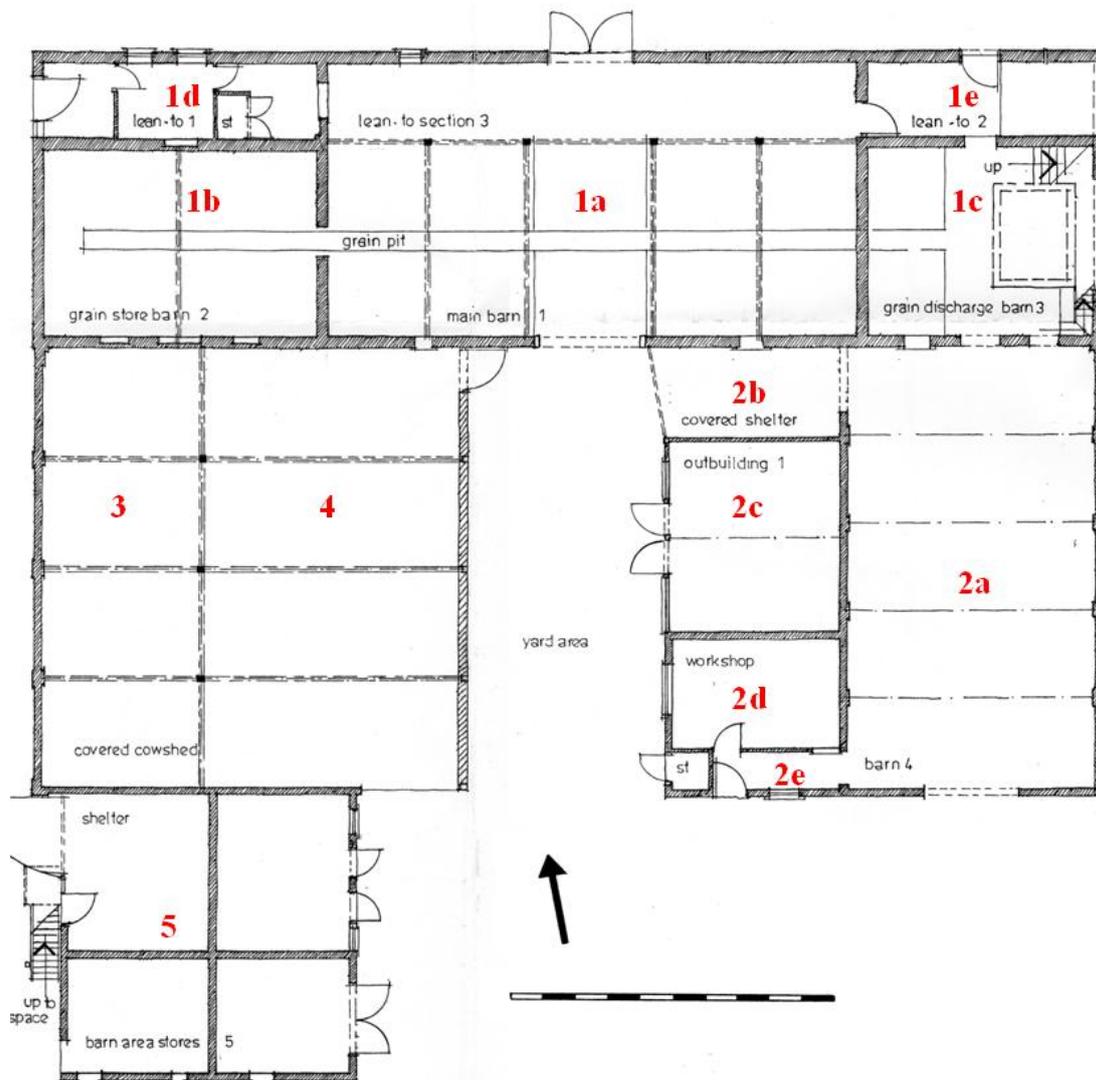
Figure 6

Ground plan of the farm buildings identifying each area with a number for ease of reference in the text and photographic record.

southern gable. The enclosed shed was entered by an original door at the southern end of its western elevation but also contains evidence of a wide entrance in its southern gable that was subsequently blocked. In the 20th century these three areas were subdivided with cement-block partitions as shown in figure 6, and a series of concrete stalls were inserted into the eastern shed to convert it into a milking parlour. At the time of inspection an unusual 19th century painted tumbrel (two-wheeled farm cart) made by W & H Ringer of Sedgeford near Hunstanton in north-west Norfolk was stored in the northern bay of the shelter-shed (2b). This building is not depicted on the tithe map of 1843 but had appeared by the time of the First Edition Ordnance Survey in 1884.
