Clare Priory Church new extension
Clare Priory
CLA 037

Archaeological Monitoring Report

SCCAS Report No. 2013/039

Date of Fieldwork: February 2011 and November 2012

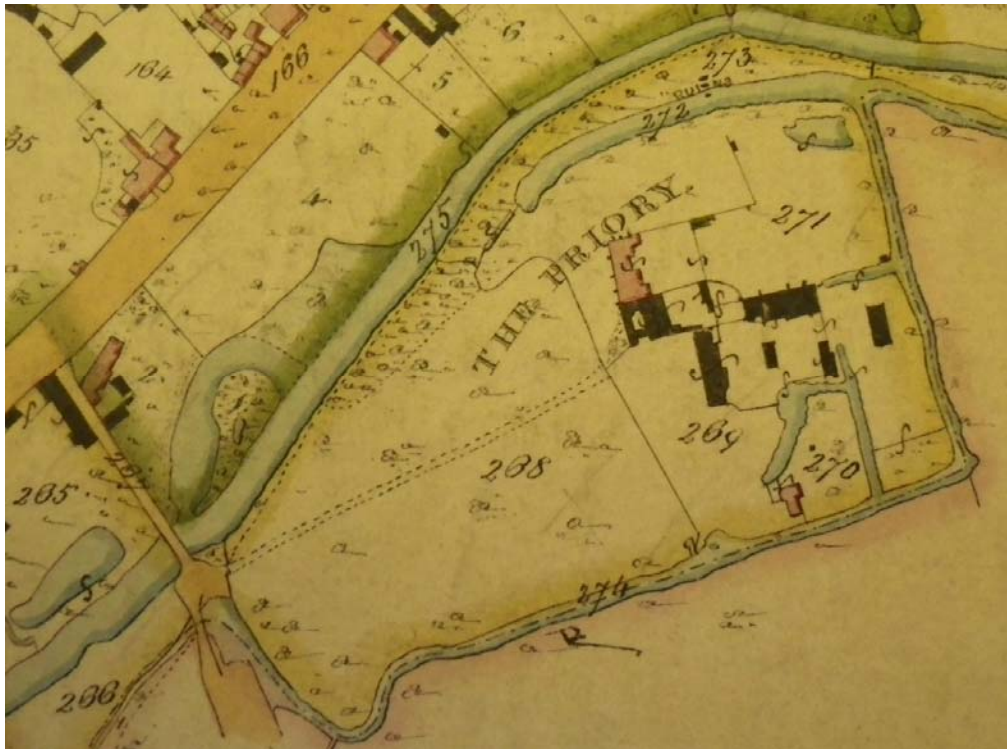
Clare Priory as shown on the tithe map of 1846. The Prior's house, converted to a dwelling, is shown in pink with various accompanying out-buildings in black including the infirmary in the centre of the complex. The apportionment records that the property is owned by Caroline Barker and occupied by 'herself and others'. 271 is listed as 'Mansion House', 270 as 'cottage yard and lodge' and 269 as 'yards, stables and buildings'. The watercourse, 275, is the new cut excavated to power a water mill to the east; the earlier course of the River Stour (274) forms the rectilinear enclosure to the south of the Priory buildings and defines the county boundary. Note the channel off the Stour leading to the west end of the infirmary/dorter that would have flushed through the building when it functioned as the reredorter.

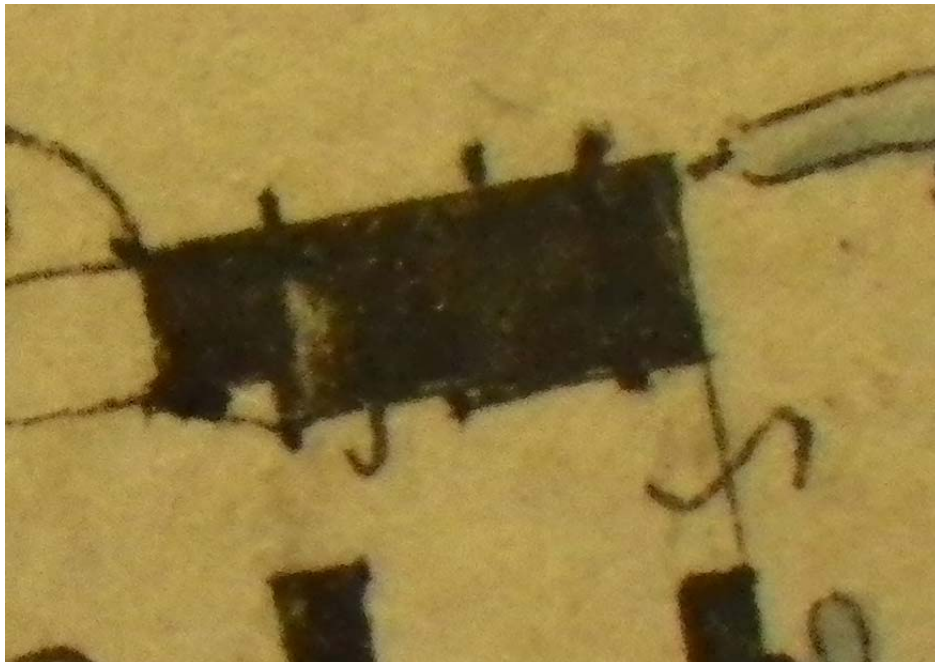
Figure 2. Details from Tithe map for the parish of Clare 1846 (SRO ref IR 30/33/105)

Detail from the 1846 tithe map showing the building as both longer and wider with the addition of extra bays on the east and south sides; a footprint similar to the one represented in Joshua Kirby's engraving of c.100 years earlier (Fig. 4). The apparent location of the corner buttresses inward of the eastern (right) end of the building suggests an extension has been added although there is no sign of it on the east face or below ground in the limited view offered by the monitored excavations.

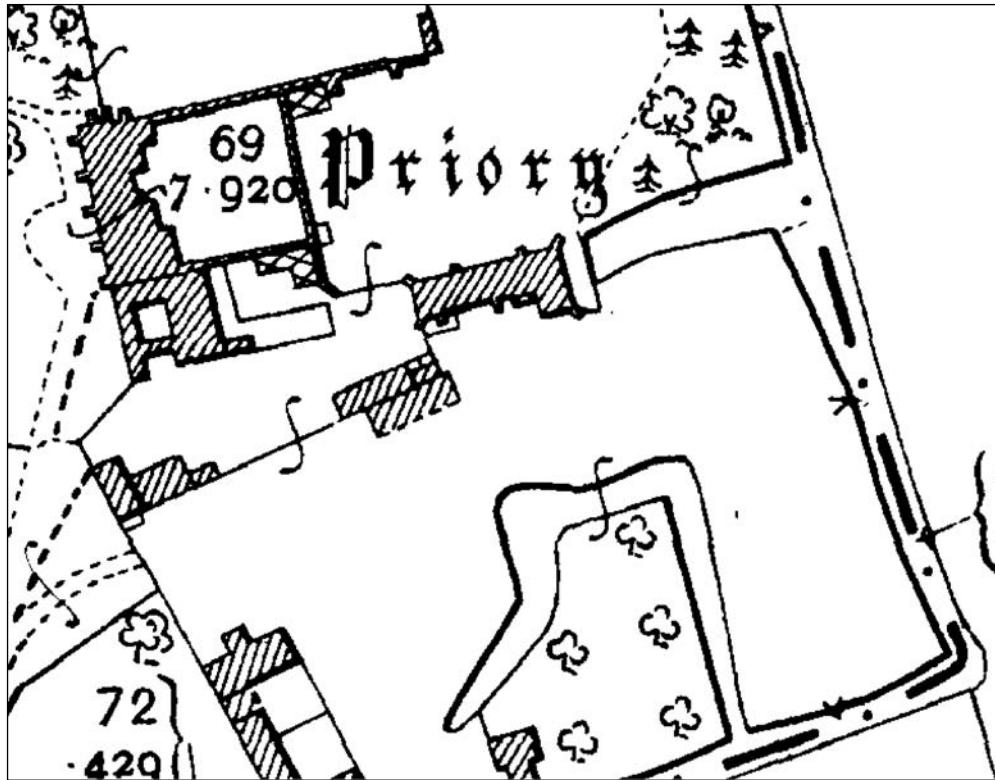
Figure 3. Second edition Ordnance Survey Map, published 1904 which depicts the 'church' unchanged from the first edition map published in 1876 and in the form we see it today. Note that the stepped profile of the south wall, shown on the tithe map (Fig. 2) has gone and the NE and SE corner buttresses are now shown on the end of the building.

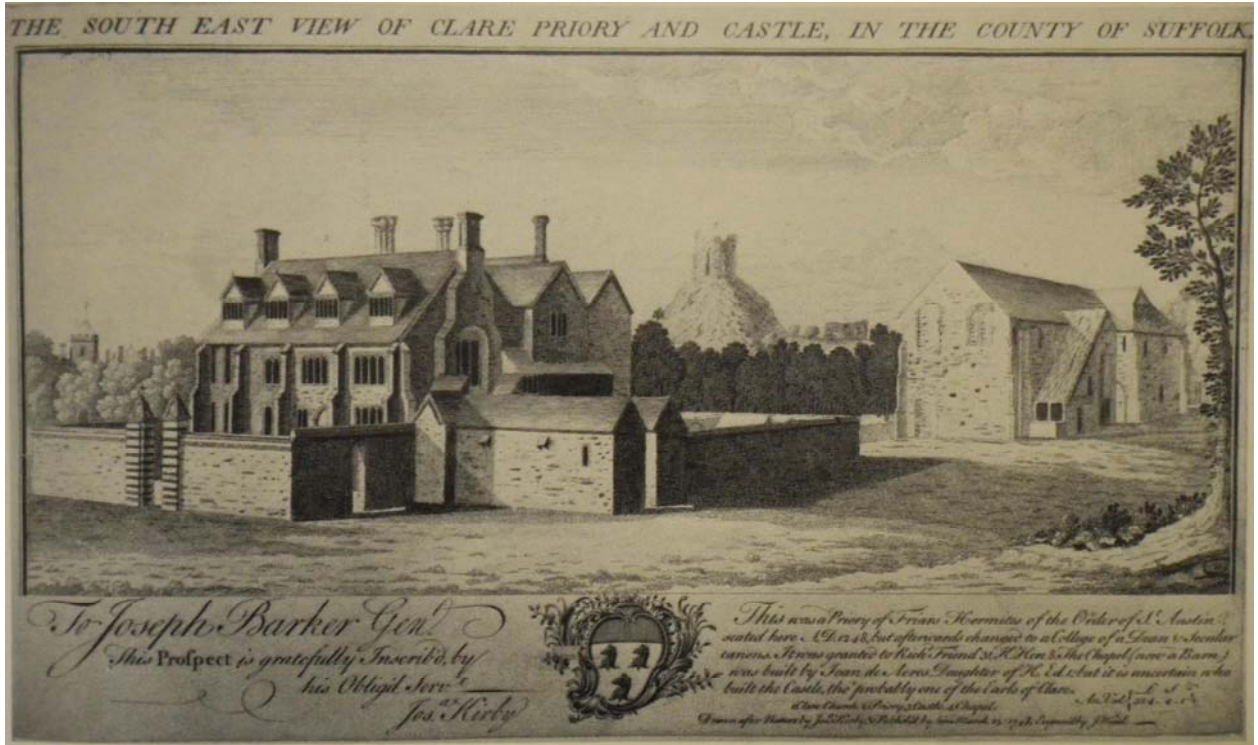
Figure 4. Joshua Kirby's engraving of Clare Priory in 1748 showing the converted remains of the Prior's house in the foreground on the left and the 'church' to right. The south side of the church is shown complete with an outshot stair, beneath the long sloping roof and a hip-roof with gablet over the cross-wing (two features which no longer exist) The building footprint looks the same as that shown on the tithe map 100 years later. (SRO ref HD526/32/Farrer collection).

walls when something thin and flat was required. The arcade of arches in east wall of the cross-wing identifies it as the reredorter and it is suggested (by layout convention) that the main part of the building contained a dorter (dormitory) and an infirmary on the first floor. The first floor was accessed by at least two doors: one in the west gable, (which has since been converted to a window) and a second in the south wall near the junction with the cross-wing. Physical evidence of this second door no longer exists but it was approached by an external stair enclosed within an out-shot which rose against the south wall and is shown on Joshua Kirby's engraving of 1748 (Fig. 4).

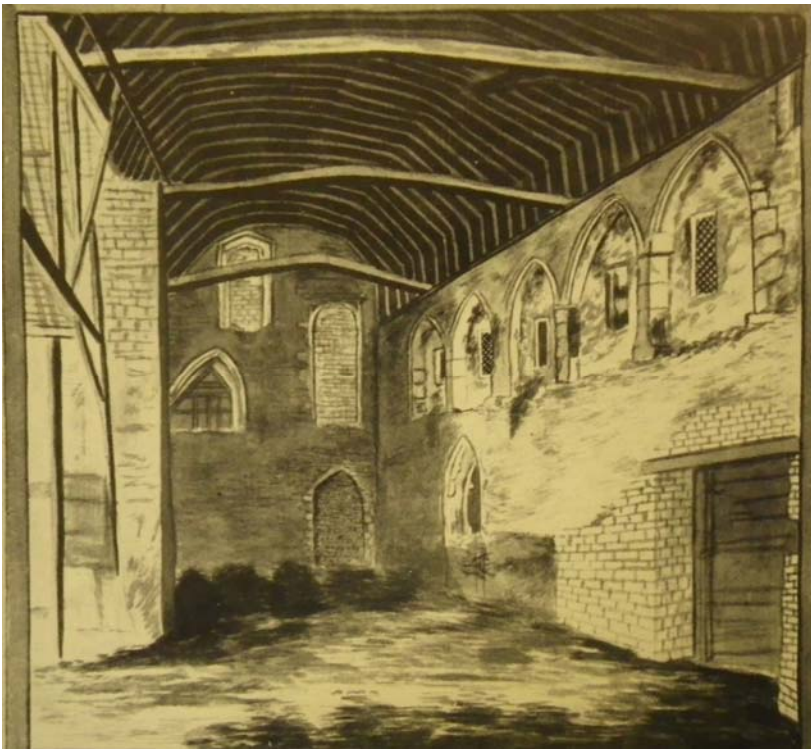
Left: A drawing of the interior of the priory from 1791 published in Thomas Walford's *History of Clare* (SRO ref 1511/67/1). It shows the first floor no longer in place, the small inserted door in the north wall on the right (surrounded by brickwork) and the large barn doors on the left. Note through the open doors on the left the timber-frame work supporting the outshot roof can be seen. Any doors to this opening must have been on the front of the outshot cum porch.

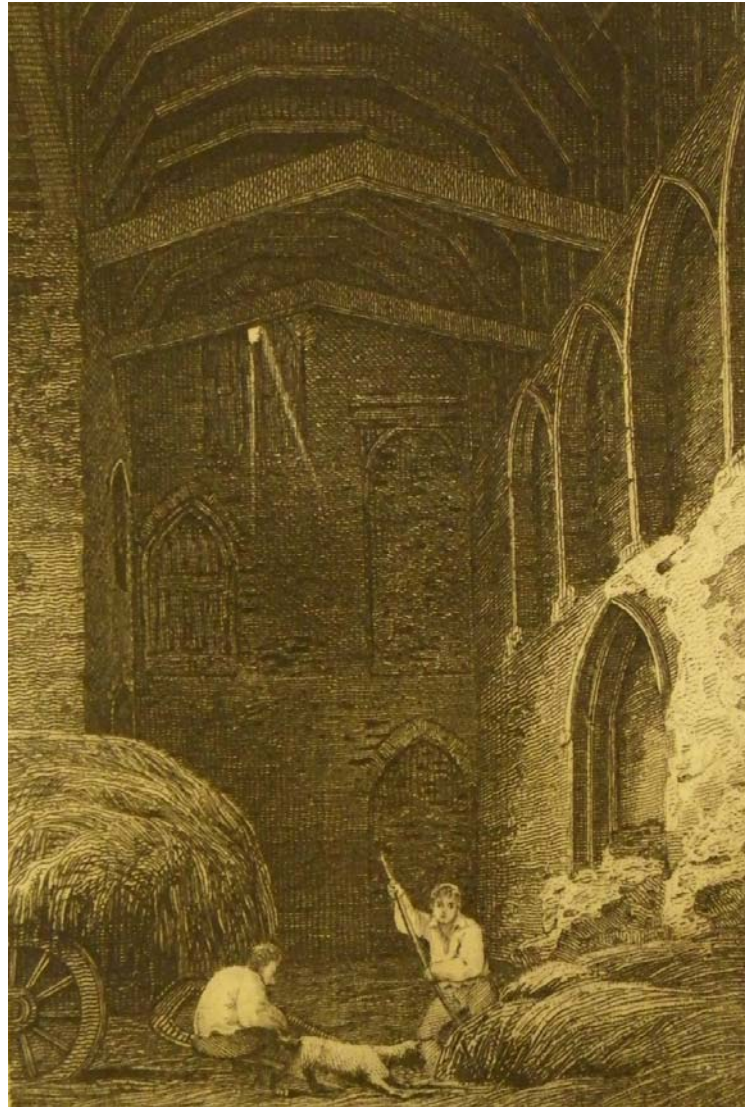
Figure 5. Antiquarian engravings showing the interior of the church as a barn

John Grieg's illustration from 1810 (SRO ref HD526/32/Farrer collection). Note the cranked tie beams spanning the building (often associated with crown post roofs) and the unusual arrangement of openings in the end gable wall which seem to suggest a door above the eave height of the long walls (in contradiction of the tie-beam evidence).

The stairs and the first floor had been removed by 1791 when the interior of the building is shown as a single open space (Fig. 5) but the walls of the out-shot appears to have been retained, and it functioned as a porch, until after 1837 when its outline is still

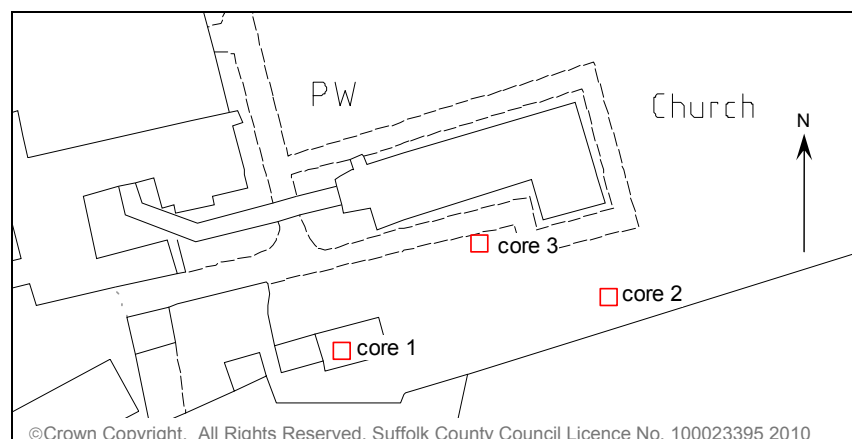
Figure 1. Location of geo-technical boreholes

Three boreholes were observed (Fig. 1), but these were of limited archaeological value due their small diameter. Only the upper part of each soil profile could be assessed and no bonded masonry was encountered.

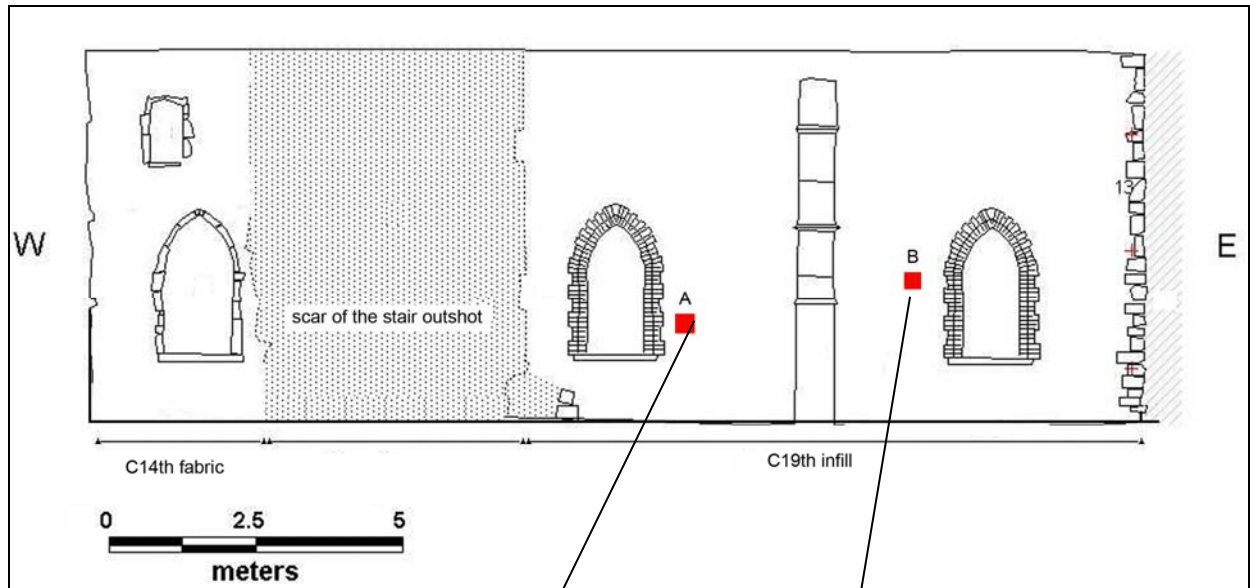
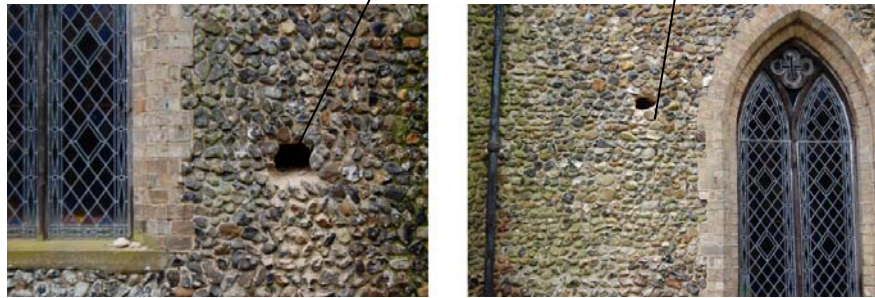
Locations of Test-holes A and B

The positions of the test-holes are shown on Figure 2. Each hole measured c.200mm x 200 mm and were cut out by the monitoring archaeologist using a combination of a hammer and bolster, and a drill. Hole A penetrated the full depth of the wall. Hole B was 200mm-300mm deep and was aborted once it was established that the core material was the same as that seen in Hole A.

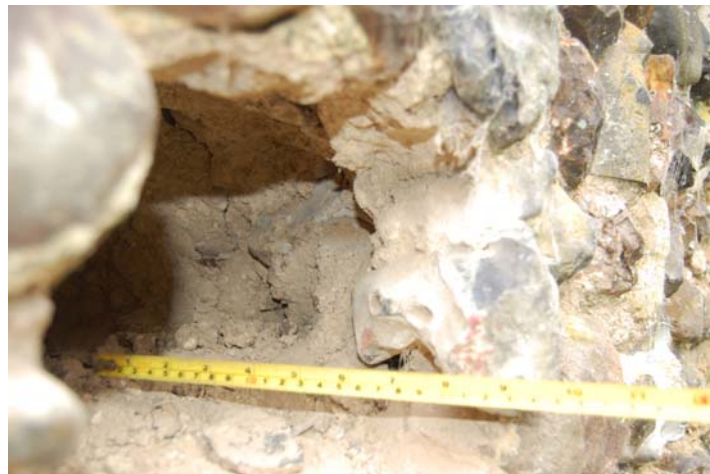
Detail of test hole A

The test-holes demonstrate that the south wall is a traditional construction, with a flint face over a bonded flint rubble core. The core and face work are contemporary and relatively recent. The post medieval date for the infill section is supported by the dating of the ceramic building material and glass recovered from the core.
