ARCHAEOLOGICAL MONITORING REPORT

SCCAS REPORT No. 2013/137	Parish: Polstead
St Mary's Church, Polstead. Installation of an extension to the drains drain to the west of the	Planning Application No.: N/A
	OASIS No.
	HER Event No.: PLS 044
Address:	Grid Reference: TL 9888/3808
	Number of Site visits: 2
	Date of visits: 22-23 October 2013

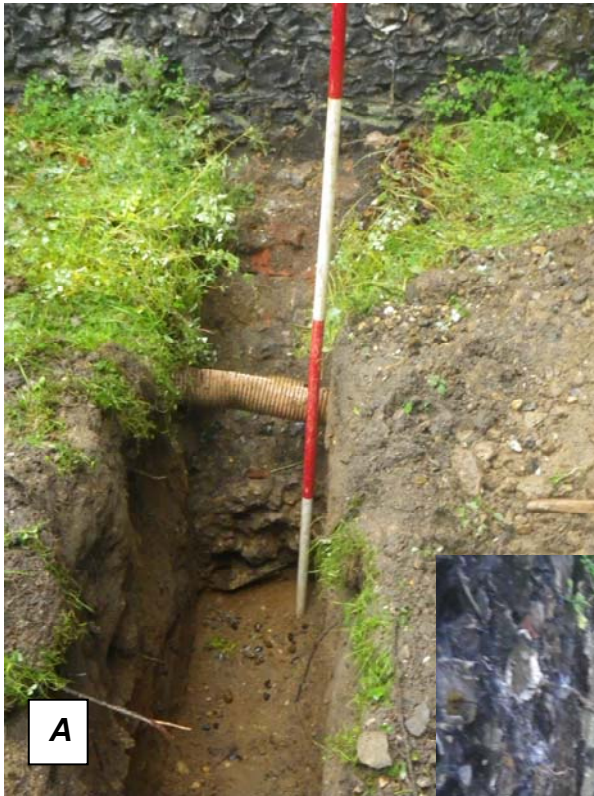
At the base of north aisle wall the trench uncovered a substantial buried footing (S3 Figs

The top of the footing was c.650mm-700mm above the floor level inside the north aisle. The floor levels inside the church have however been lowered by between 150-400mm since the church was first built so that the carved 'foot stones' of the Norman arcade piers and west door are now perched above the ground (Pls C and D); the exposed foundations beneath them having been dressed with tiles then plastered to give the illusion of a finished face.

A) Footing beneath the west wall of the aisle. The base of the footing was c.1m below the existing ground surface and sat on natural sand; the whole depth of the footing was exposed within the trench footing. The orange pipe is part of the *french drain* that surrounded the church at the base of the wall and cut into the top of the footing
