# BUILDING SURVEY REPORT

## ST MARGARET'S CHAPEL, WENHASTON with MELLS HAMLET WMH 003

A REPORT ON THE BUILDING RECORDING AND SITE  
INVESTIGATIONS, 2007

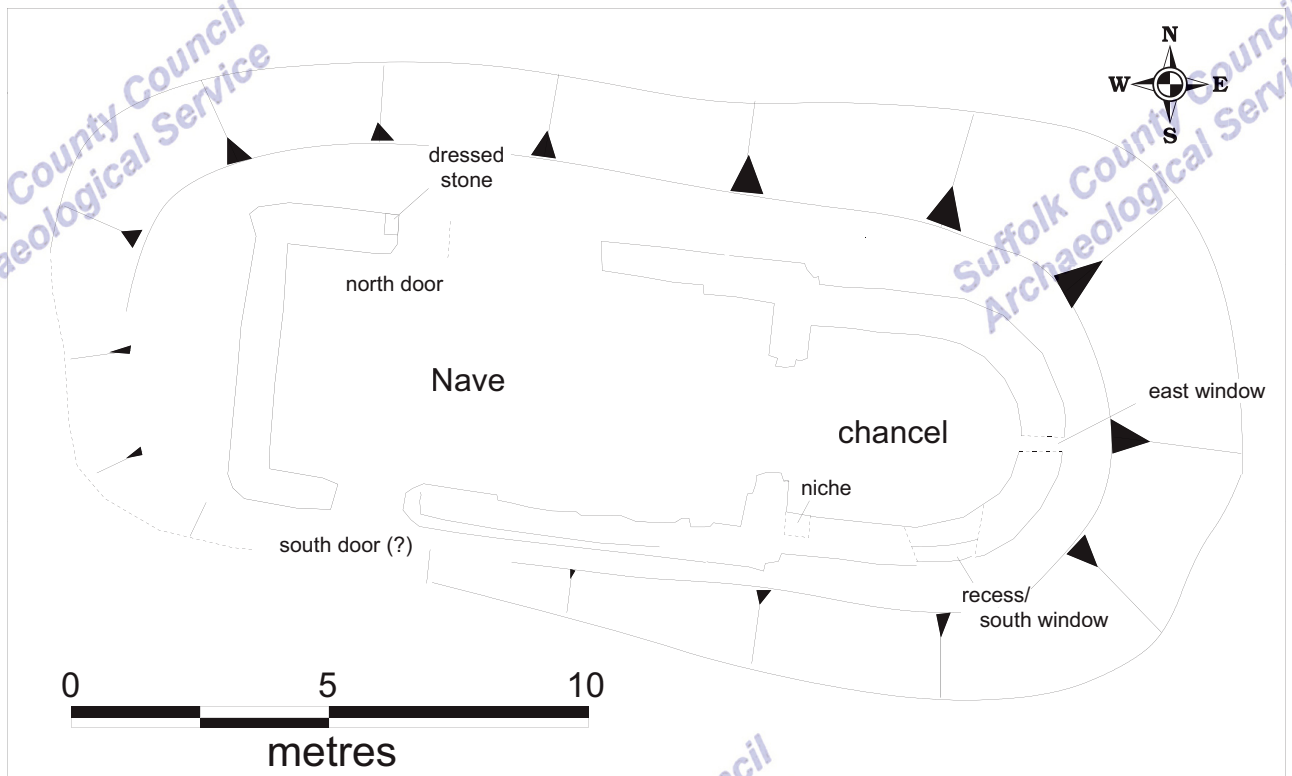
Figure 2. Chapel Ground Plan

The surveyed plan of the chapel is shown on figure 2 and described below. The subsoil is gravel sand and the ground around the chapel has been quarried away leaving the building on an elevated platform, the sides of which drop steeply from the base of the chapel walls. This is particularly evident on the north-east side of the building where the change in ground level is 1.7m.

The chapel has a two-celled plan with an apsidal end; the wall line is stepped with the chancel being slightly narrower than the nave. The nave measures 9.4m x 4.5m internally and the chancel 3.70m x 4.20m, all of the external walls were 950mm thick and the cross wall 700mm. The walls are constructed of a mix of large, unworked rounded flint cobbles and brown sandstone pebbles, these are laid in well defined courses and bonded with a lime mortar. The flints have been selected and are quite uniform in size. A fine grit sand has been used in the mortar but the chalk in the lime is in quite large nodules, variations in the coarseness of the mix could be identified from lift to lift. The fabric of the walls is weathered so that the face of the flints project 3-4cms from the bedding mortar but in places inside the building, (above the arch, and below ground) small areas of near-flush pointing survive. This was applied secondary to the construction of the wall but in antiquity, and maybe the remains of an original rendered finish. The core of the wall is similar to the face, but uses less regular and smaller flints. The flints are laid in vague rows but are not as strongly coursed as the facework.
