# THE CHURCH OF ALL SAINTS CHURCH METTINGHAM MTT 044

A REPORT ON THE TOWER RECORDING, 2008

Tower recording: All Saints Church, Mettingham

SCCAS Report No. 2008/193

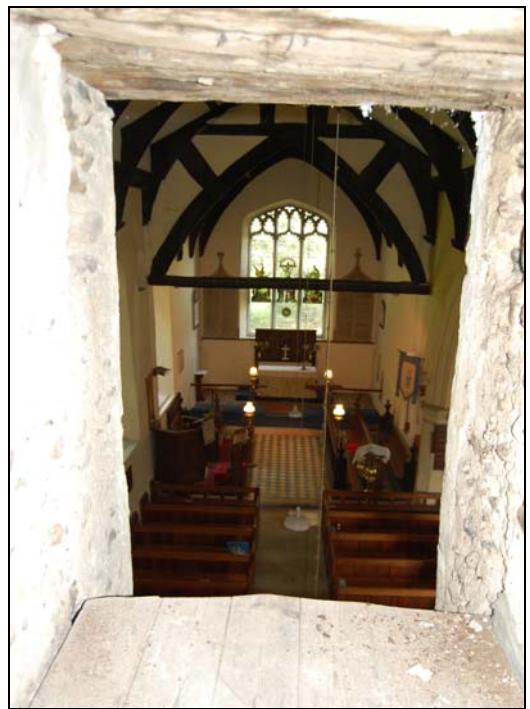
Figure 19. View of the altar from the tower room

The evidence shows that the tower room's original floor was level with the eaves height which places the room wholly above the nave and within its roof space. Although still connected to the nave the siting of the room just here rather than lower in the tower appears to be a deliberate separation of the more prosaic parts of the priest existence from his liturgical duties.
