**The Barn,
Pear Tree Farm,
Rumburgh,
Suffolk
RMB 014
Historic Building Record**

**Barn at Pear Tree Farm,
Aldous's Corner,
Rumburgh, Suffolk
(TM 339 810)**

An Archaeological Record

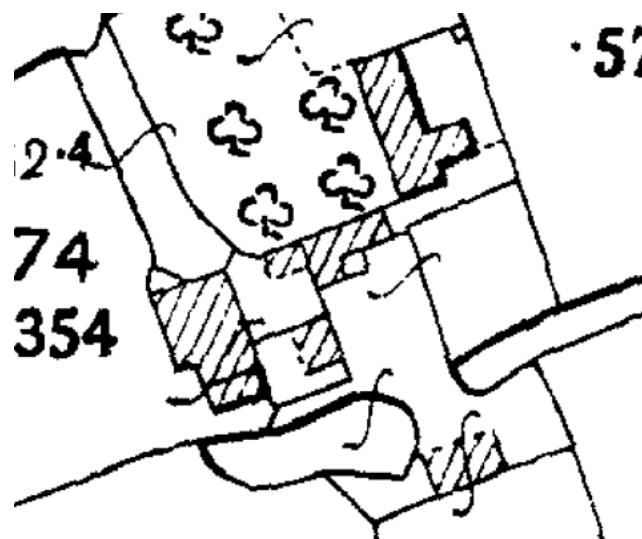
Figure 3
The Second Edition 25 inch Ordnance Survey of 1905, showing the buildings in more detail. The barn's western lean-to had yet to be extended to its southern gable, and the small southern brick stable adjoins an enclosed yard with a shelter shed on the east

The stable formerly adjoined a small enclosed yard to the east, with its own shelter shed (figure 3), but now abuts a block-work stable of the 20th century on the same site.
